**From:** [Owner]  
**Sent:** Wednesday, May 01, 2013 5:53 PM  
**To:** Bowman, T (NHTSA)  
**Subject:** Re: NHTSA complaint VOQ 10509674

Just wanted to reach you to re view the issue pertaining to the water Tank securement in your 2013 R-vision vehicle.

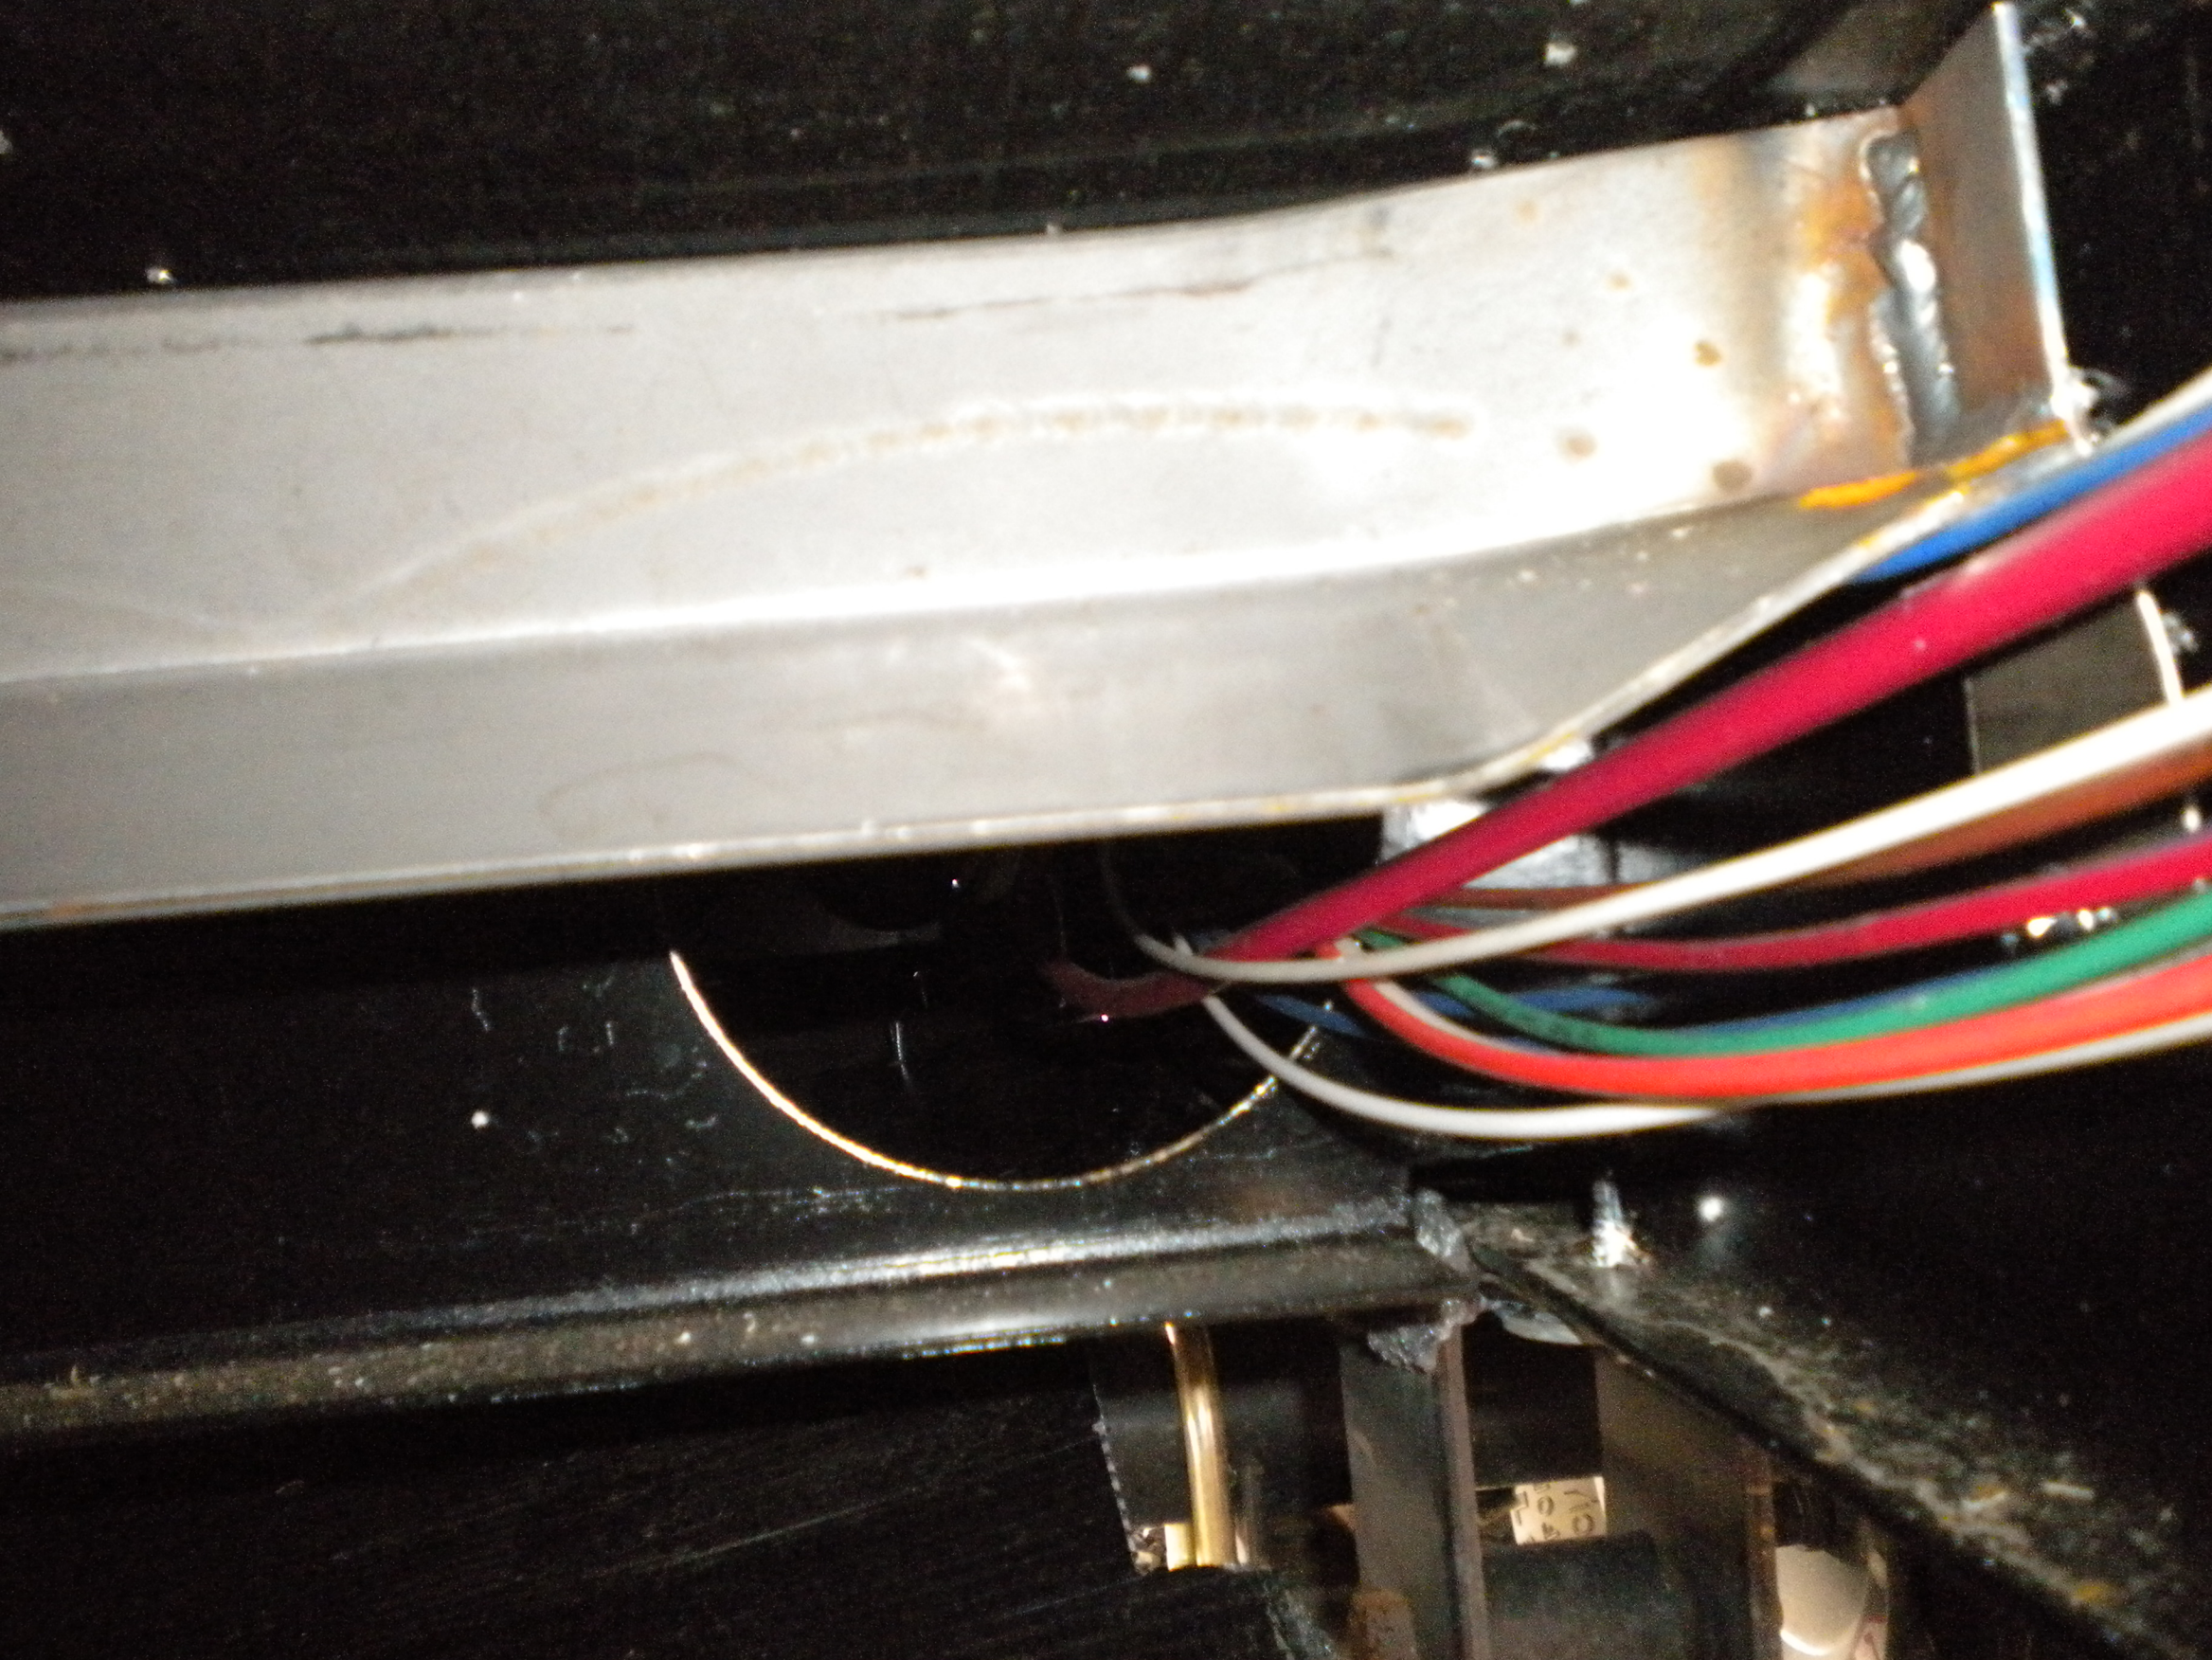
Photo 1066 shows how we found the tank. As you can see it has fallen completely off the bracket and through the underbelly.

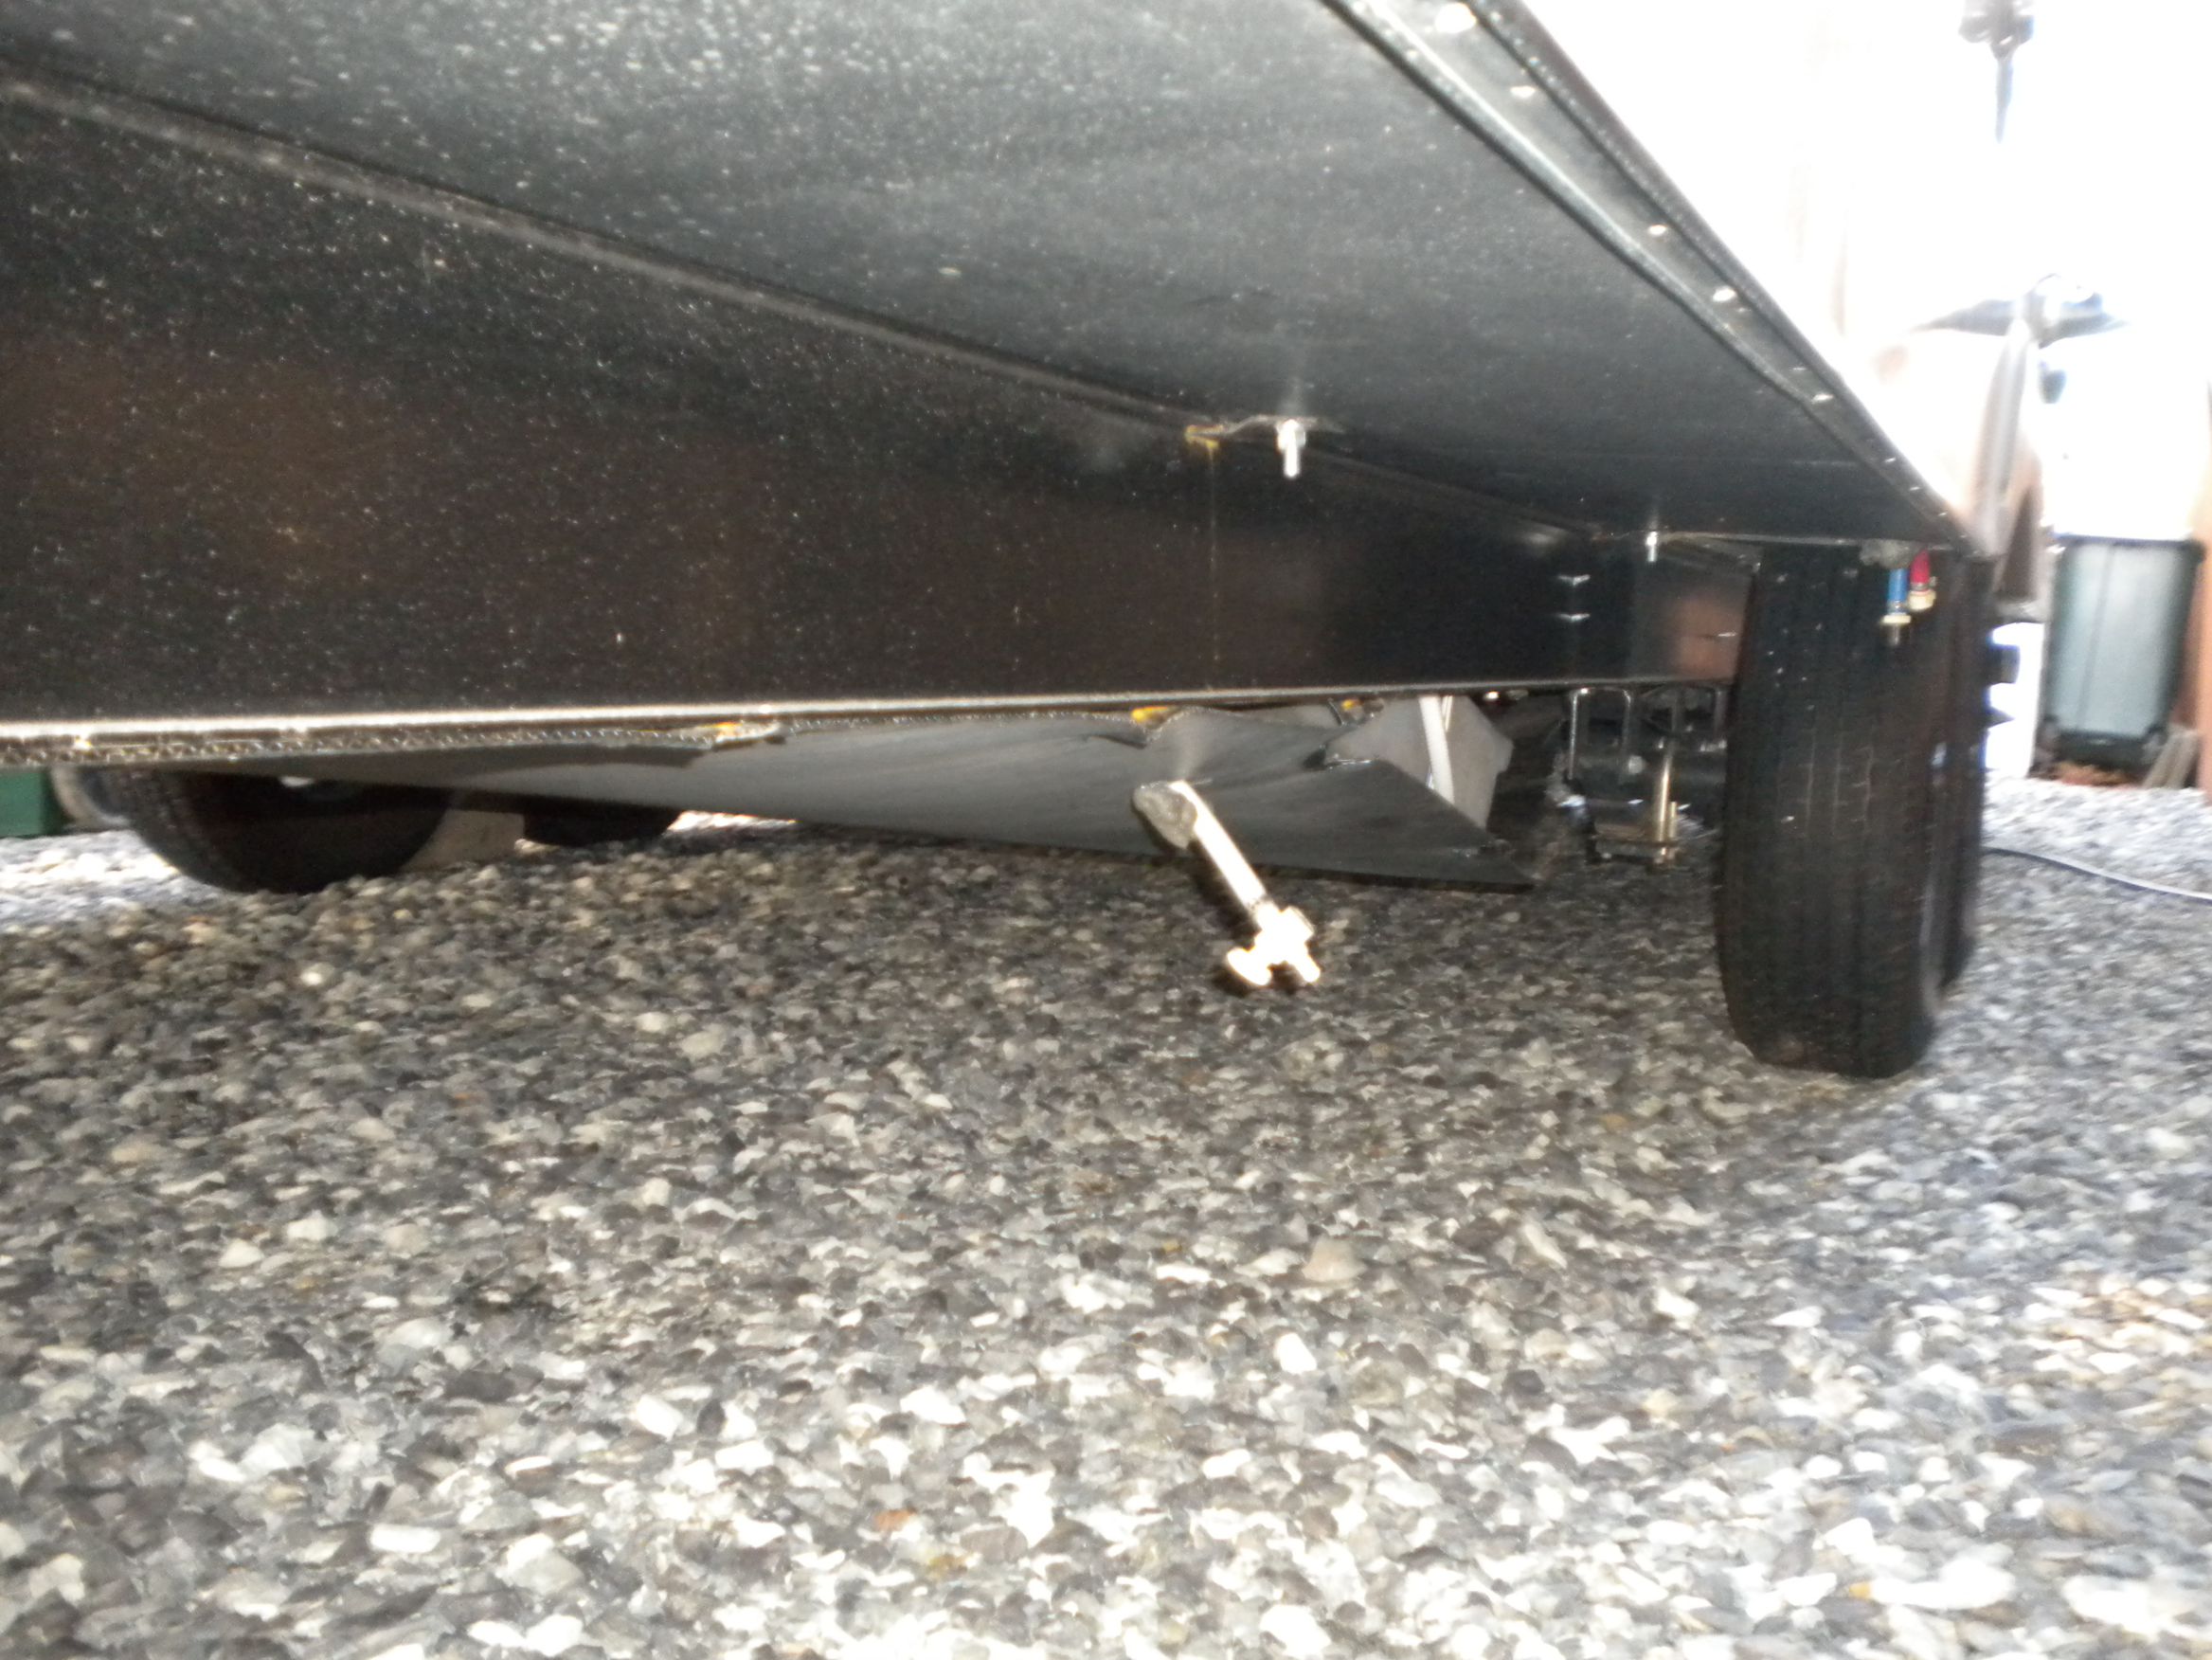
Photo1073 shows a closer side shot.

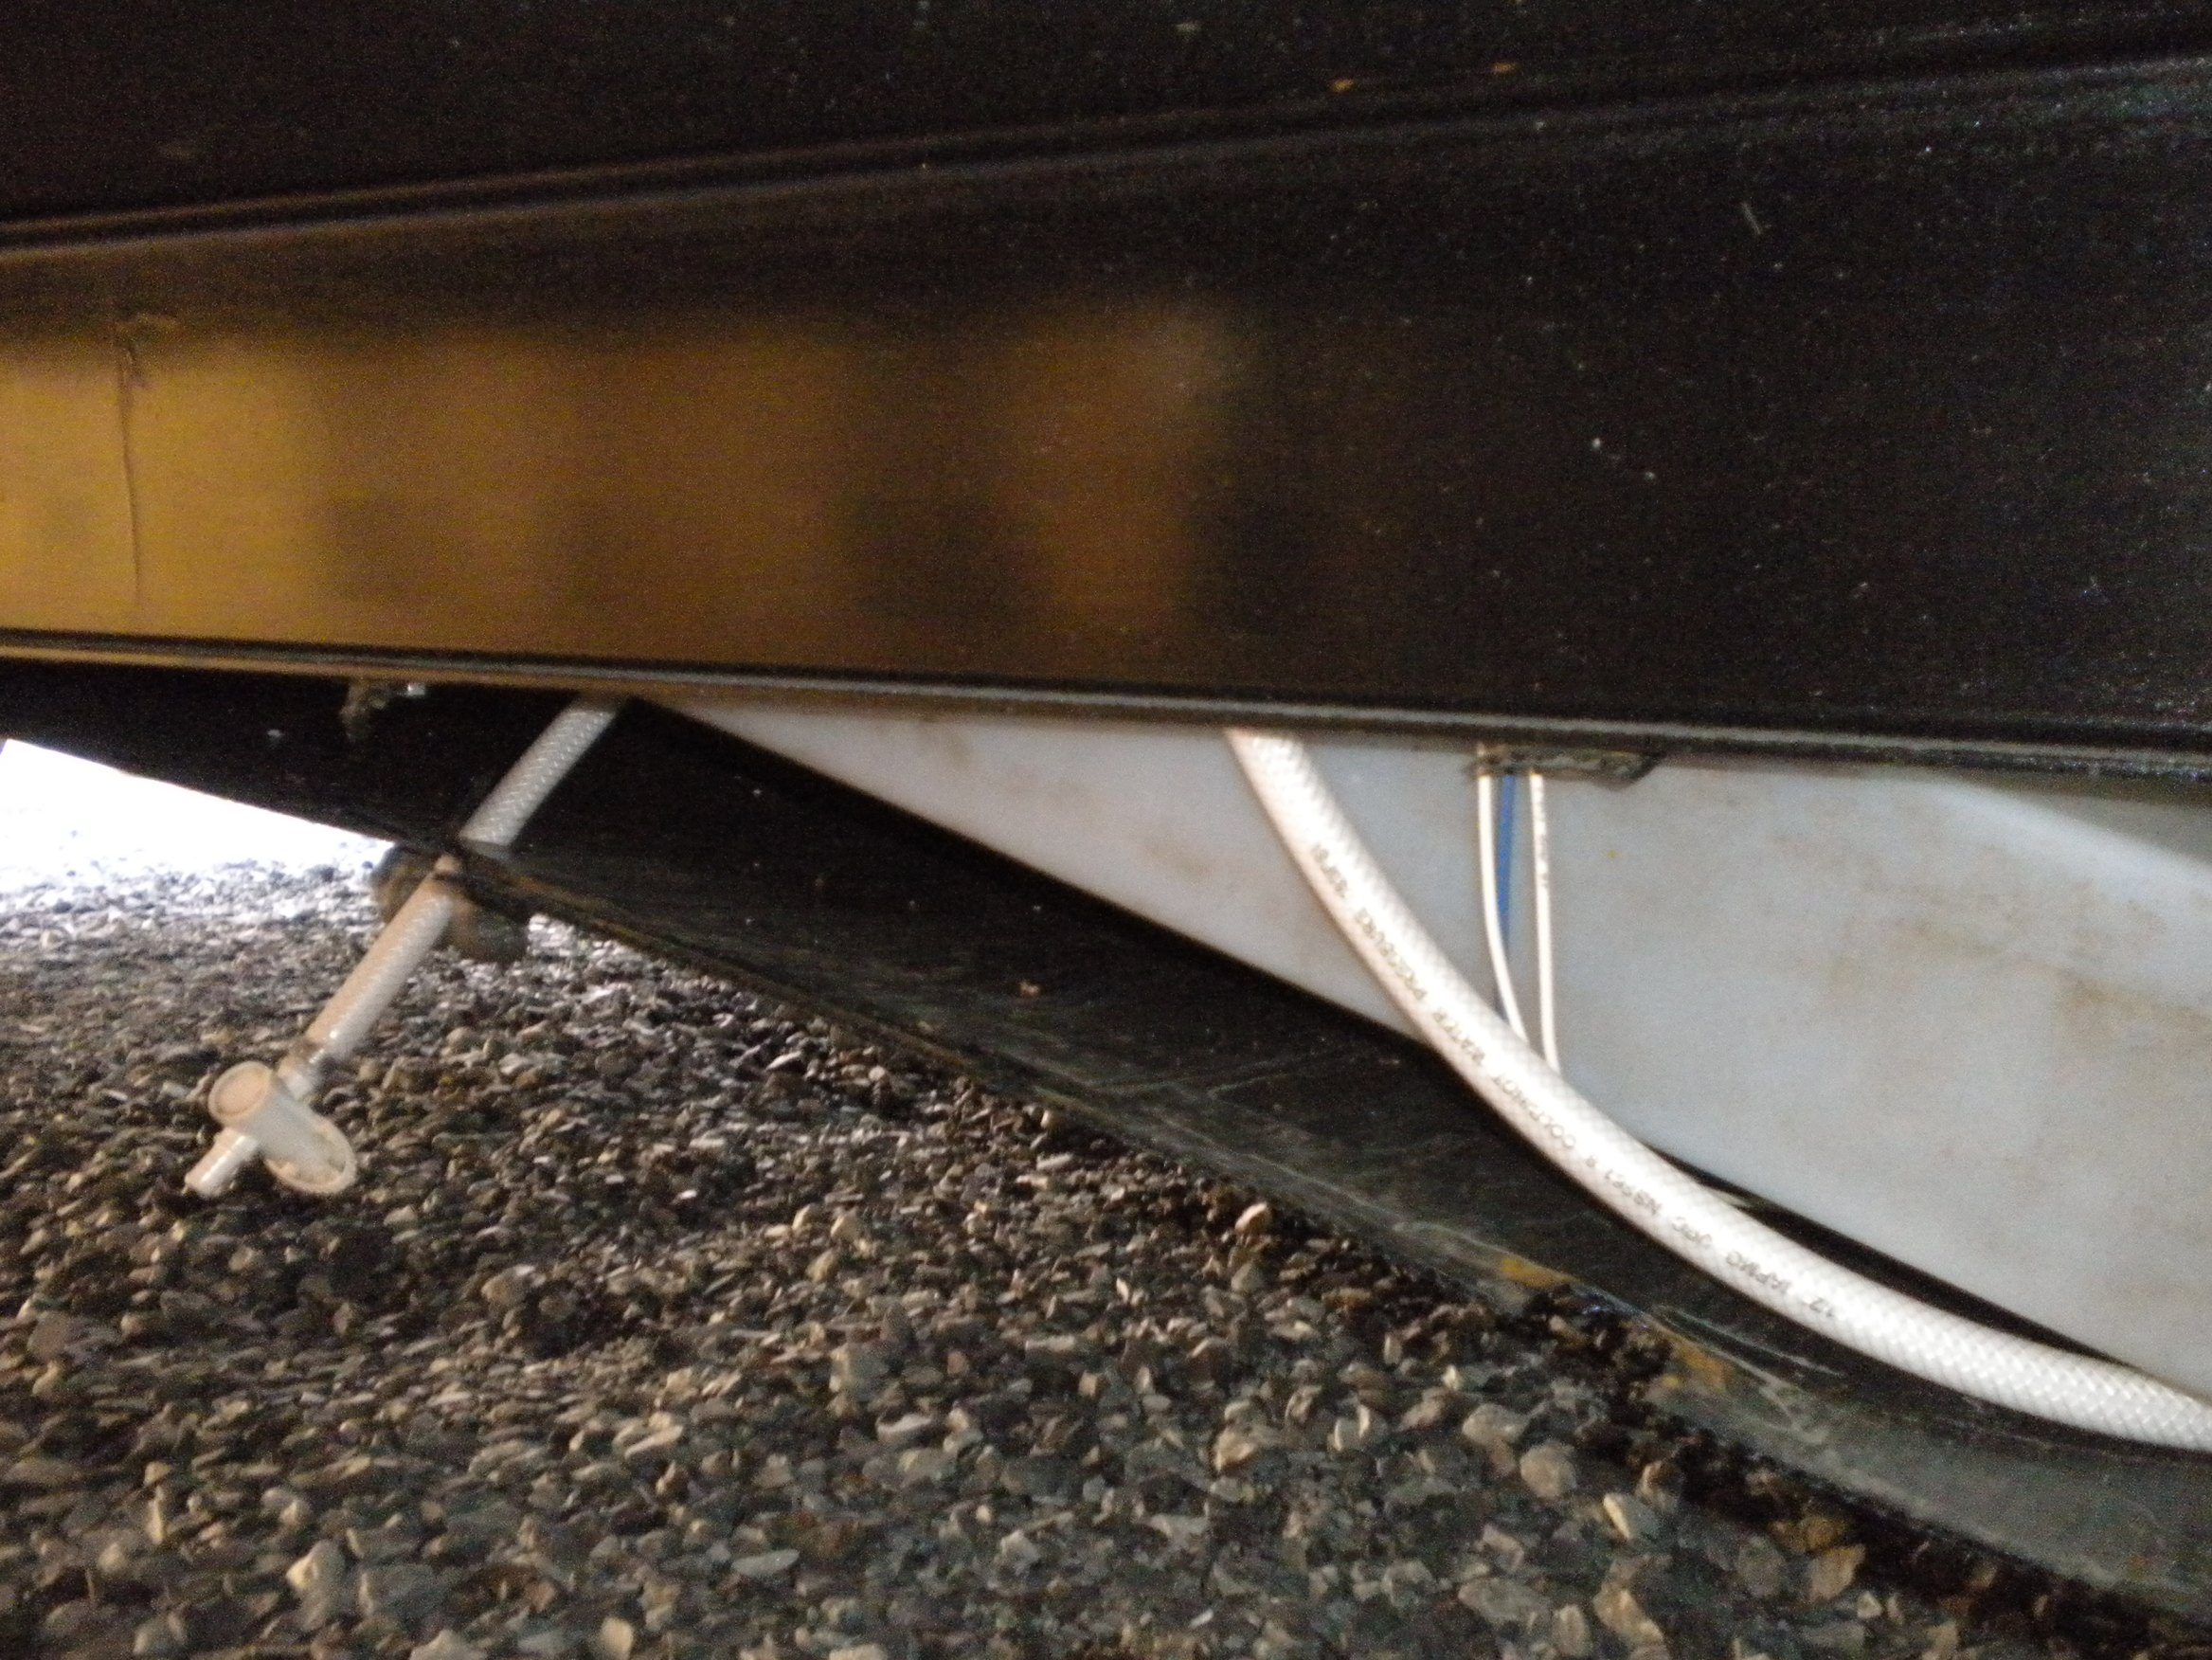
Photo 1074 shows the two self drilling screws that were used to hold the bracket into place. The company, Monaco claims that a bolts are used to secure it to the frame on one bracket and the other bracket is welded into place. I was not able to see the other bracket because of the underbelly so I am not sure what is holding it up!

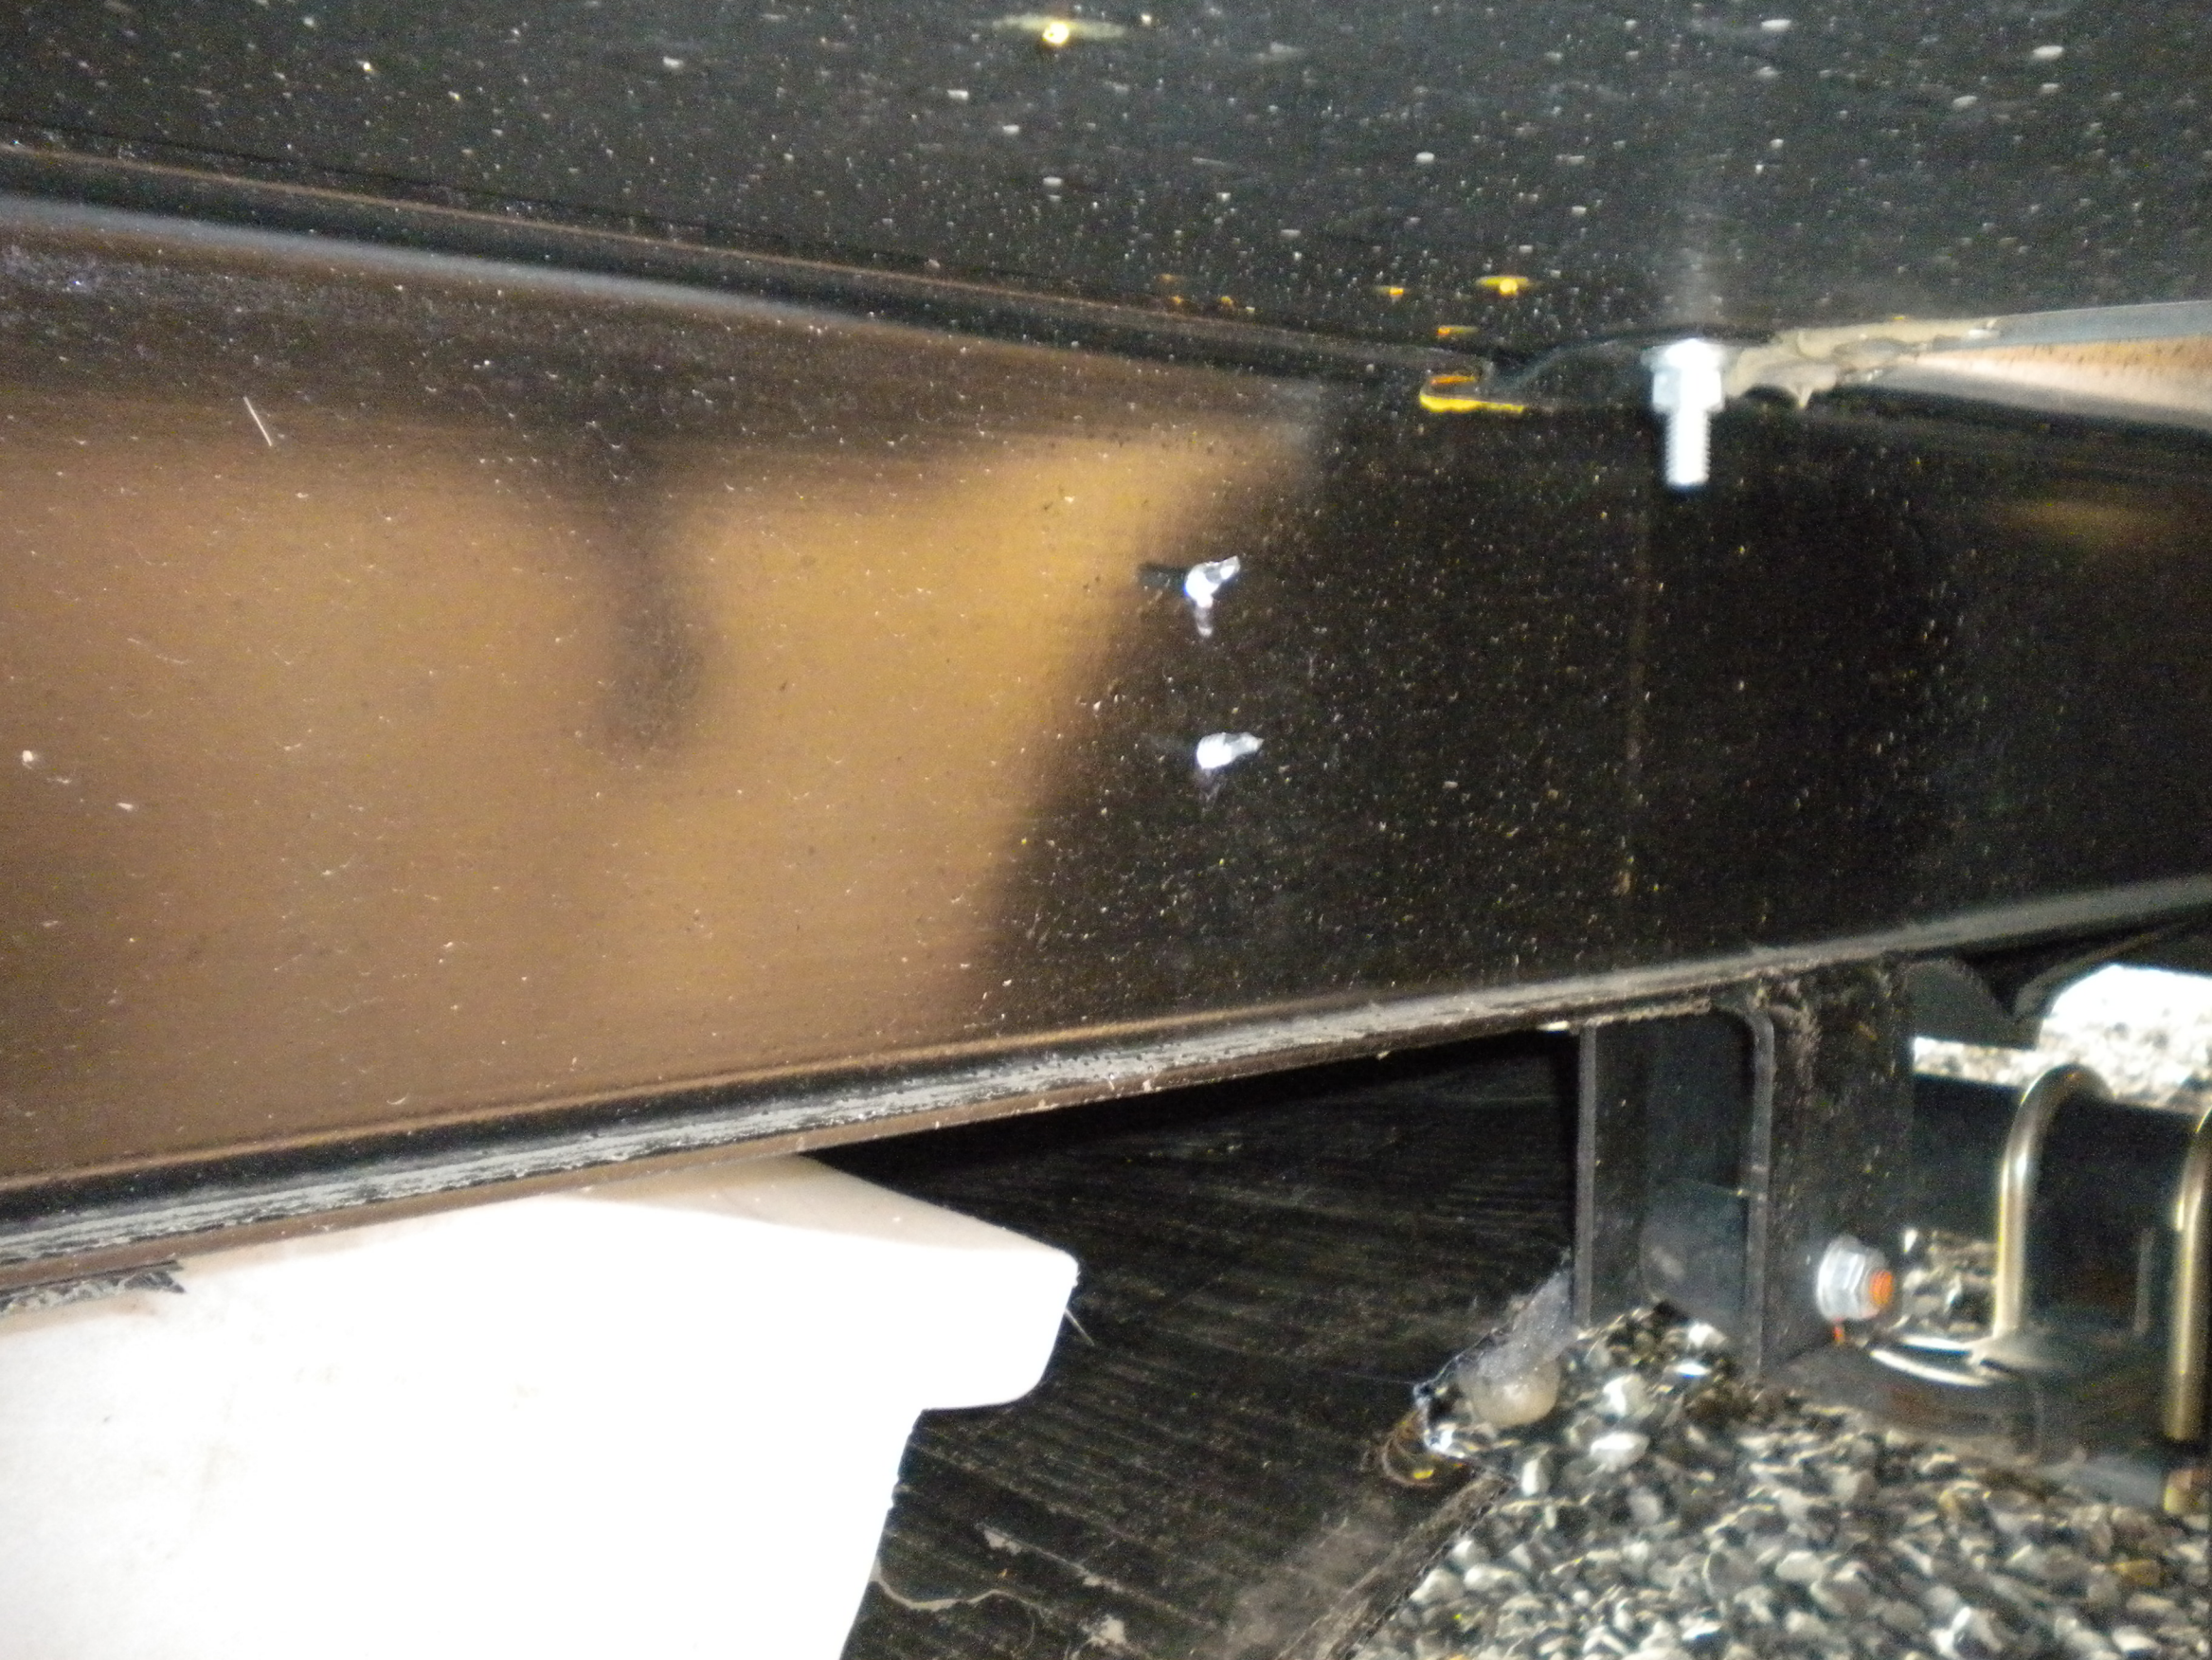
Photo 1076 shows the two self drilling screws bent upwards
