**From:** [Owner]  
**Sent:** Wednesday, May 01, 2013 5:53 PM  
**To:** Bowman, T (NHTSA)  
**Subject:** Re: NHTSA complaint VOQ 10509674

Just wanted to reach you to re view the issue pertaining to the water Tank securement in your 2013 R-vision vehicle.

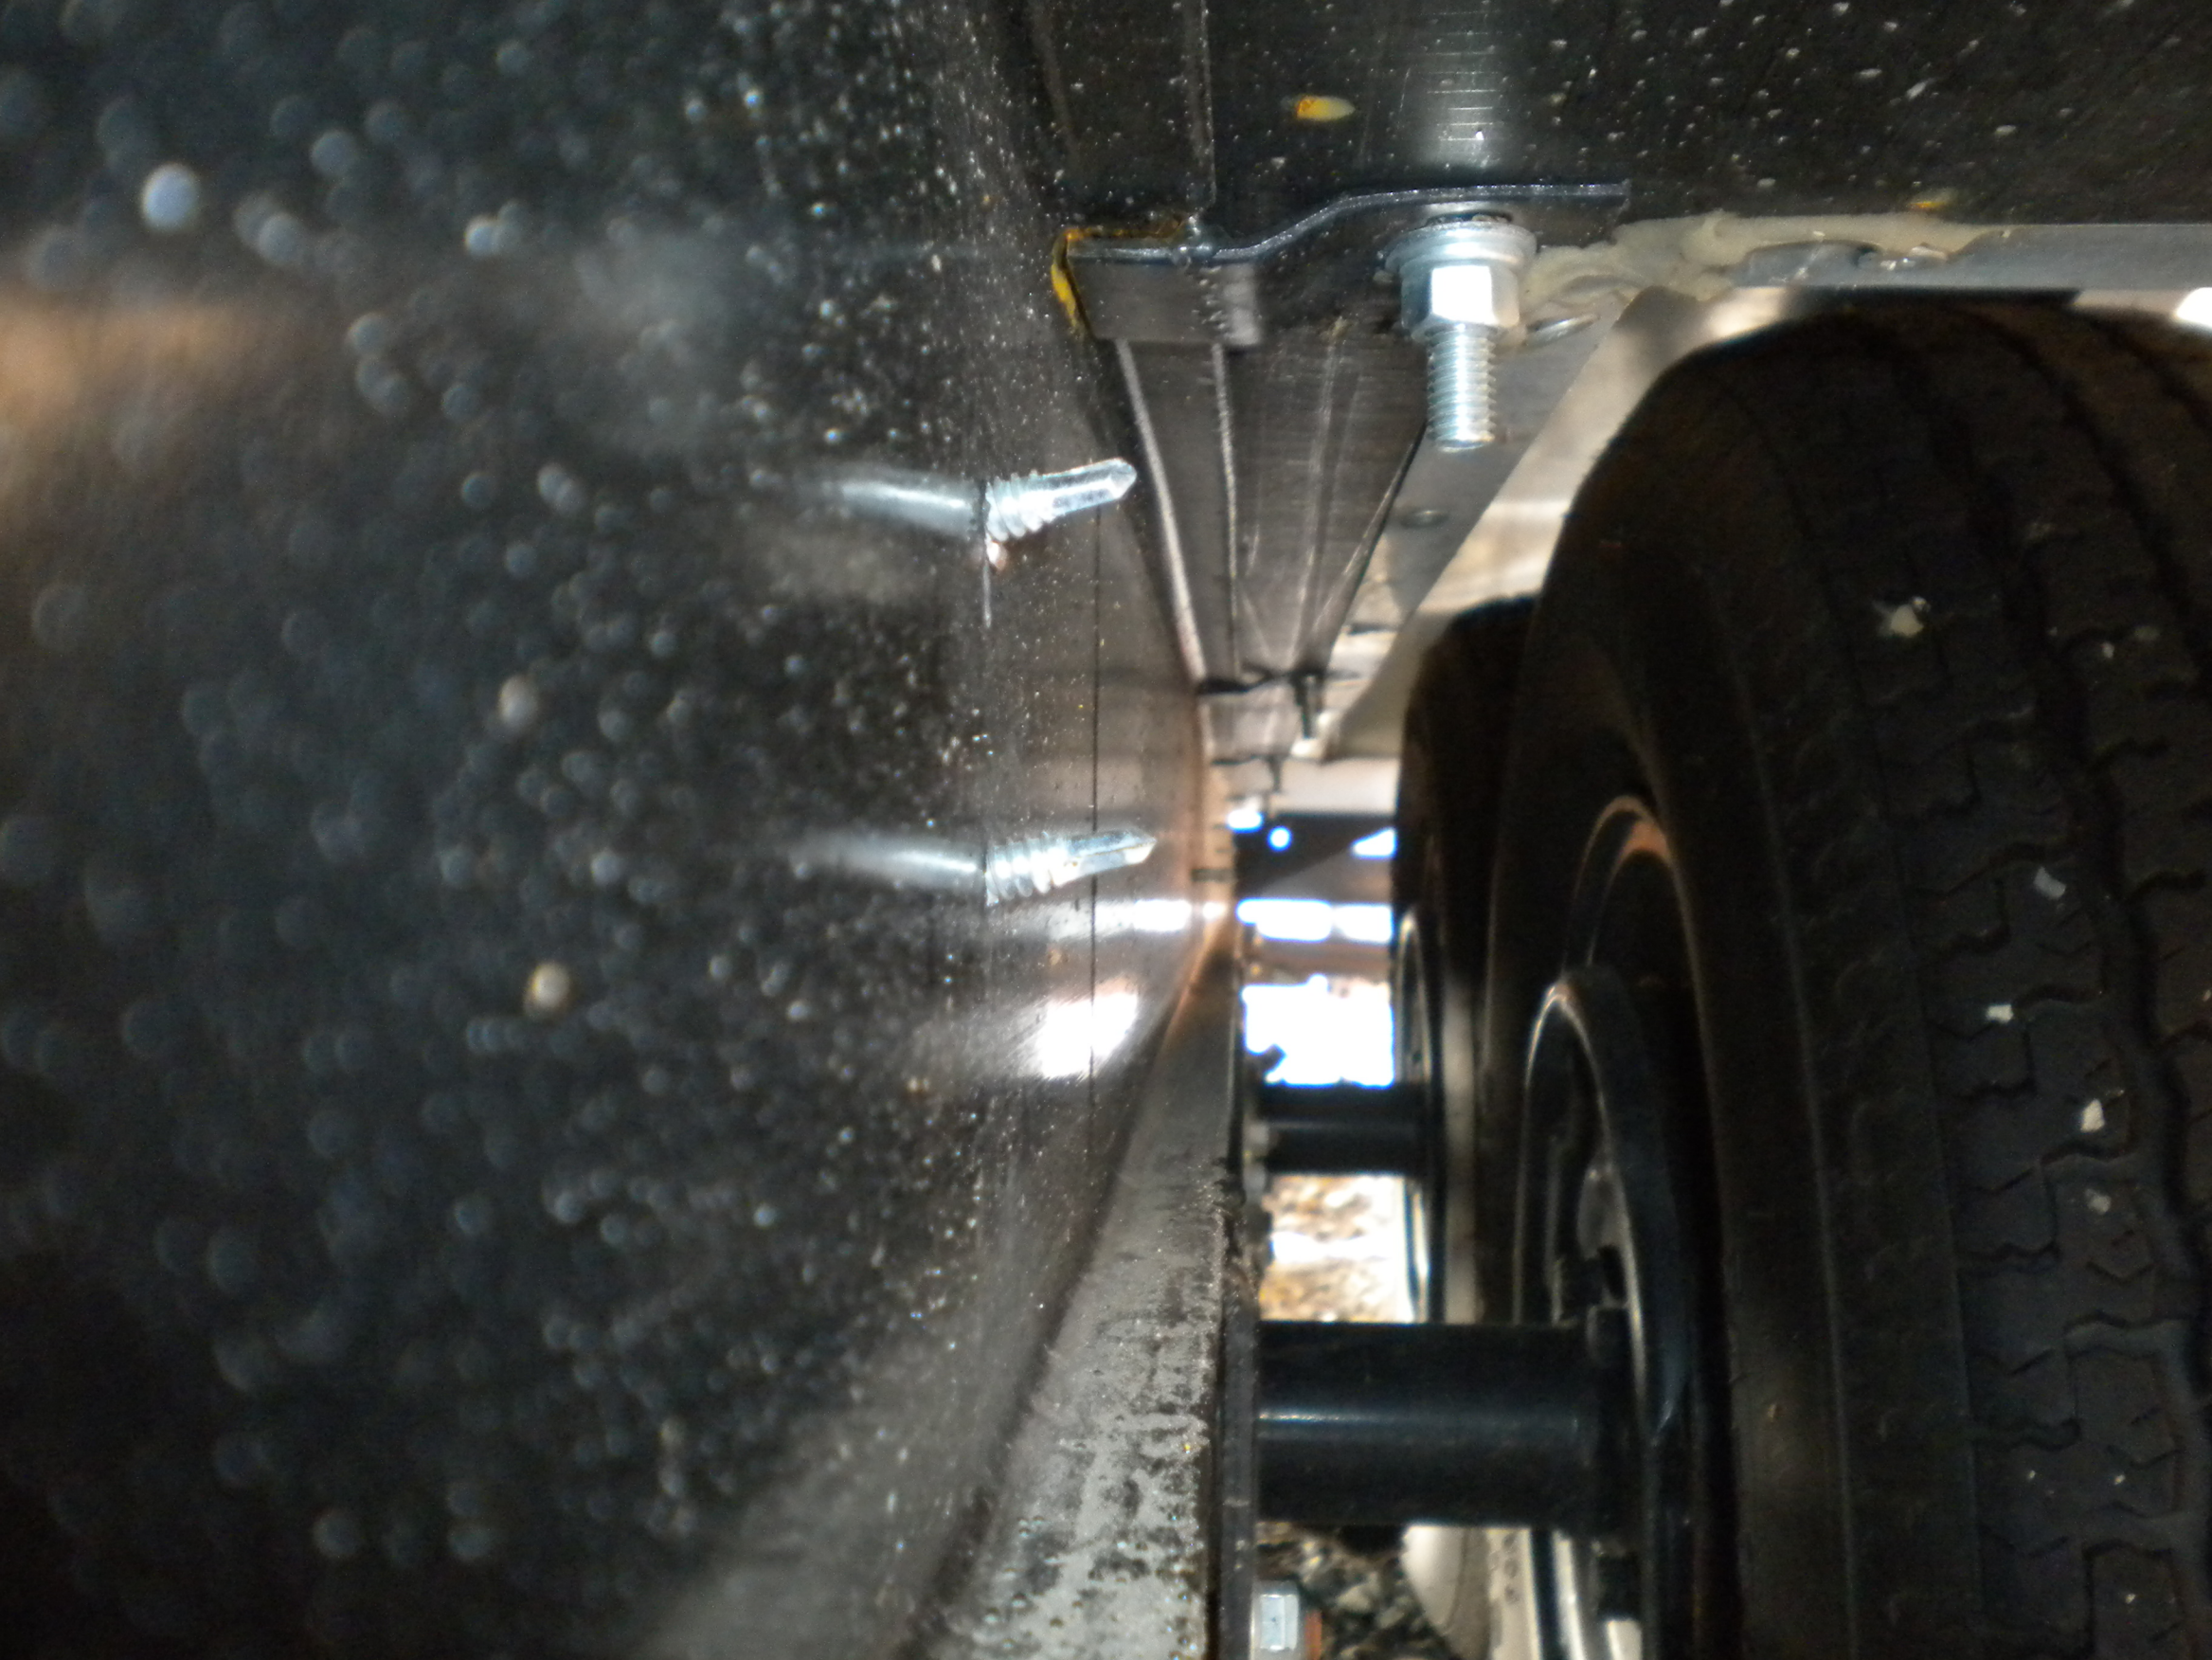
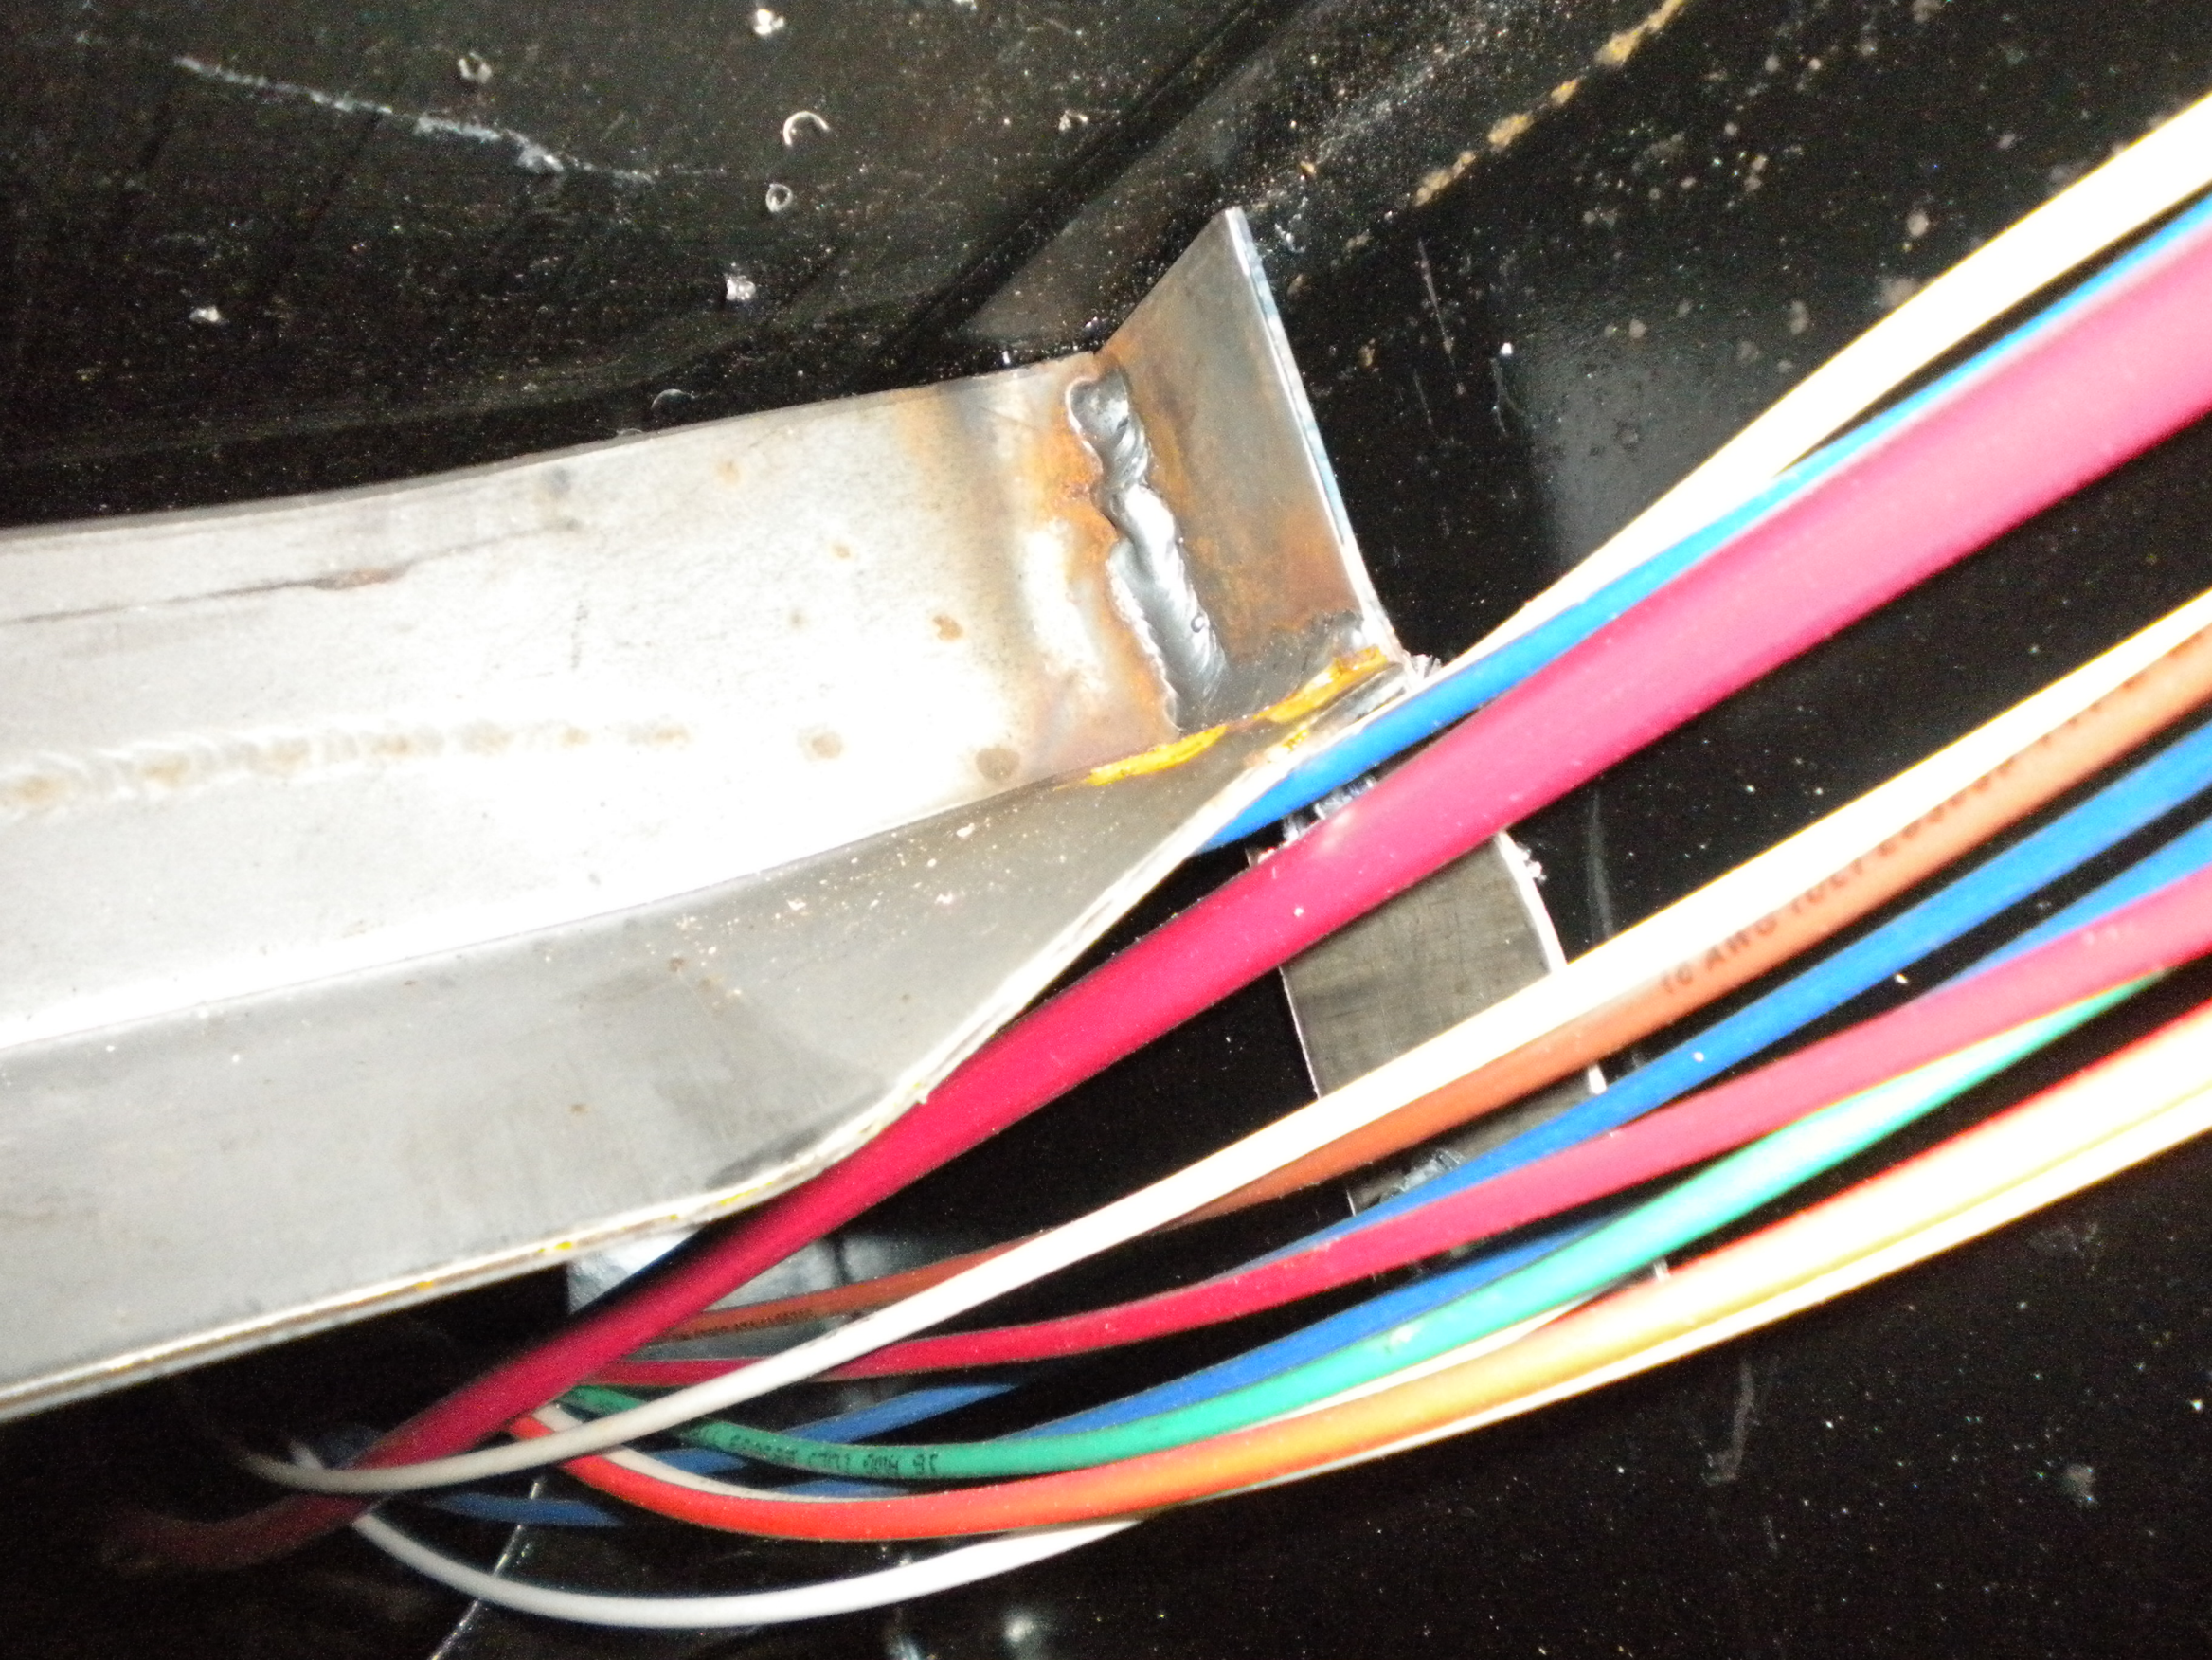
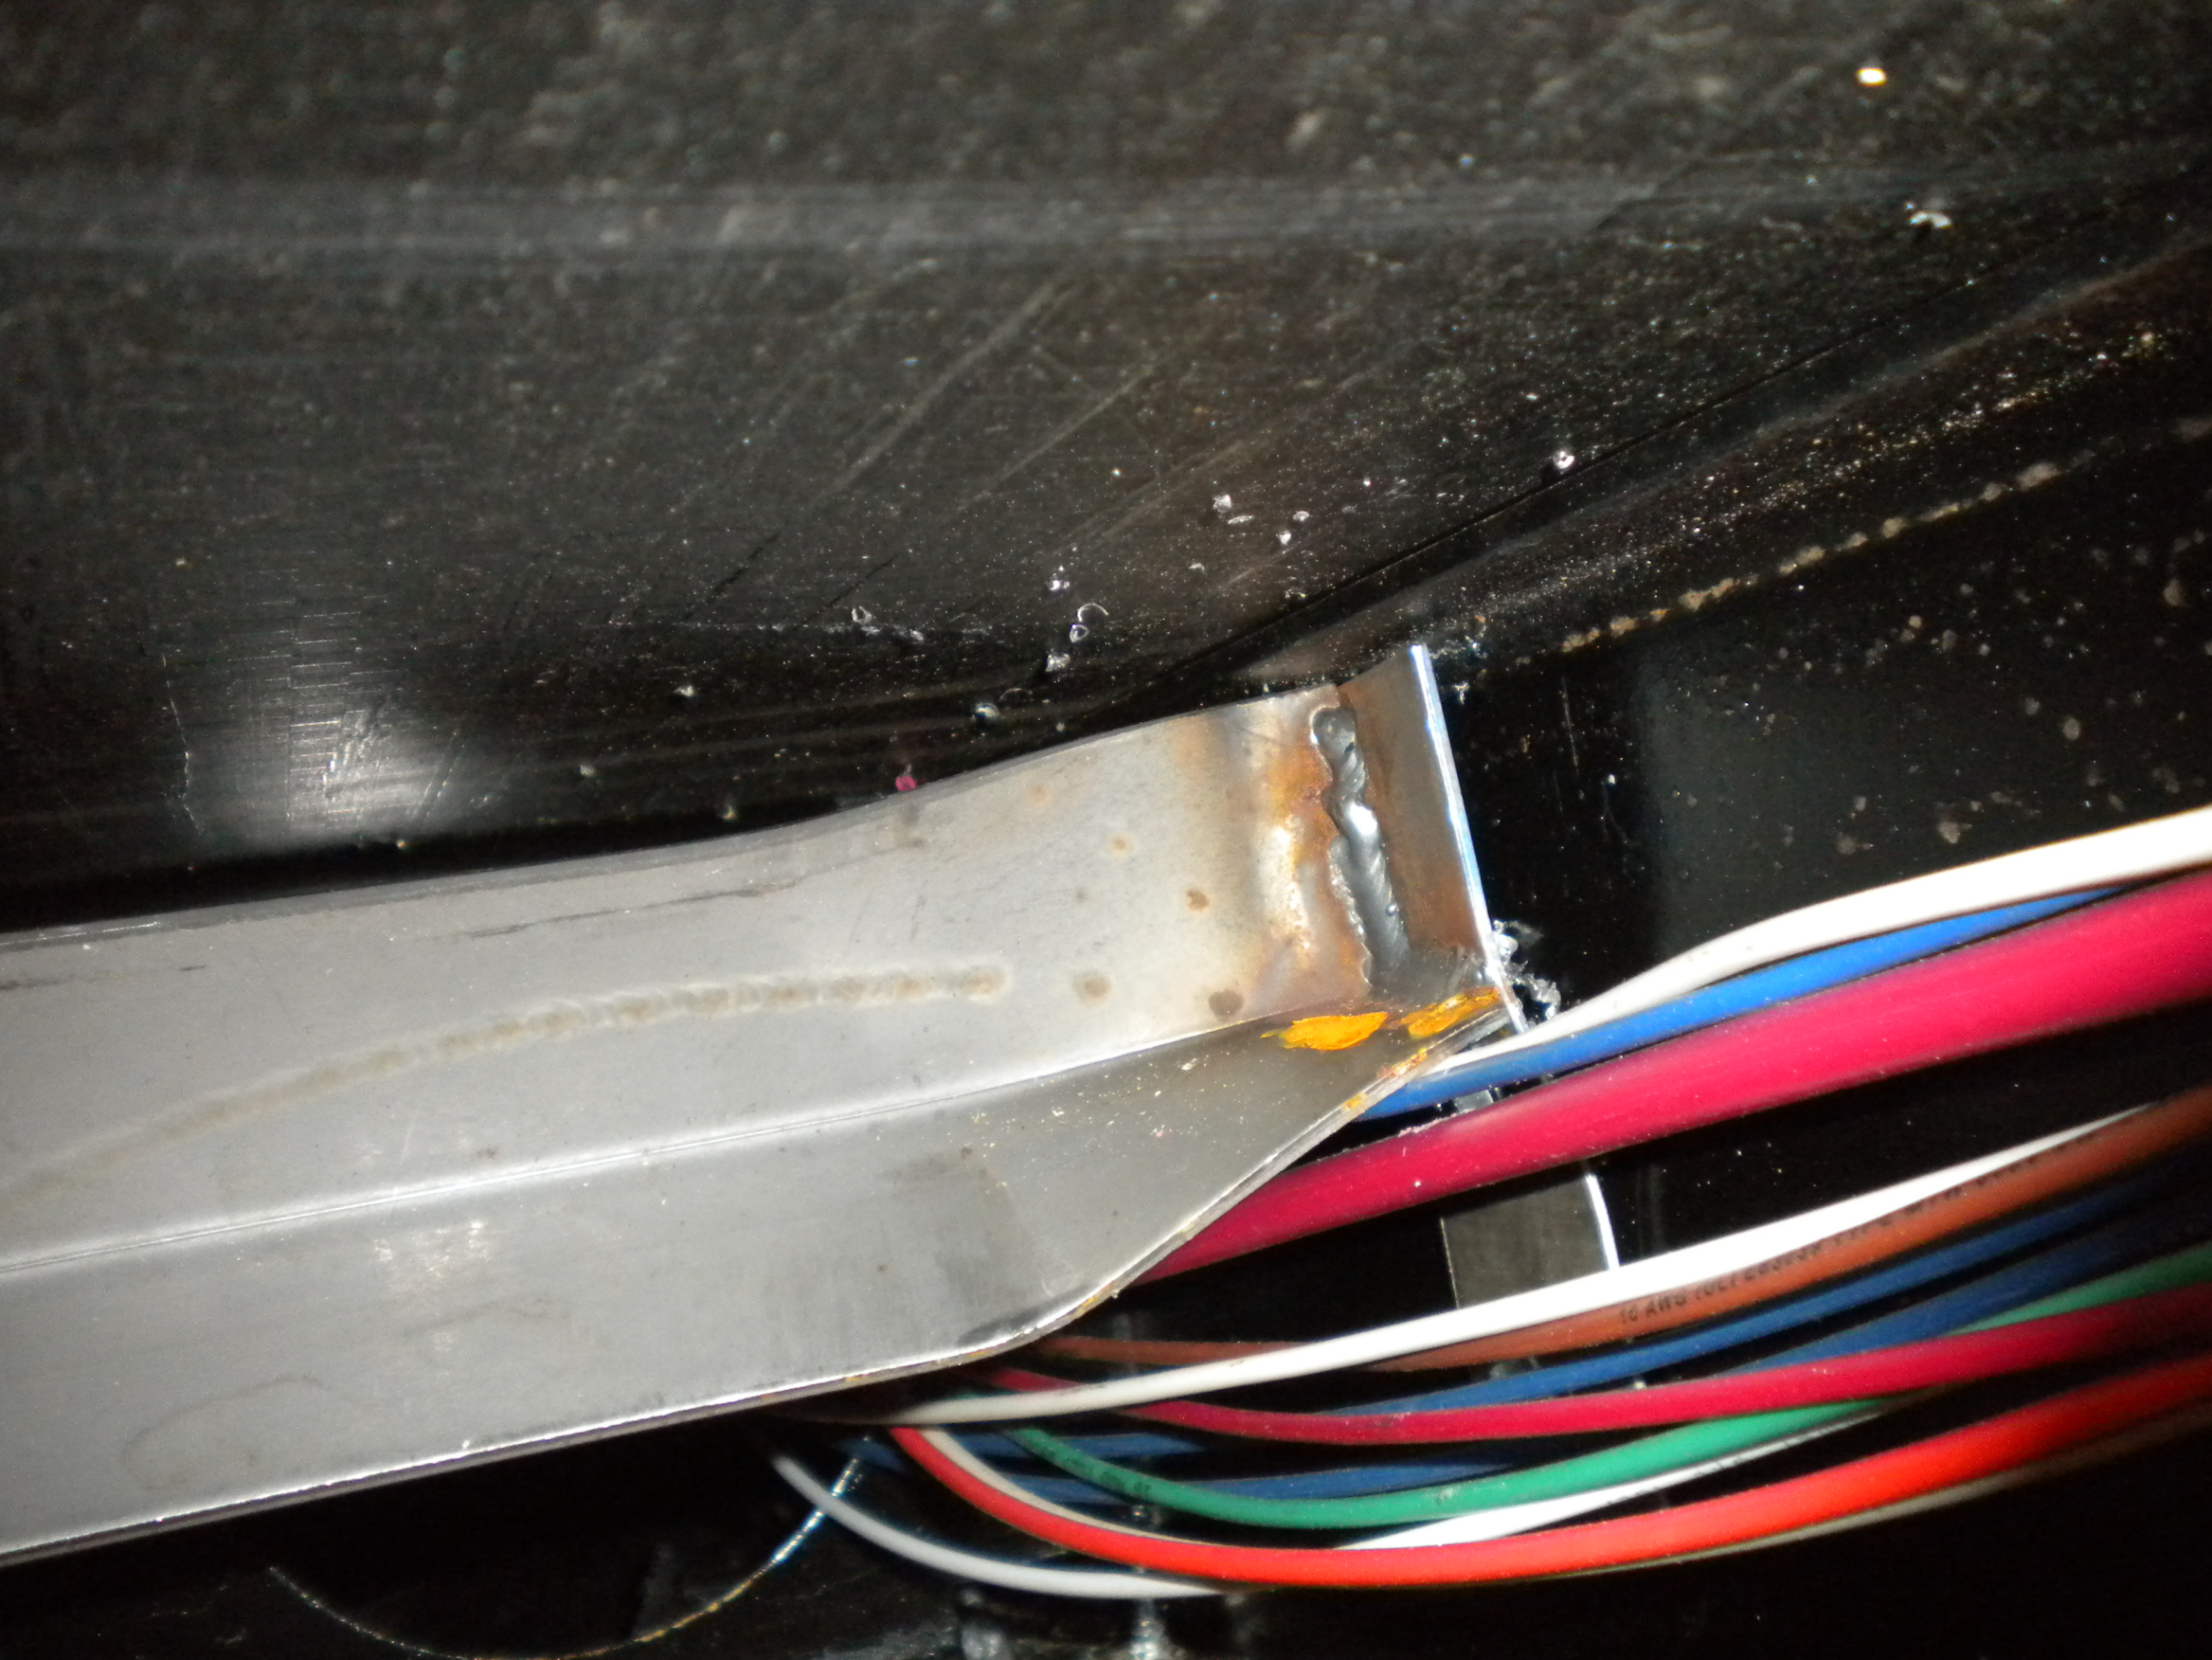
Photo 1079, 1083 and 1080 all show how the bracket pulled completely away from frame as well as the bent bracket.
