NEFCO

NEFCO # [REDACTED]	
January 19, 2016	
Company:	Allstate Insurance Company 780 Carillon Pkwy St Petersburg, FL 33716
Loss Location:	601 E Rollins Street Orlando, FL
Date of Loss:	January 5, 2016
Attention:	Ms. Terrica Ruth
Policy #:	[REDACTED]
Insured:	[REDACTED]
Claim #:	[REDACTED]

CASE STATUS UPDATE

The investigation was conducted on January 14, 2016 at Co-Part in Orlando, FL. Conditions affecting the vehicle analysis include the firefighting and overhaul operations conducted by the Orlando Fire Department and the uncovered storage of the vehicle. The risk is a 2012 Nissan Rouge. The last digits of the VIN are [REDACTED]

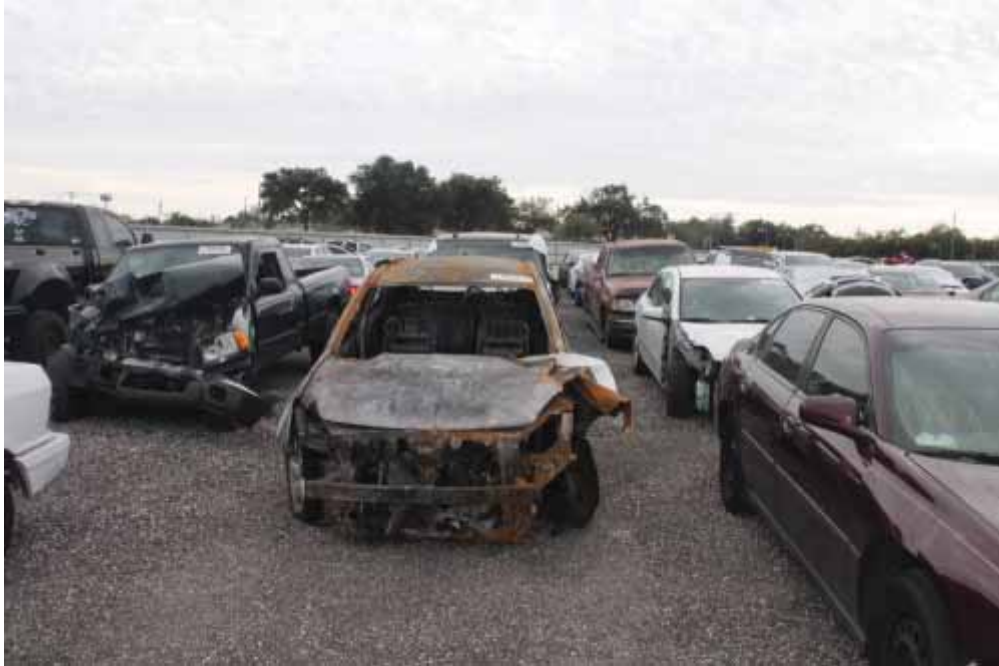
1. A view of the front of the risk

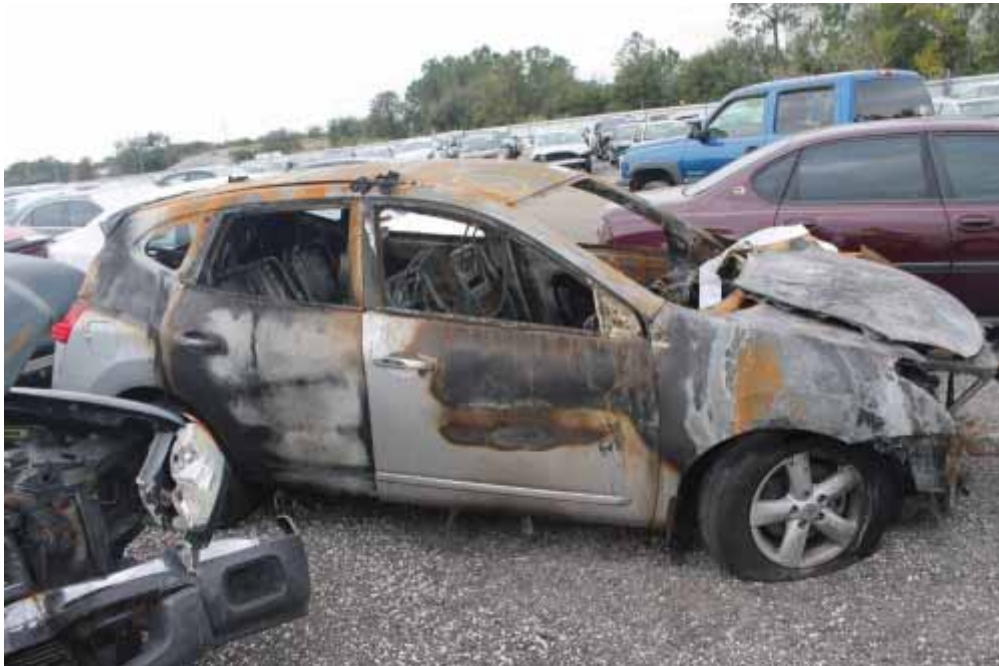
2. A view of the right side of the risk

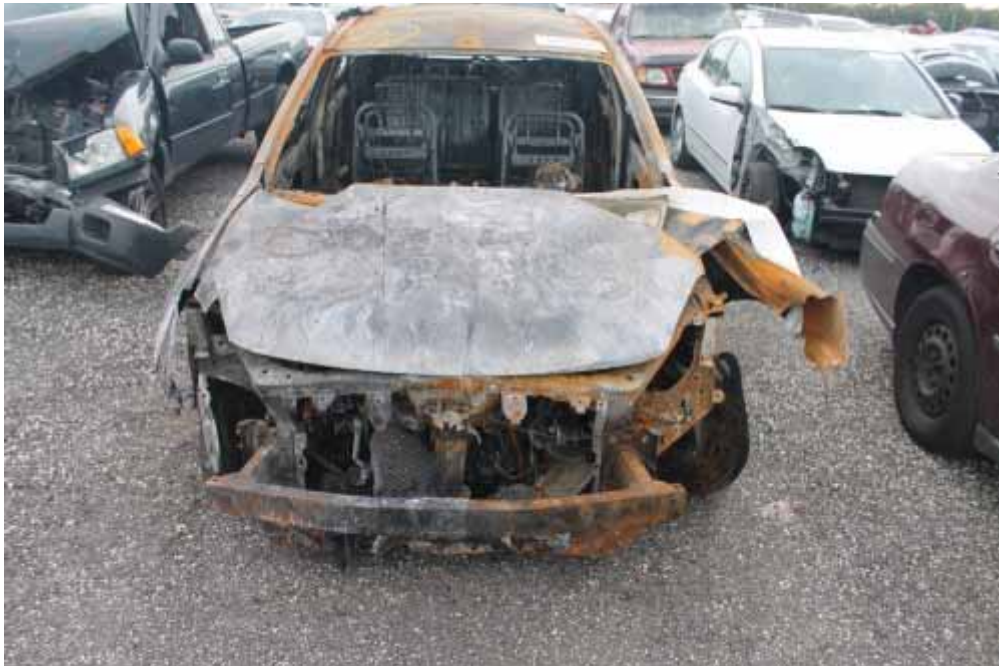
The vehicle analysis commenced at the front and revealed that the paint on the hood had been consumed. The window glass was not intact. Examination continued to the right side and revealed that the paint had been burned off of the front quarter panel from the top of the tire upward with the pattern continuing to the right A post and to the right-front door. The paint on the rear-right door was consumed down to floor level, and the paint on the upper B and C posts was also consumed. The scene analysis continued to the rear and revealed heat damage to the spoiler. Examination continued to the left side and revealed that the paint had been consumed on the rear door down to floor level with the damage extending up the C post. The paint on the front-left door had been consumed closest to the A post down to the floor. The paint on the front quarter panel was consumed. The paint on the roof had been consumed. The scene analysis continued with an examination of the underside of the vehicle and was unremarkable. This examination was limited, as the vehicle was sitting low to the ground.

12. A view of the hood of the risk

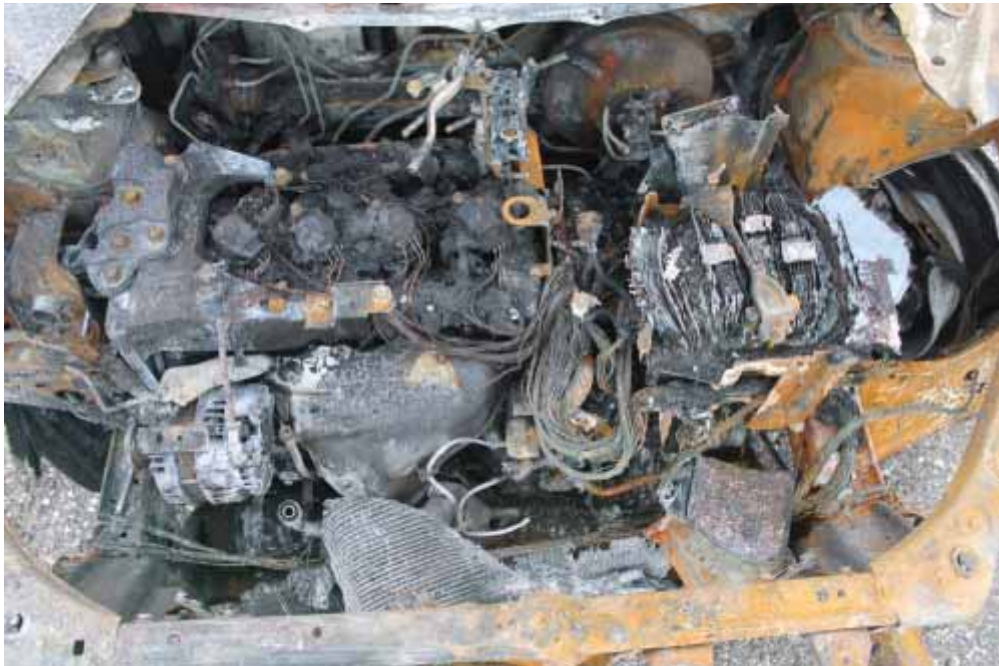
The vehicle analysis continued into the engine compartment and revealed heavy fire damage to the engine compartment. The hoses and belts had been consumed in the fire. Examination of the passenger compartment revealed that all of the available combustibles had been consumed. Examination of the rear cargo area revealed heat and smoke damage with some combustibles intact, indicating that the fire had spread from the passenger compartment into the cargo area.

14. A view of the engine compartment

It is my recommendation that Tires Plus and Nissan be placed on notice and an expert in automotive electrical be utilized.

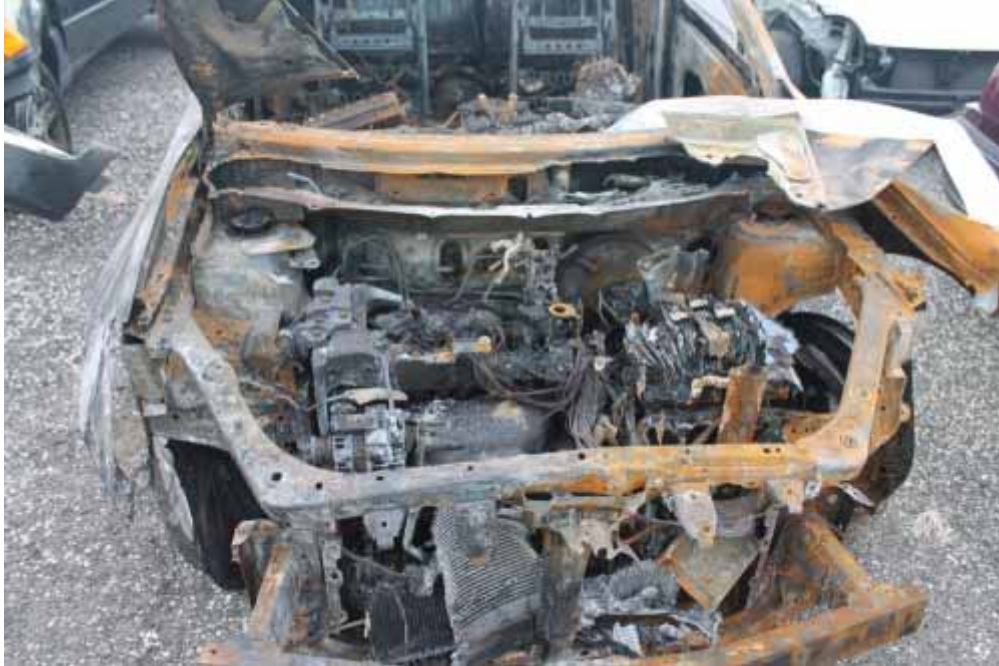
15. A view of the engine compartment

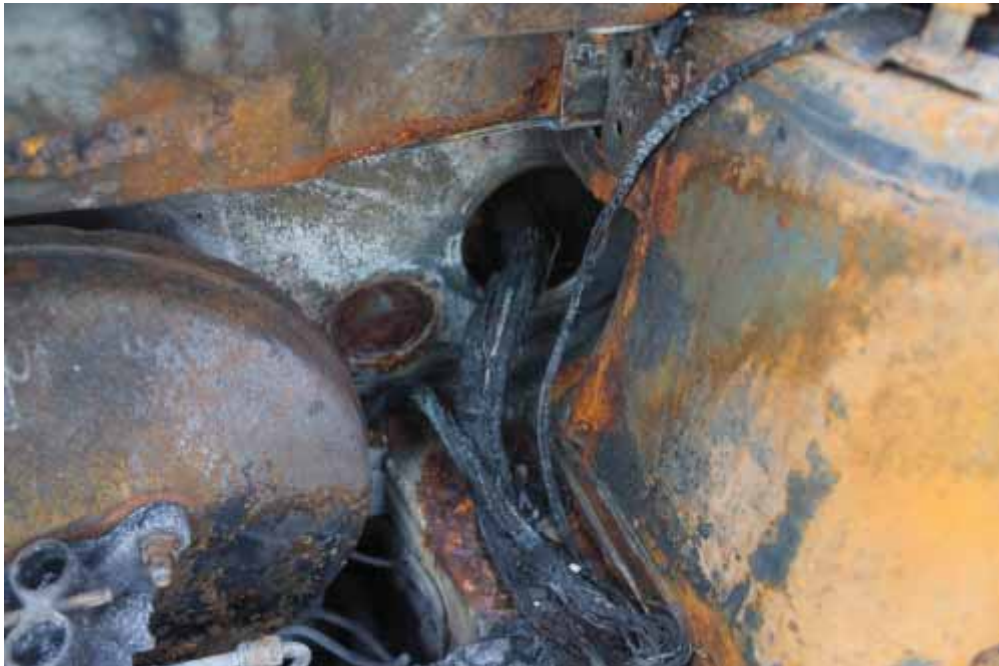
16. A view of the wiring harness

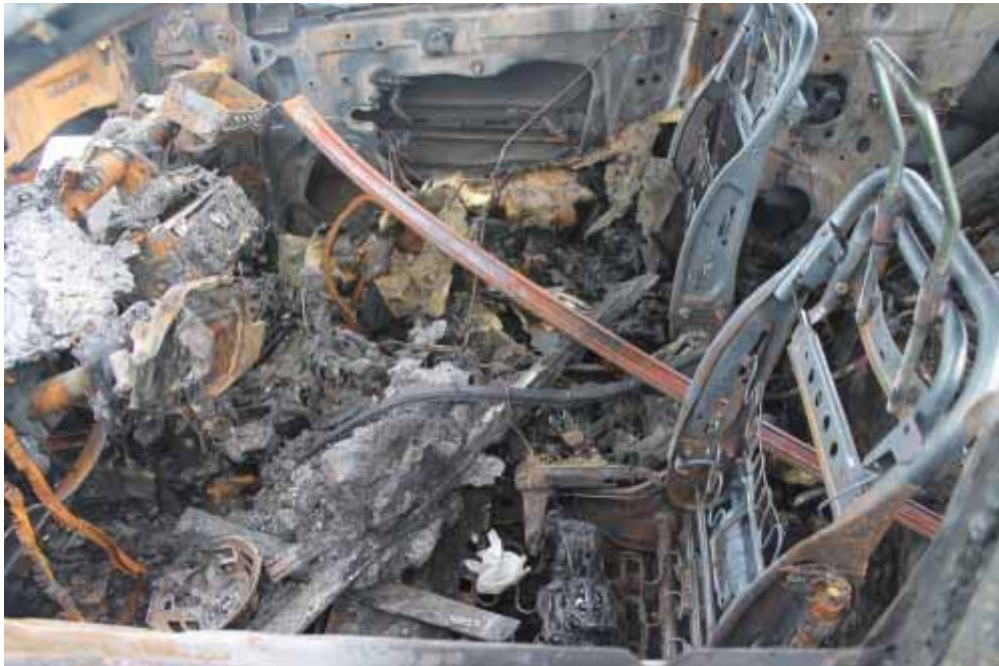
18. A view of the front passenger compartment

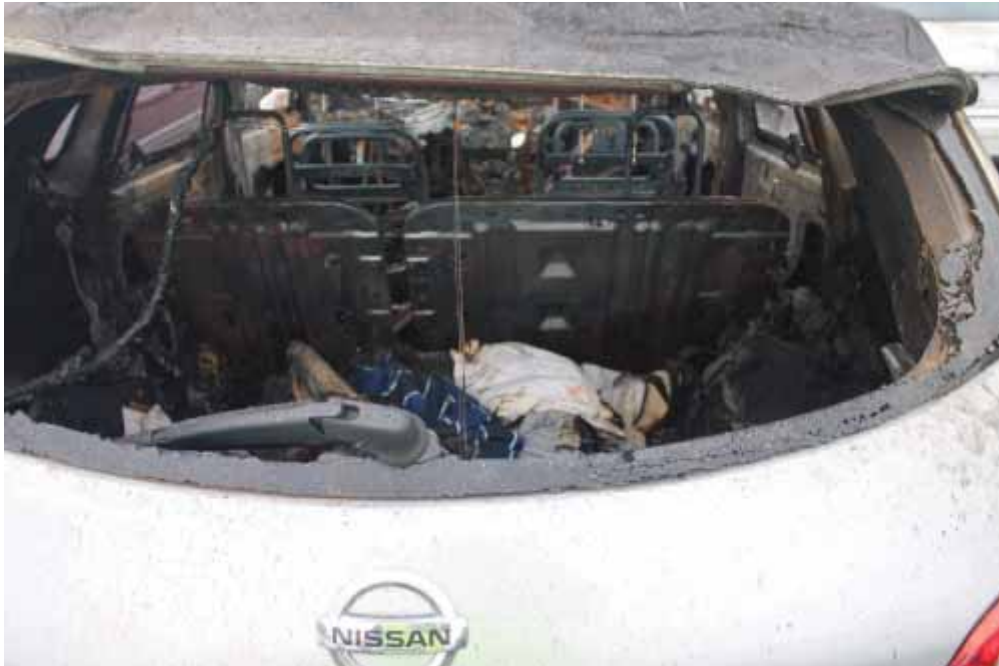
23. A view of the cargo area

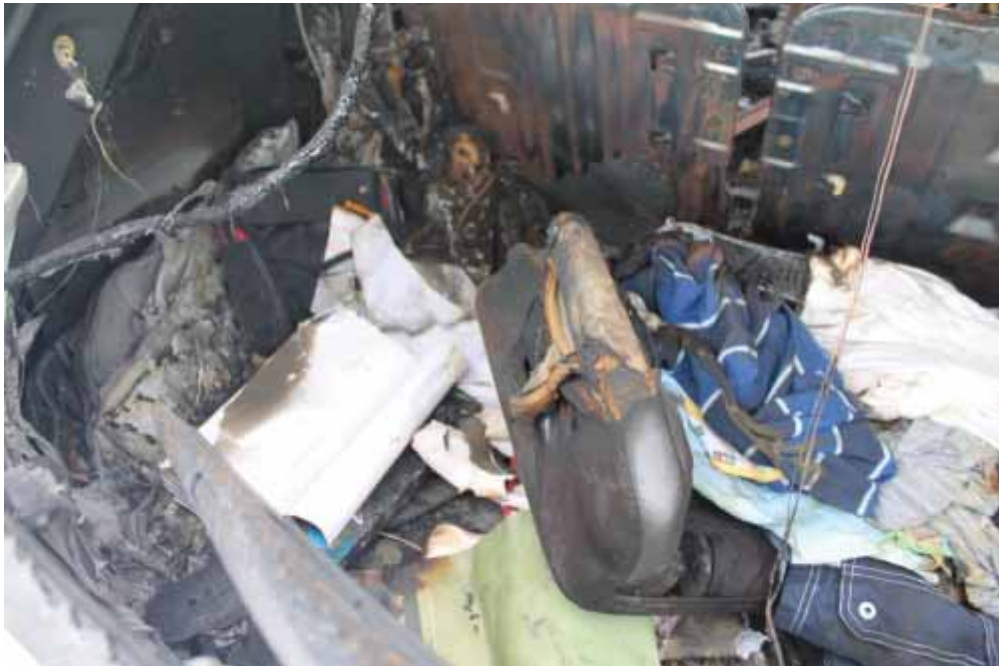
24. A view of the cargo area
