From: [Wells, T. Cynthia CTR \(NHTSA\)](#)
To: [Fogle, Brenda CTR \(NHTSA\)](#)
Subject: FW: Your Vehicle Owners' Questionnaire #11083773
Date: Monday, April 23, 2018 7:57:45 AM
Attachments: [image001.jpg](#)
[image002.jpg](#)
[image003.jpg](#)
[image004.jpg](#)

Please add this email chain and pictures to VOQ #11083773 in public repository.

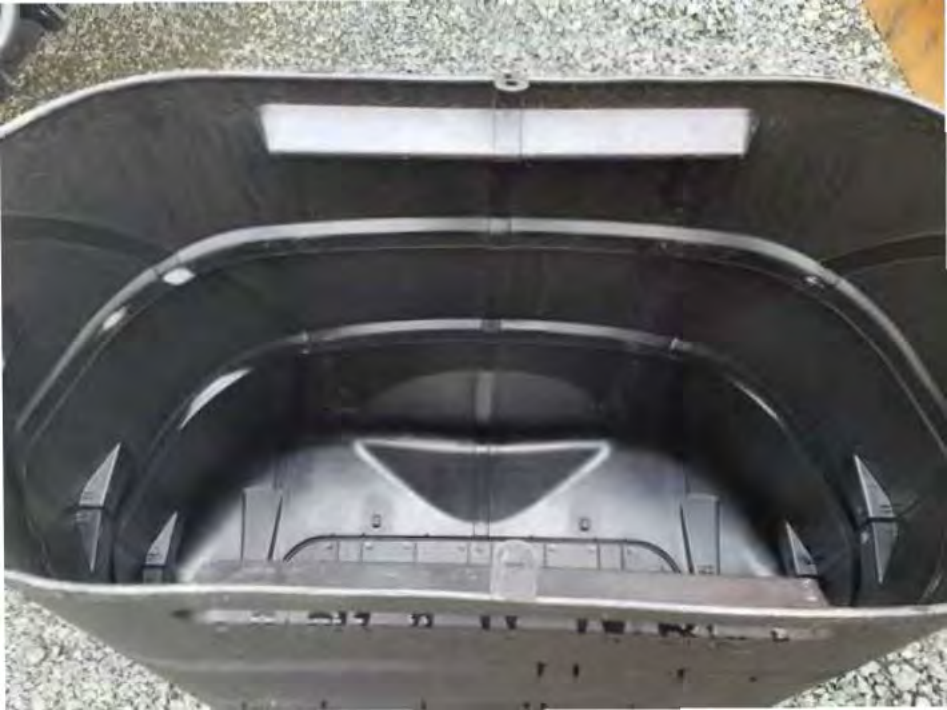
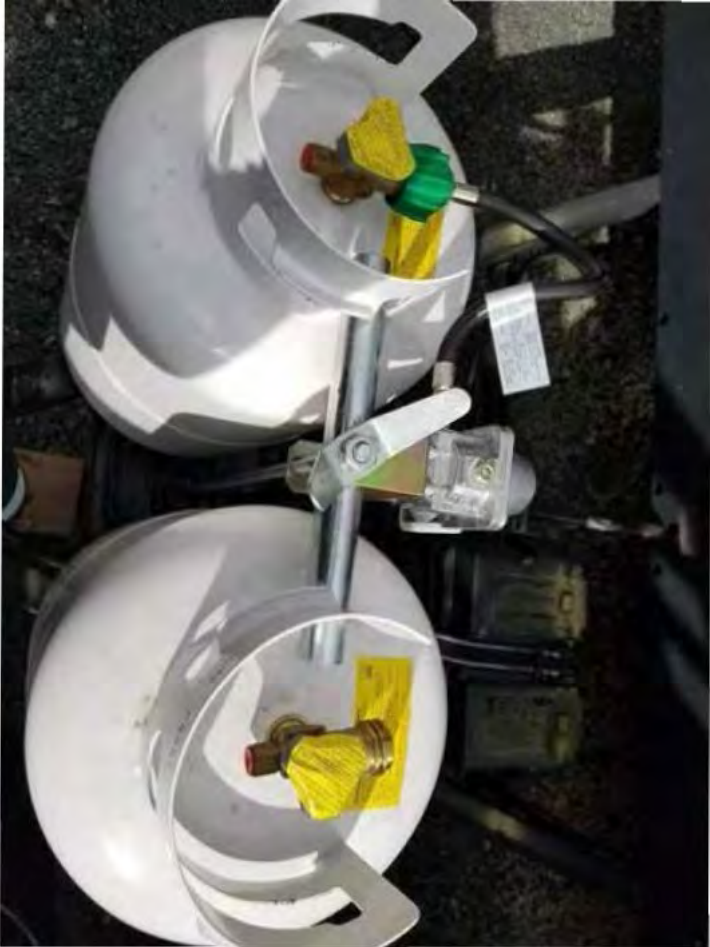
Here you go. Sorry if I wasn't clear enough, but I do not think the cover is damaging the hose. I only noticed the leak because the cover touched the hose as I was removing the cover. Once it was off, any movement of the hose caused the same problem. The first bad hose did not leak during removal or installation of the cover. I found that leak when I moved the hose while changing tanks. One of my concerns is that depending on the position of the tanks and how they are locked down, installation of the cover could possibly put enough pressure on the hose to hold the leaky crimp open. I noticed the noise from the pressure leak - not sure someone with impaired hearing would realize what had happened.

I did notice slight marking on the inside of the cover, so I opened the top access hole while the cover was installed, and the other tank hose was not actually touching the cover when it was in place. I had tilted the cover while removing it when this last hose released pressure.
