Reference: Recreational Vehicle Safety Recall Notice NHTSA 19V-655  
This notice applies to your vehicle [REDACTED]

**Appendix B – NHTSA Part 573 Safety Recall Report 19V-655**

**Appendix D – Picture of Inverter and Fuse in 2016 19' Airstream Trailer**

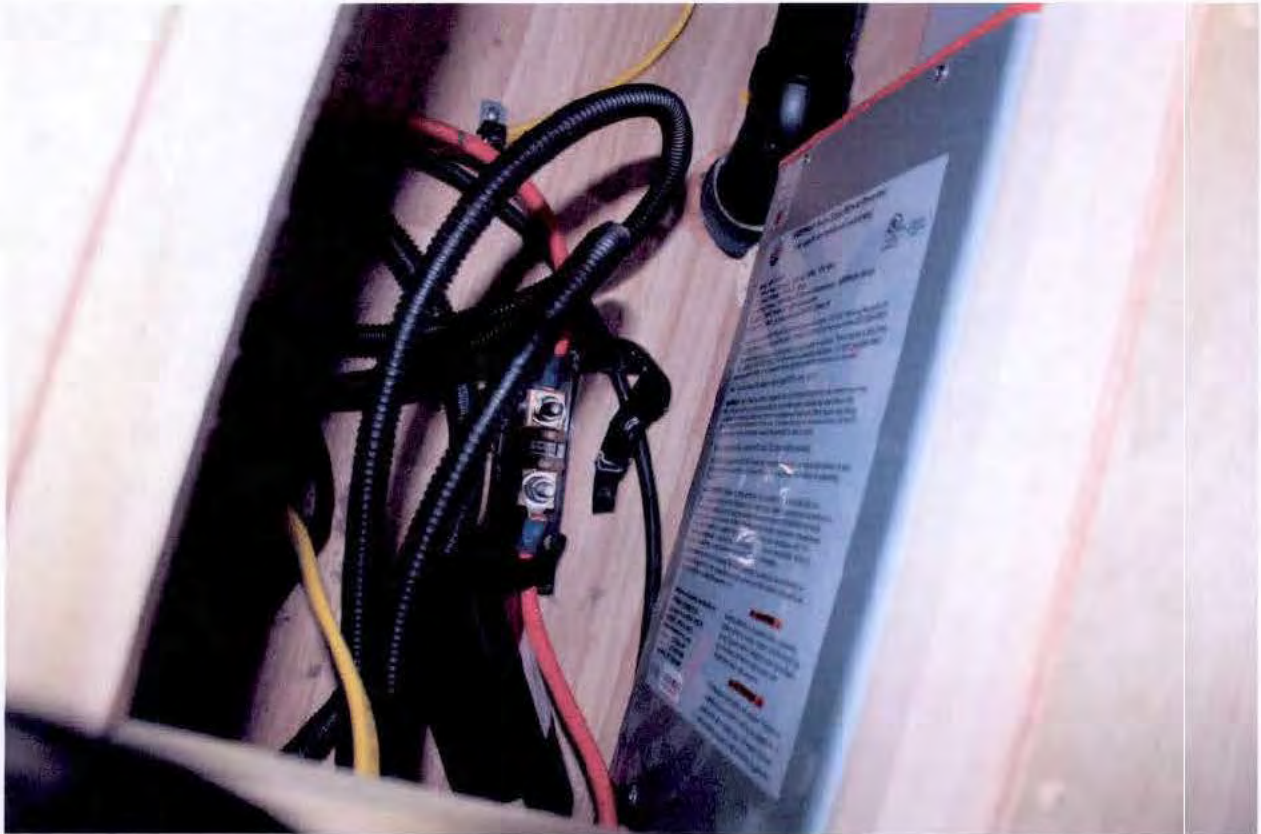
So it appears that from the VIN number and the safety recall notice, that my trailer should definitely be included in the recall. How about the actual problem referred to in the recall notice. Your recall notice states the following: "The affected travel trailers covered in this recall have been identified as having a 1000 Watt inverter mounted on the lower bedframe wall with the inverter fuse mounted

on the floor below." **As shown in the picture in Appendix D of this letter, that is exactly the case for my particular Airstream, so it should be covered under this recall.**

The affected travel trailers covered in this recall have been identified as having a 1000 Watt inverter mounted on the lower bedframe wall with the inverter fuse mounted on the floor below. If the inverter comes away from the wall and makes contact with an uncovered inverter fuse there is a potential of an electrical short, or fire which could result in property damage, and personal injury.

**Description of the Defect :** The inverter was installed on a vertical wall, and the inverter fuse was mounted on the floor below the inverter. The inverter came in contact with the inverter fuse causing an electrical event.

**Description of the Cause :** The inverter was mounted on a wall, the inverter fuse is mounted in a location below the inverter; if the fasteners holding the inverter failed, this would allow the inverter to make contact with inverter fuse.

An inspection of the inverter and inverter fuse will occur. If the inverter and inverter fuse are not mounted on the same surface the inverter fuse will be relocated, and secured to the same surface as the inverter. We will also be installing a protective cover on the inverter fuse bar. This will be done at no cost to the owner. The repair will take approximately .50 hours.

Description of Remedy Program : An inspection of the inverter and inverter fuse will occur. If the inverter and inverter fuse are not mounted on the same surface the inverter fuse will be relocated, and secured to the same surface as the inverter. We will also be installing a protective cover on the inverter fuse bar. This will be done at no cost to the owner.
