OF INFORMATION ACT (FOIA), 5 U.S.C.552(B)(6)

From: [REDACTED]
Sent: Monday, April 04, 2022 3:27 PM
To: DataQuality, DataQuality (NHTSA) <DataQuality@dot.gov>
Subject: ODI Complaint ----- 11447877----- Edited by vehicle owner

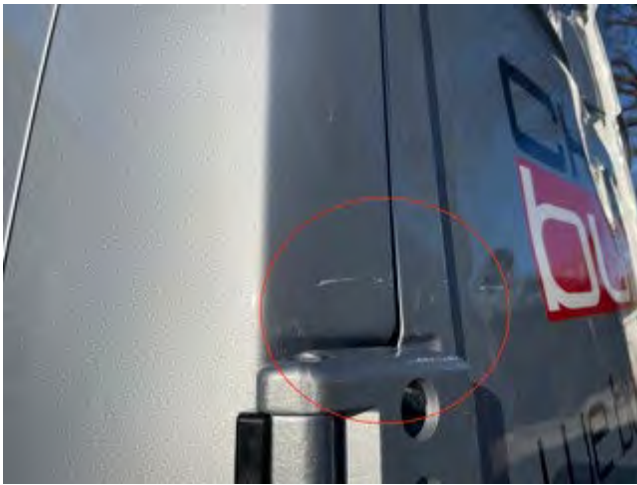
Repair was finished by Mercedes-Benz of Nanuet on Feb 4, 2020
I never received invoice from them, as it went through insurance company
