| VEHICLE INFORMATION | | | | | |
|---|---|---|---|---|---|
| 17 digit Vehicle Identification Number Located at bottom of windshield on driver's side<br>WDGGS3H86G [REDACTED] | | | MAKE<br>MERCEDES BENZ | Model<br>GLK350 | Model Year<br>2014 |

| FAILED COMPONENT(S)/PART(S) INFORMATION | | |
|---|--|---|
| Vehicle Components Codes: 070000 FUEL SYSTEM, GASOLINE (Fuel Pump Assy) | | Failure Mileage<br>90000.0 |

2014 Mercedes-Benz GLK 350, enclosed picture of defected part and copy of repair invoice

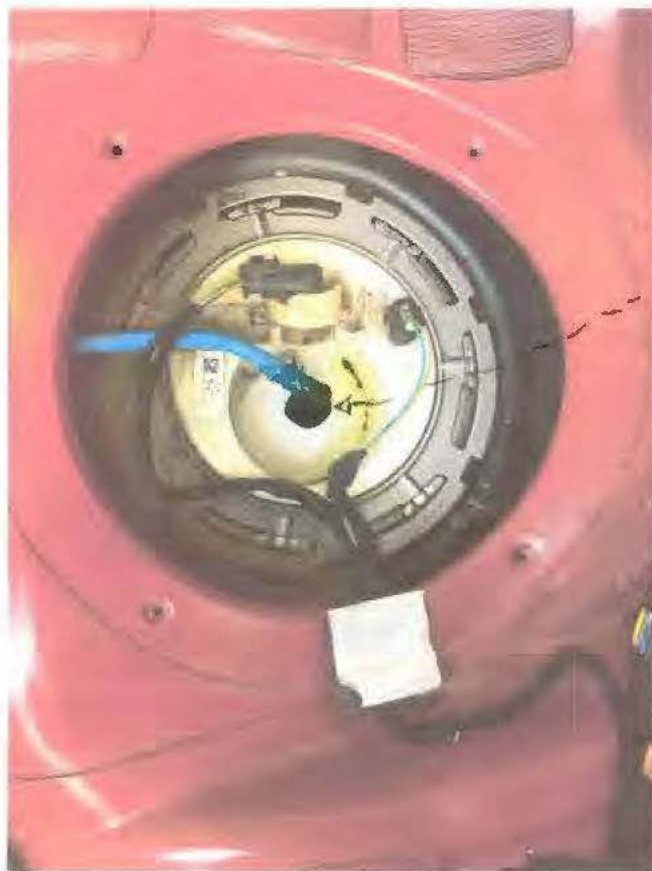
**Problem:** Fuel Delivery Module (The plastic flange leaks when the electric fuel pump engages) Cracked at the top of the fuel pump or the plastic flange leak and caused fuel to develop a pool at the top of the unit (see the enclosed picture). This happens when the tank is above 1/4 full and when the vehicle is operating resulting in strong fuel fumes inside the vehicle and fuel leaking from the undercarriage onto the tailpipe. This design flaw is damage and a Safety Hazard that could result into physical harm individuals or possible death, if the vehicle explodes from the leak of fuel on the tailpipe while driving or fumes could cause inhalation problems that can affect sinus.

See below is a picture of the faulty component with gas in the well of the faulty part.

← Plastic Flange Leaking  
- Fuel in the well of the  
Leaking Assy.

99034 FUEL PUMP ASSEMBLY IS LEAKING FROM THE PLASTIC CONNECTION TO THE FUEL FEED LINE ON TOP OF FUEL TANK. 3.00 TECH PERFORMED DRAIN AND FILL FUEL TANK. REMOVE/INSTALL REAR BOTTOM SEAT CUSHION. PERFORMED REMOVE/INSTALL FUEL TANK ACCESS COVERS. FOUND FUEL PUMP ASSEMBLY LEAKING FUEL ON TOP OF PUMP AT FUEL FEED LINE CONNECTION. TECH PERFORMED REMOVE/REPLACE FUEL FILTER ASSEMBLY UNITS IN FUEL TANK. PERFORMED TEST DRIVE AND POST TEST DRIVE INSPECTION, NO FUEL LEAK PRESENT. RETURNING VEHICLE TO CUSTOMER. CUSTOMER HAS REQUESTED THE OLD PART BE RETURNED TO OWNER. TECH PLACED OLD PARTS IN BOXES, AND PLACED THEM IN REAR CARGO AREA OF VEHICLE.
