TECHNICAL SERVICE BULLETIN

2.0L EcoBoost - Coolant In Cylinders, White Exhaust Smoke And/Or Illuminated MIL

19-2346
19 December 2019

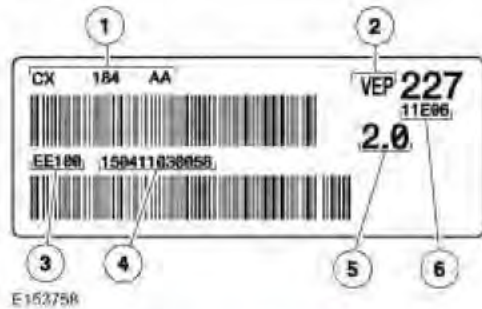
1. For Edge/Escape vehicles, proceed to Step 3. For Fusion/MKZ/MKC vehicles, inspect the engine code information label located on the end of the cam cover. Refer to Figure 1 Callout 1 for the engine part number. Verify that the engine base part number matches the following requirements:

Item	Description
1	Engine part number

- (1). Fusion/MKZ - engine base part number is 910
- (2). MKC - engine base part number is 206
