FIELD TECHNICAL REPORT

TQCN DOC# Affiliate FTR-80N129671 TMS		Dept. QA-Vehicle and	Source FTS	Location TMS-GST	Ref	Date	
					43351-1	10/24/2007	
Problem Area	Primary N	lodel	Model Year	Production Date	Odometer	VIN (confirm 17 characters):	
PPO/DIO	Tacoma		2006	01-Aug-2006	7176 mi	5TEKU72N06Z	
Condition Title	<u> </u>						
FLOOR MAT A	LL WEATH	ER - REF# 5	58525

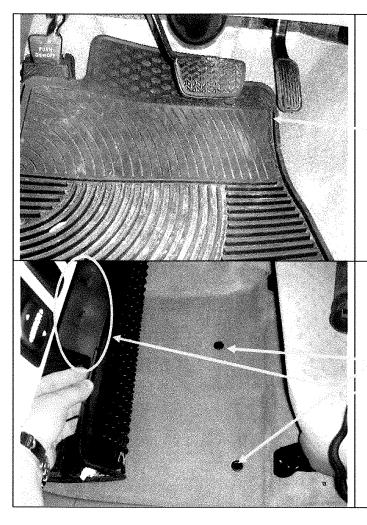
Ridge of the mat interferes with the proper operation of the accelerator pedal.

Note mat installed with out retainer clips.

Excessive flashing has not been trimmed off of the rear portion of the mat.
