PE03-050

ATTACHMENT 2B

CASE NUMBER: 00753370

SERIES: ELDOORADO

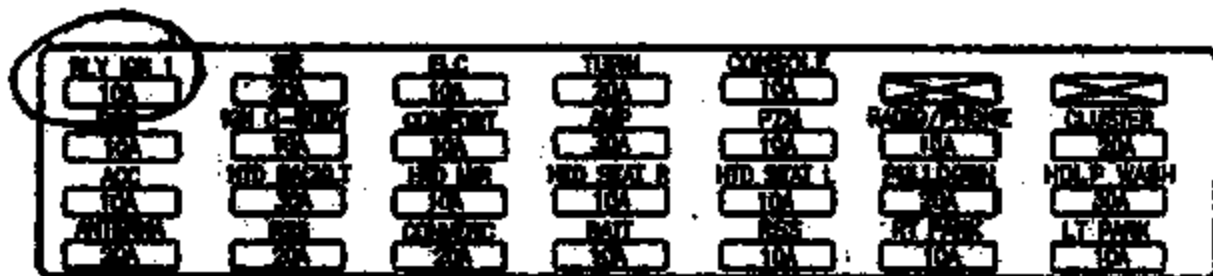
3-22-74

TRUNK COMPARTMENT FUSE BLOCK
