Crown Victoria / Grand Marquis Full Face Wheel Populations

EA04-034
Appendix F
6/1/2005

Steel Wheel - 16x7.0
Base Part Number: 1007

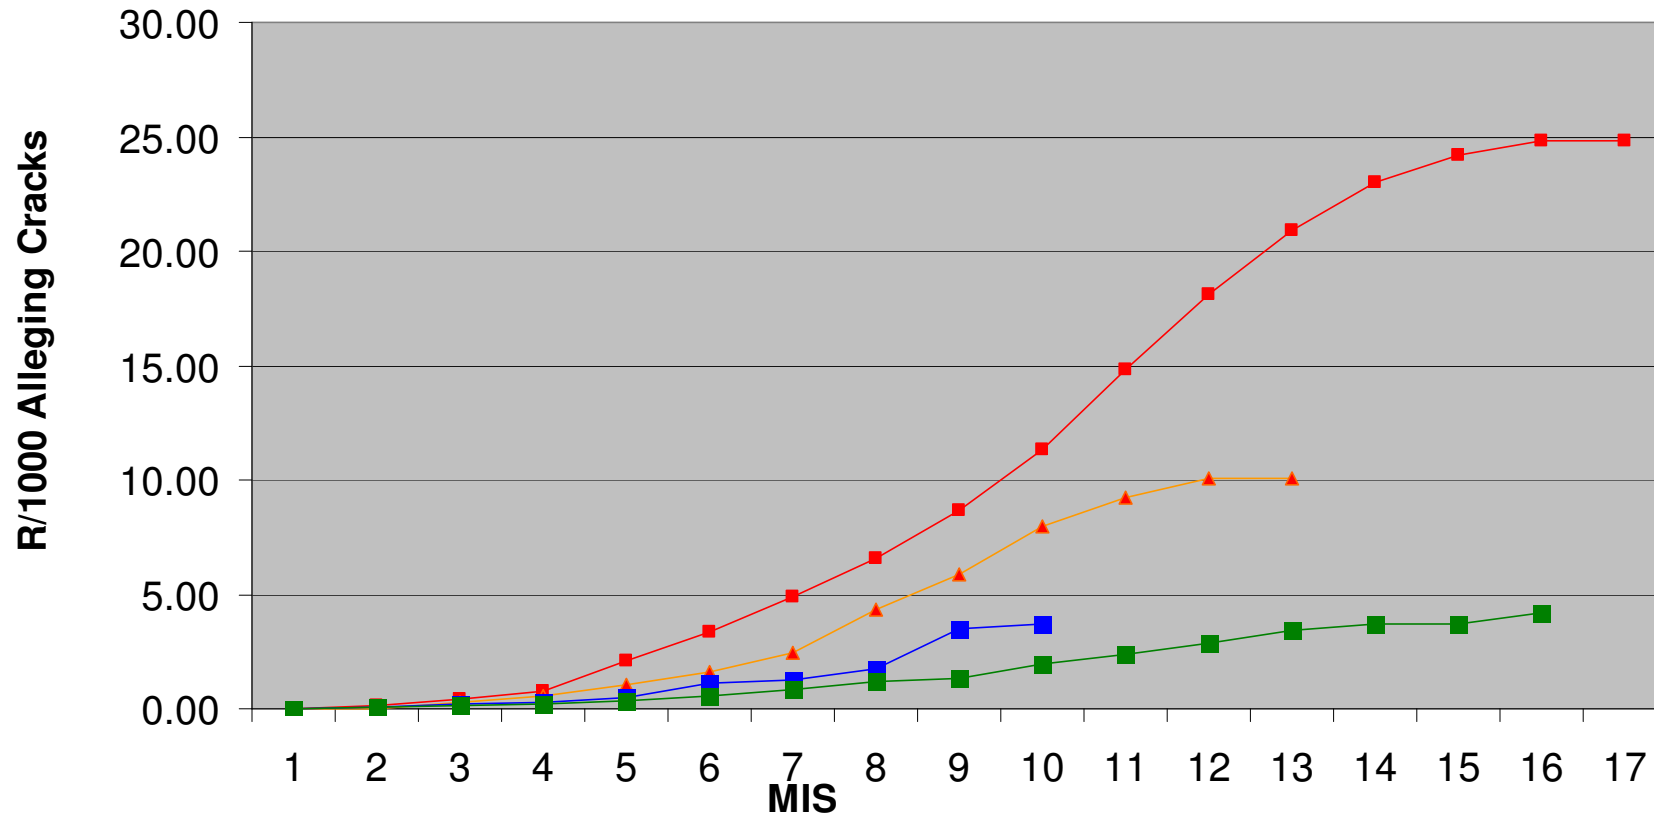
Alleged Cracked Wheel R/1000 as of 8/1/03 and 8/4/04 (CF only)

—■— S1 Fleet R/1000 —▲— S2 Fleet R/1000 —■— M Fleet R/1000 —■— CF Fleet R/1000

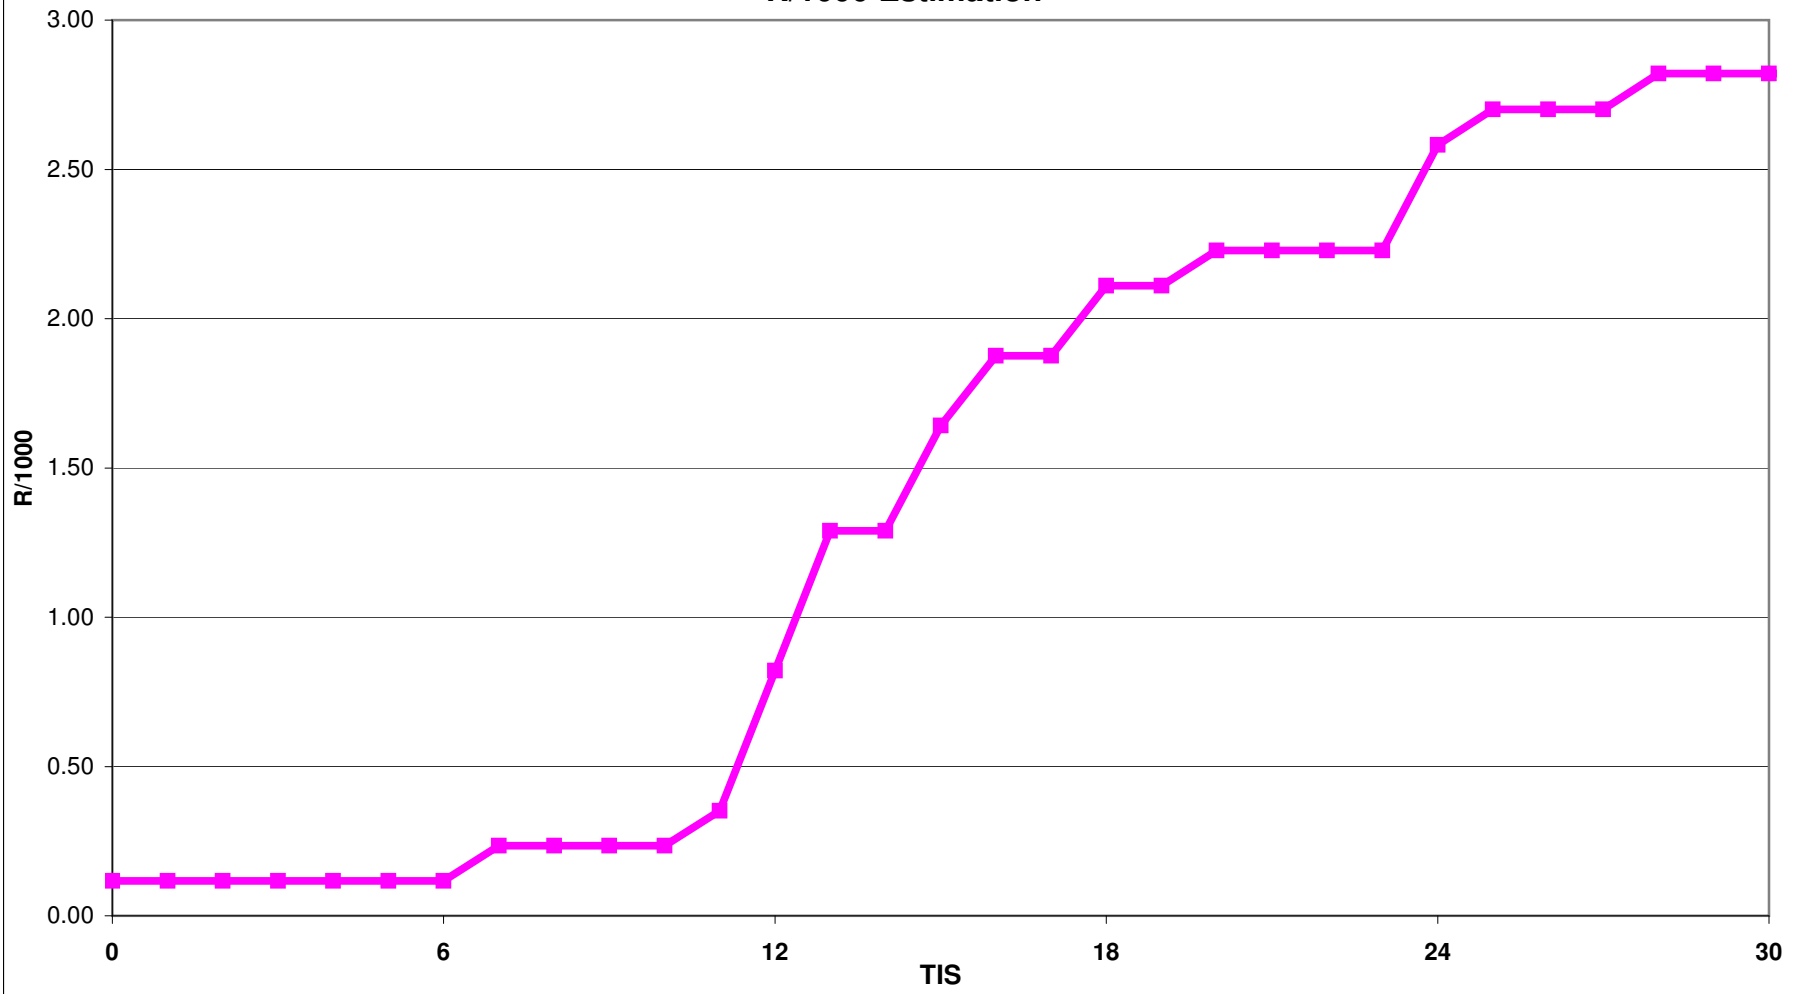
SSV_Rate

Inquiry PE08-070
Expedition MY2004-2006
SPECIAL SERVICES EQUIPMENT PACKAGE
R/1000 Estimation
