## Field Product Observation Report

<b>To:</b> FPOR <-- optional Note: An e-mail copy is always sent to National, in addition to above e-mail recipient(s).	
<b>Subject:</b> Peeling chrome on Sonata front interior door handles	<b>UPC:</b>
<b>Originator:</b> Steve Heiss	<b>Report #:</b>
<b>Dealer Code:</b> KY001	<b>Date:</b> 01/22/2003
<b>VIN:</b> KMHWF25H32A [REDACTED]	<b>Contact Person:</b> Brian King
<b>Model:</b> Sonata*	<b>Mileage:</b> 8294
<b>Production Date:</b> 04/09/02	<b>Model Year:</b> 2002*
<b>Part Name:</b> front interior door handle	<b>Category:</b> 17 Latch*
<b>Part Number:</b> 82610-3D010, 82620-3D010	
<b>Customer Complaint:</b> Cusotmer complaint that the chrome is peeling on the front interior door hadles creating a very sharp edge.	
<b>Dealer Observations:</b> The dealer verified the cusotmer complaint	
<b>Corrective Action:</b> Both right and left front door handles were replaced.	
<b>Did this action resolve condition?</b> <input checked="" type="radio"/> Yes <input type="radio"/> No

<b>To:</b> FPOR <-- optional Note: An e-mail copy is always sent to National, in addition to above e-mail recipient(s).			
<b>Subject:</b> Inside Door Handles Peeling Chrome			<b>UP

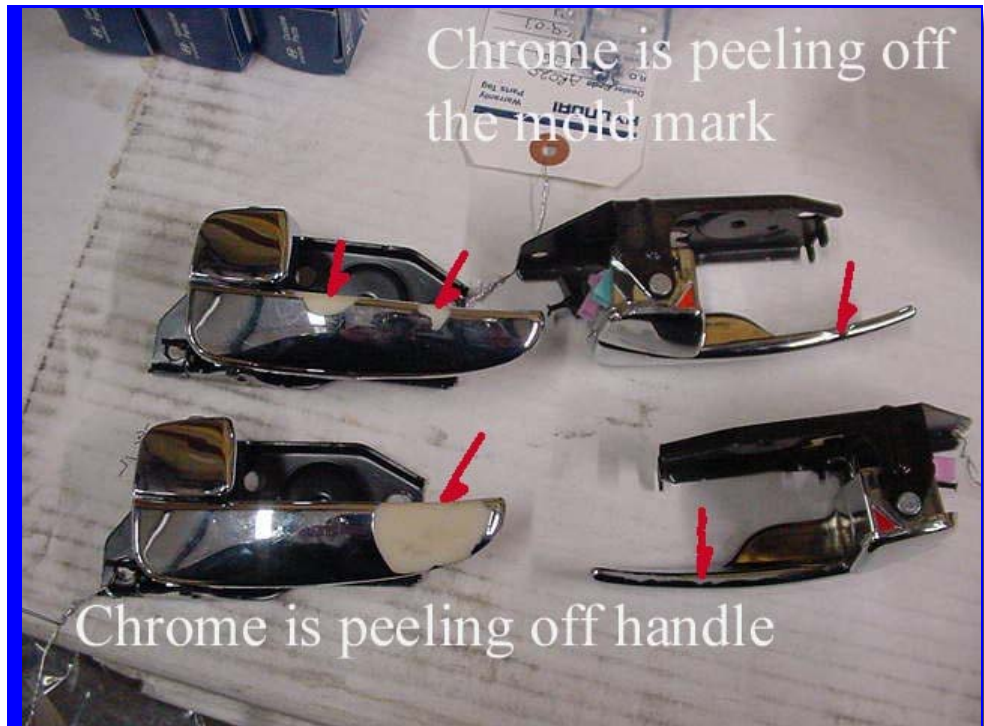
Door handle chrome peeling off

- The chrome is peeling on the inside door handle. See photos below.
- Other Vehicles

Replaced the Handle P/N 82610-3D010

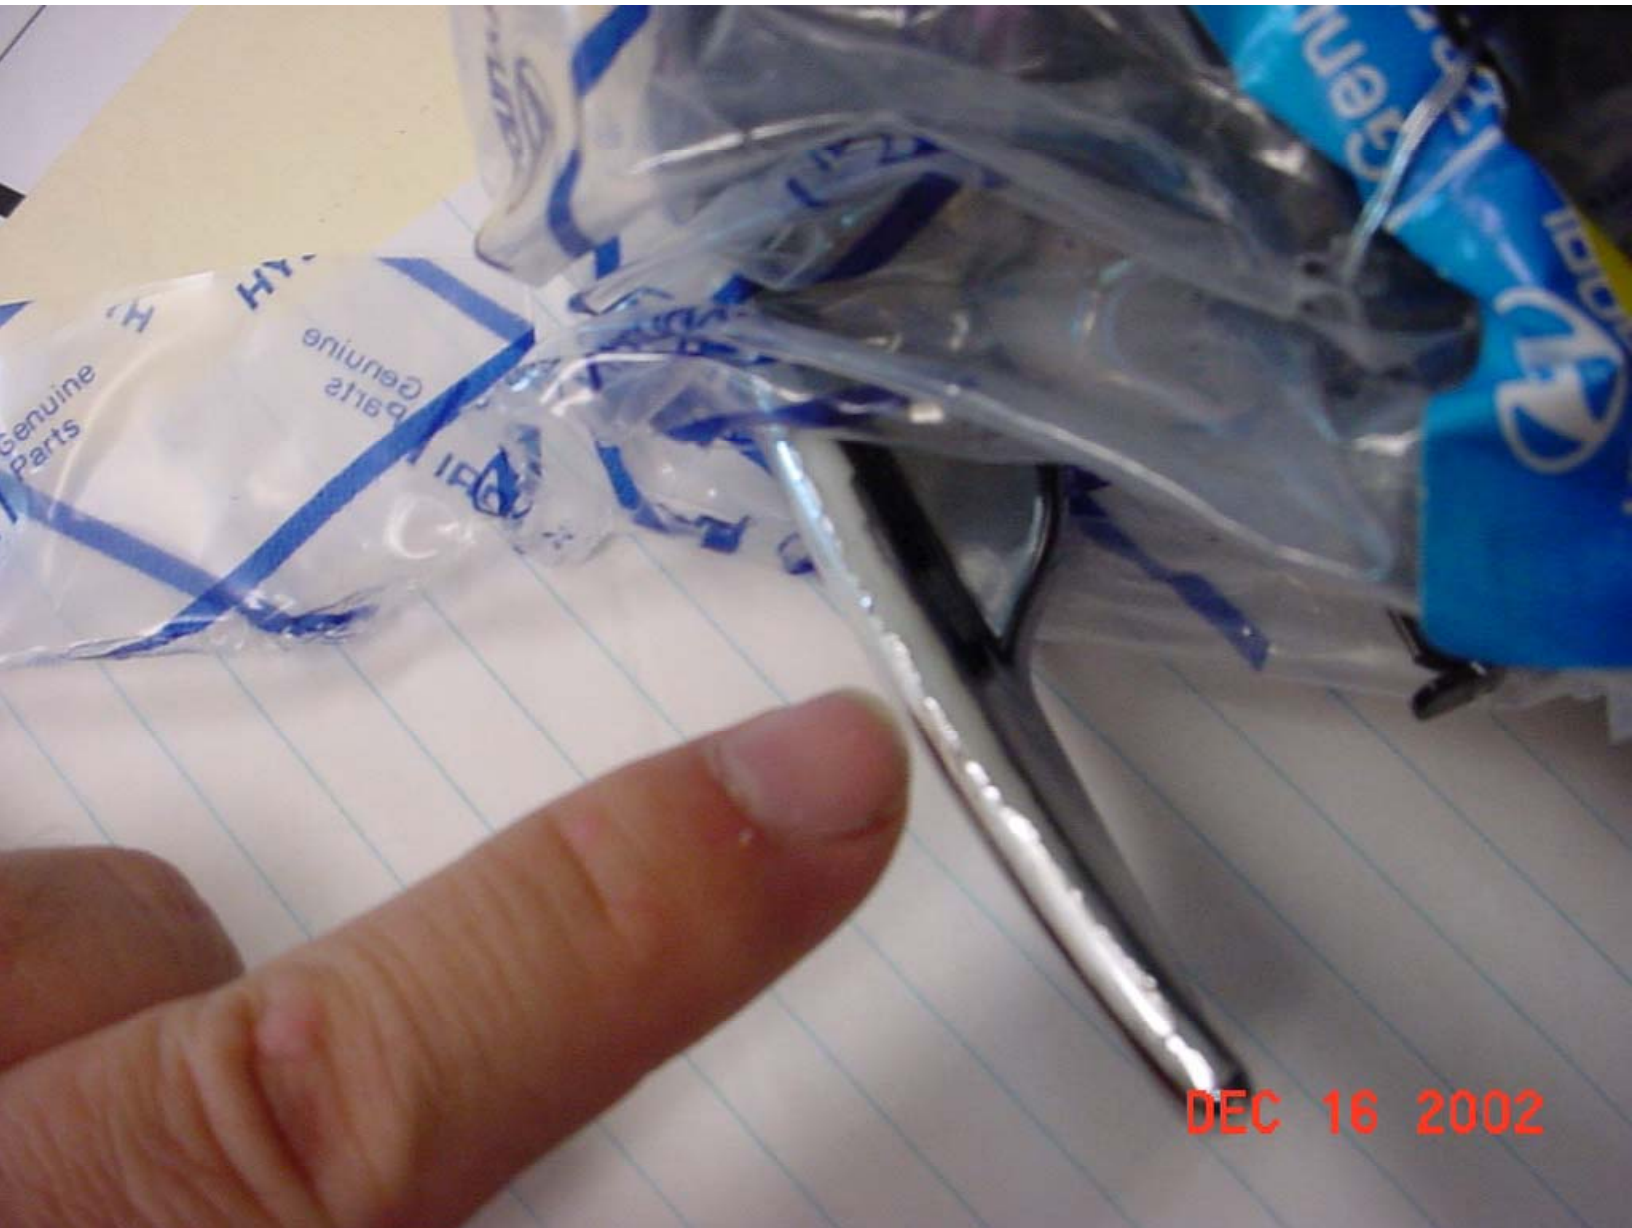
PARTS HELD AT DLR PENDING HMA REQUEST FOR RETURN Mvc-284f.jpg

<b>To:</b> FPOR <-- optional Note: An e-mail copy is always sent to National, in addition to above e-mail recipient(s).			
<b>Subject:</b> BODY- INTERIOR			<b>UPC:</b>
<b>Originator:</b> Scott Snyder	<b>Report #:</b>	<b>Date:</b> 12/18/2002	
<b>Dealer Code:</b> NV015	<b>Contact Person:</b> TOM MOORE		
<b>VIN:</b> KMHWF25S72A KMHWF35H12A KMHWF25S82A KMHWF25S72A KMHWF25S52A KMHWF25S82A KMHWF35H42A KMHWF25S72A KMHWF35H92A		<b>Mileage:</b> 10000 7337 6152 17700 3397 6801 1318 3833 1617	
<b>Model:</b> Elantra*		<b>Model Year:</b> 2002*	
<b>Production Date:</b>		<b>Category:</b> 17 Latch*	
<b>Part Name:</b> DOOR HANDLE		<b>Part Number:</b>	
<b>Customer Complaint:</b> CUST STATES CHROME PLATING ON BOTH FRONT DOOR HANDLES PEELING OFF, CREATING SHARP EDGES THAT MAY HAVE CUT FINGERS			
<b>Dealer Observations:</b> CHROME PEELING AT TOP SEAM WHERE CHROME PLATING IS JOINED BETWEEN THE INSIDE AND THE OUTSIDE OF THE HANDLE

<b>Corrective Action:</b> REPLACE THE DOOR HANDLE			
<b>Did this action resolve condition?</b> <input checked="" type="radio"/> Yes <input type="radio"/> No			
<b>Condition verified by personal inspection of company employee?</b> <input checked="" type="radio"/> Yes <input type="radio"/> No			
<b>Were Photos Taken?</b> <input checked="" type="radio"/> Yes <input type="radio"/> No			
<b>Parts Inspected?</b> <input checked="" type="radio"/> Yes <input type="radio"/> No			
<b>Parts Sent?</b> <input type="radio"/> Yes <input checked="" type="radio"/> No			
<b>Comment:</b>
