**From:** Clarence Ditlow [cmdiii@autosafety.org]  
**Sent:** Wednesday, July 07, 2010 10:06 PM  
**To:** Boyd, Richard (NHTSA); Yon, Scott (NHTSA); Hershman, Larry (NHTSA)  
**Cc:** Medford, Ronald (NHTSA)  
**Subject:** Jeep Grand Cherokee Crash Test  
**Attachments:** Grand Cherokee Fuel Spray at FHWA 2.jpg

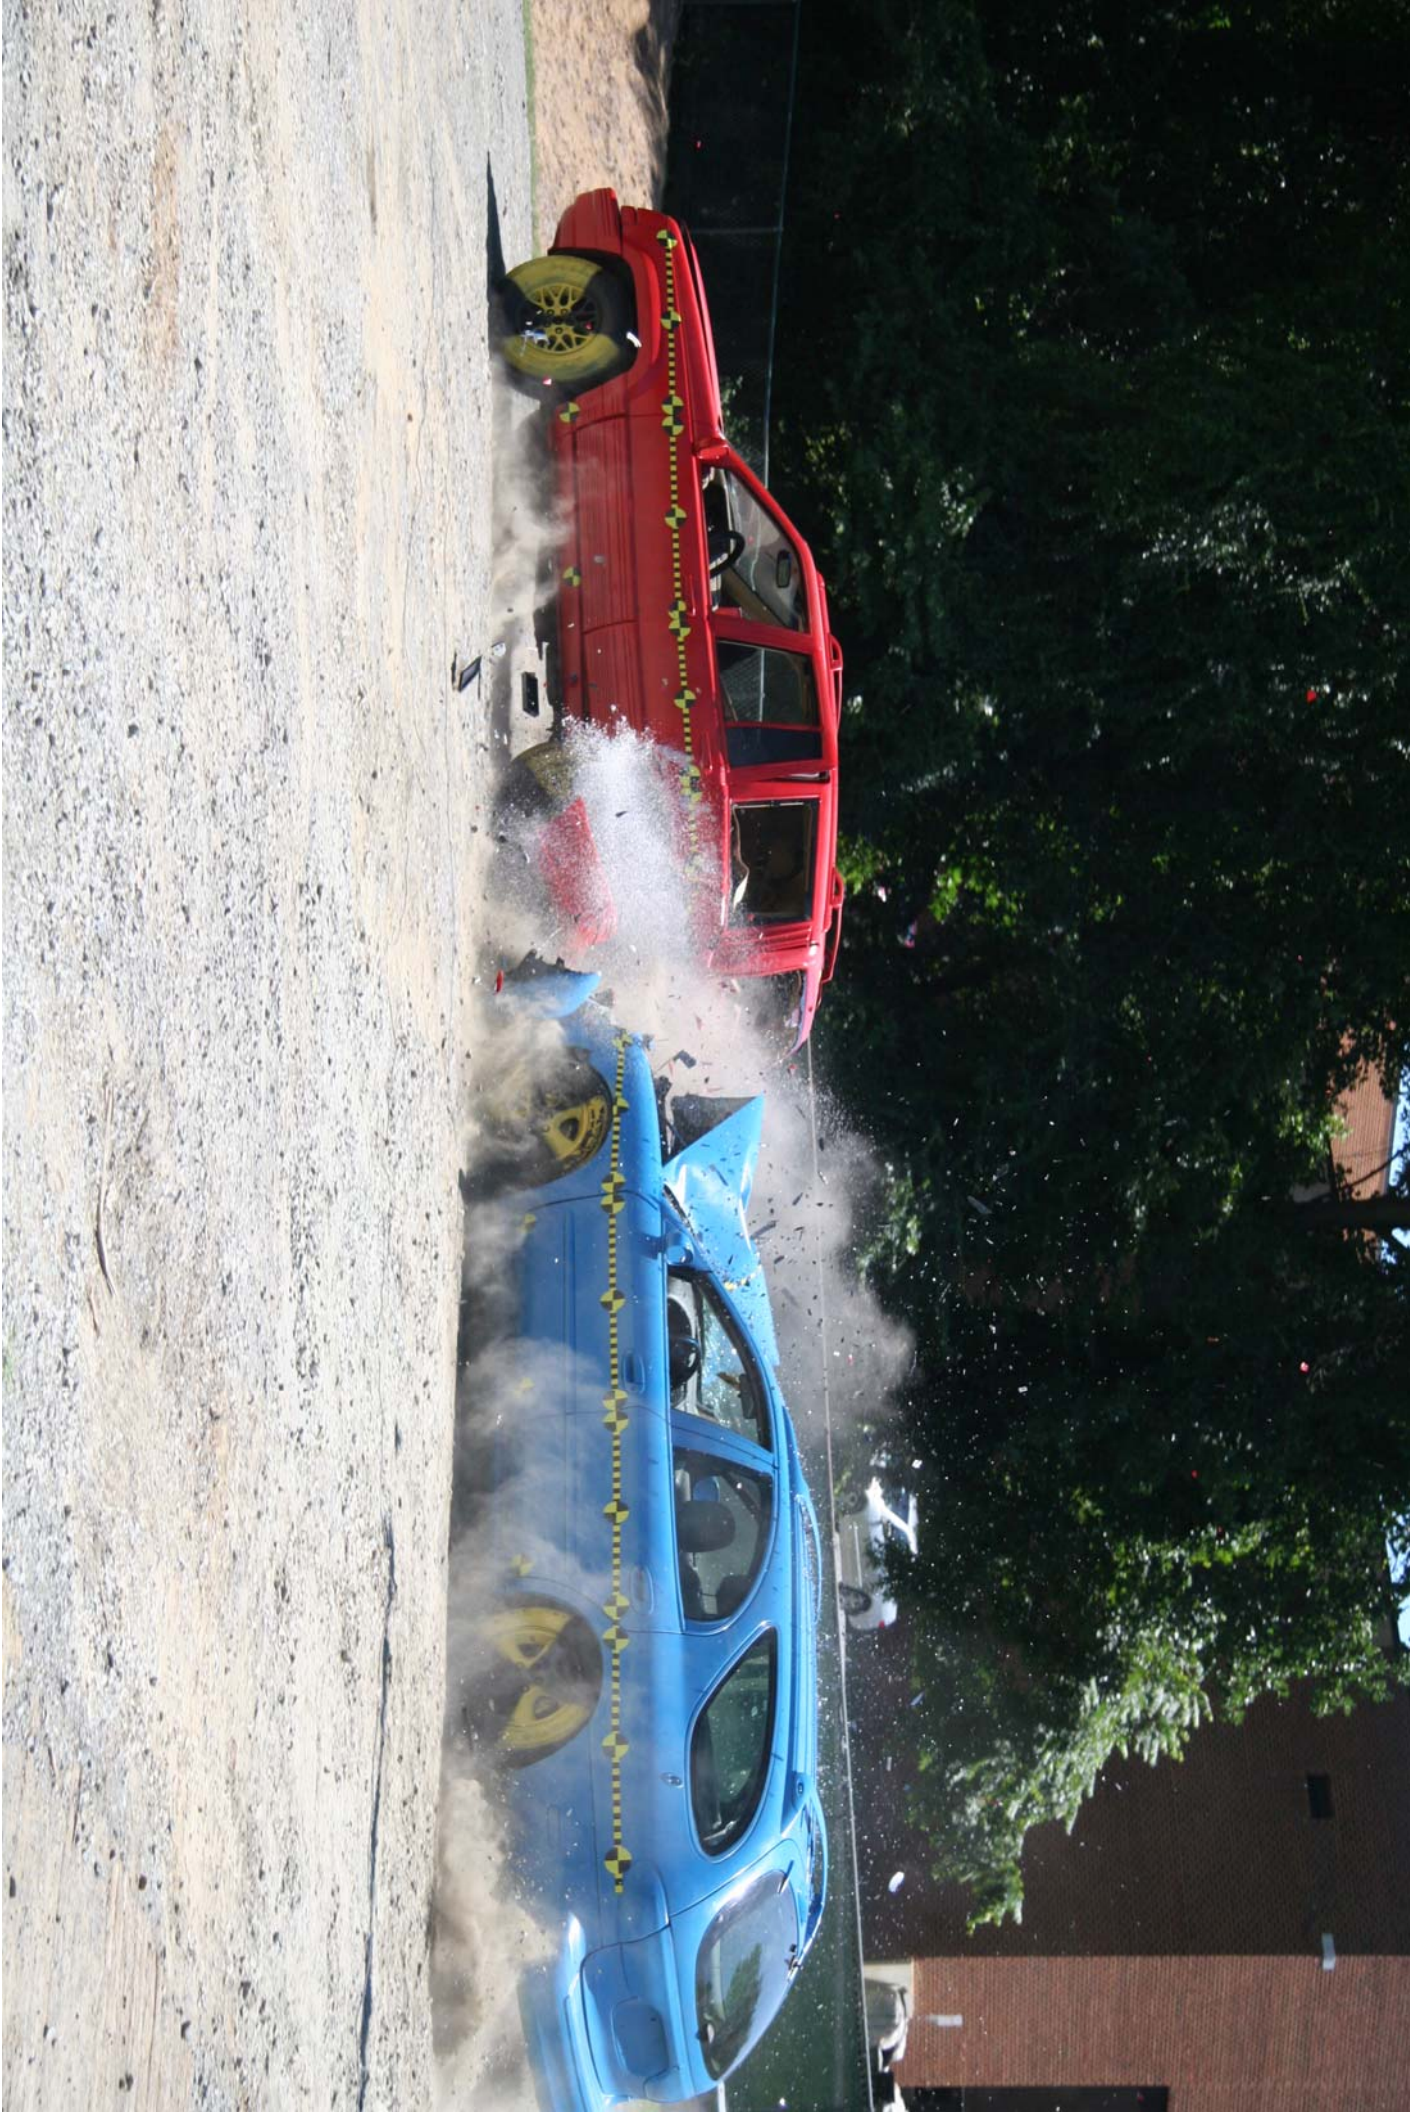
We will be sending a detailed report later – as the attached photos show, there was a catastrophic failure in that the fuel and vent hoses were pinched in the hole in the fuel rail. The resultant relative movement of the fuel tank and frame rail pulled not only the fuel and vent hoses out of the tank but took the check valve with it that allowed the plume of Stoddard fluid (gasoline surrogate) to disperse from the tank into the air & form an ideal mixture for combustion should there be a combustion source.
