EA12-001

CHRYSLER

FIELD DATA SUBJECT

**CONFIDENTIAL - Prior Approval Required Before Duplicating**  
**Preliminary Vehicle Investigation Report(PVIR)**

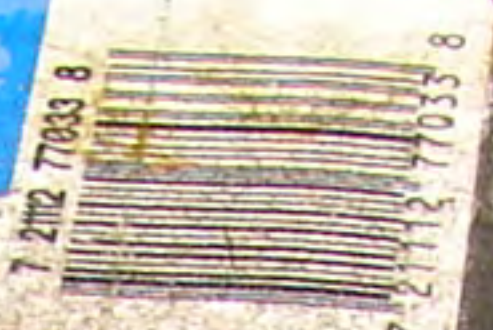
Part Number 86-1  
Capacity 700  
Cold Cranking Amperes 525  
Reserve 90  
DISTRIBUTED BY AUTOCRAFT - PO BOX 2710 - ROANOKE, VA 24001
