ODI RESUME

Investigation: PE 14-007
Date Opened: 03/20/2014
Investigator: Robert Young
Approver: Frank Borris
Subject: Front brake malfunction - Motorcycle

Problem Description: Loss of brake effectiveness caused by front brake pad ejection from the brake caliper.

Title: Brake Rotor Change

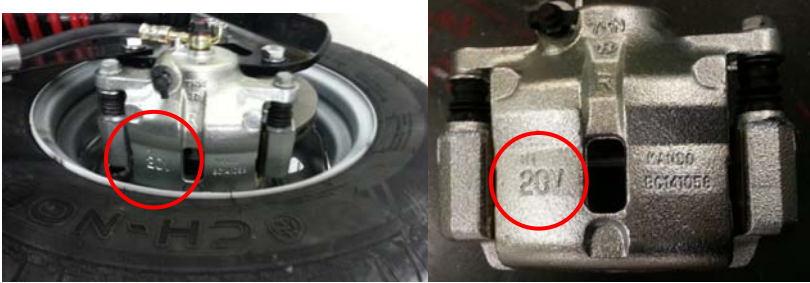
Step	Instruction	Visual Aid
1	<p>Inspect front brake caliper and determine if caliper is marked with a 20V or a 20S.</p> <p>20S no further action is required 20V proceed with pad, rotor and brake caliper spacer replacement</p> <p>Tools needed :</p> <p>Torque wrench 3/4 & 9/16 sockets 5/16 Allen key socket Long flat head screw driver 17mm socket Loctite 262 red</p>

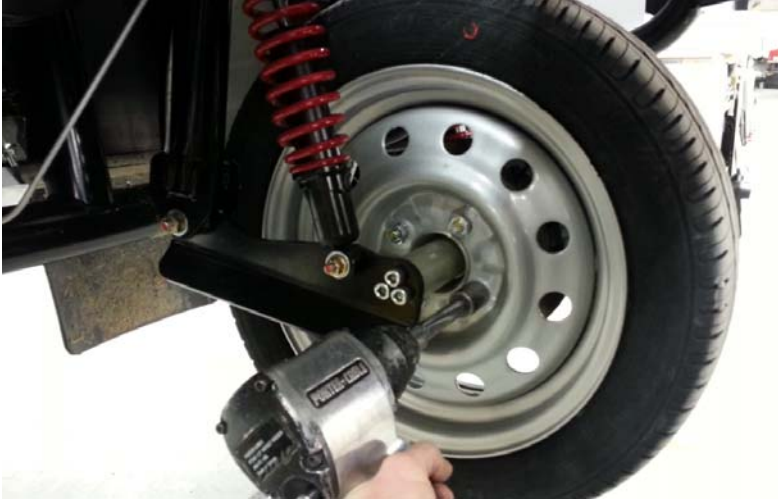
2	<p>Lift vehicle on approved lift or Jack up front of vehicle and safely secure with jack stands, never work on a vehicle supported only by a jack.</p> <p>Remove the wheel bolts. 17mm socket</p>

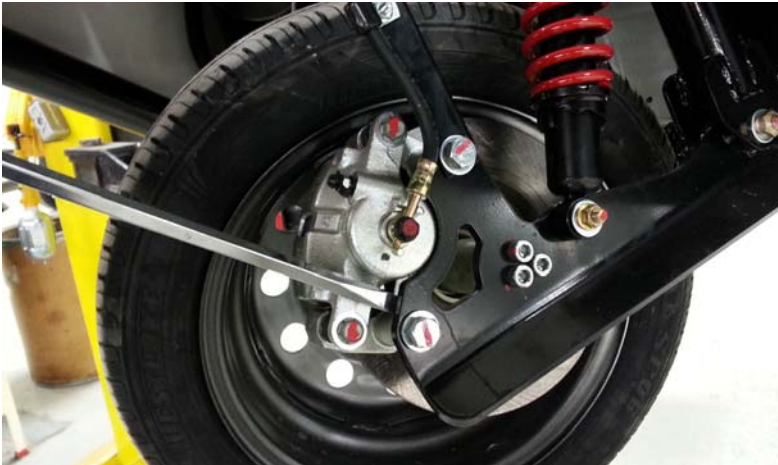
3	<p>Use a screwdriver to loosen the caliper.</p>

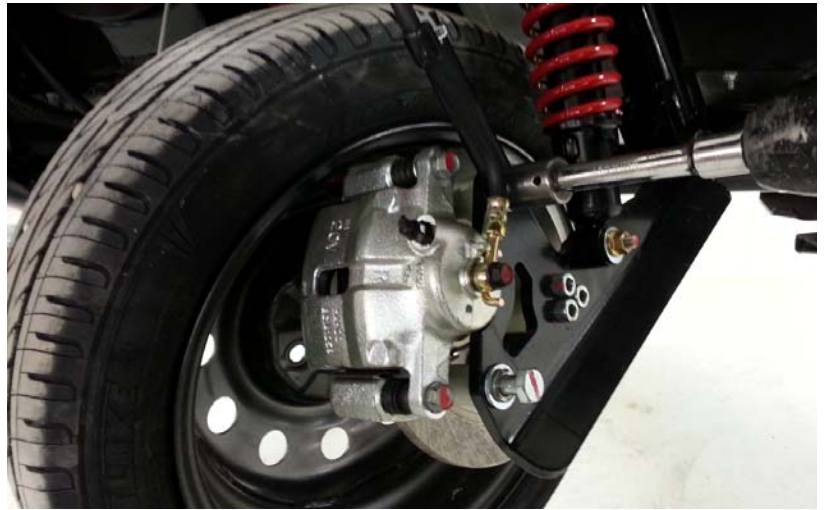
4

Remove the caliper bolts.
3/4 inch socket

Place the brake caliper in safe place

Do not let it hang from brake hose.

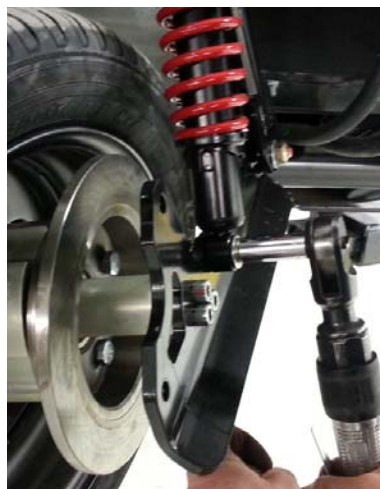
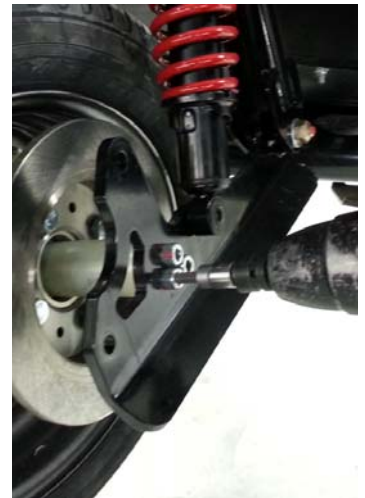
5

Remove the shock bolt.
9/16 socket

Remove the axle bolts.
5/16 inch Allen key socket

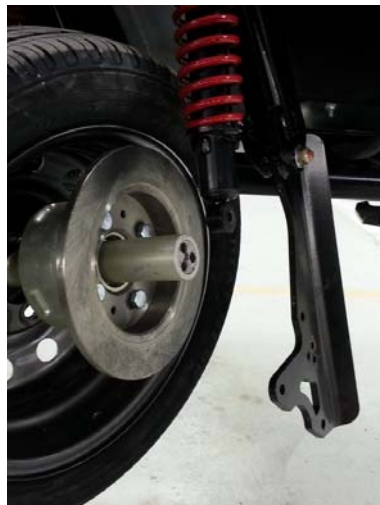
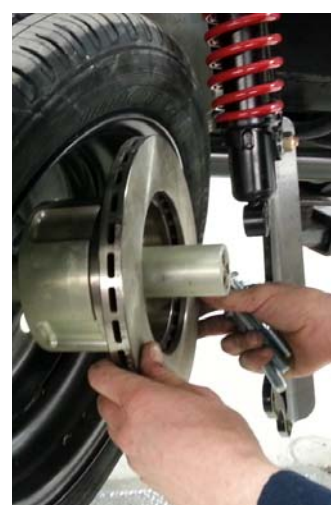
6

Rotate the arm of the way.

Do not exert extra force on axle while it is hanging on right side arm only.

Remove solid brake rotor.

Install new vented rotor

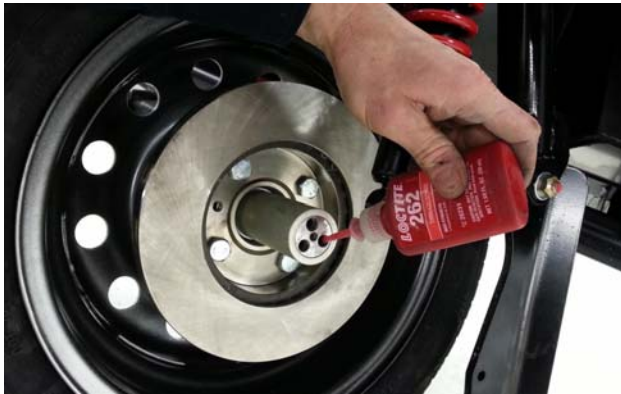
7	<p>Clean axle to leading arm mating surface</p> <p>Apply red Loctite 262. Make sure axle spacer is still in position.</p>

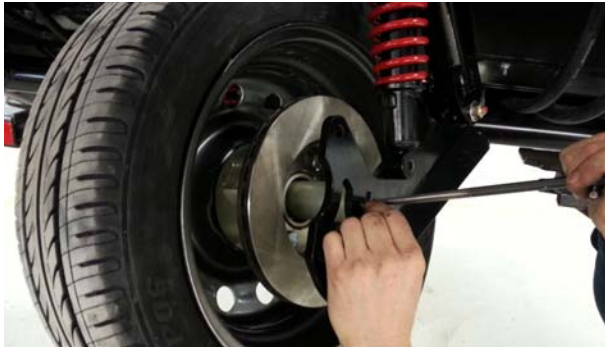
8	<p>Rotate leading arm back into position and start the 3 -5/16 axle bolts by hand paying special attention not to strip the bolts or the axle.</p>

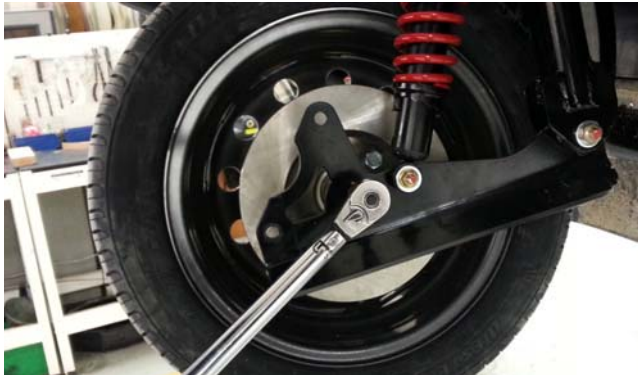
9	<p>Tighten the axle bolts in three steps.</p> <ul style="list-style-type: none">1st. 25 ft-lb2nd. 45 ft-lb3rd. 55 ft-lb <p>At final re torque all 6 axle bolts to 55 ft-lb.</p> <p>Check the other side axle bolts to 55 ft-lb to make sure.</p>

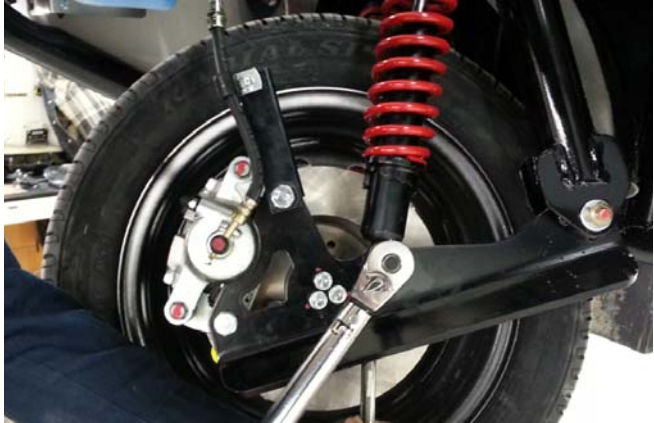
10	<p>Reinstall lower shock bolt and nut</p> <p>Tighten the shock bolt to 35 ft-lb.</p>

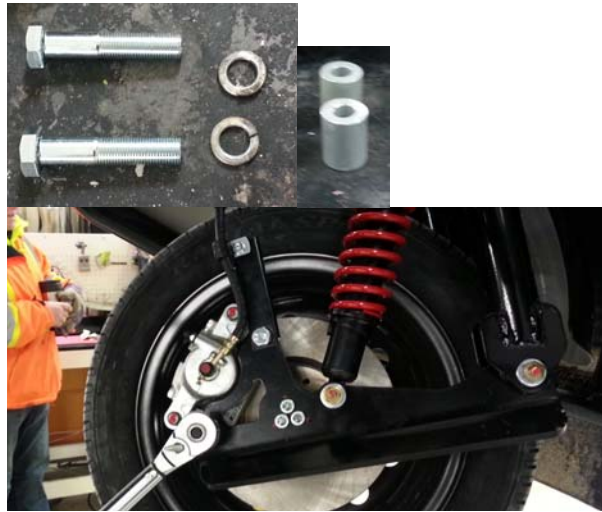
11

Reinstall brake caliper with new bolts and spacers supplier.
New spacers are 33.18mm in length
Bolts.....

Old spacers must be sent back to factory with VIN number.

Reinstall the caliper.

Tighten the caliper bolts to 50 ft-lb.

* old spacers are 39mm in length

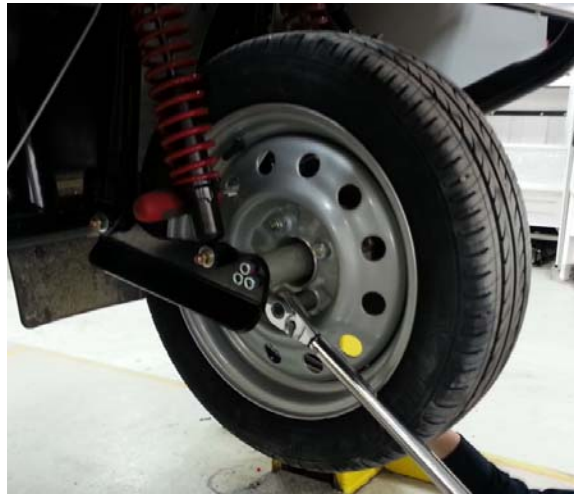
12

Replace the wheel bolts.

Tighten the wheel bolts to 70 ft-lb.

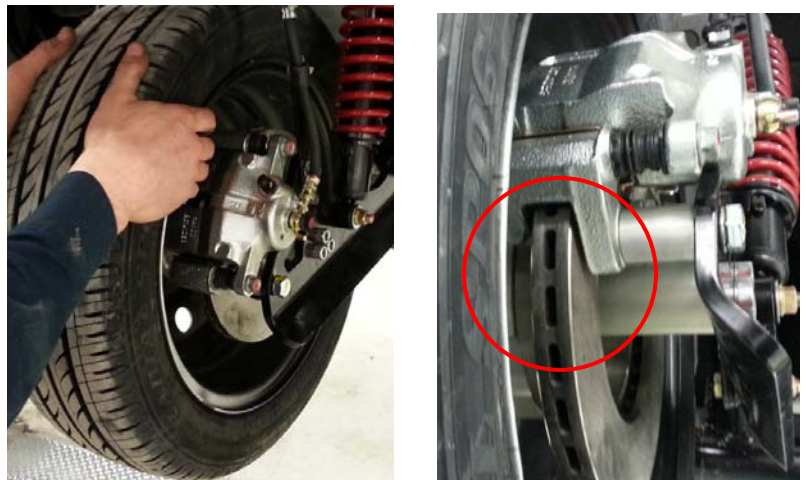
13

Rotate front wheel assembly and make sure it spins freely.

Check the location of the rotor to the center of the caliper.

Lower vehicle from lift
Pump Brake pedal several times before starting.
Test drive
