**National Highway  
Traffic Safety  
Administration**

# ODI RESUME

**Investigation:** PE 14-018  
**Date Opened:** 06/24/2014  
**Investigator:** Stephen Mchenry      **Reviewer:** Jeff Quandt  
**Approver:** Frank Borris  
**Subject:** Pedal Operation Interference

**Manufacturer:** Nissan North America, Inc.  
**Products:** MY 2012-2014 Nissan Versa and Versa Note  
**Population:** 360,000 (Estimated)  
**Problem Description:** Drivers describe incidents of interference between the tunnel carpet cover trim panel and the driver's right shoe when attempting to release the accelerator pedal, allegedly resulting in brief incidents of unwanted acceleration or delayed brake application.

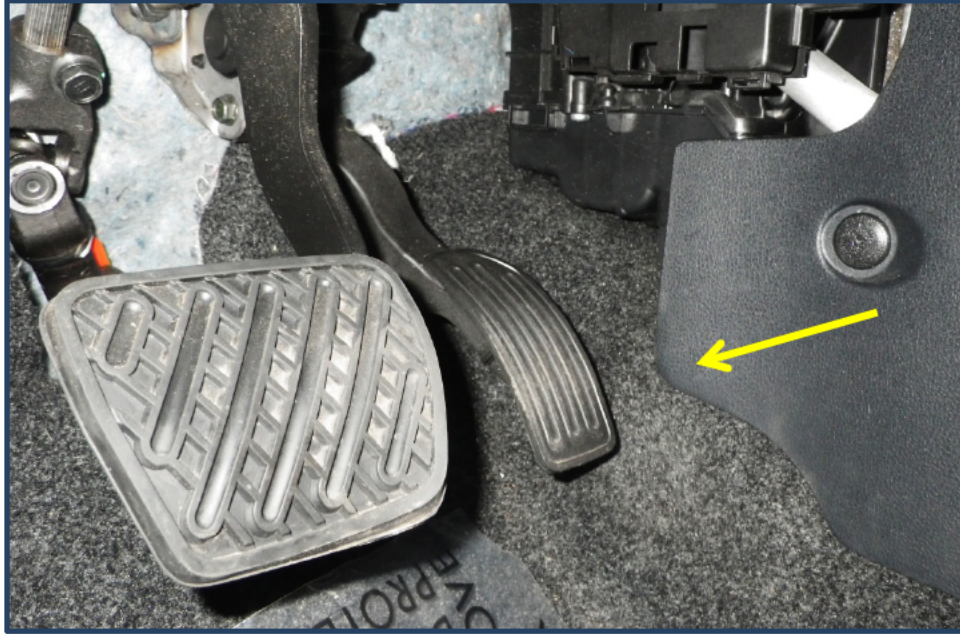
One complainant, VOQ 10597004, alleges that their foot was trapped by the trim panel such that they had to use their right hand to grab their leg and pull up to get their foot free, almost causing a crash during the event. The trim panel in question (Figure 1) is located next to the accelerator pedal and the lower corner is positioned such that it is near the right outer edge of the driver's shoe. The complainant supplied a photograph (Figure 2) showing how the edge of the panel wedged itself in the driver's shoe. Complainant 10573057 alleged that when attempting to remove their foot from the accelerator pedal to apply the brake, their shoe was caught by the trim panel which delayed braking ability several times. Two of the four complainants note that the vehicles were rental cars.

Figure 1: Position of trim panel MY 2013 Versa  
(Arrow indicates corner that interferes with driver's shoe)

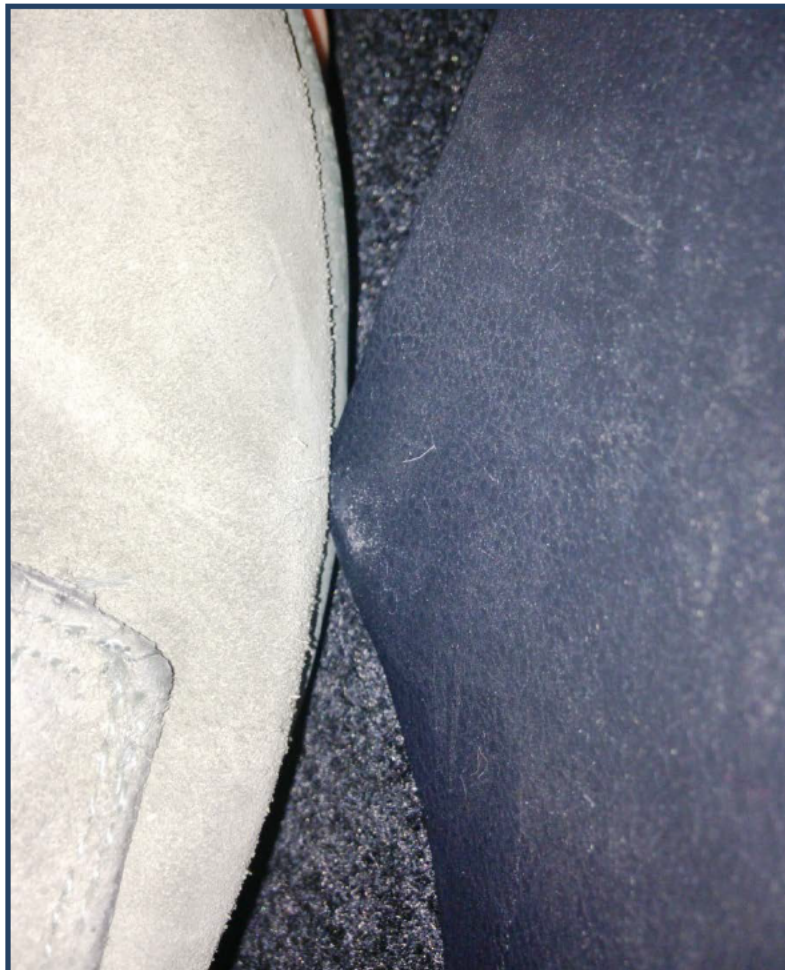
Figure 2: VOQ 10597004 demonstration of interference
