**PRODUCT ALLEGATION RESOLUTION
PRELIMINARY INSPECTION
FIELD PHOTOGRAPHIC NOTES**

Vehicle Brand: JEEP

Model: GRAND CHEROKEE OVERLAND

File # 23961176

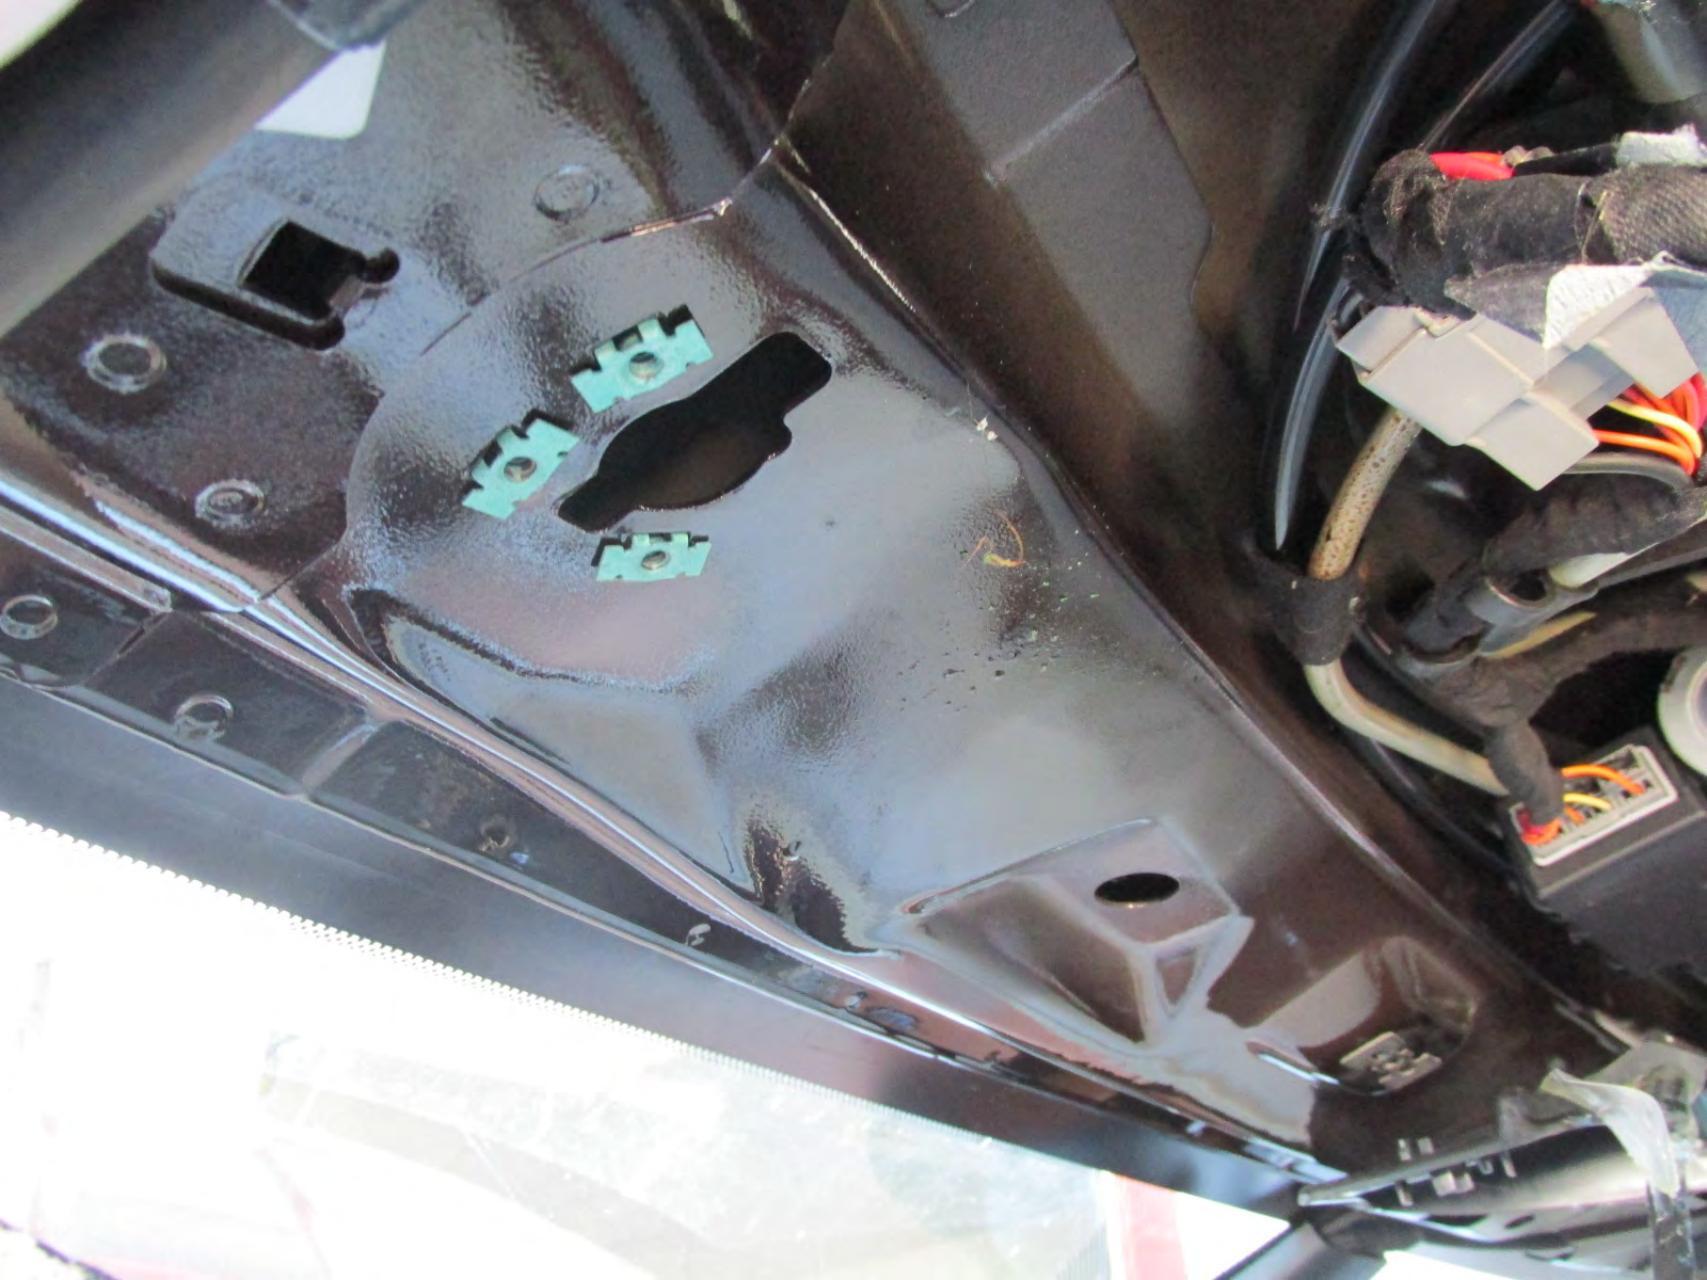
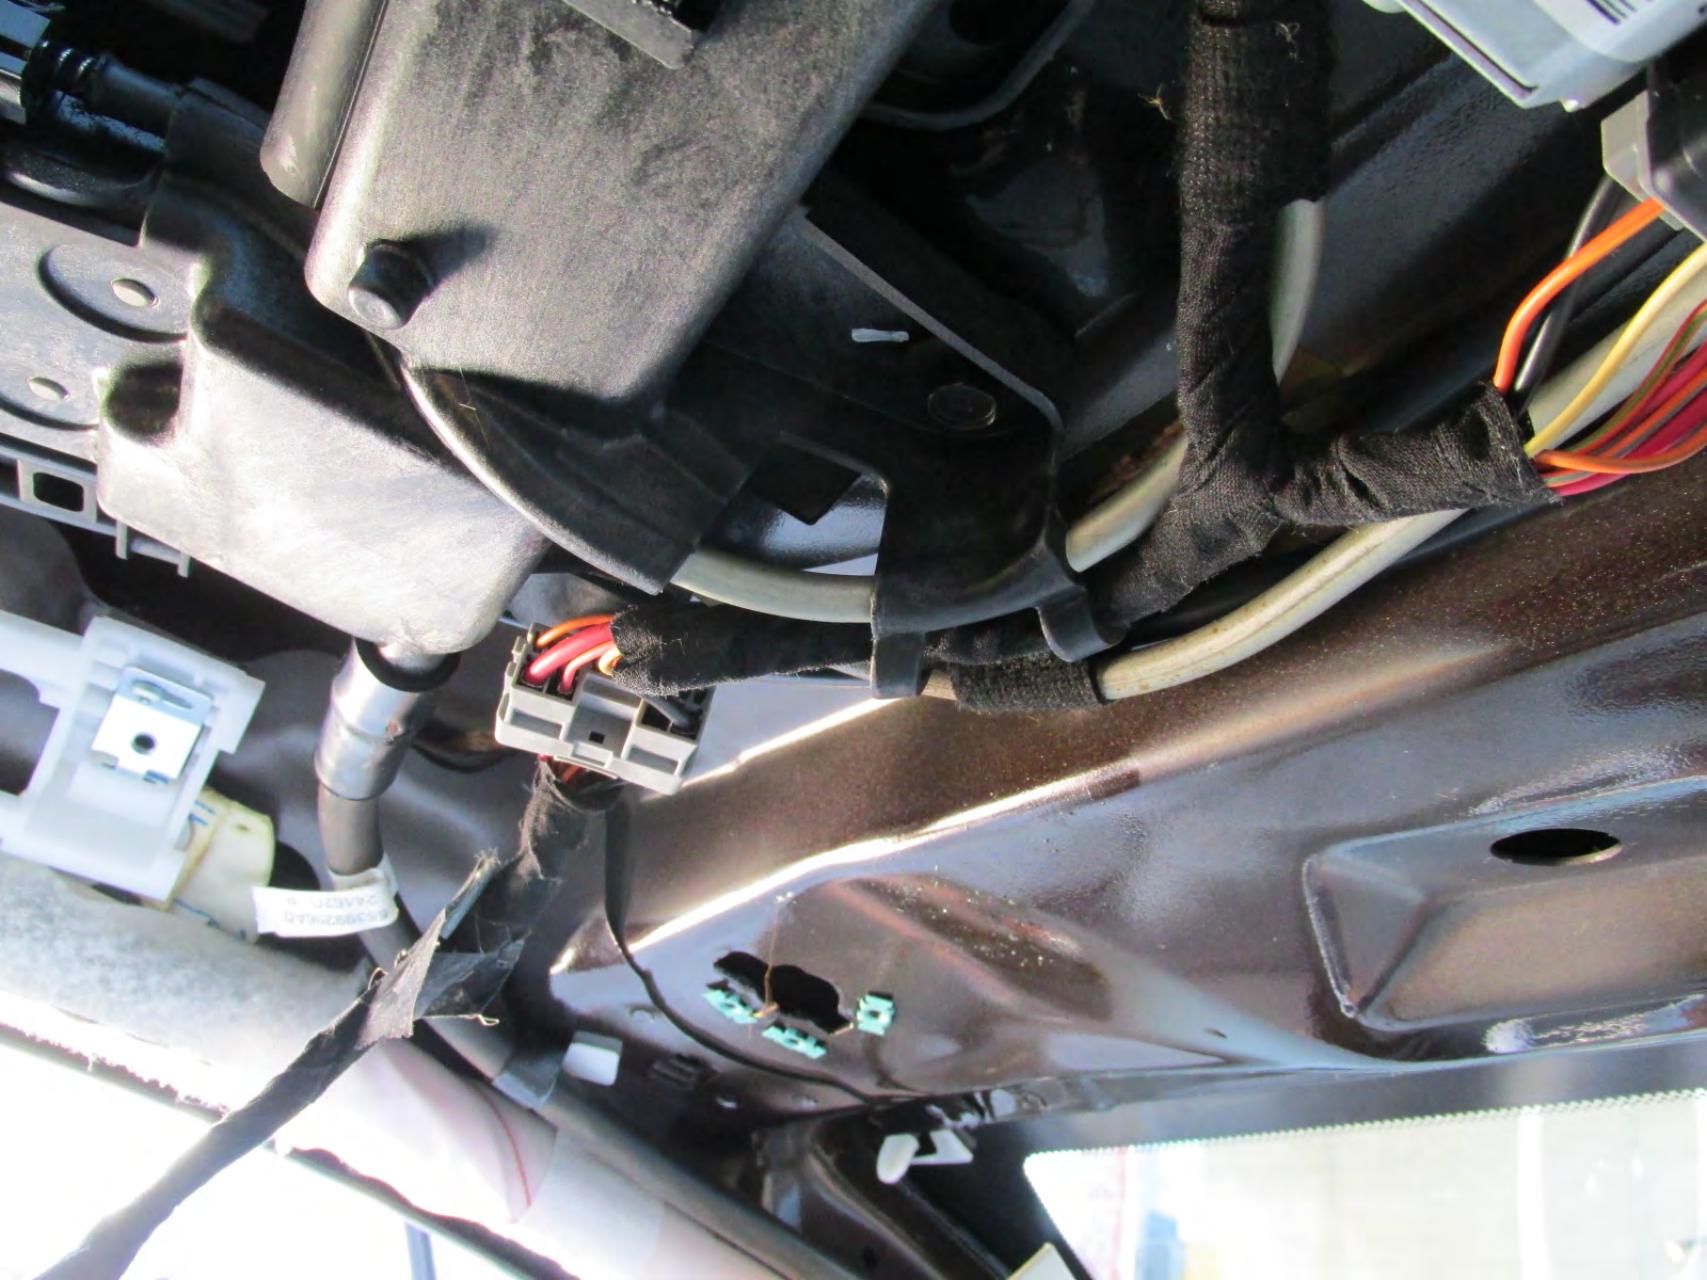
DAMAGED
WIRE STRAND
ATTACHED AT
TOP BY PARTIALLY
MELTED WIRE
INSULATION

This photograph shows a close-up of a damaged electrical connection. A black wire strand is visible, partially melted and attached to a metal terminal or bus bar. Handwritten text and arrows point to the damage, identifying the 'DAMAGED WIRE STRAND' and the 'PARTIALLY MELTED WIRE INSULATION' at the top attachment point.

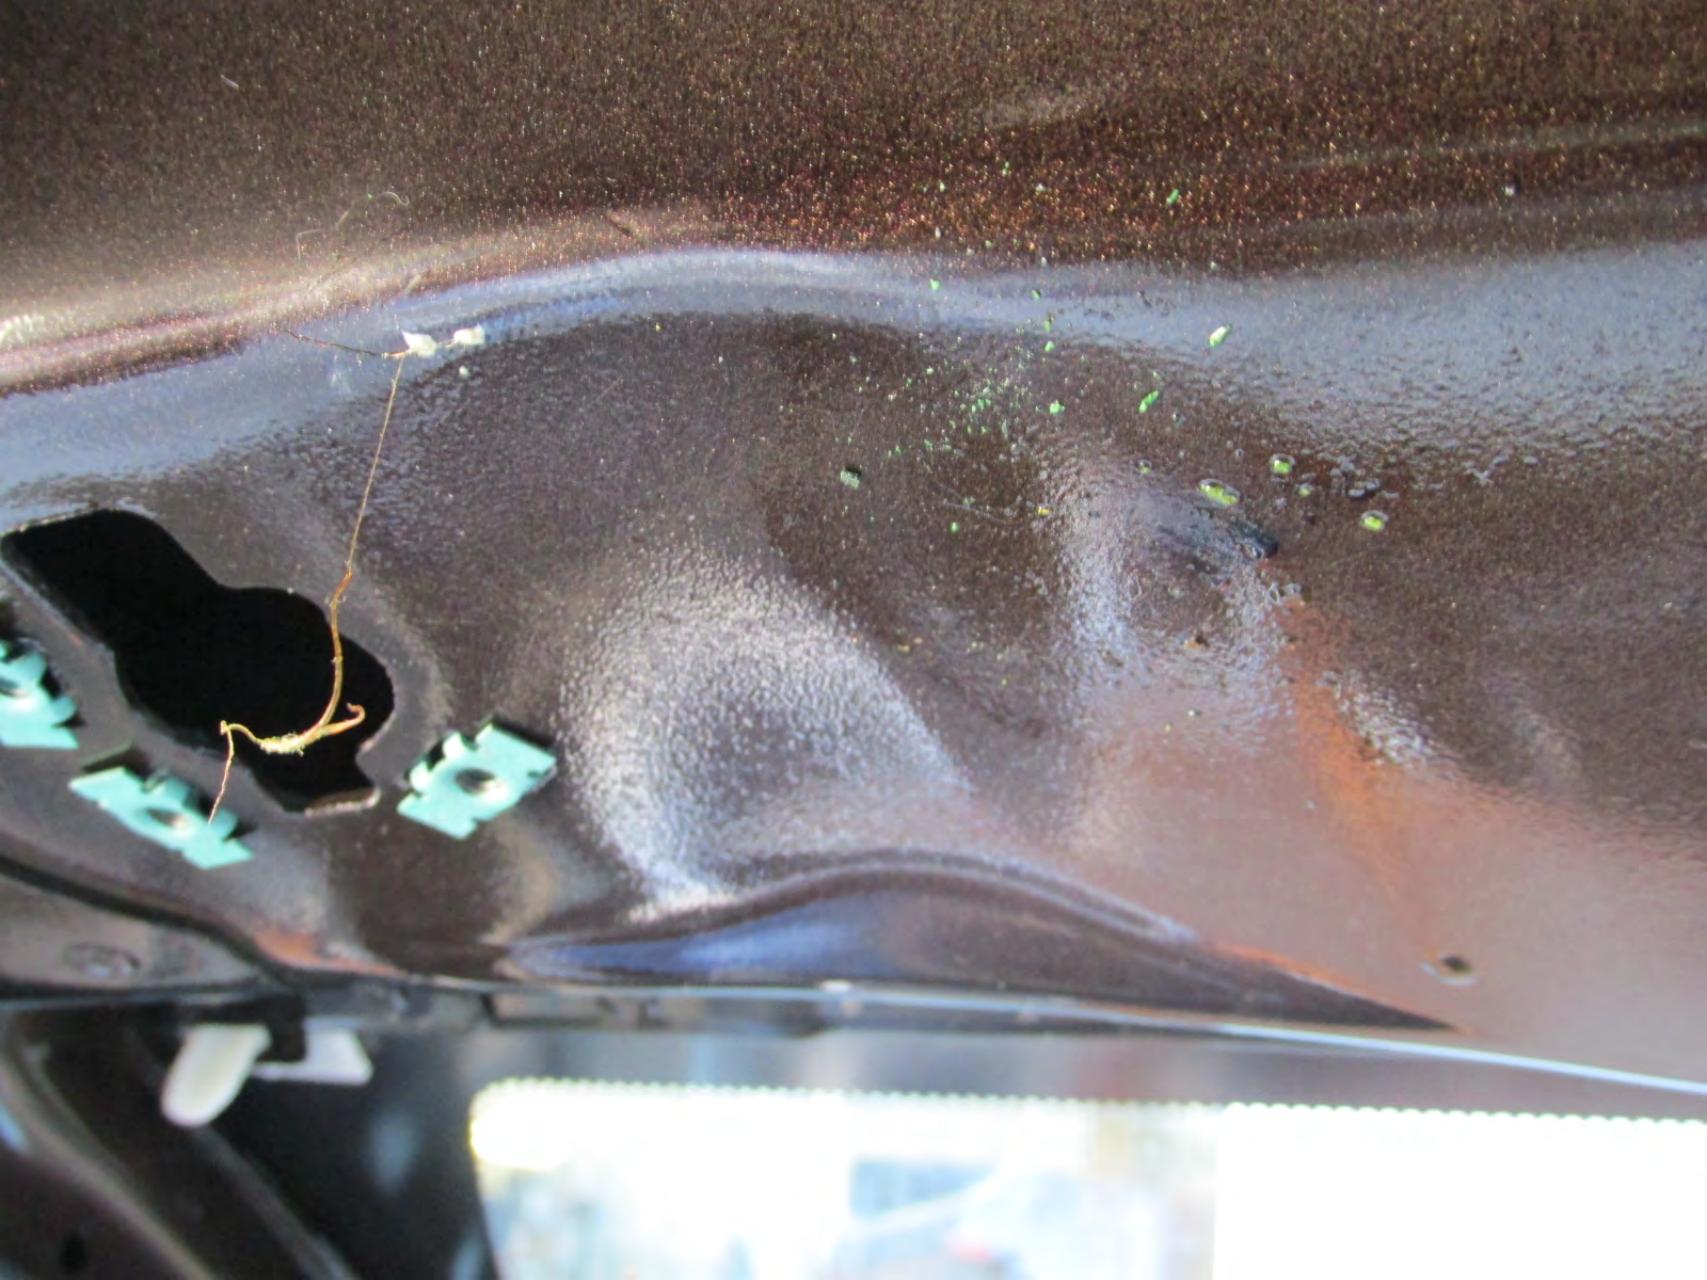
052. DESCRIPTION OF DAMAGED WIRE STRAND ON FORWARD ROOF UNDERSTRUCTURE
053. CLOSER VIEW OF DAMAGED WIRE STRAND AND MELTED WIRE INSULATION FROM REAR
054. CLOSER VIEW OF DAMAGED WIRE STRAND AND MELTED WIRE STRAND FROM UNDERNEATH ROOF STRUCTURE AREA

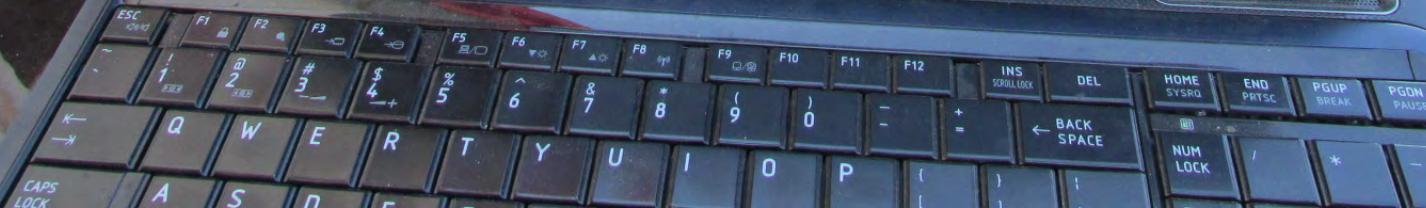
ECU	DTC Code	Status	DTC Description
PCM	U1411	Active	Implausible Fuel Volume Signal Received
PCM	U1449	Stored	Implausible ERS Message Received
ABS	U0422-00	Active	Implausible Data Received From Body Control Module-
ASCM	U0431-00	Active	Implausible Data Received from IPM (FCM/TIPM)-
TPM	C1503-96	Stored	Tire Pressure Sensor 3-Component Internal Failure
DMFR	U0155-00	Active	Lost Communication With Cluster/CCN-
DMFR	U0232-00	Active	Lost Communication with Blind Spot Detection Module-
DMFR	U0209-00	Active	Lost Communication With Memory Seat Control Module-
DMFR	U0164-00	Active	Lost Communication With HVAC Control Module-
DMFR	U0203-00	Active	Lost Communication With Left Front Door Module-
DMFR	B21A1-00	Stored	ECU Reset/Recovery Occurred-
HSM	U0164-00	Active	Lost Communication With HVAC Control Module-
HSM	U0155-00	Active	Lost Communication With Cluster/CCN-
SAS	P0579-00	Stored	Speed Control Switch 1 Performance-
