Reference: NVS-212ef; EA14-001

Attached is Chrysler Group LLC's response to the referenced inquiry EA14-001. In performing the analysis and reaching conclusions, and by providing the information contained herein, Chrysler Group LLC is not waiving its claim to attorney work product and attorney-client privileged communications.

EA14-001 Summary:

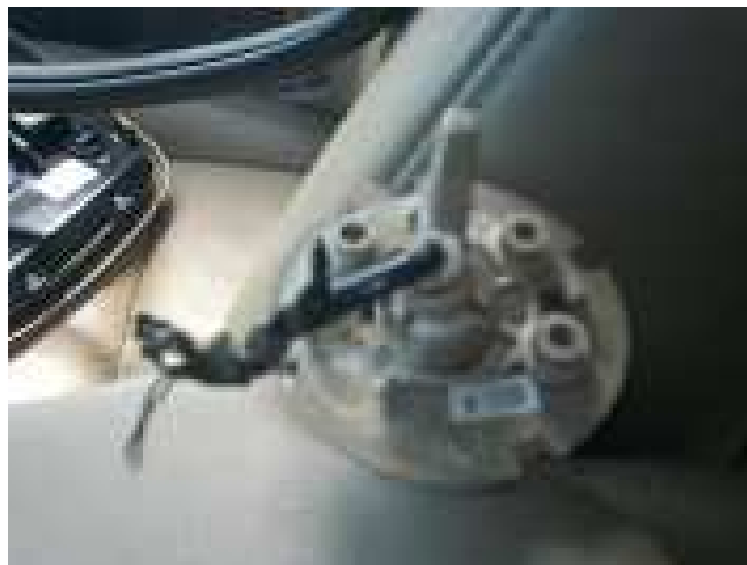
Figure 1- Warranty Claim #163704

The additional inputs reported in this submission are also representative of localized, minor resistive short damage that was reported in the PE submission. For example, the two vehicles noted in Figures 1 and 2 below were driven to a dealer and repaired under Chrysler's warranty policy. The photo evidence shows the localized, minor damage to the sun visor and/or headliner.

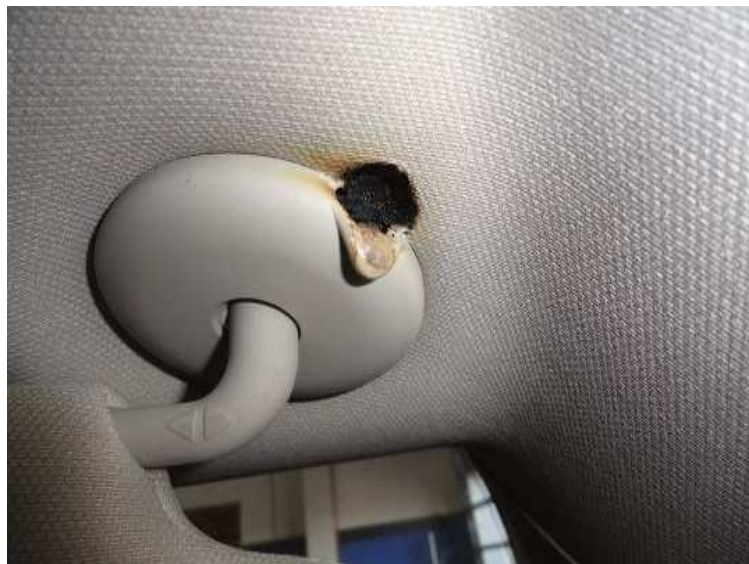
Figure 3- CAIR #34319516 Photo 1029312bf.jpg

The four vehicles noted below in Figures 3 through 6 were received as customer complaints and reported to have experienced a fire. These photos also show evidence of localized, minor damage to the sun visor and/or headliner.

MATTER #	1244248
FILE TYPE	Legal Claim
FILE NAME	[REDACTED]
CAIR #	24319516
DATE OF INCIDENT	12/15/13
DATE OF NOTICE	12/16/13
MODEL/MODEL YEAR	2011 Jeep Grand Cherokee Laredo
VIN	1J4RR4GG8BC [REDACTED]
MILEAGE	50,726
OWNER	[REDACTED]
COURT	None
DOCKET #	None
ALLEGED DEFECT	Interior Fire
DESCRIPTION	The owner states that he was driving his vehicle and smelled something burning. He saw smoke and a small flame coming from the mount for the passenger side sun visor. He hit the burning area with his hand and put the fire out.
CRASH	No
PROPERTY DAMAGE	Yes
INJURIES	0
FATALITIES	0
ANALYSIS	An inspection ² of the vehicle revealed the origin of the fire to be the passenger sun visor where the visor mounts to the vehicle. The customer had hail damage to the flat surfaces of the roof repaired in May, 2012 by the dealer. The cause of the fire appears to be a short in the wiring to the sun visor light. The contact is between one of the mounting screws and the wiring.

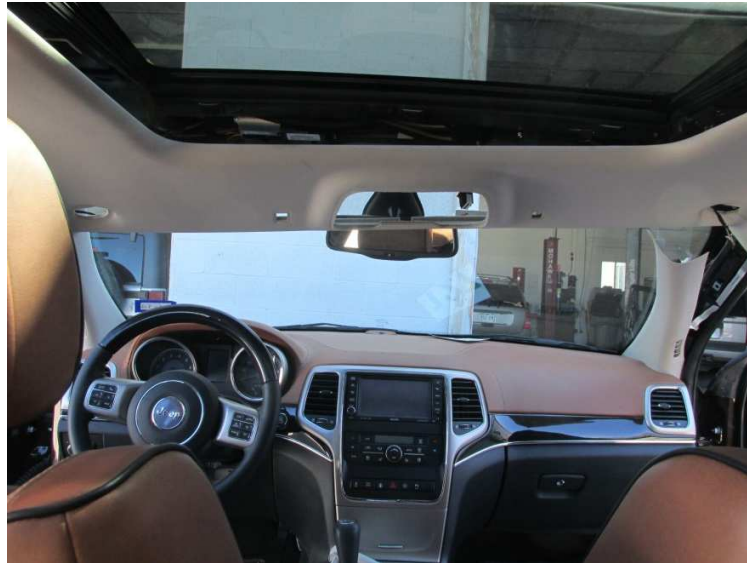
Figure 4 - CAIR 23961176 Photo 1018501gf.jpg

MATTER #	1242122
FILE TYPE	Legal Claim
FILE NAME	[REDACTED]
CAIR #	23961176
DATE OF INCIDENT	9/14/13
DATE OF NOTICE	9/18/13
MODEL/MODEL YEAR	2012 Jeep Grand Cherokee Overland 4x4
VIN	1C4RJFCT9CC [REDACTED]
MILEAGE	13,882
OWNER	[REDACTED]
COURT	None
DOCKET #	None
ALLEGED DEFECT	Interior Fire
DESCRIPTION	The owner states that he was driving approximately one half mile from his home to his mailbox when he noticed smoke coming from his left sun visor. As he reached his garage he turned off the vehicle, disconnected the battery and called roadside assistance.
CRASH	No
PROPERTY DAMAGE	Yes
INJURIES	0
FATALITIES	0
ANALYSIS	An inspection ⁴ of the vehicle revealed that the origin of the fire was the wiring harness mounted on the left backside of the headliner. The cause of the fire appears to be a pinched wire.

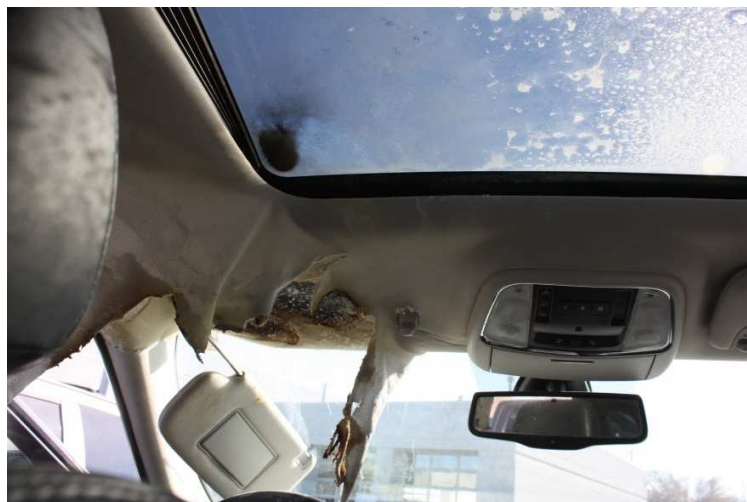
Figure 5 - CAIR 24234572 Photo 0418421tf.jpg

Note: It is apparent in Figures 5 and 6 that the fire departments also damaged the headliner areas in these vehicles as a part of their response activity.

MATTER #	1243820
FILE TYPE	Legal Claim
FILE NAME	[REDACTED]
CAIR #	24234572
DATE OF INCIDENT	11/22/13
DATE OF NOTICE	11/22/13
MODEL/MODEL YEAR	2012 Dodge Durango Crew AWD
VIN	1C4RDJDG8CC [REDACTED]
MILEAGE	12,000
OWNER	[REDACTED]
COURT	None
DOCKET #	None
ALLEGED DEFECT	Interior Fire
DESCRIPTION	The owner states that after his wife returned home from driving their son to school and parked their vehicle in the garage she noticed smoke filling the inside of the vehicle. Mrs. West immediately called the fire department.
CRASH	No
PROPERTY DAMAGE	Yes
INJURIES	0
FATALITIES	0
ANALYSIS	An inspection ³ of the vehicle revealed that the origin of the fire was the driver`s side headliner directly above the sun-visor vanity mirror. The cause of the fire appears to be an electrical short.

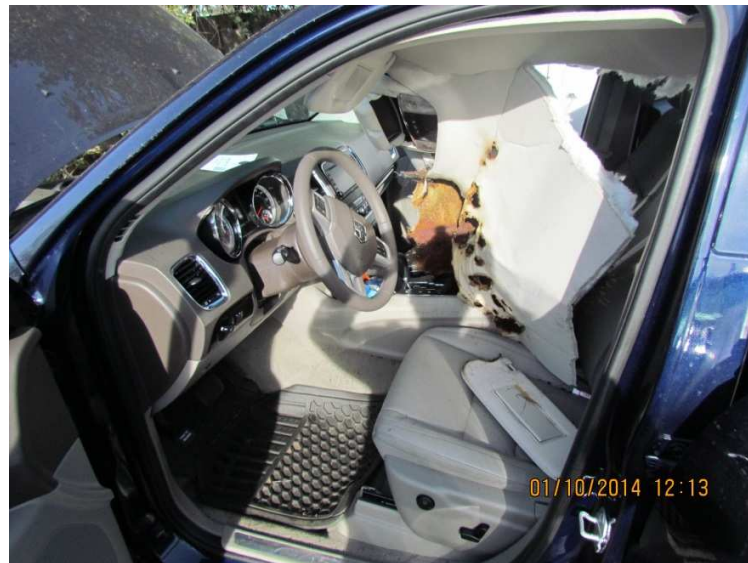
Figure 6 - CAIR 24401035 Photo 0644271uf.jpg

MATTER #	1244632
FILE TYPE	Legal Claim
FILE NAME	[REDACTED]
CAIR #	24401035
DATE OF INCIDENT	1/6/14
DATE OF NOTICE	1/7/14
MODEL/MODEL YEAR	2013 Dodge Durango Crew AWD
VIN	1C4RDJDG9DC [REDACTED]
MILEAGE	4,000
OWNER	[REDACTED]
COURT	None
DOCKET #	None
ALLEGED DEFECT	Interior Fire
DESCRIPTION	The owner states that he had been driving for approximately 20 minutes when he saw light coming from the right side dash. He pulled over and opened the right front door at which time he noticed white smoke emitting from the right passenger area. He proceeded to drive to the dealer and the smoke continued to get thicker. He also noticed flames behind the visor. The owner pulled over and called the fire department.
CRASH	No
PROPERTY DAMAGE	Yes
INJURIES	0
FATALITIES	0
ANALYSIS	An inspection ¹ of the vehicle revealed that the origin of the fire appears to be the right front headliner from the overhead console toward the right front vanity visor. The vehicle had prior hail damage repair at which time the headliner was removed and repaired by a third-party repair facility. The owner reported that the overhead front dome lamp had not been operating correctly for some time. The cause of the fire appears to be electrical.
