PHOTOGRAPH DISCRPTIONS

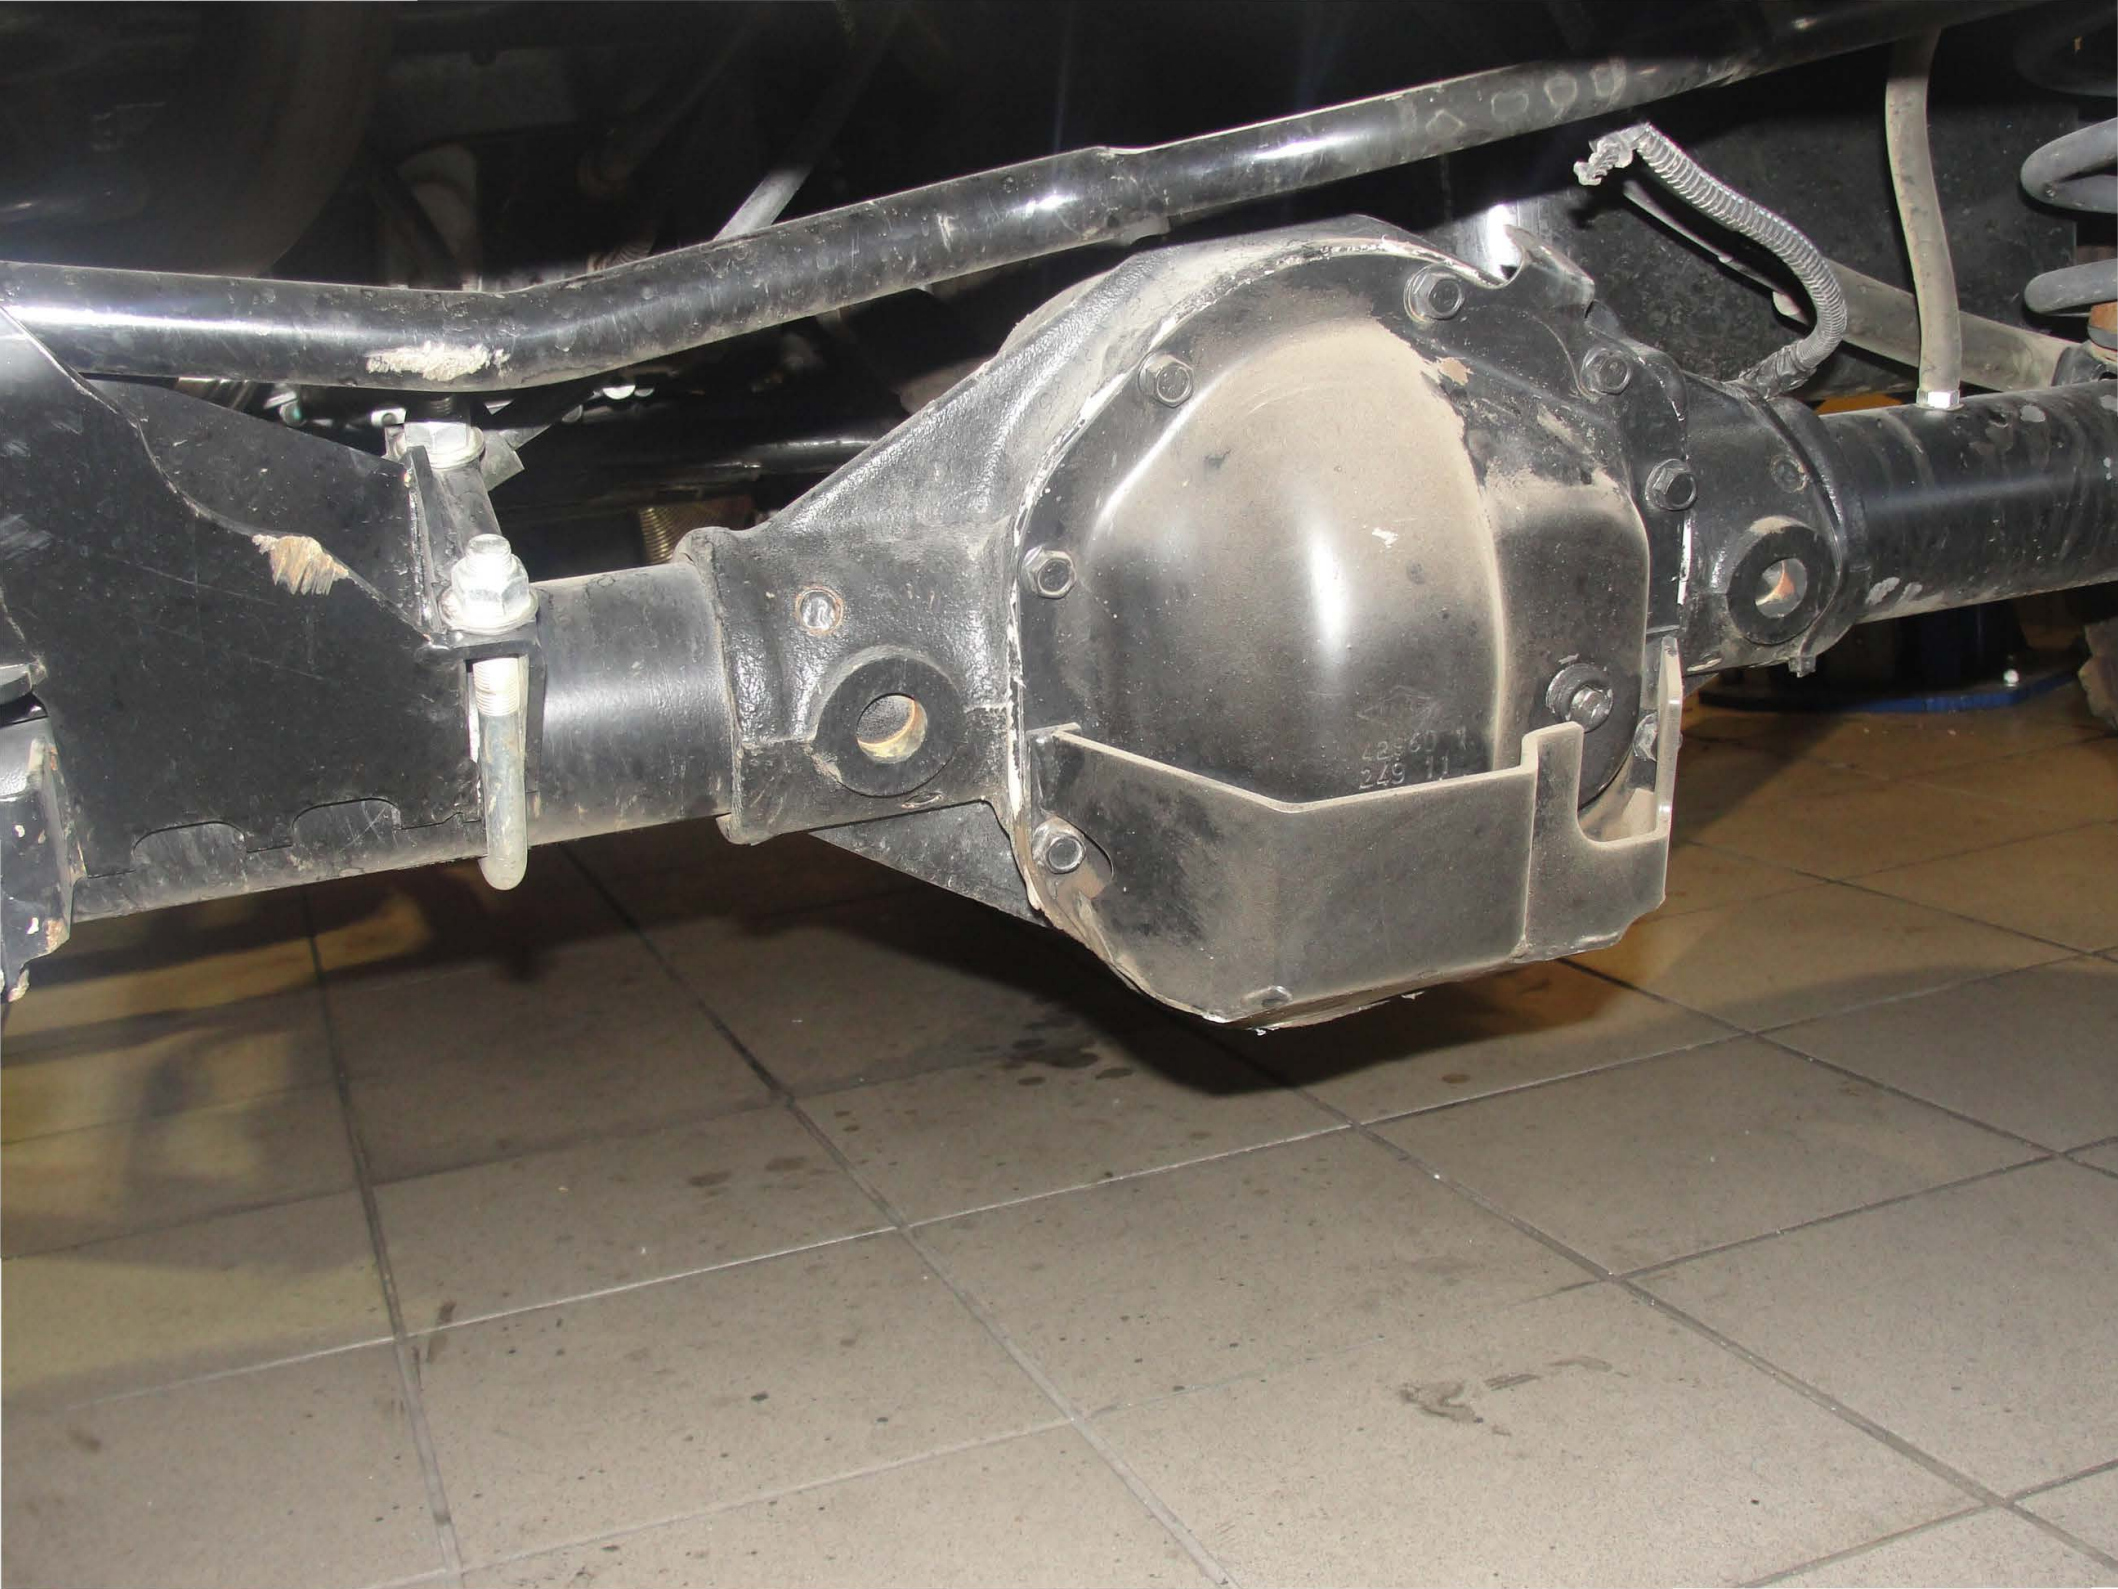
| | ECU | Code | Status | Description |
|--|---|---|---|---|
| | ORC | B1B02 | Active | Driver Airbag Squib 1 Circuit Open |
| | ORC | B1B06 | Active | Driver Airbag Squib 2 Circuit Open |

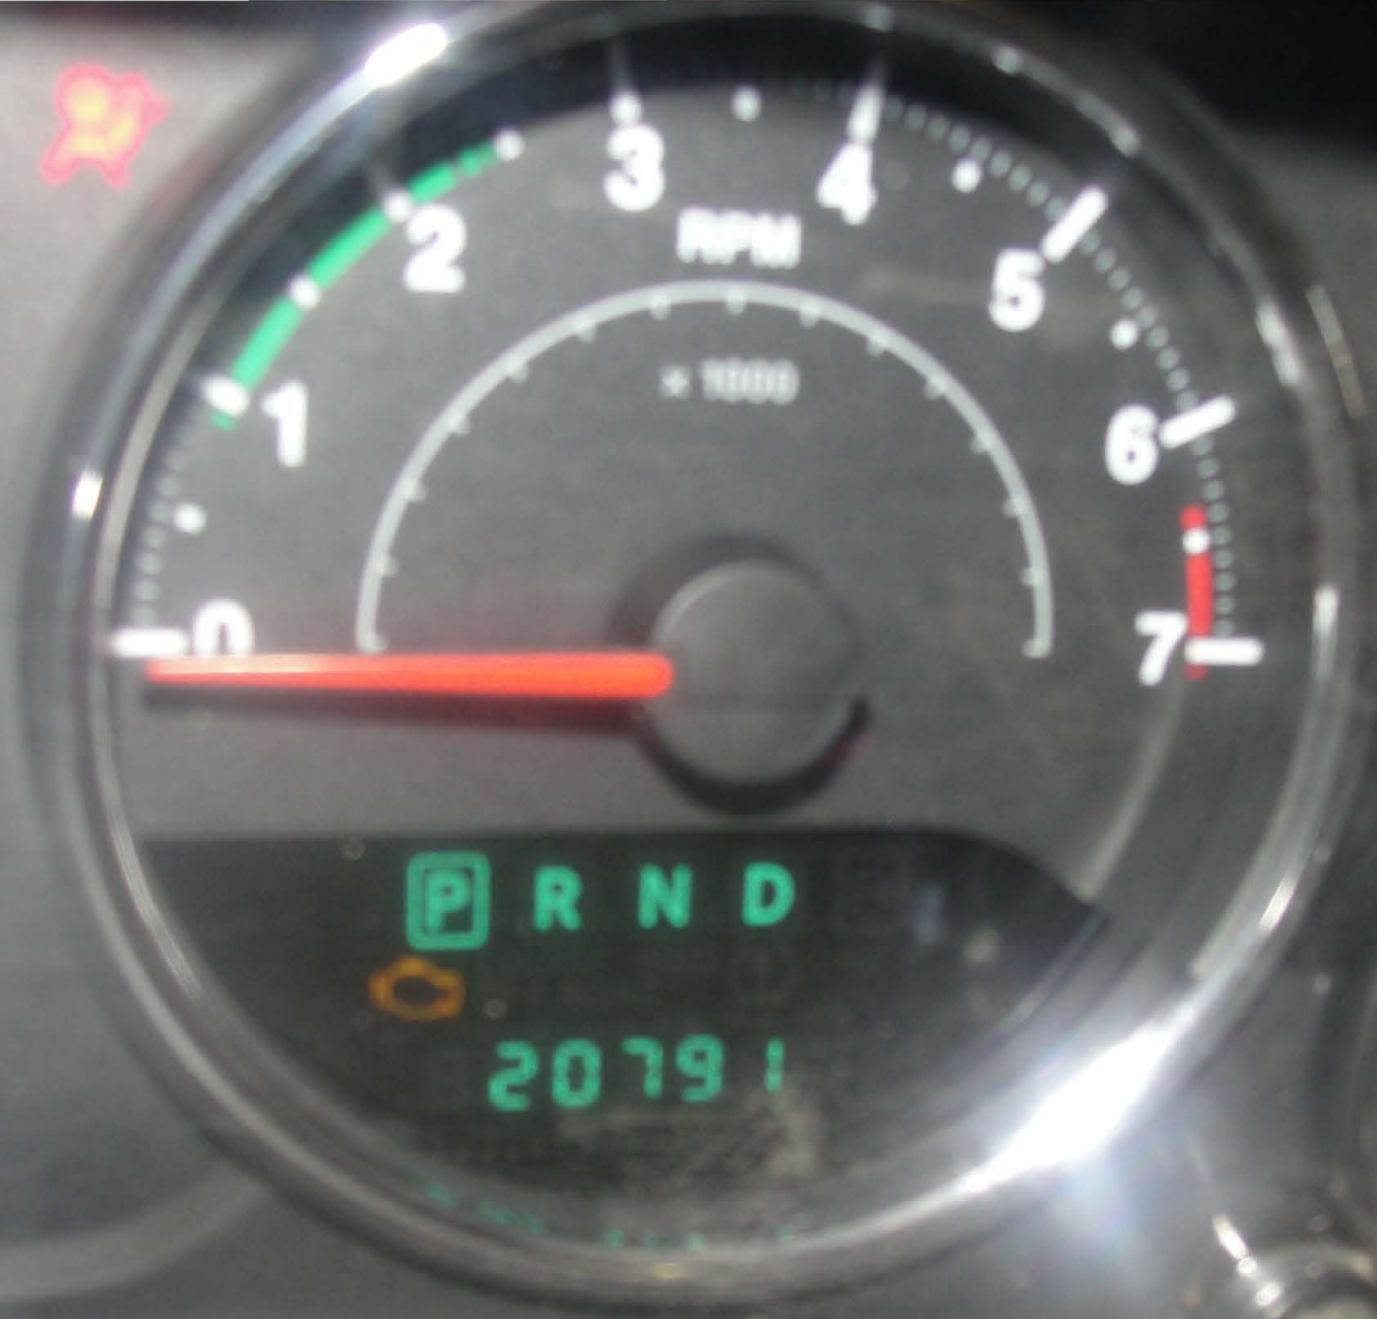
1. Dash vin tag
2. Odometer reading
3. CDR hook up
4. Front general view of vehicle
5. RF corner view of vehicle
6. Right side view of vehicle
7. LR corner view of vehicle

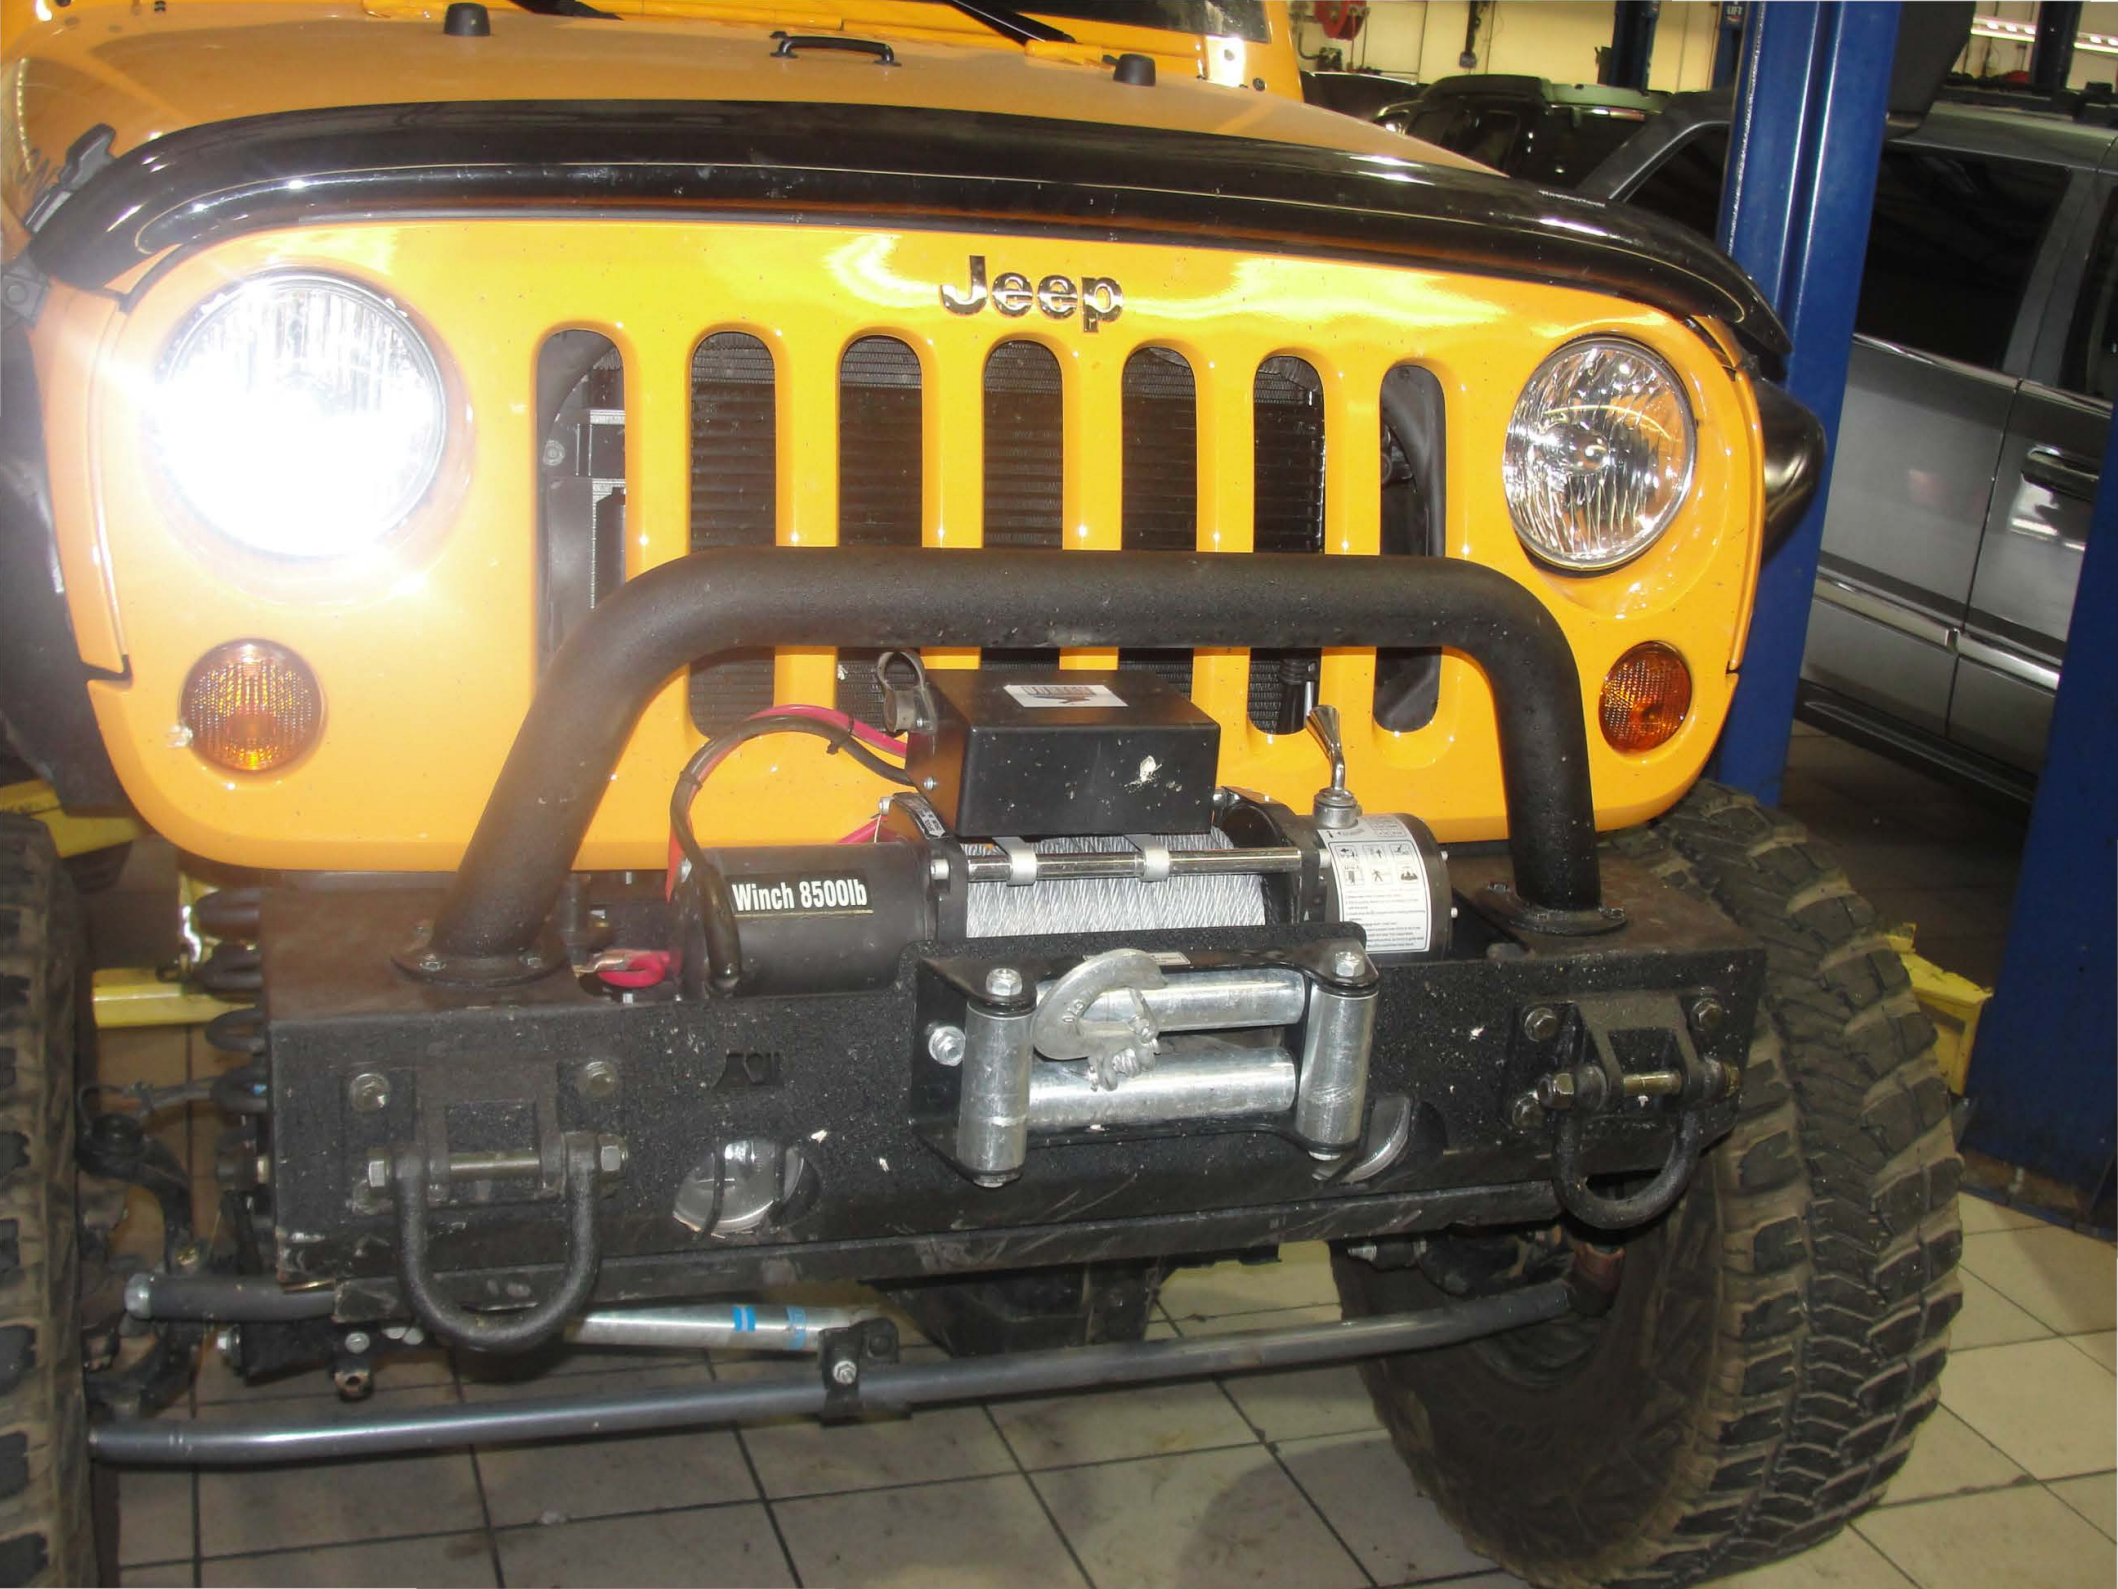
39. Aftermarket right wheel suspension parts
40. Aftermarket left wheel suspension parts
41. Aftermarket winch added
42. Front air bag sensor in place and wire attached

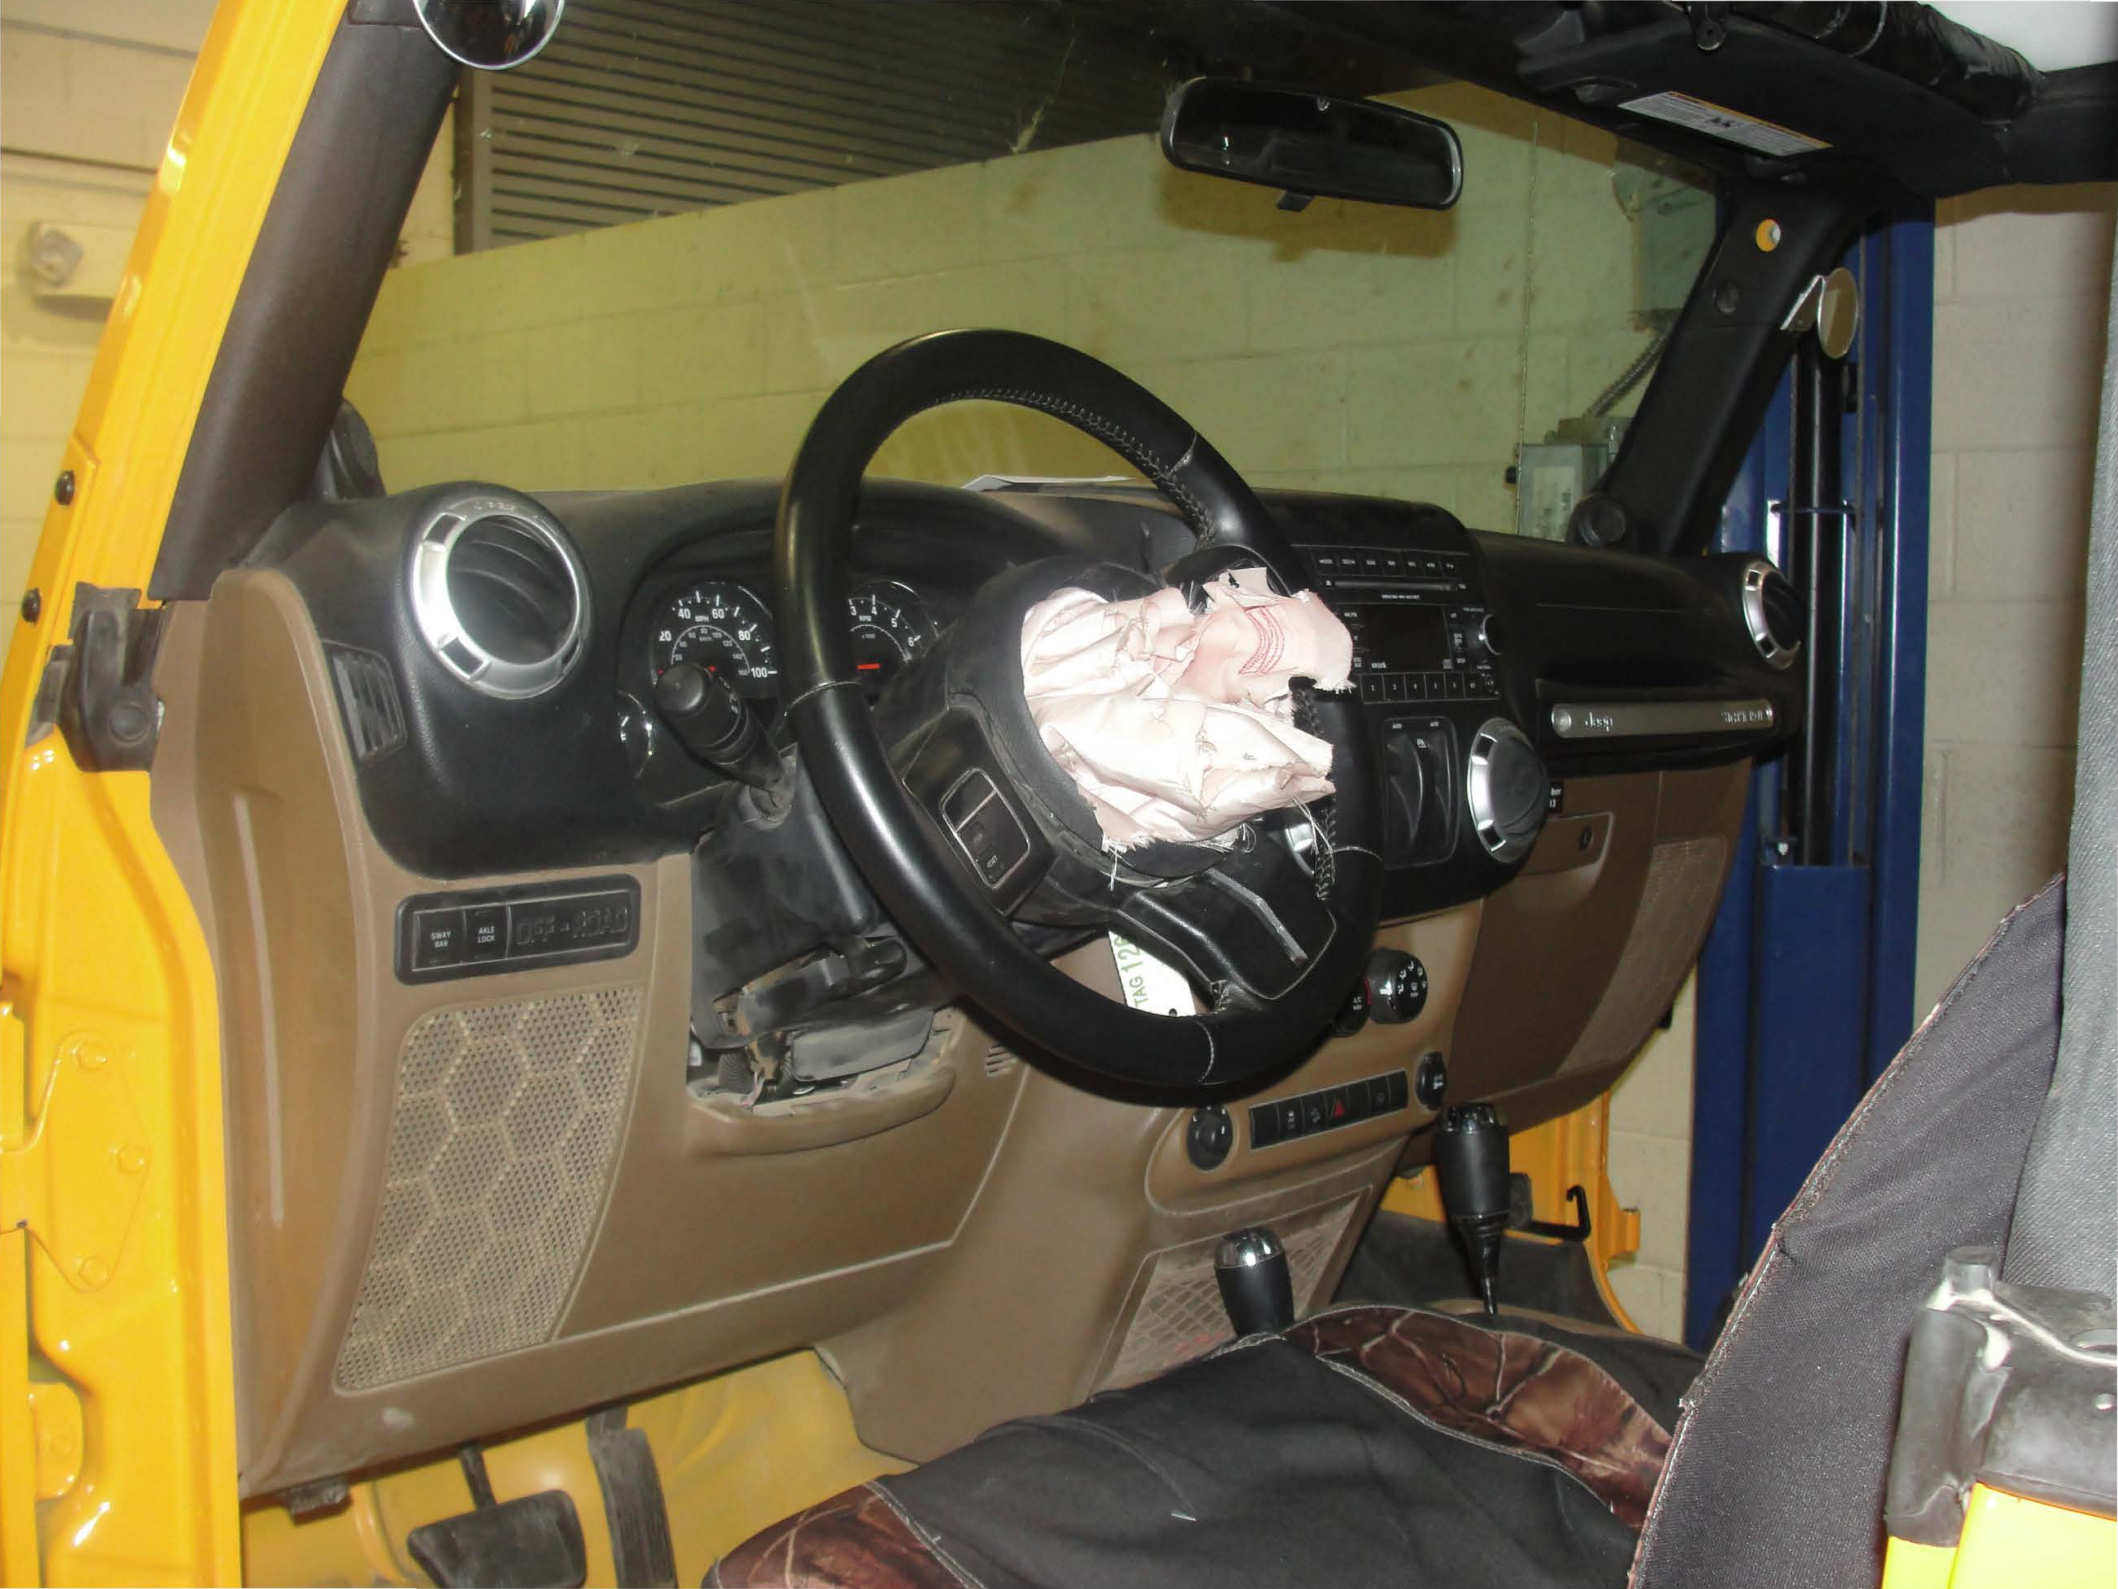
34. Crush distance of gas tank skid plate
35. Length of skid plate damage
36. With of skid plate damage
37. Aftermarket shock absorber
38. Second aftermarket shock absorber
