2007-2009 MY Spectra Vehicles Front Passenger OCS Sensor Mat Kia New Vehicle Limited Warranty Extension

GROUP BOD	MODEL 2007~2009MY Spectra (LD)
	NUMBER 130	DATE February 2016
TECHNICAL SERVICE BULLETIN		
SUBJECT: FRONT PASSENGER OCS SENSOR MAT DIAGNOSIS AND REPLACEMENT

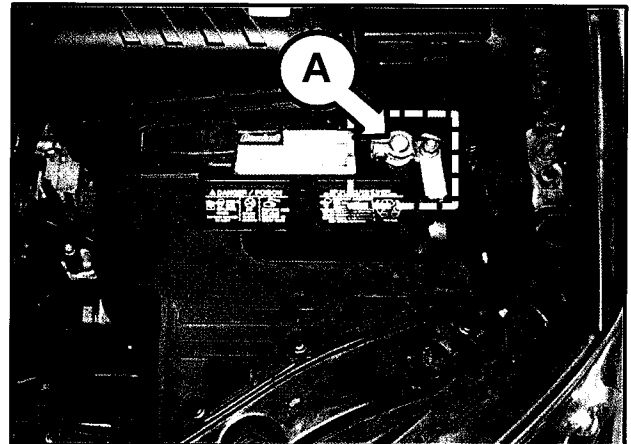
1. Place the ignition key in the 'OFF' position and record customer's radio presets.
2. Disconnect Negative (-) terminal (A) from the battery. **NOTE: make sure voltage is bled off before proceeding.**

Not removing the Negative (-) terminal from the battery may result in accidental airbag deployment and possible physical injury.

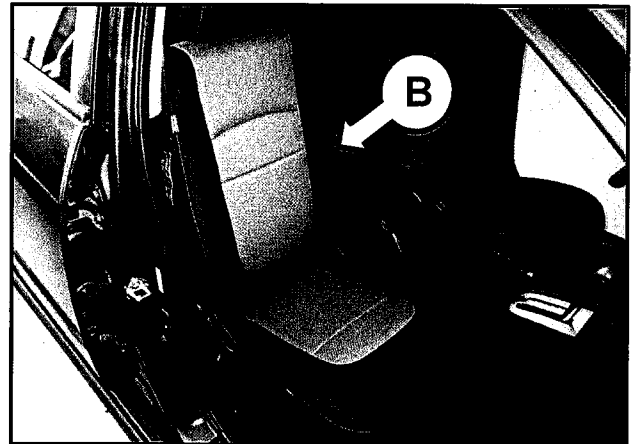
3. Remove the passenger seat assembly (B) by referring to the applicable Service Manual on KGIS.

Tightening Torque (Seat Mounting Bolts):
29 ~ 39 lb-ft (39 ~ 53 Nm)

Use caution when removing the seat from the vehicle to avoid scratching any interior trim panels.

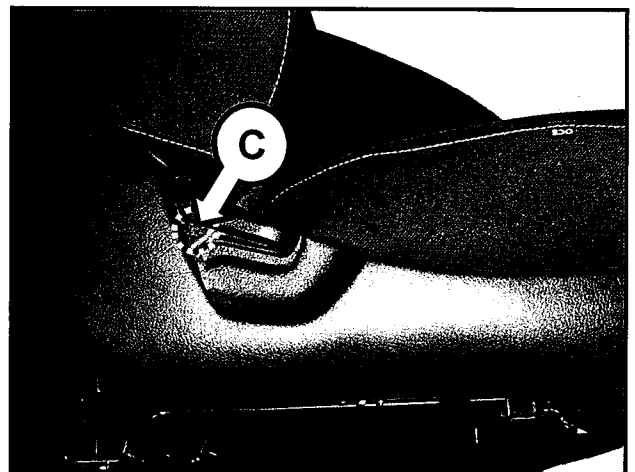
4. Remove one (1) screw (C) securing the seat back release lever cover and remove the cover from the lever.

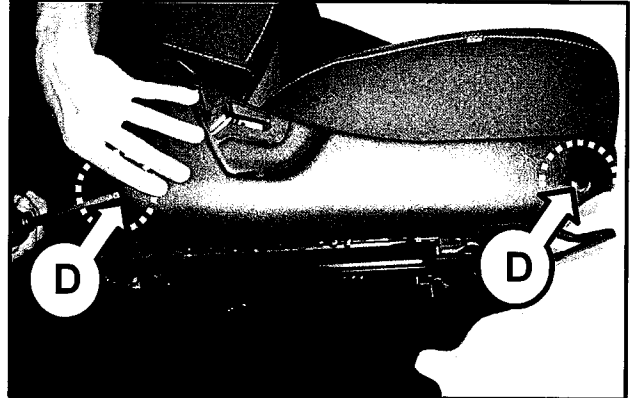
5. Remove two (2) screws (D) securing the seat side cover to the seat frame and remove the side cover.

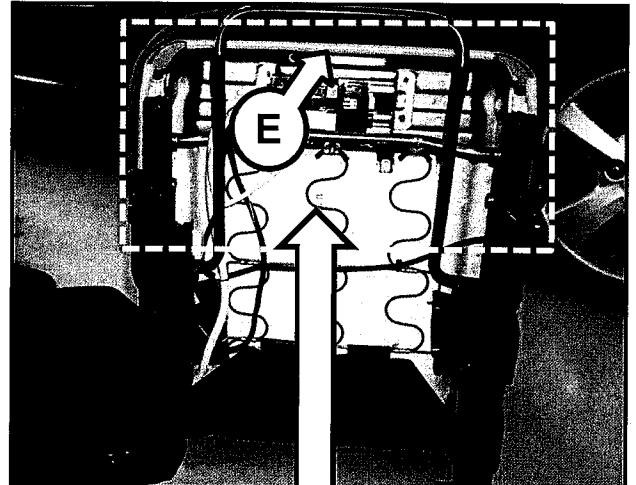
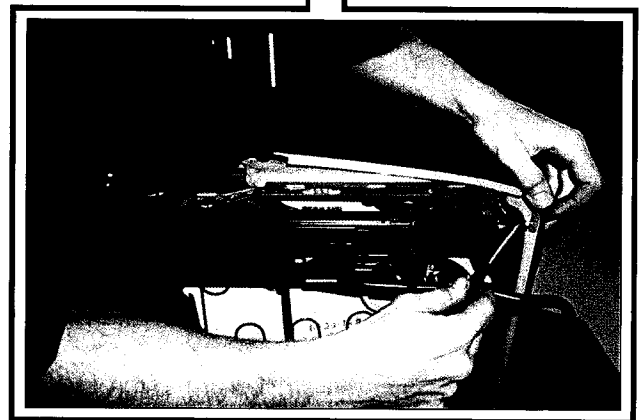
6. Carefully undo the seat cover plastic hooks (E) running across the front of the seat.

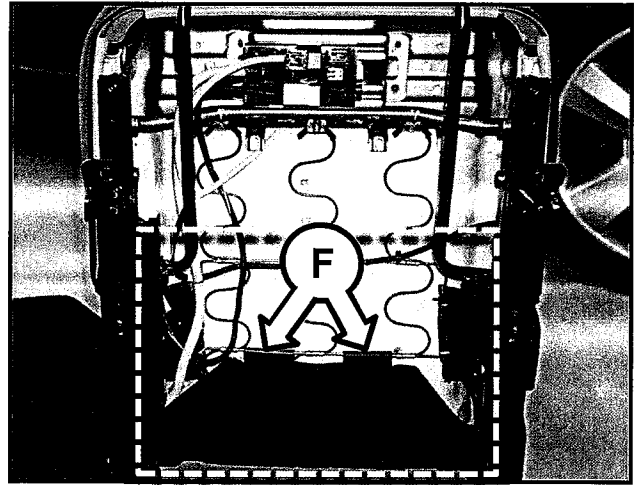
7. Undo two (2) plastic hooks (F) securing the rear seat cover attachment panel.

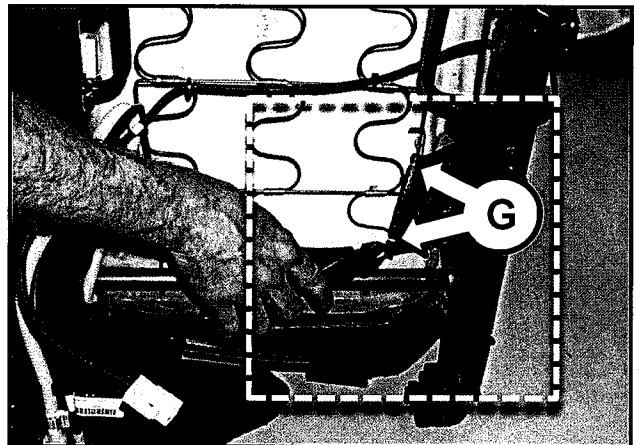
8. Use a pair of side cutters to remove two (2) hog rings (G) from the right side seat cover attachment panel, as shown.

Replace with new hog rings (P/N: 88627 11201). To install the new hog rings, use the Hog Ring Pliers (P/N 09880 4F000A) or equivalent.

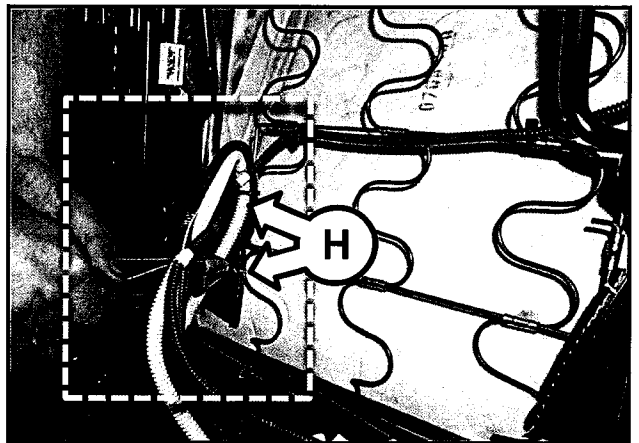
9. Use a pair of side cutters to remove two (2) hog rings (H) from the left side seat cover attachment panel, as shown.

Replace with new hog rings (P/N: 88627 11201). To install the new hog rings, use the Hog Ring Pliers (P/N 09880 4F000A) or equivalent.

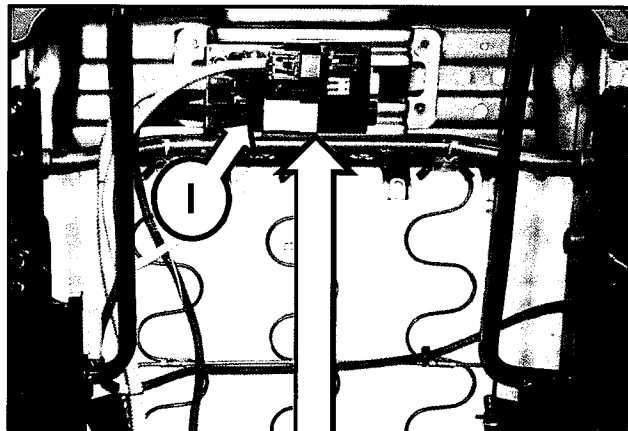
10. Carefully remove the connector mounting plate (I) from the seat frame.

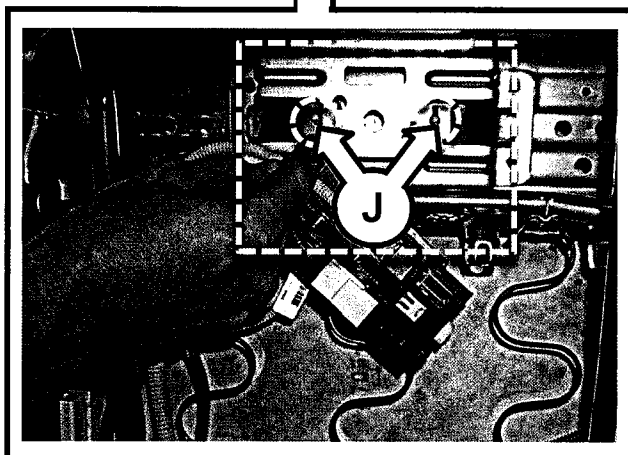
11. Use a pick tool to remove two (2) plastic clips (J) securing the OCS control module to the seat frame.

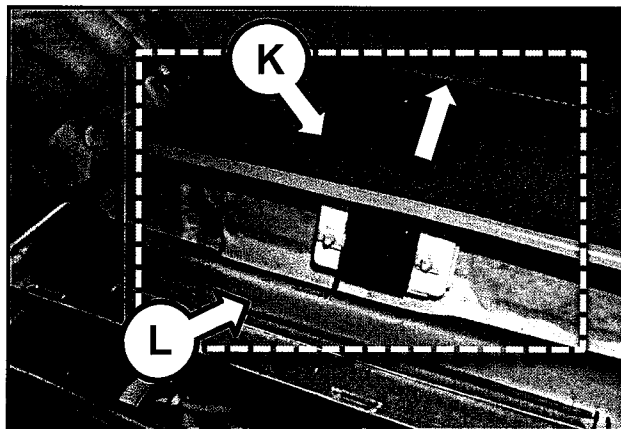
12. Carefully pull the seat cushion assembly (K) away from the seat frame (L).

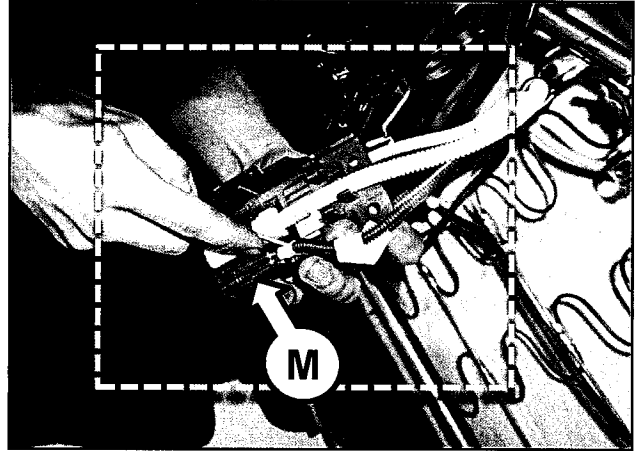
13. Use a pick tool to carefully remove the OCS connector (M) from the mounting plate, as shown.

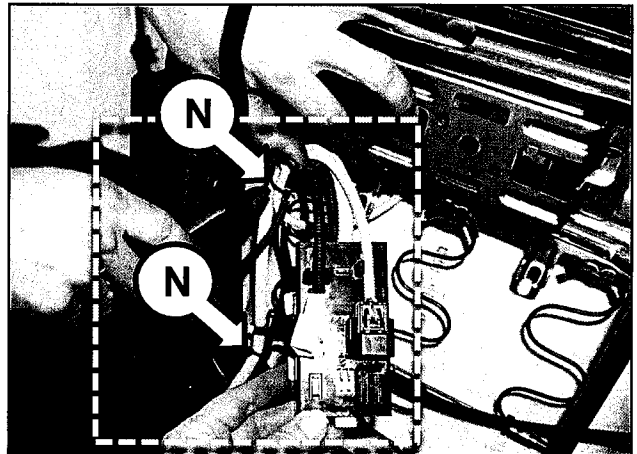
14. Use a pair of side cutters to carefully remove the cable ties securing all under-seat harnesses together.

To prevent damage to the under-seat harnesses, make sure to replace all cable ties removed in step 14.

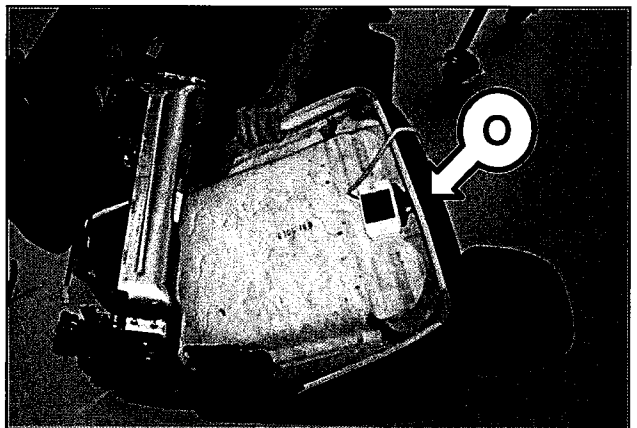
15. Carefully remove the seat cushion assembly (O) from the seat frame, as shown.

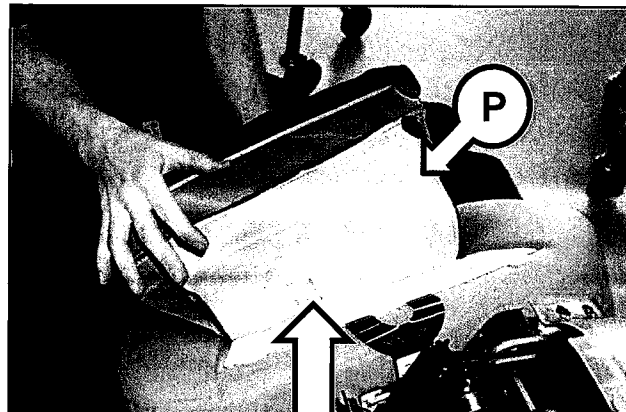
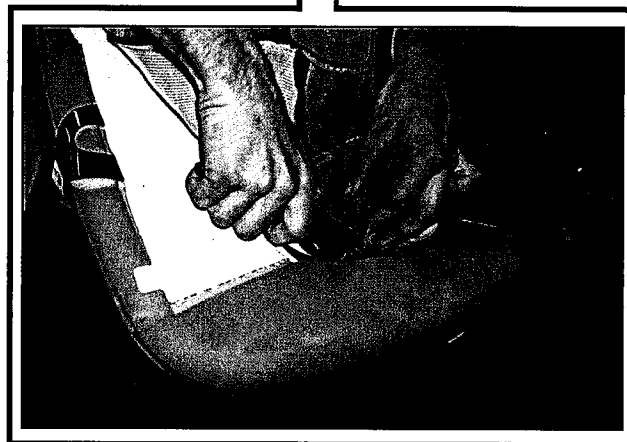
16. Carefully pull the seat cover material (P) back and remove nine (9) hog rings securing the seat cover to the seat cushion.

Replace with new hog rings (P/N: 88627 11201). To install the new hog rings, use the Hog Ring Pliers (P/N 09880 4F000A) or equivalent.

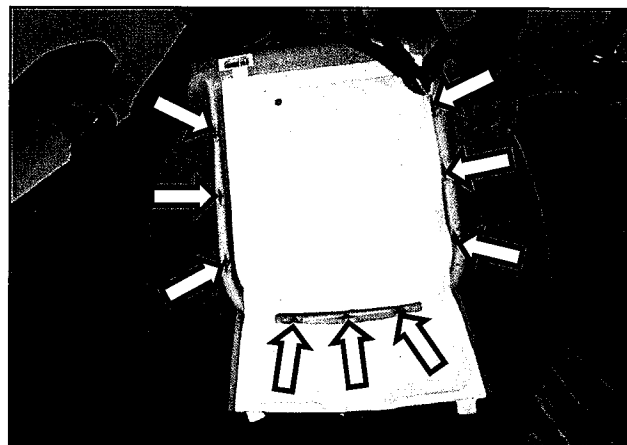
17. Remove the seat cover from the lower cushion and inspect each of the nine (9) seat cover attachment points for remaining hog ring debris.

To prevent damaging the seat cover material, make sure to remove all hog ring debris from the lower cushion.

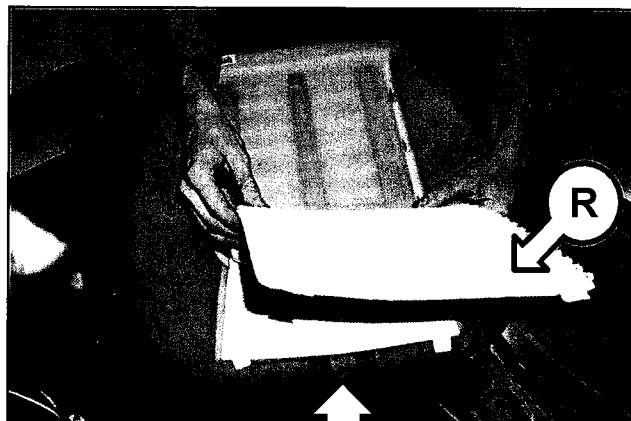
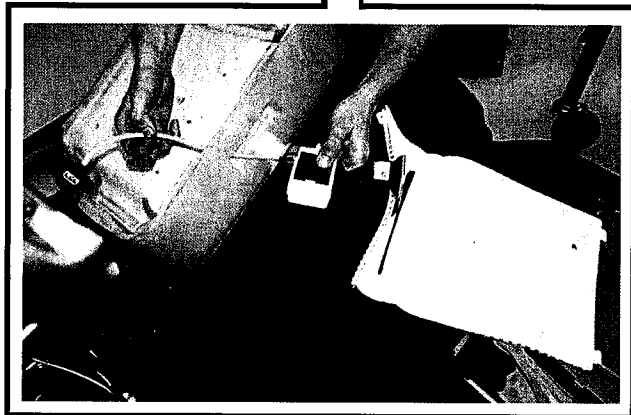
18. Remove the original OCS mat (R) and harness from the seat cushion, as shown.

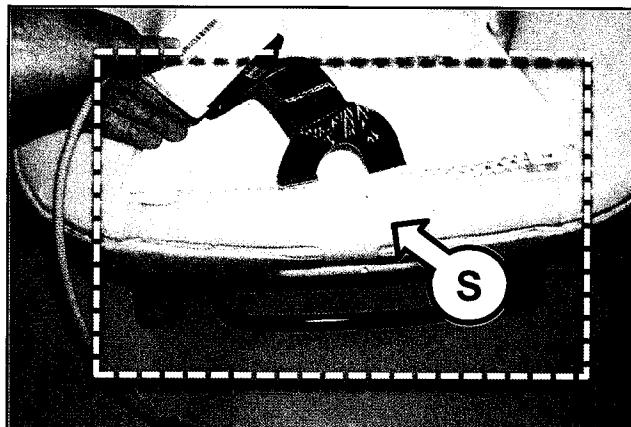
19. Place the replacement OCS mat on the lower cushion and note the indentation in the foam (S). This indentation should be used to align the replacement mat with the seat cushion.

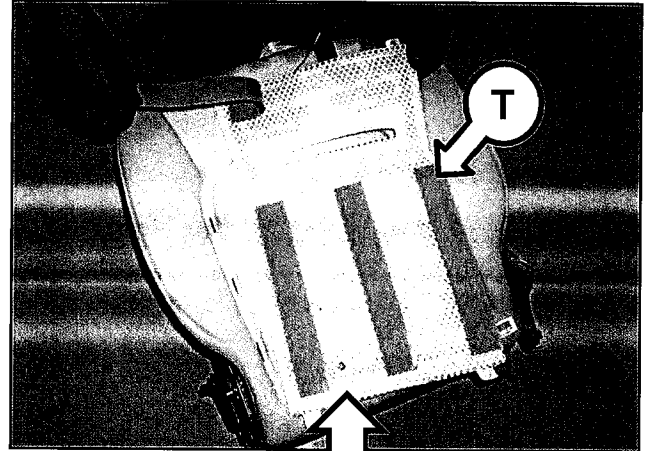
20. Turn the replacement OCS mat over and remove the protective lining (T) from the four (4) adhesive strips

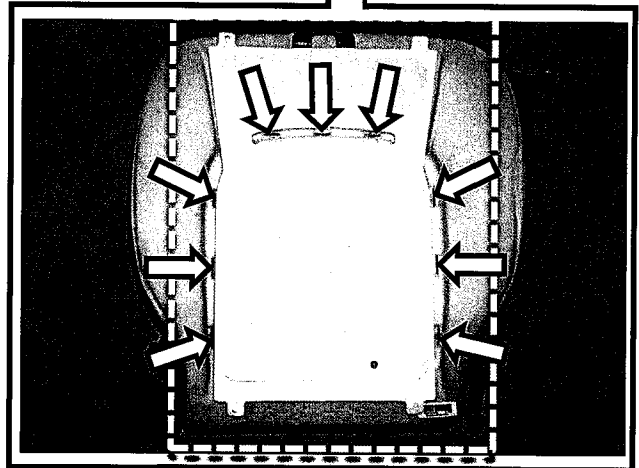
21. Place the OCS mat on top of the seat and examine the placement mat. **NOTE:** make sure the OCS mat does **NOT** obstruct access to any of the nine (9) seat cover attachment points, as shown.

The OCS mat **MUST** be in the correct position prior to applying pressure and adhering it to seat cushion.

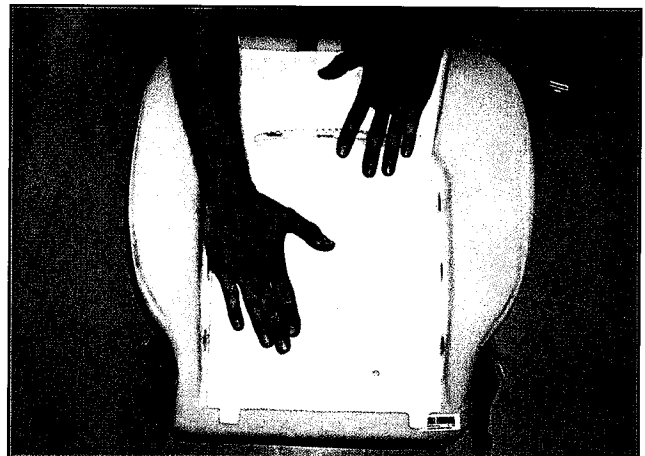
22. Press down, as shown, to ensure the OCS mat is firmly adhered in place.

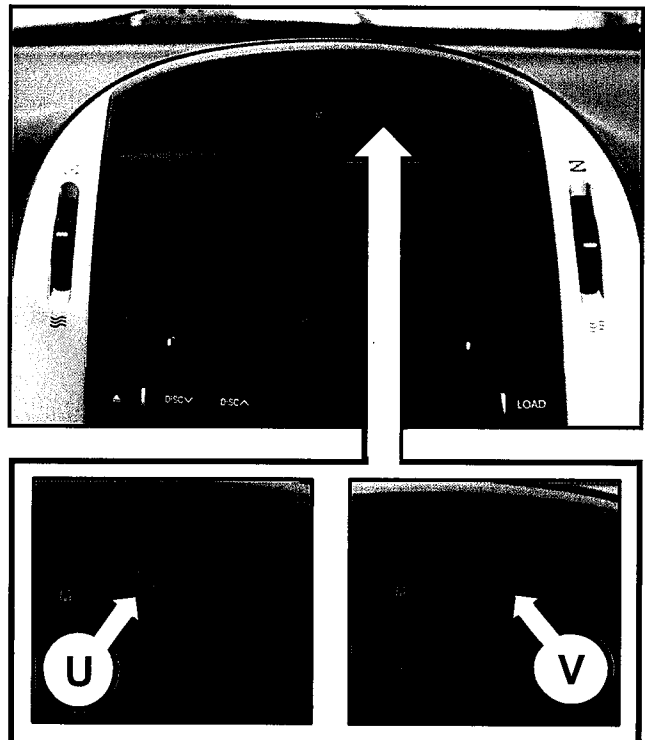
25. Verify the operation of the PASSENGER AIR BAG "OFF" indicator lamp, as described below:

1) Indicator lamp ON (U):

- Infant or child restraint system with a 12 month old.
- Unoccupied

2) Indicator lamp OFF (V):

- Properly positioned adult or child age 13 and up.
