### 2007-2009 MY Spectra Vehicles Front Passenger OCS Sensor Mat Kia New Vehicle Limited Warranty Extension

GROUP <b>BOD</b>	MODEL <b>2007~2009MY Spectra (LD)</b>
	NUMBER <b>130</b>	DATE <b>February 2016</b>
<b>TECHNICAL SERVICE BULLETIN</b>		
SUBJECT: <b>FRONT PASSENGER OCS SENSOR MAT DIAGNOSIS AND REPLACEMENT</b>

**SUBJECT: FRONT PASSENGER OCS SENSOR MAT DIAGNOSIS AND REPLACEMENT**

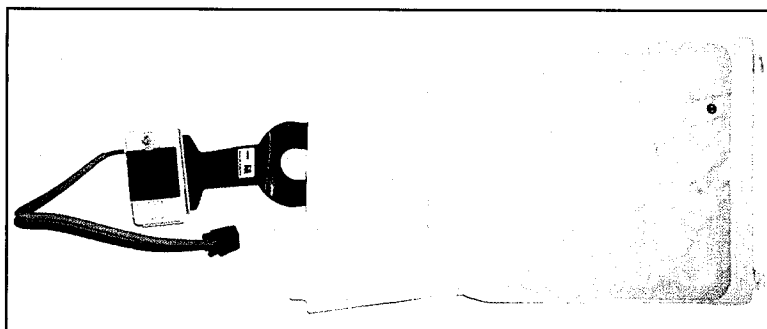
This bulletin provides information related to the replacement of the front passenger Occupant Classification System (OCS) sensor mat in 2007~2009MY Spectra (LD) vehicles, produced from September 26, 2006 through April 6, 2009. The sensor mat is intended to detect child seats and small stature occupants who could be harmed by deployment of the passenger frontal air bag. If the sensor mat is not working properly, the airbag warning light on the cluster will illuminate and **DTC(s) B1447, B1448, B1449 and/or B1450** may be stored. If the airbag warning light is illuminated and one or more the above DTCs are stored, follow the repair procedure outlined in this bulletin to replace the OCS mat.
