## ODI RESUME

**Investigation:** EA 16-001  
**Prompted by:** Field Incident, PE14-020  
**Date Opened:** 02/03/2016  
**Investigator:** Kyle Bowker  
**Approver:** Stephen Ridella  
**Subject:** CNG Fuel System Integrity

## EA16-001 Closing Report

**Subject:** CNG Fuel System Integrity

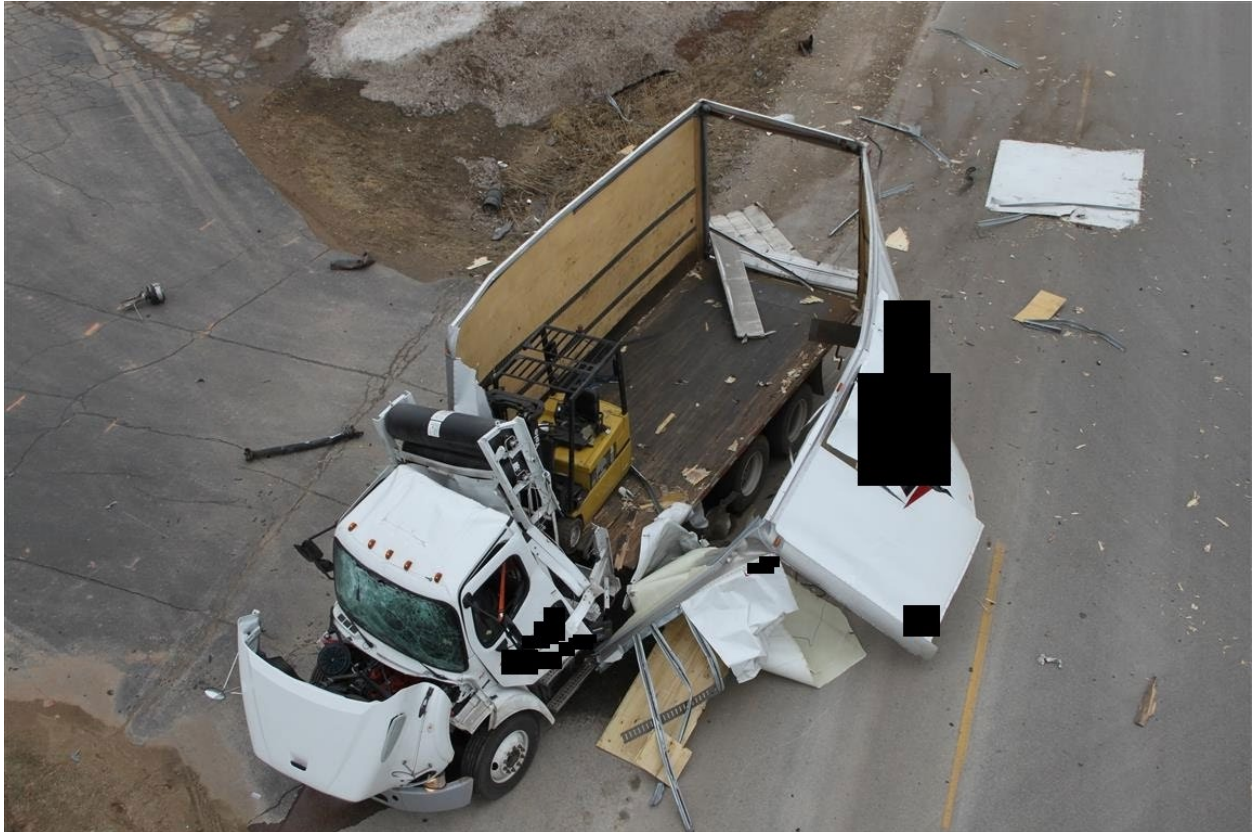
Figure 1. April 3, 2014, Subject Incident Vehicle

**Problem Description:** During a braking maneuver, an unsecured forklift rolled forward, penetrated the front wall of the cargo compartment and struck a compressed natural gas (CNG) fuel container mounted behind the truck cab, causing it to burst with explosive force.

**Subject Incident Vehicle:** The subject Freightliner Business Class M2 incident vehicle was equipped with a dry freight van body manufactured by Delta-Waseca Inc. At the time of the incident, the subject vehicle was not operated with a cargo securement system (e.g. vehicle structure, securing devices, and blocking and bracing equipment) suitable for transporting a forklift truck in accordance with Federal Motor Carrier Safety Administration (FMCSA) cargo securement requirements.<sup>4</sup> There was no suitable front-end structure to resist penetration by a forklift truck nor did the CNG fuel system have any shielding to protect against such impacts. The unsecured forklift truck rolling forward, penetrating the cargo compartment and fuel container enclosure, and then striking the fuel system directly led to the CNG fuel container rupture. The motor carrier received a citation for violation of 49 CFR 393.100(a) “No or improper load securement.”

**DTNA Assessment:** According to its January 23, 2015, IR response letter, DTNA’s assessment of the fatal April 3, 2014 incident states the causal and contributory factors include: loading the forklift truck into the truck’s cargo compartment with the forks facing forward towards the CNG fuel system; improper cargo securement; driving the truck at speed greater 17mph (driving at a slower speed may have reduced the opportunity for the unsecured cargo to shift); abrupt braking vehicle maneuver; and potential driver distraction. DTNA states that no unreasonable risk to motor vehicle safety is identified, provided industry required cargo securement and safe driving practices are followed.
