EA16-002

**Preliminary Vehicle Investigation Report(PVIR)**

YEAR	BRAND	VEHICLE IDENTIFICATION NUMBER	BUILT DATE	ODOMETER	SERVICE DATE
2012	DODGE CHARGER RALLYE RWD FOUR DOOR SEDAN	2C3CDXHG7CH1 [REDACTED]	10-21 07	3586	12/10/2011
NAME OF OWNER		ADDRESS/LOCATION	CITY	STATE	COUNTRY
[REDACTED]		[REDACTED]	SUNRISE	FL	USA
ZIP	COLOR	MODEL	HOME PHONE	BUSINESS PHONE	
[REDACTED]	Black Clear Coat	LDD	[REDACTED]		
SELLING DEALER NAME	BUSINESS CENTER	DLR. CODE	CITY	STATE	COUNTRY
ARRIGO DODGE CHRYSLER JEEP RAM	66	45426	TAMARAC	FL	USA
INSPECTOR - NAME FIRST, LAST, MIDDLE		INSPECTOR'S COMPANY	INSPECTOR'S PHONE NO.		
James Daugherty T		EAA	954-749-3637		
DAMAGE ESTIMATE			REPAIR ESTIMATE		
<input checked="" type="radio"/> MINOR <input type="radio"/> MODERATE <input type="radio"/> TOTAL LOSS			\$ .00

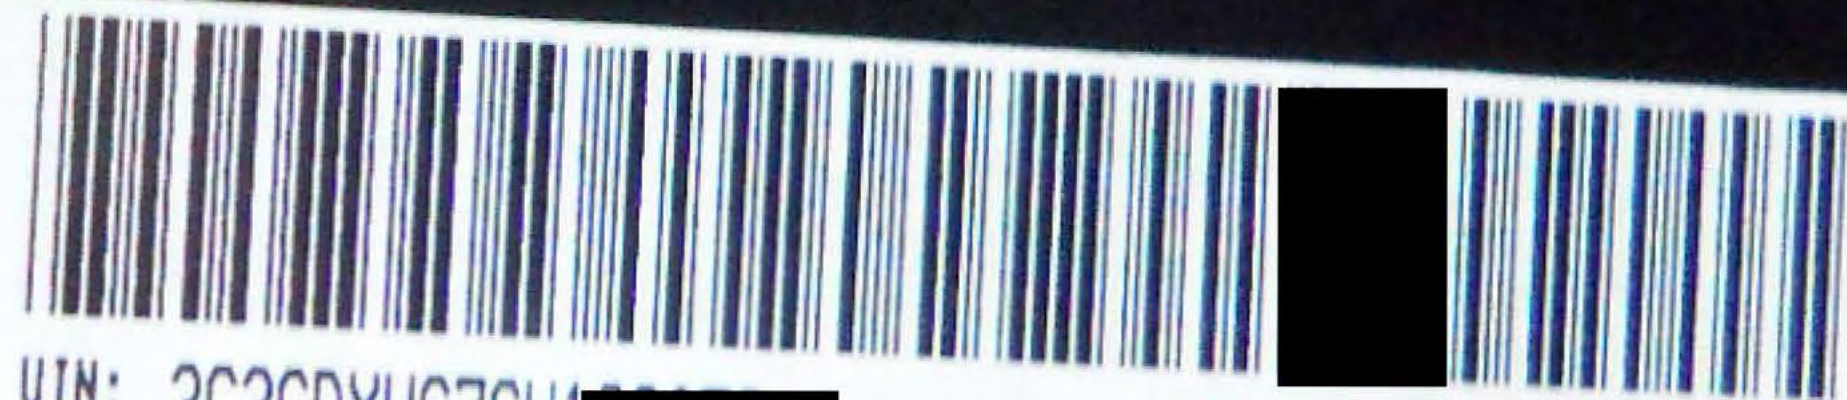
MFD BY **CHRYSLER GROUP LLC**

THIS VEHICLE CONFORMS TO ALL APPLICABLE U.S.A. FEDERAL MOTOR VEHICLE SAFETY,  
BUMPER AND THEFT PREVENTION STANDARDS IN EFFECT ON  
THE DATE OF MANUFACTURE SHOWN ABOVE.

VIN: 2C3CDXHG7CH1 [REDACTED]
