EA16-002

FLAT CHRYSLER

ENCLOSURE 04

CAIR Backup

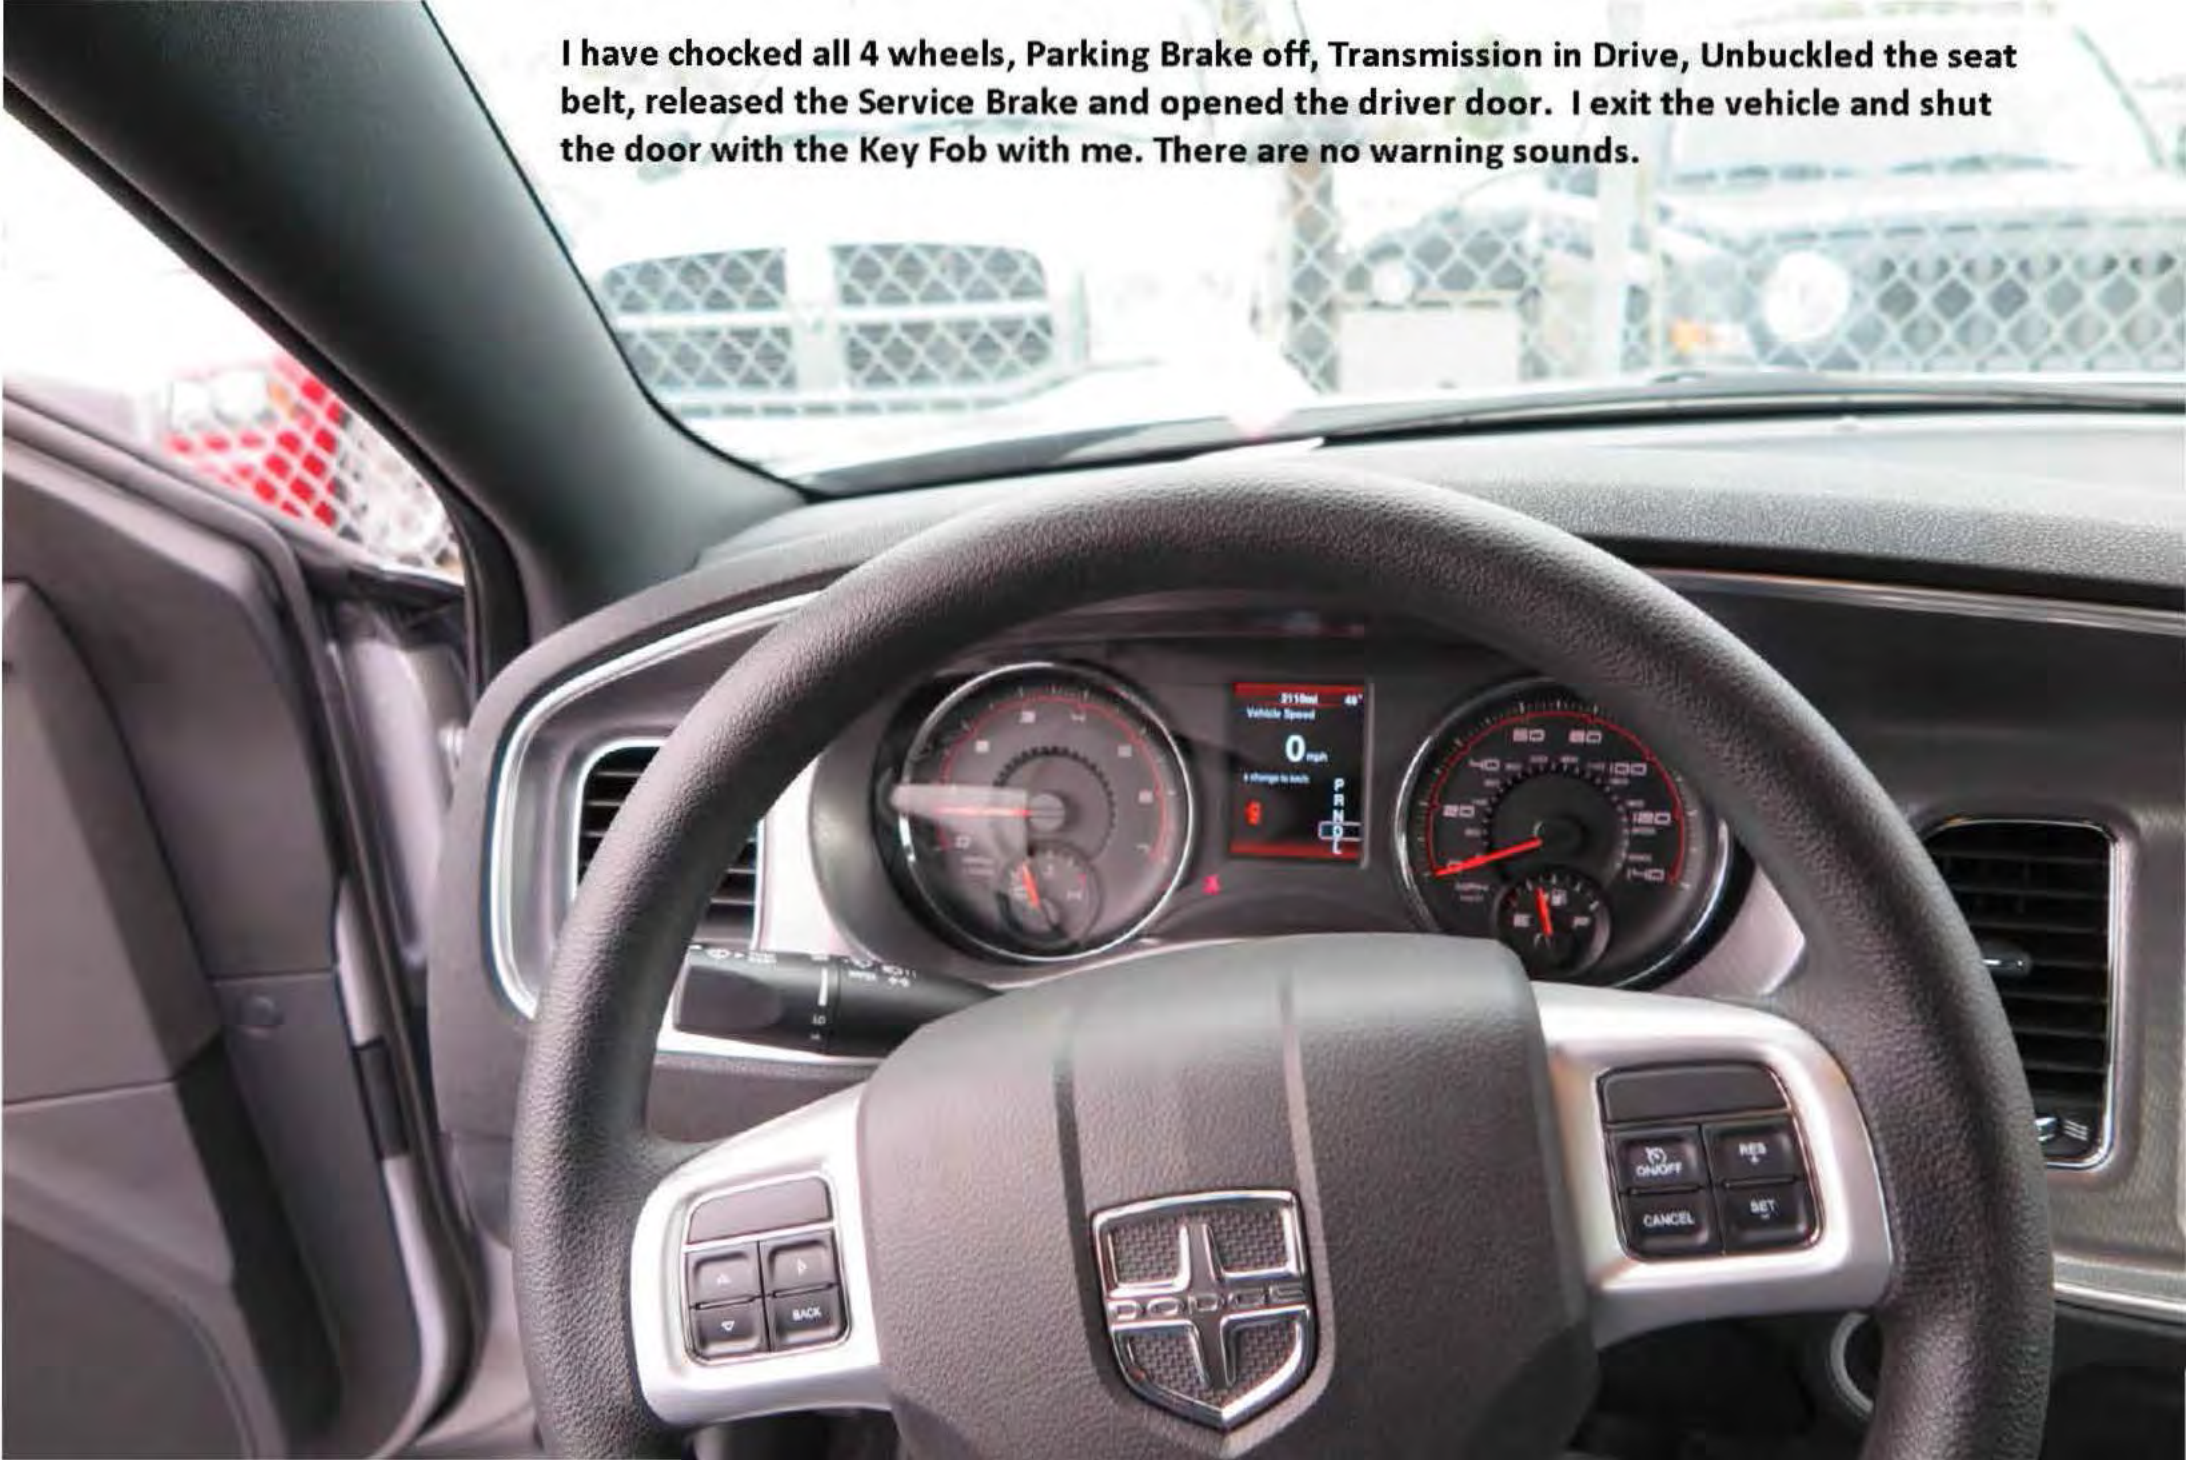
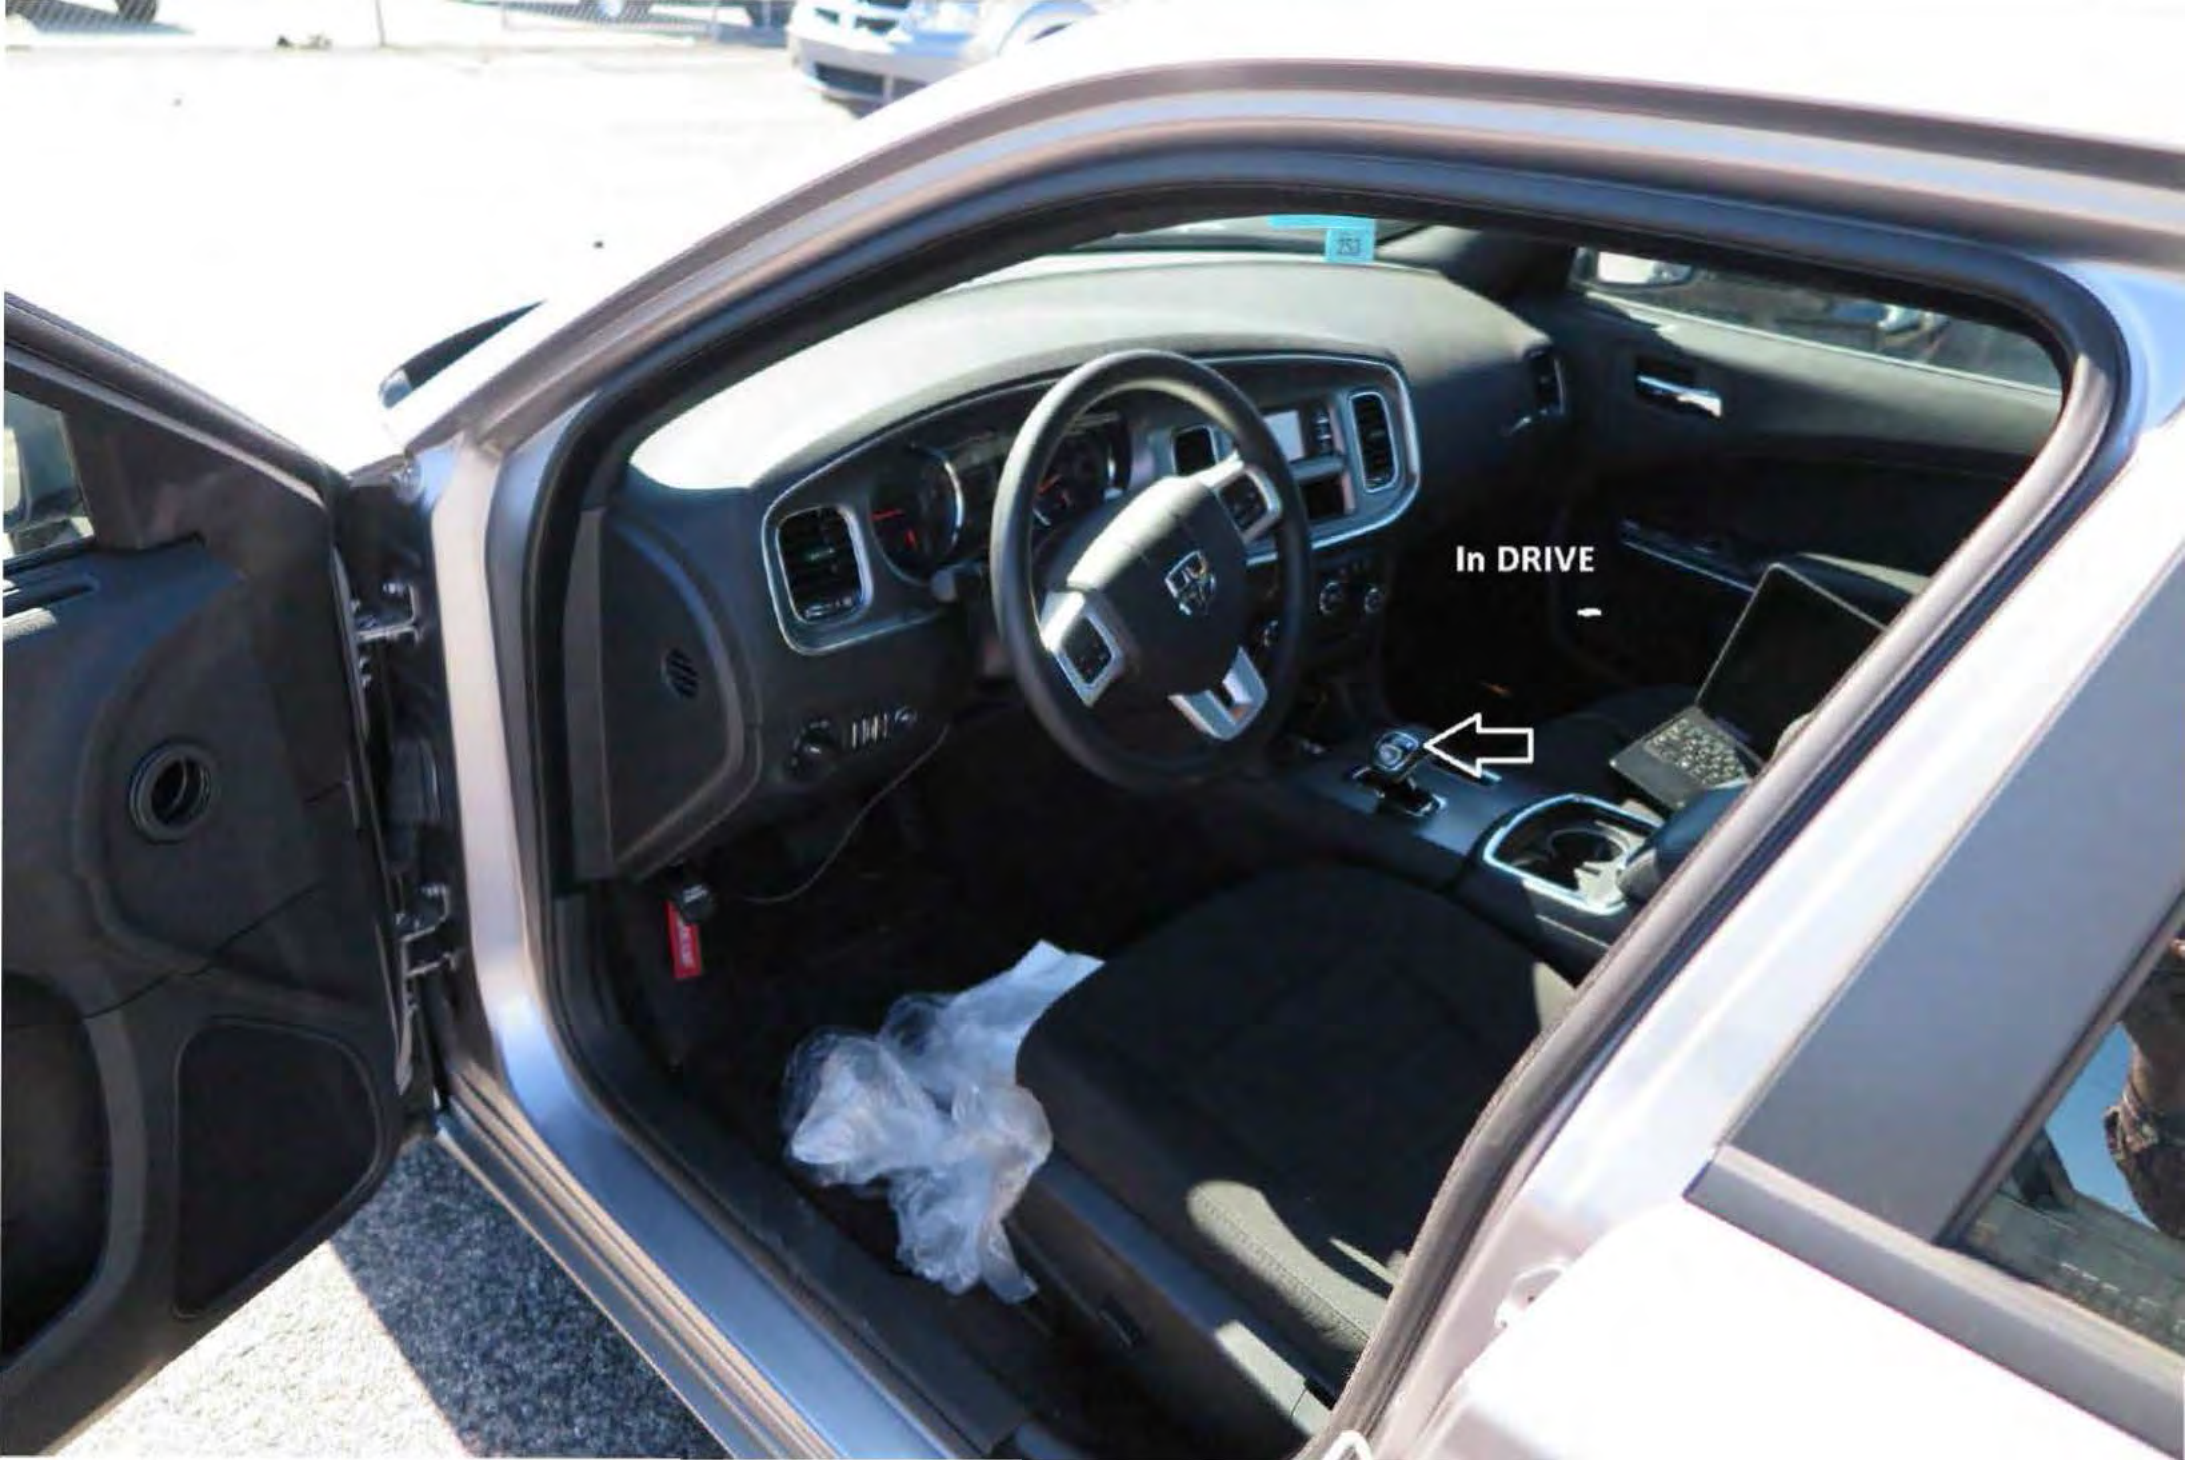
I have chocked all 4 wheels, Parking Brake off, Transmission in Drive, Unbuckled the seat belt, released the Service Brake and opened the driver door. I exit the vehicle and shut the door with the Key Fob with me. There are no warning sounds.

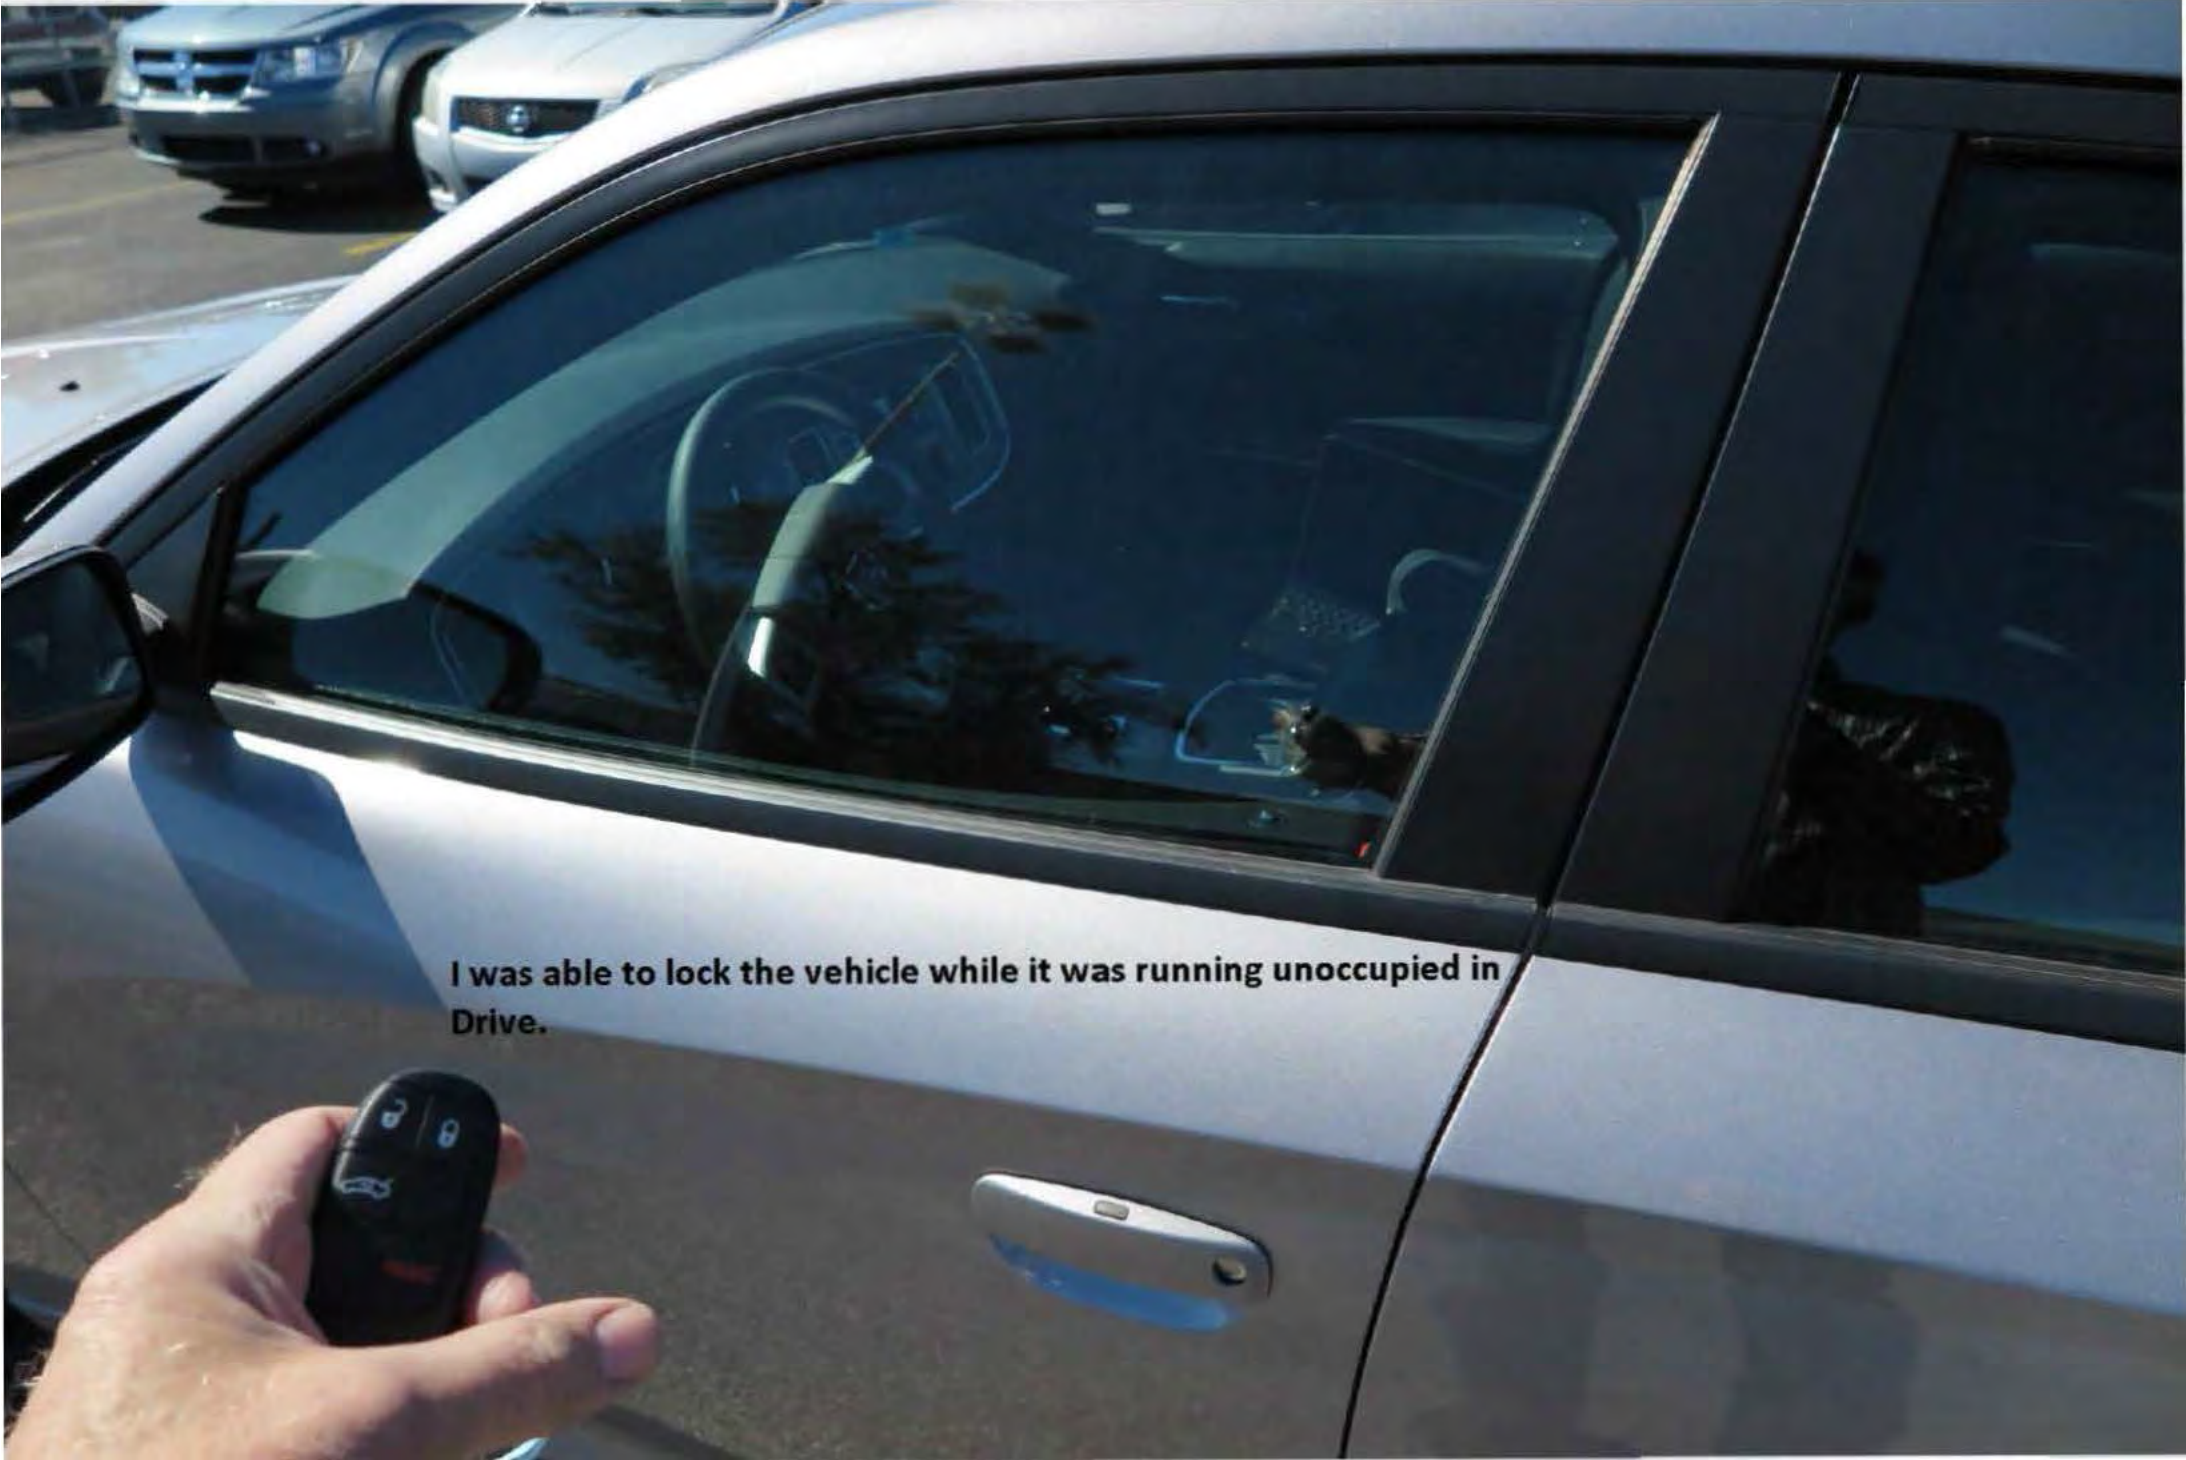
In DRIVE

I was able to lock the vehicle while it was running unoccupied in Drive.

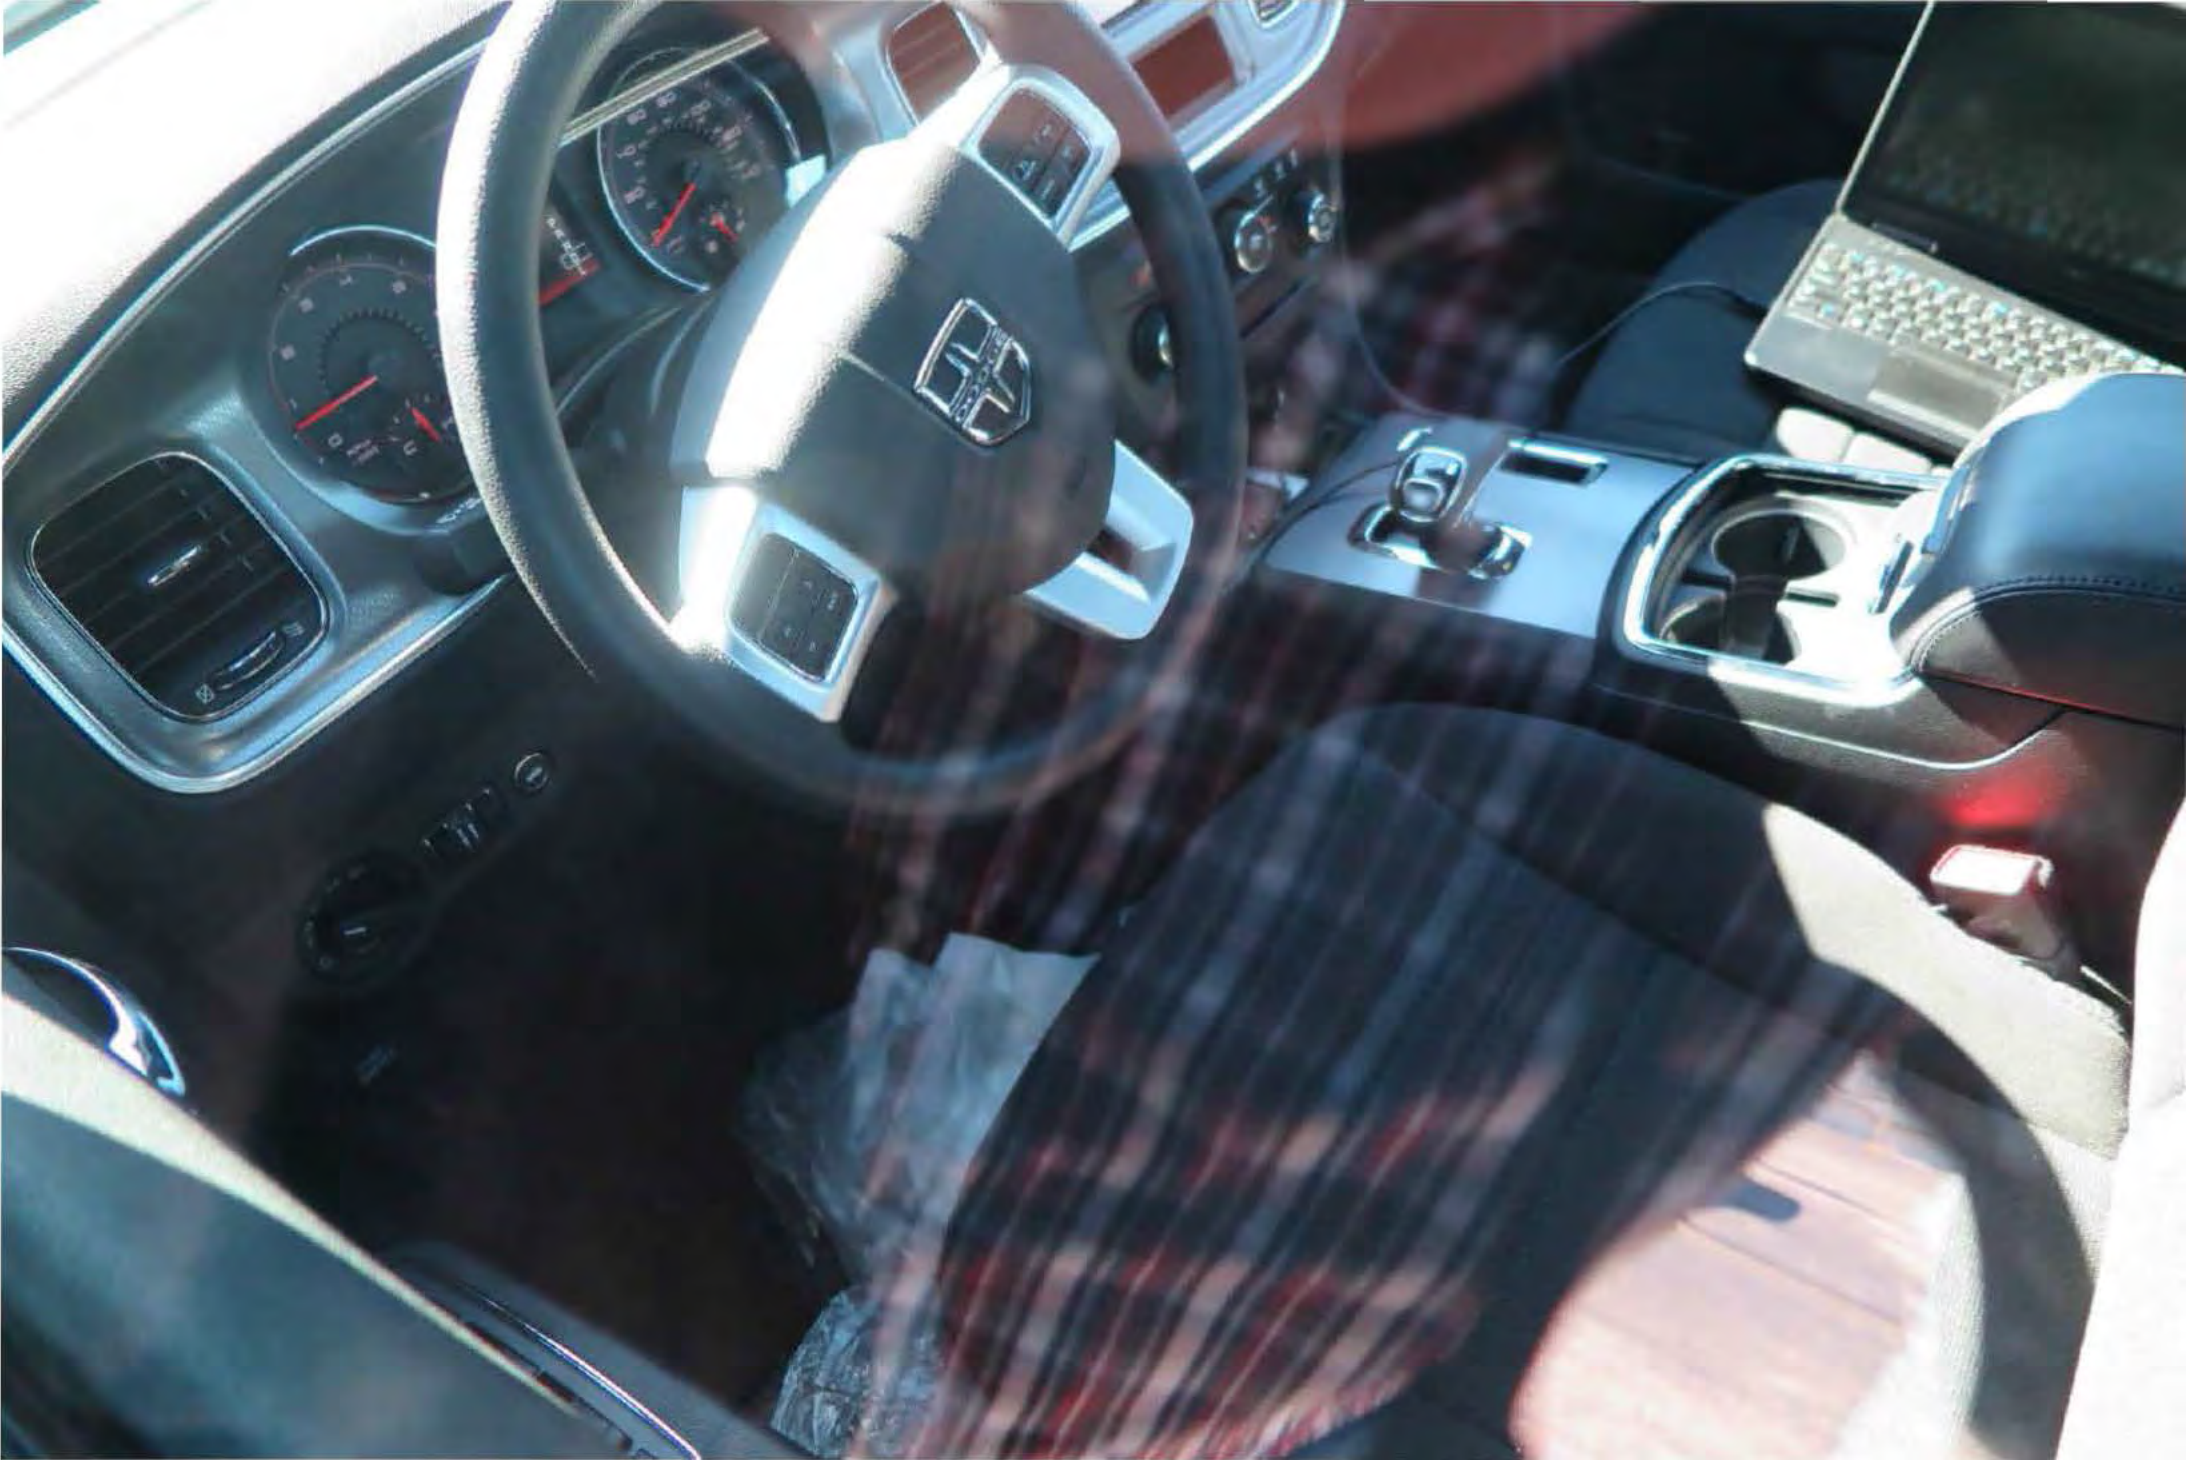
I repeated the steps with the vehicle running in Drive. This time I opened the door and placed the Key Fob outside the vehicle. I then shut the driver door and the "Key has Left vehicle" came ON and the warning Chime only came ON after I closed the door.

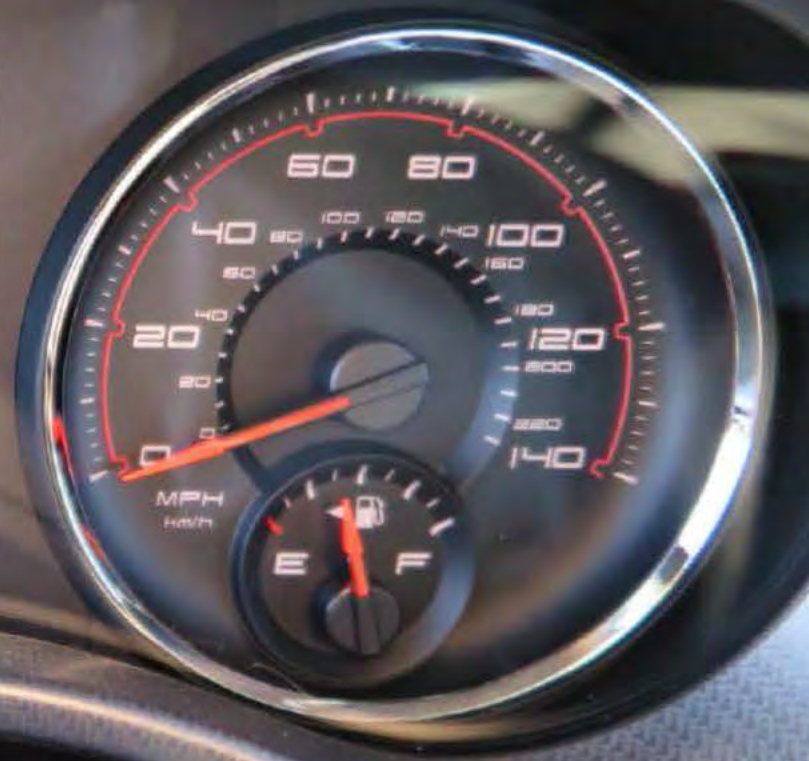
Service brake pedal released and ONLY the Parking brake is applied. I slowly raised the engine speed to this point and the vehicle remained stationary. The vehicle wheels are NOT chocked at this time.

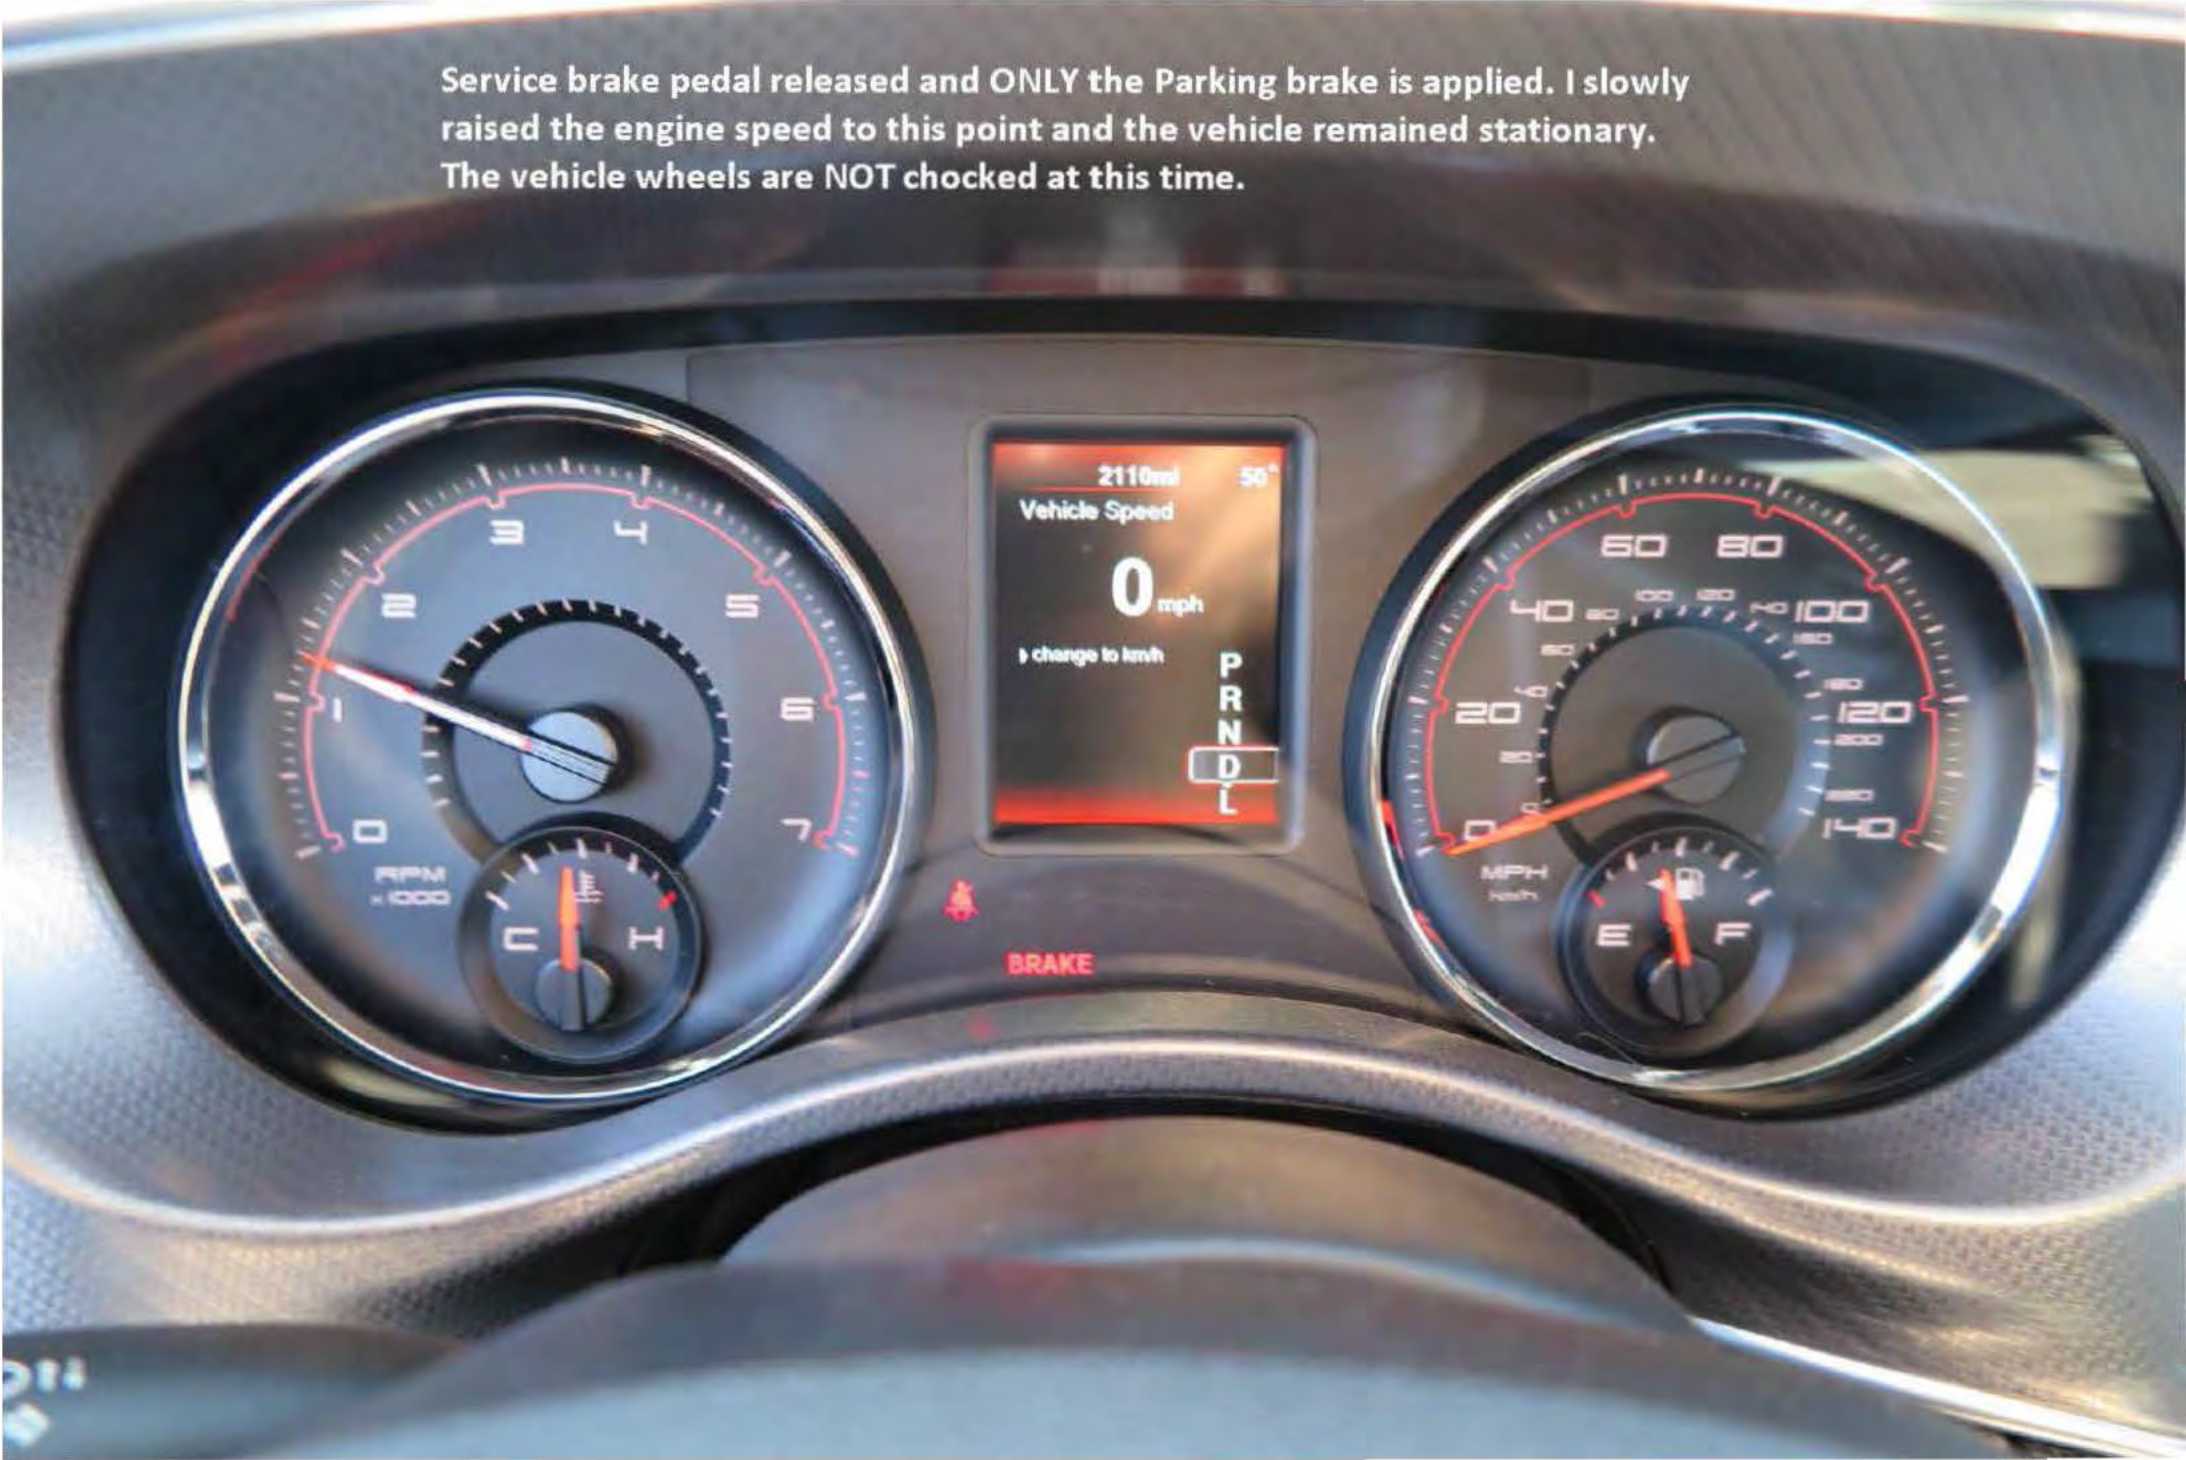
ONLY the Parking brake is applied,
vehicle remained stationary.

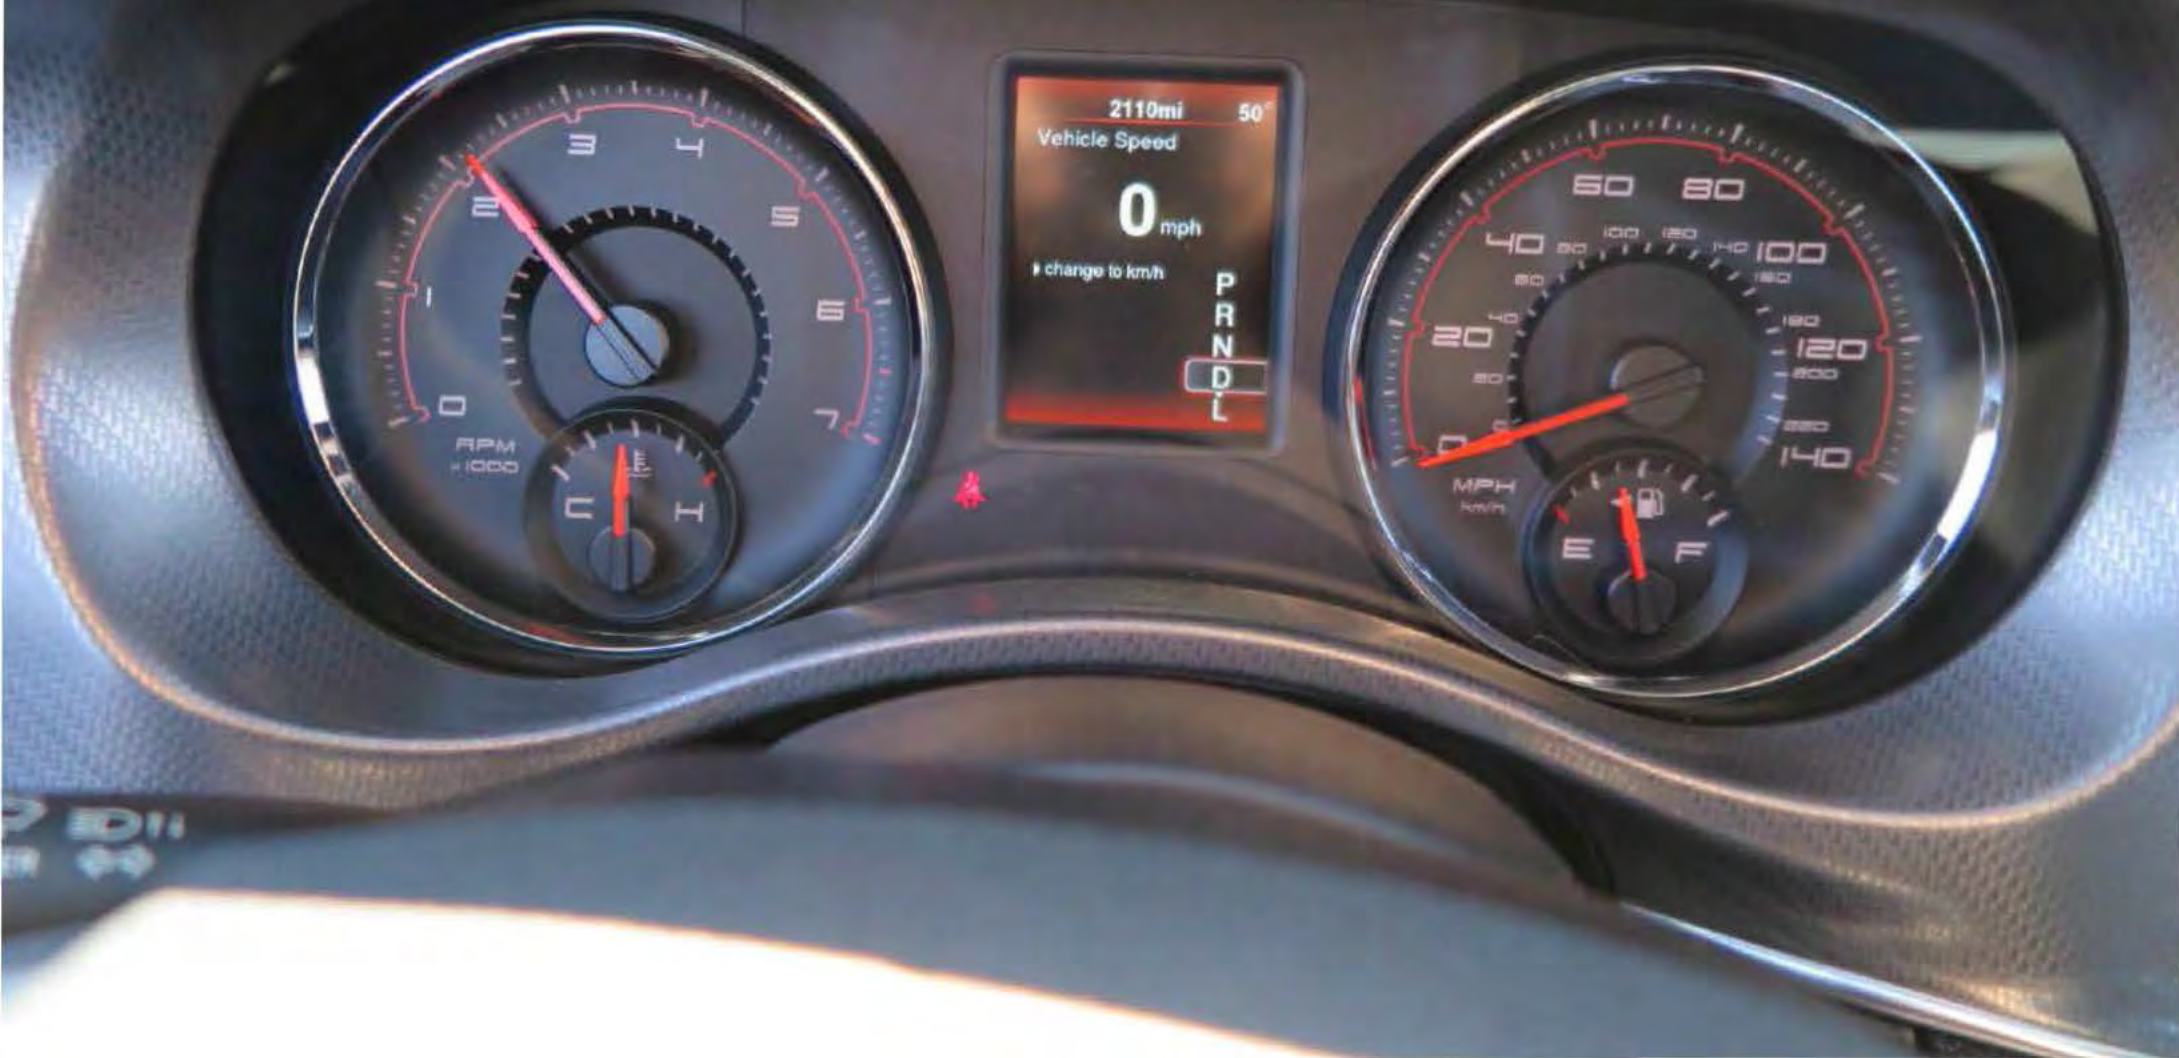
Parking brake released, Service Brake pedal firmly applied and the accelerator pedal is pressed to the floor.
