# Consumer Assistance Center Case Report

**Title:** Dlr opened Service Alert Escalation because brakes locking up, dlr CND.

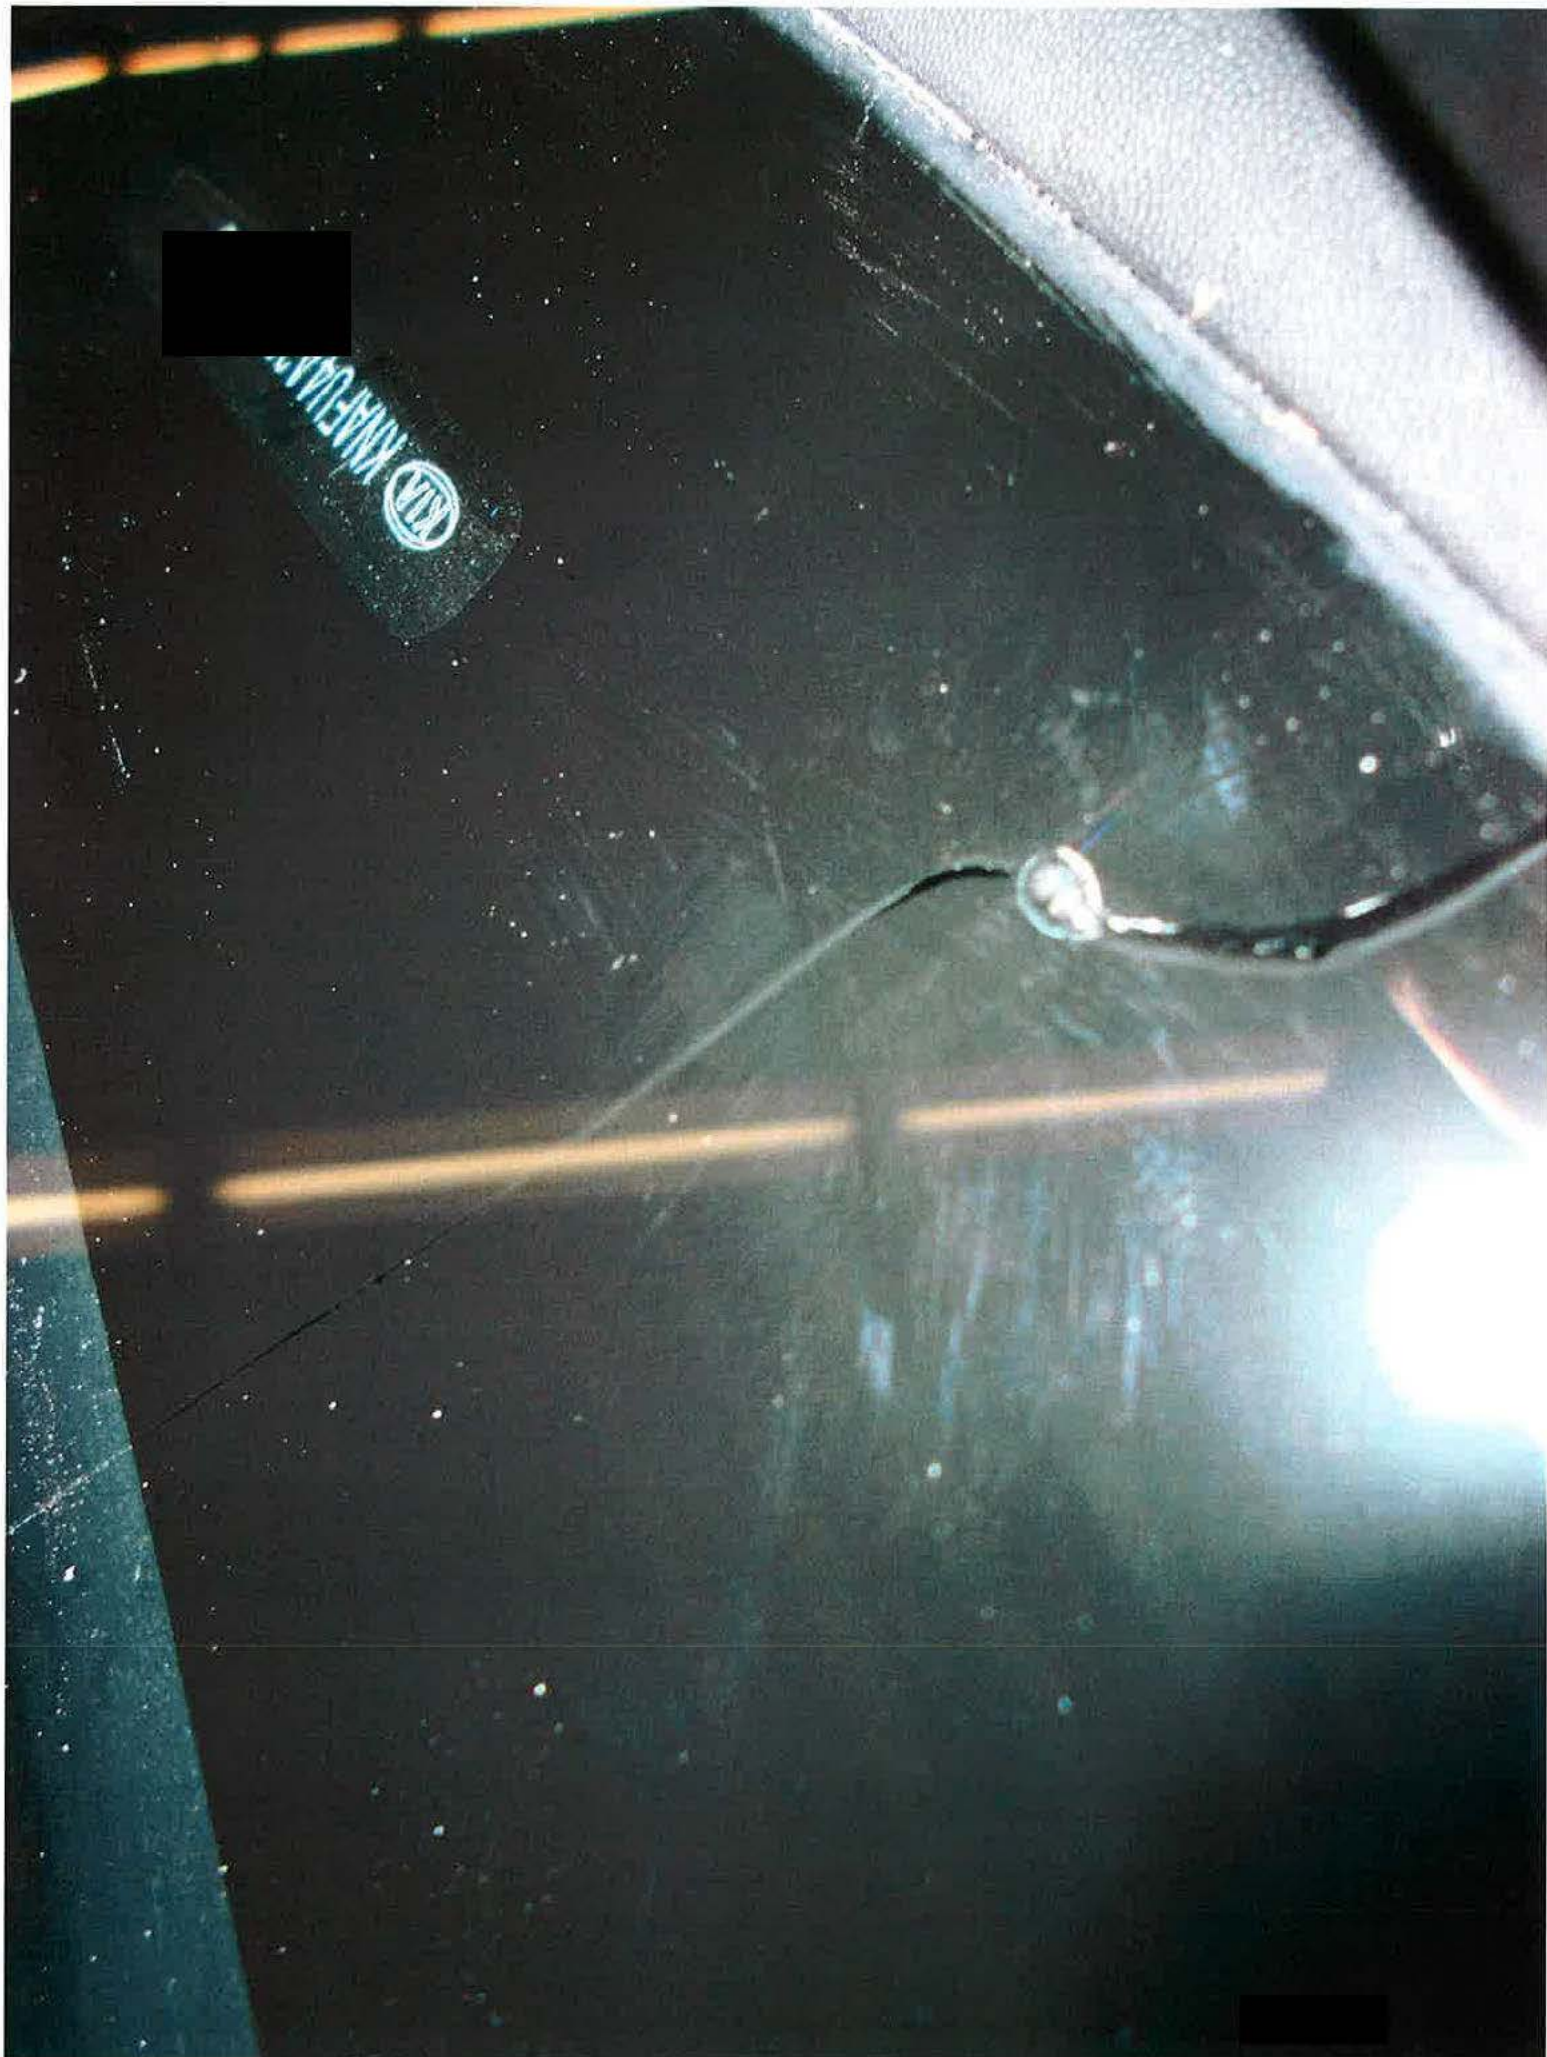
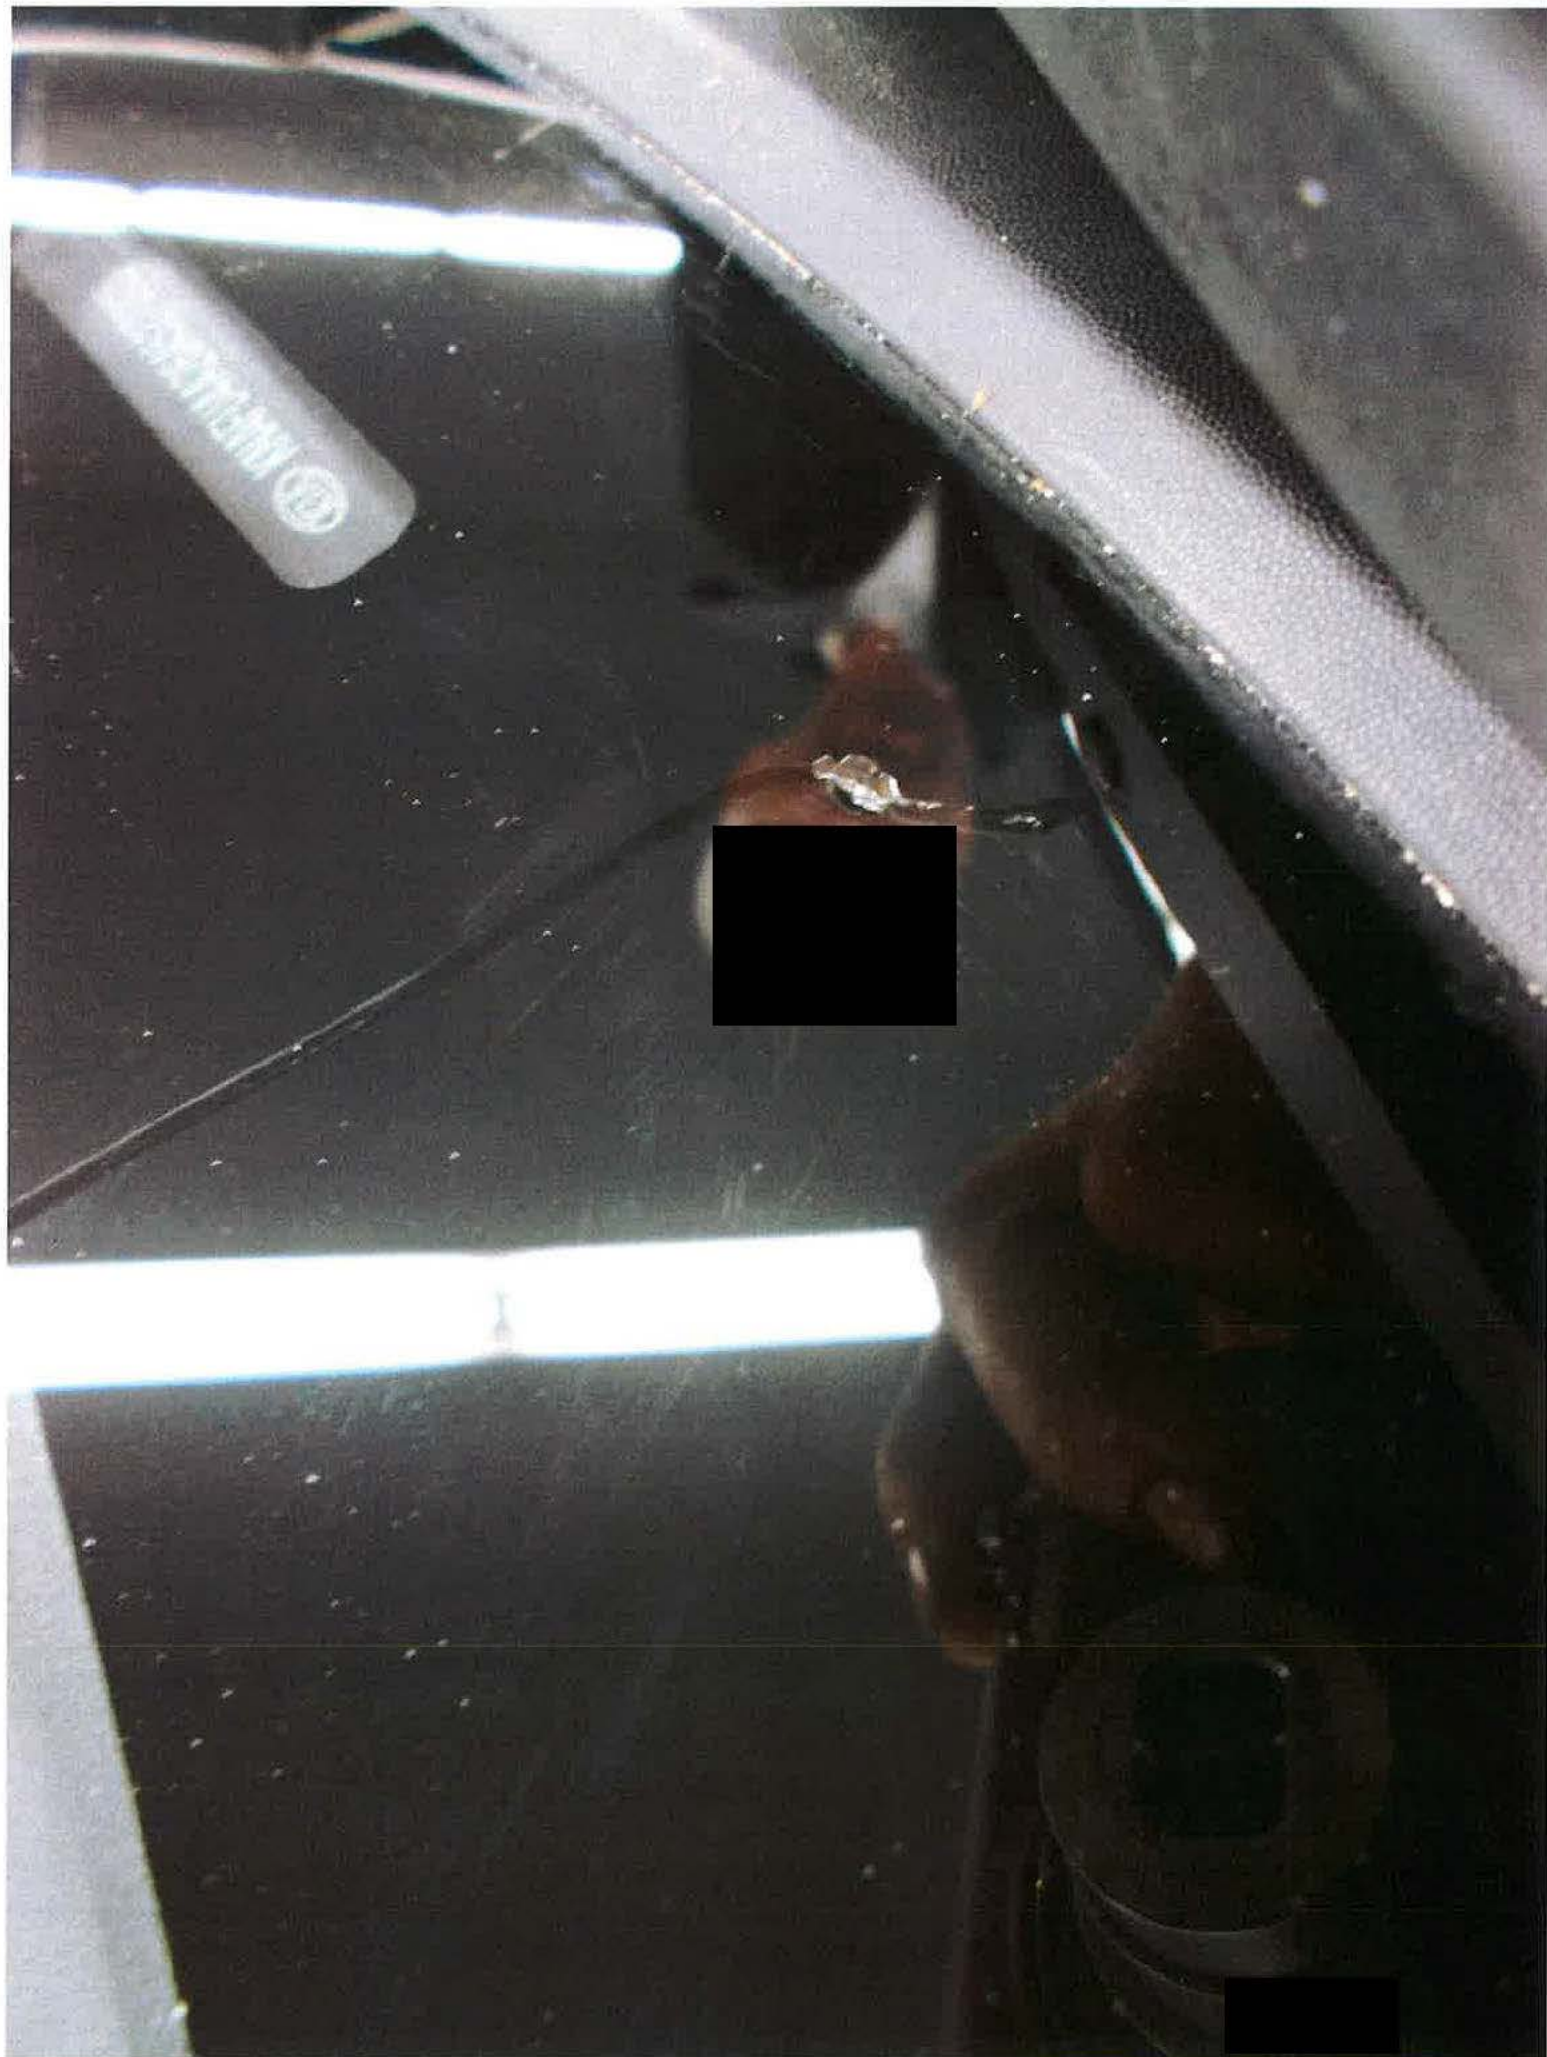
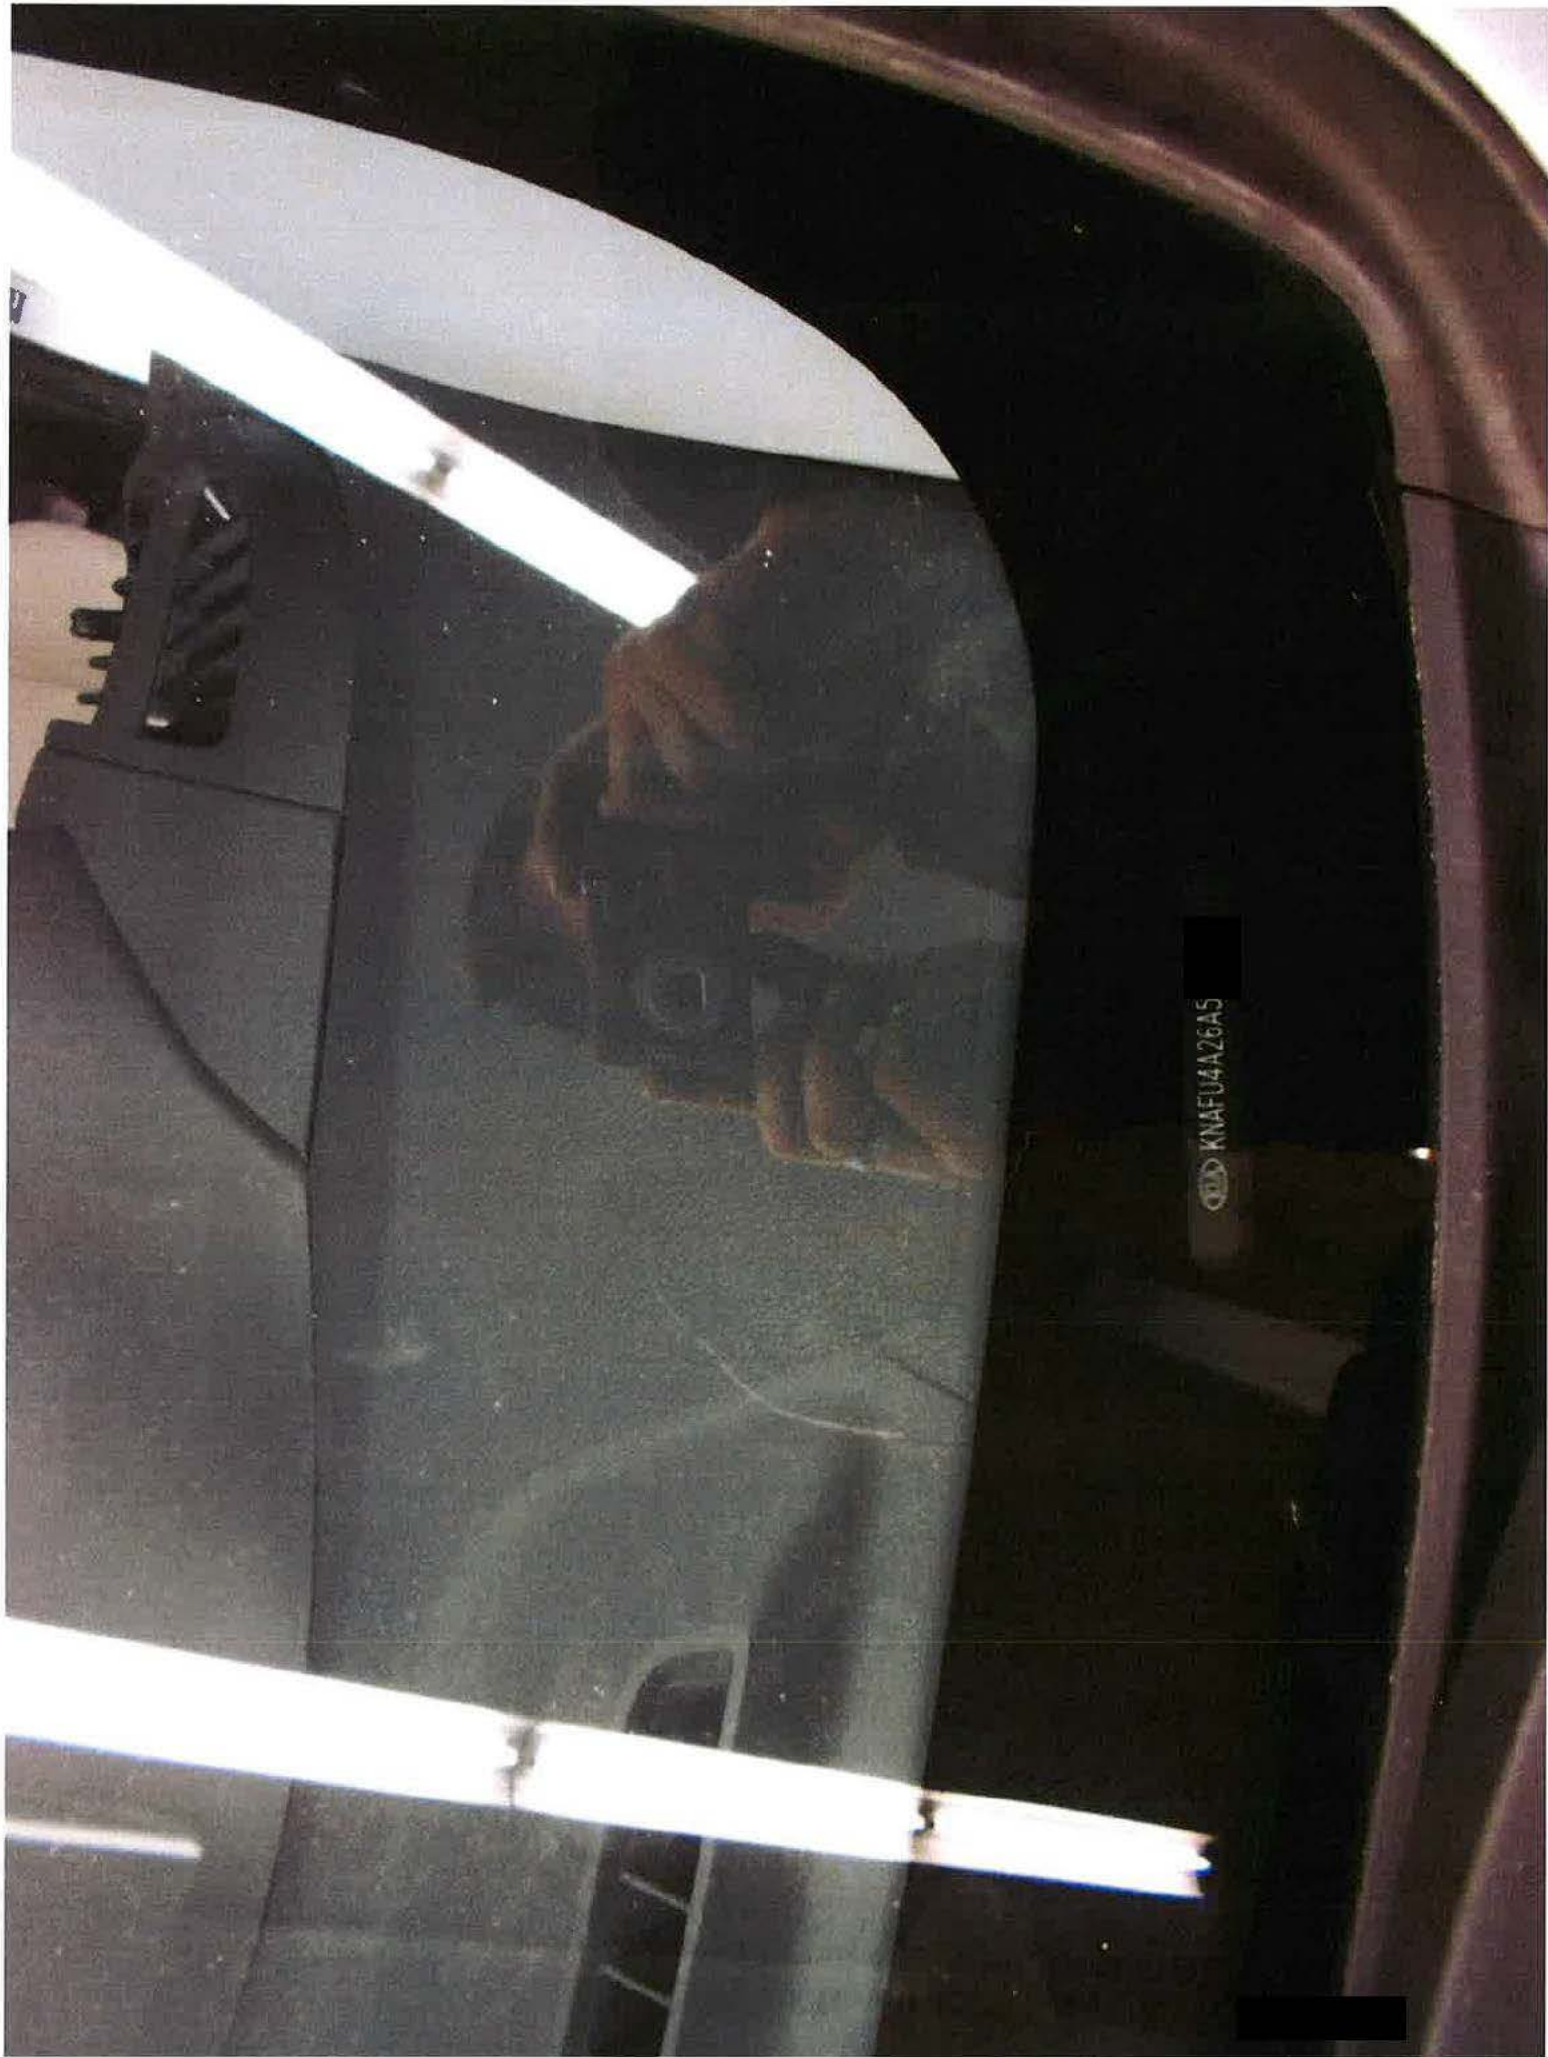
Here are the pictures of base of windshield and crack.

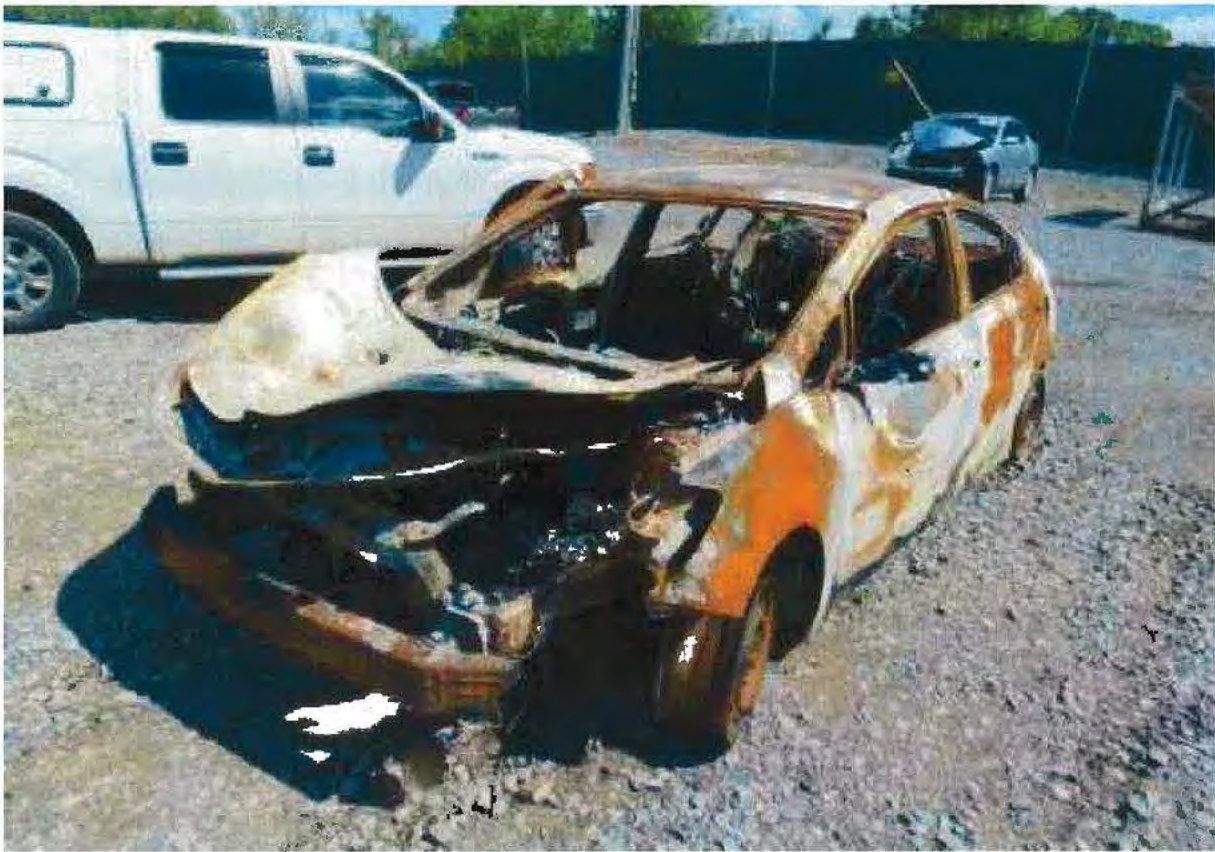
***Photo Information***

1. Front and driver side of the vehicle.

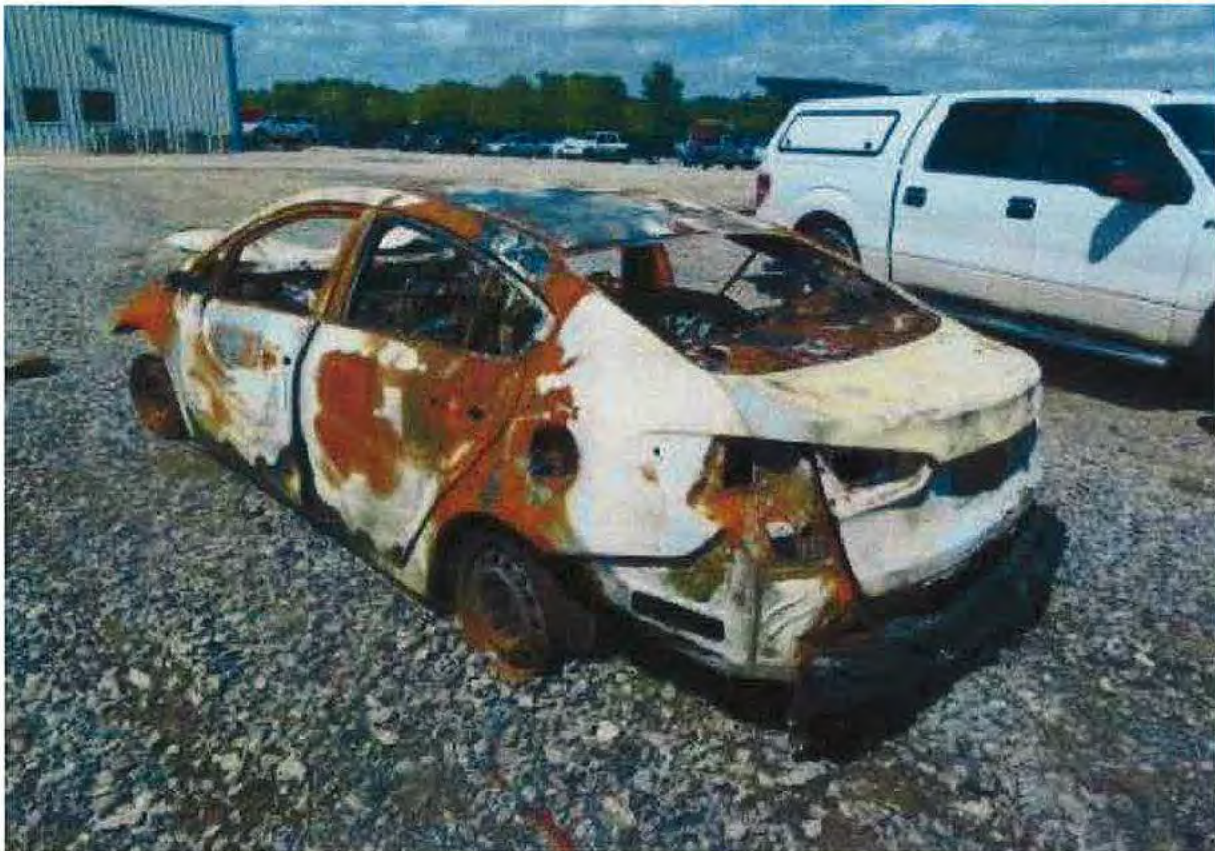
***Photo Information***

2. Rear and driver side of the vehicle.

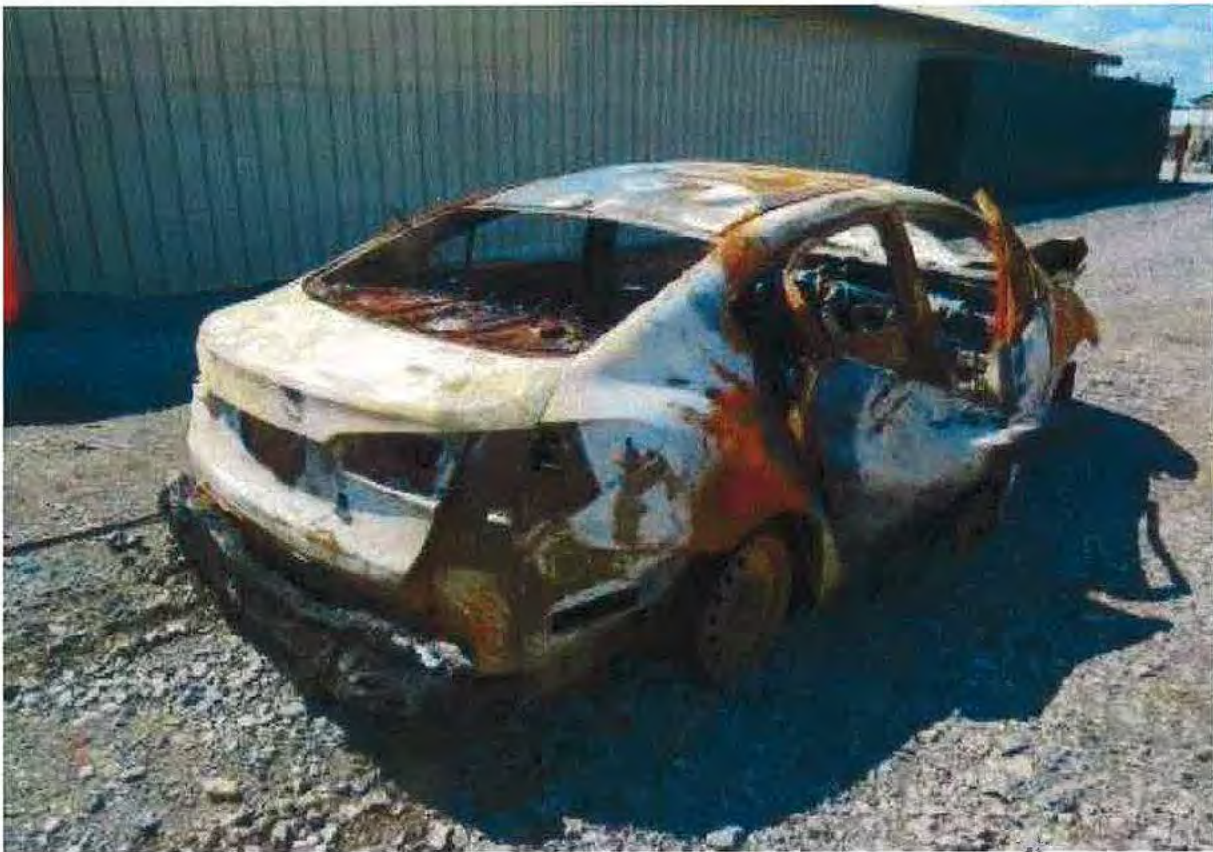
**Photo Information**

3. Rear and passenger side of the vehicle.

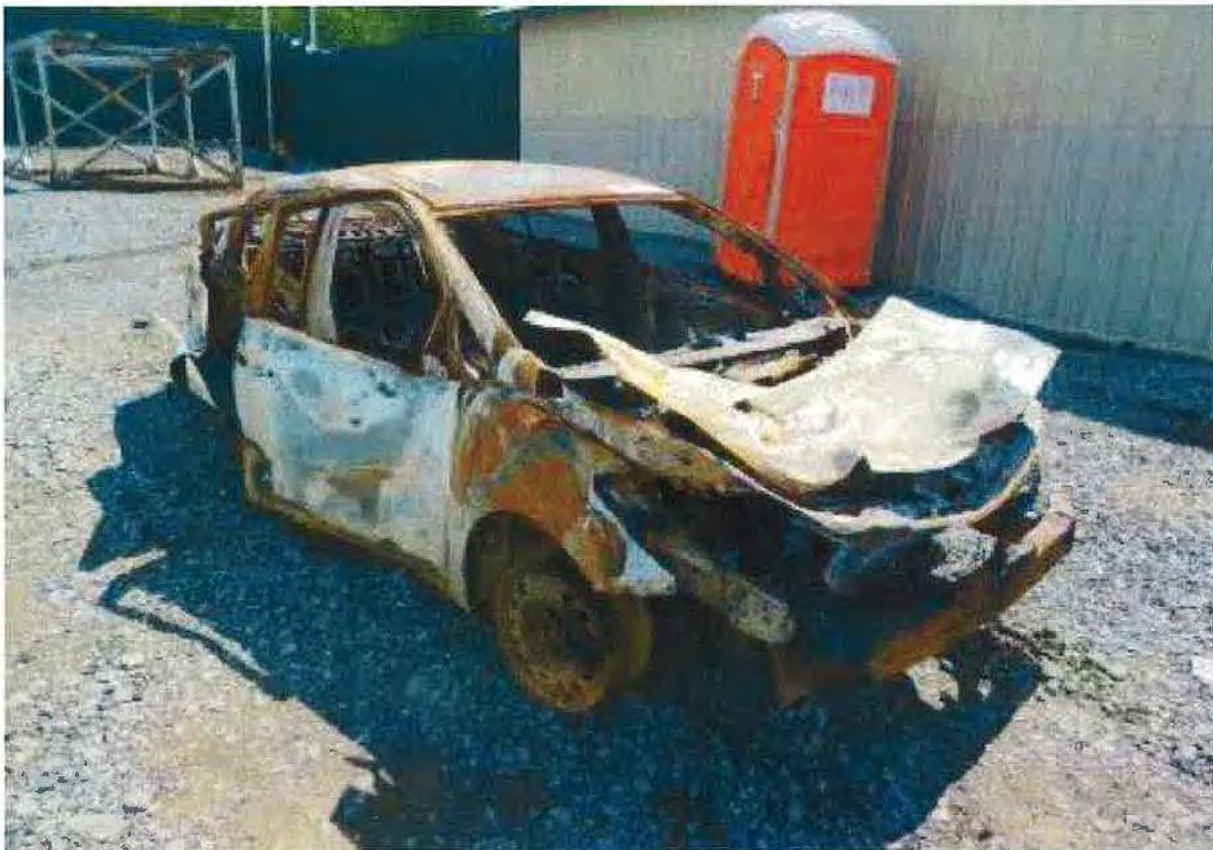
4. Front and passenger side of the vehicle. Note that extensive degradation of the vehicle did occur during the course of the fire. [REDACTED]

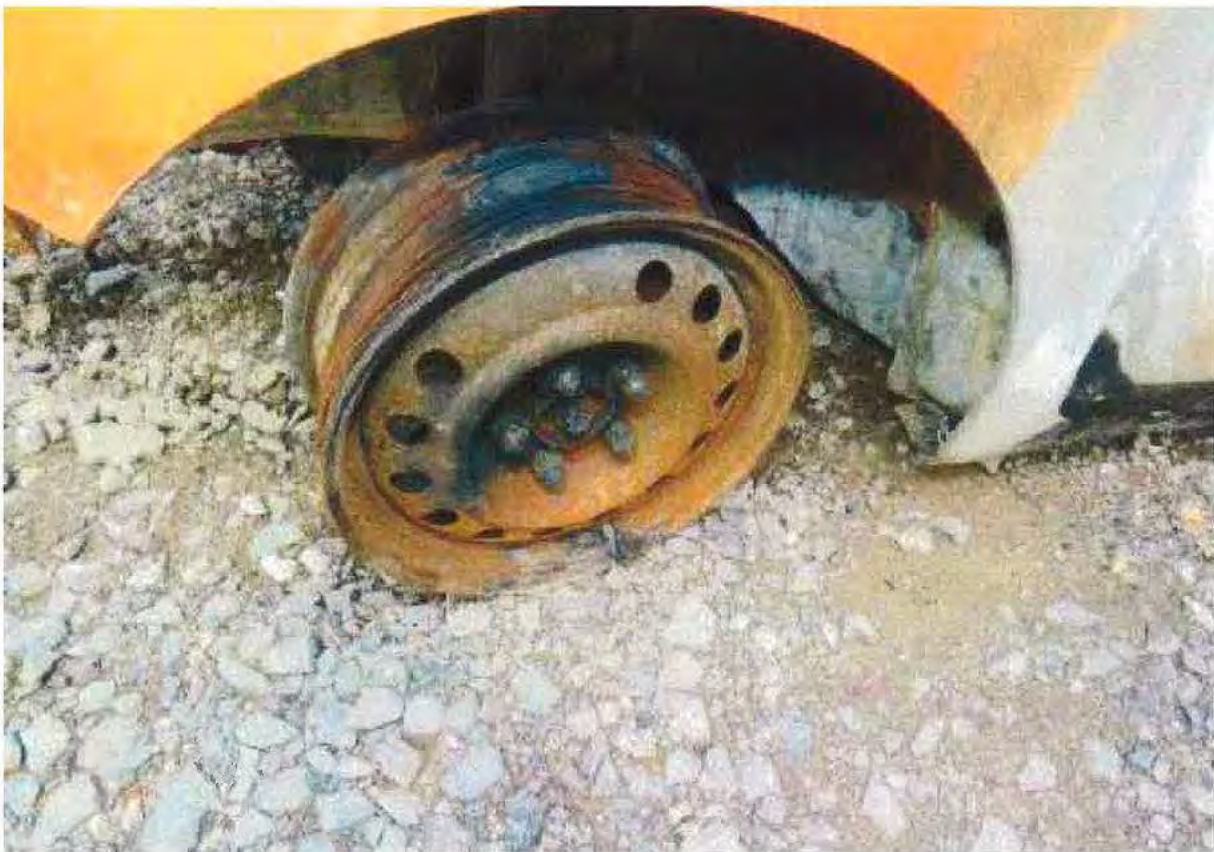
**Photo Information**

5. The left front wheel showing design.

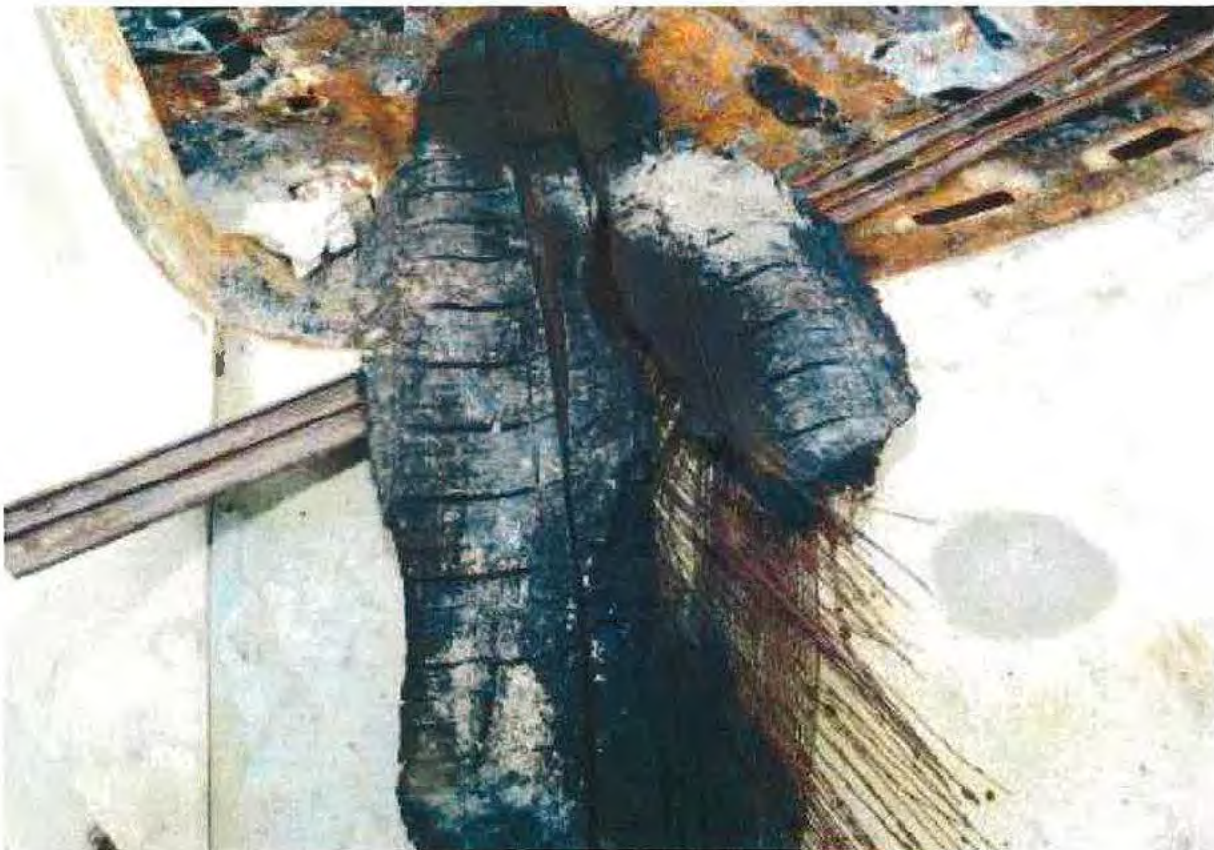
**Photo Information**

6. The tire pad showing tread design and condition.

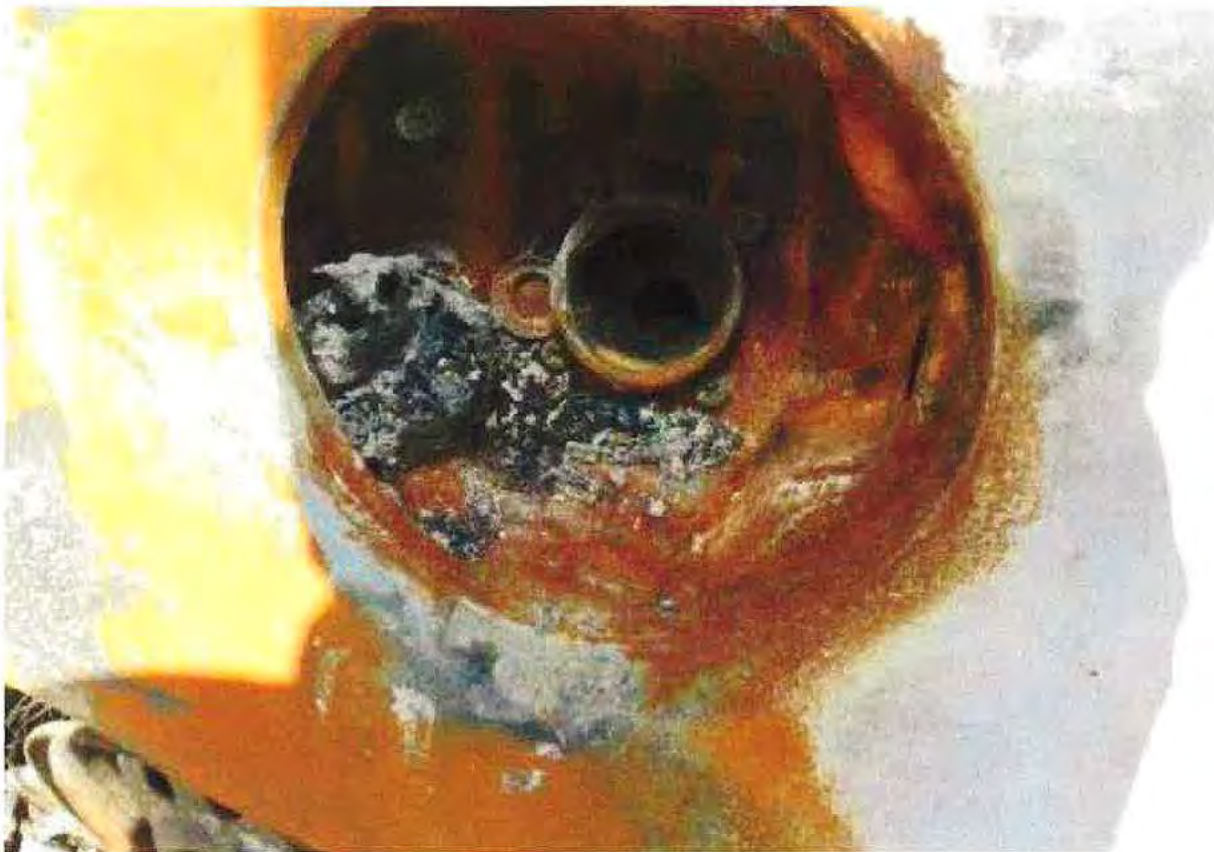
**Photo Information**

7. The fuel filler neck. The cap was in place at the time of the fire.

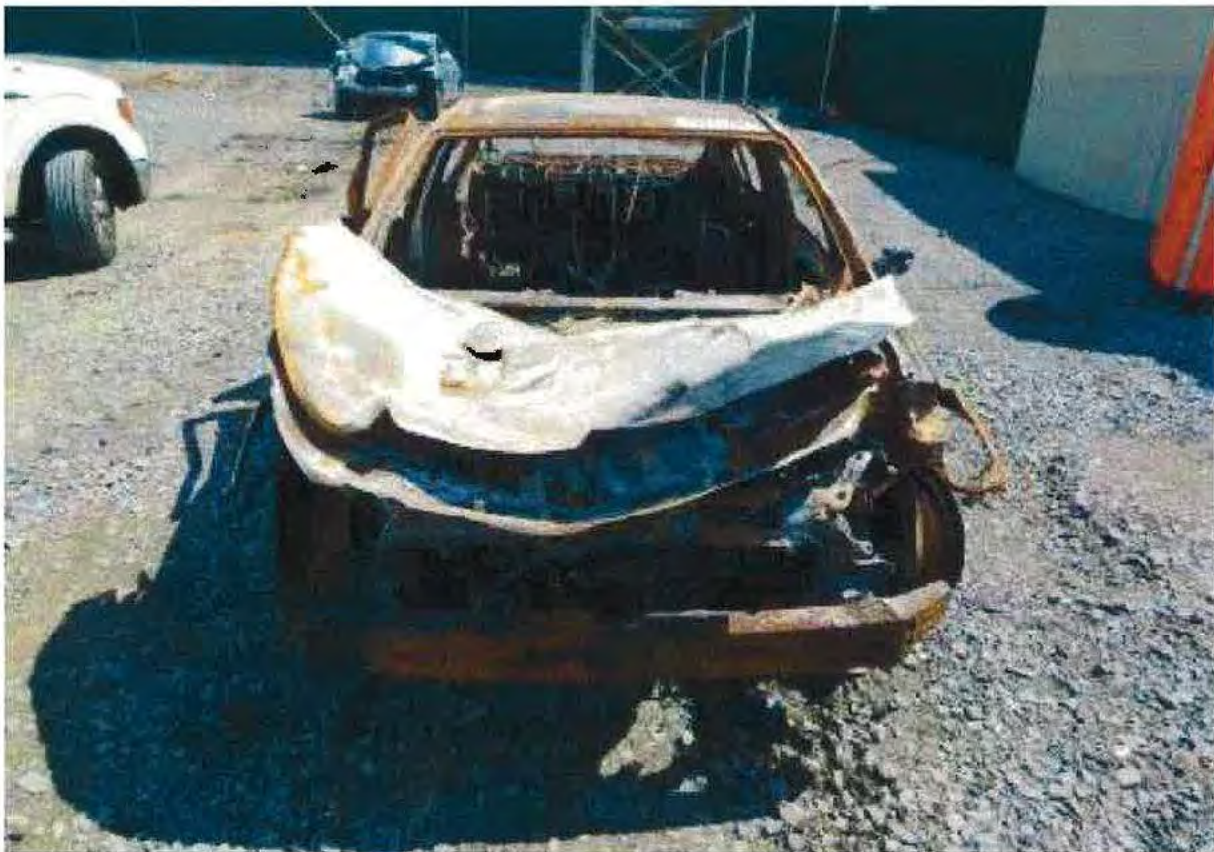
**Photo Information**

8. Overview of the hood and front grill area. The hood was down and latched at the inception of the fire. [REDACTED]

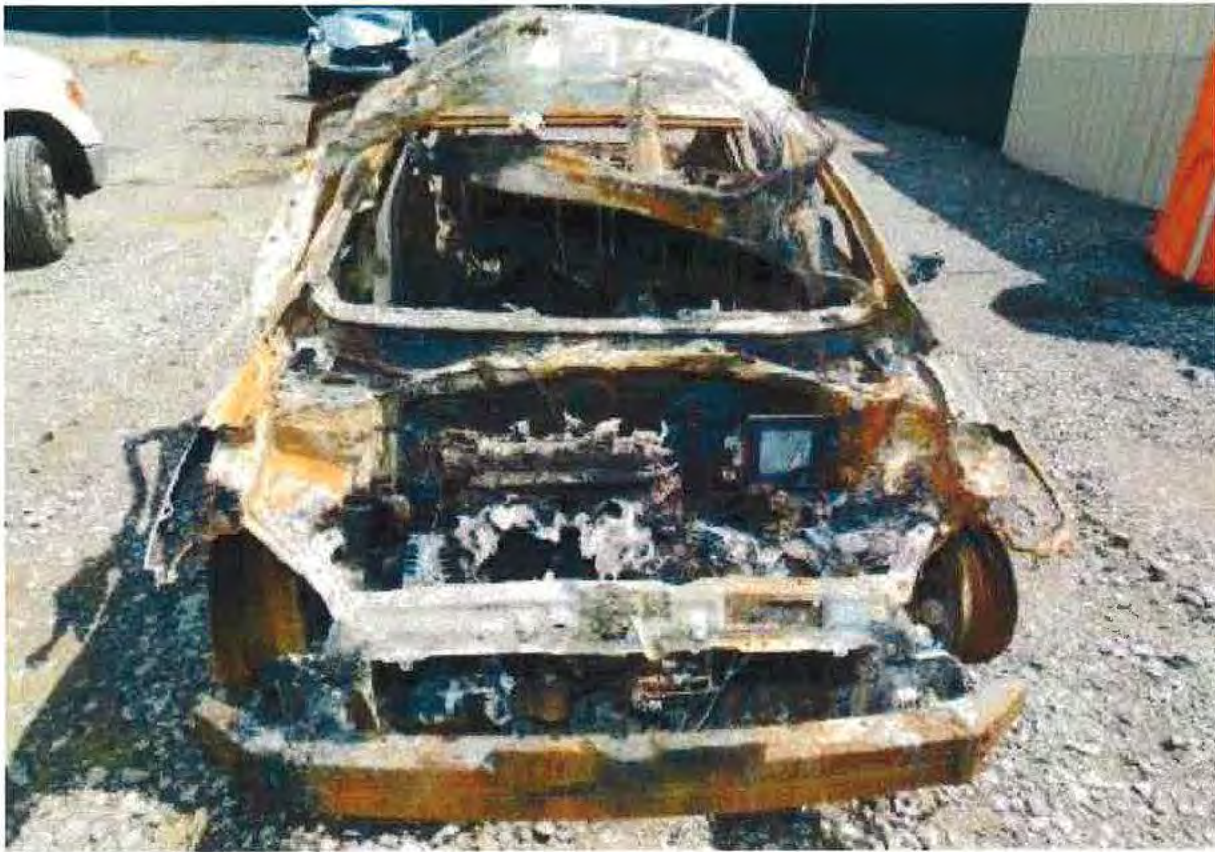
9. Overview of the motor compartment following removal of the hood. All components were found in their appropriate locations.

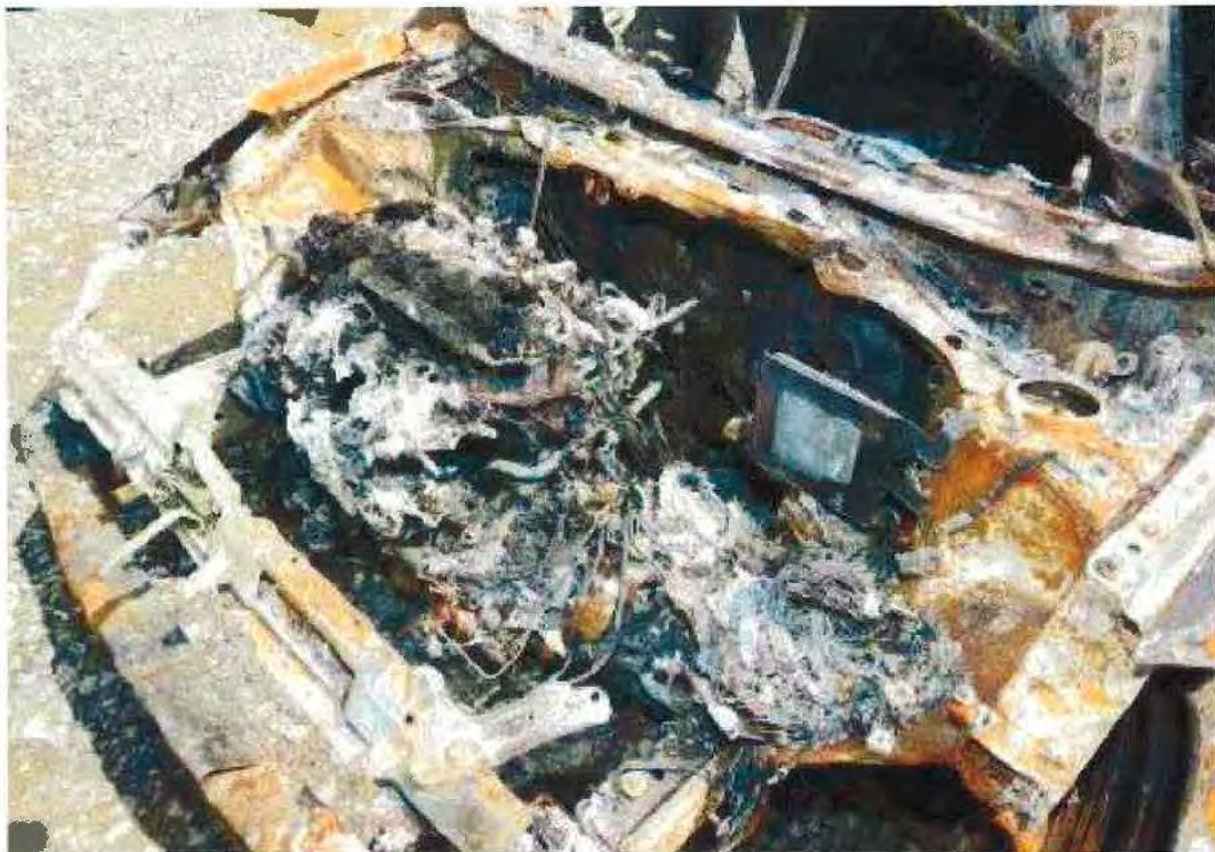
10. The driver side of the motor compartment. The damage configuration demonstrates the fires movement from the passenger compartment through the firewall/bulkhead in [REDACTED] motor compartment.

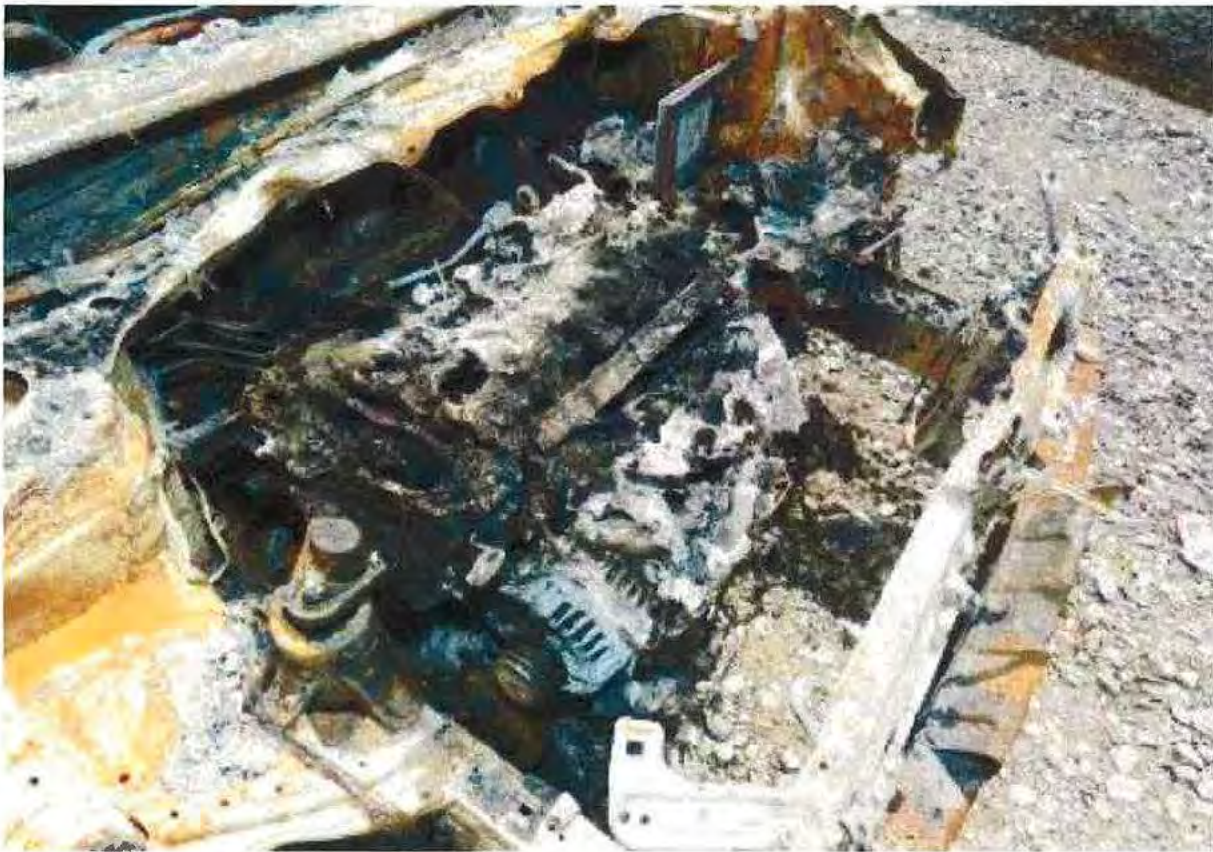
11. The passenger side of the motor compartment. There is no evidence of the fires initial inception within the motor compartment area.

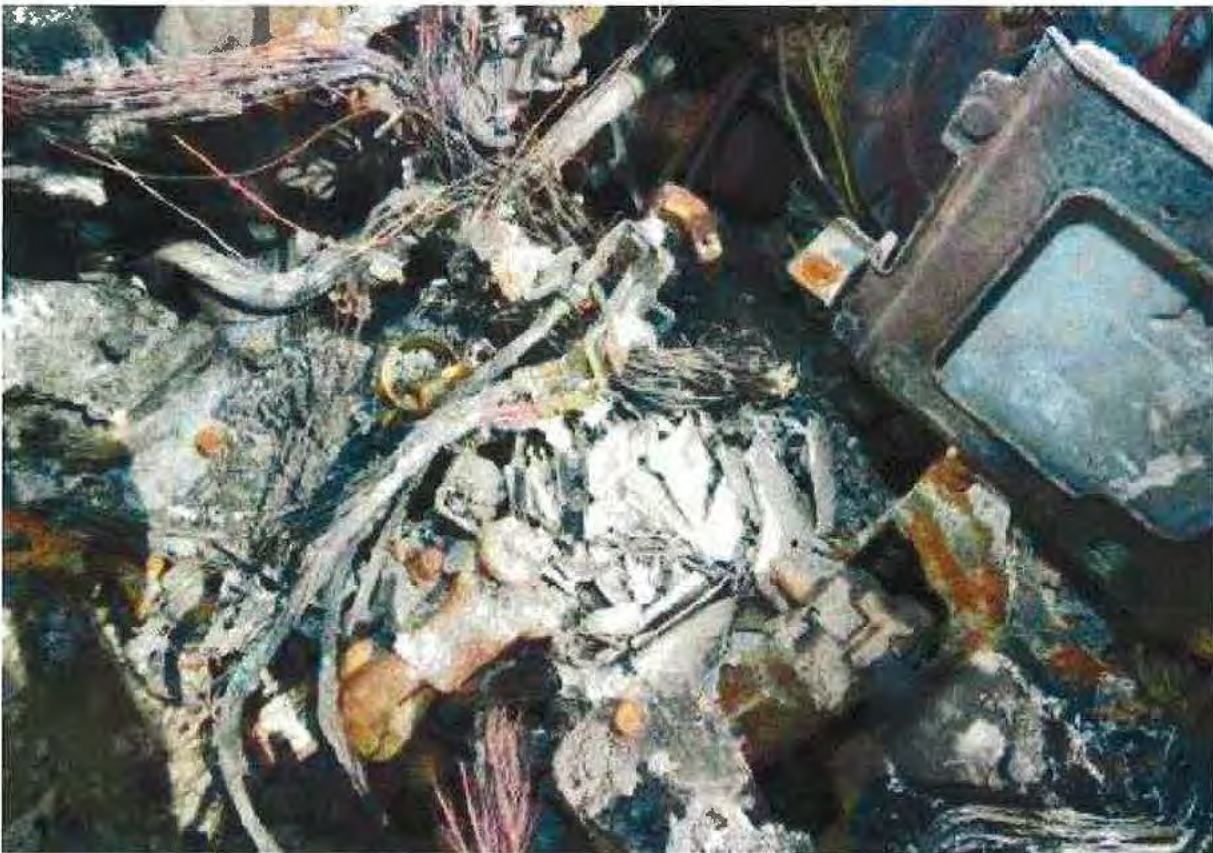
12. The remains of the battery and primary electrical wiring showing extensive degradation due to heat and flame impingement. There is however no evidence of the fires inception at the battery location.
