# Consumer Assistance Center Case Report

**Title:** Dlr opened Service Alert Escalation because brakes locking up, dlr CND.

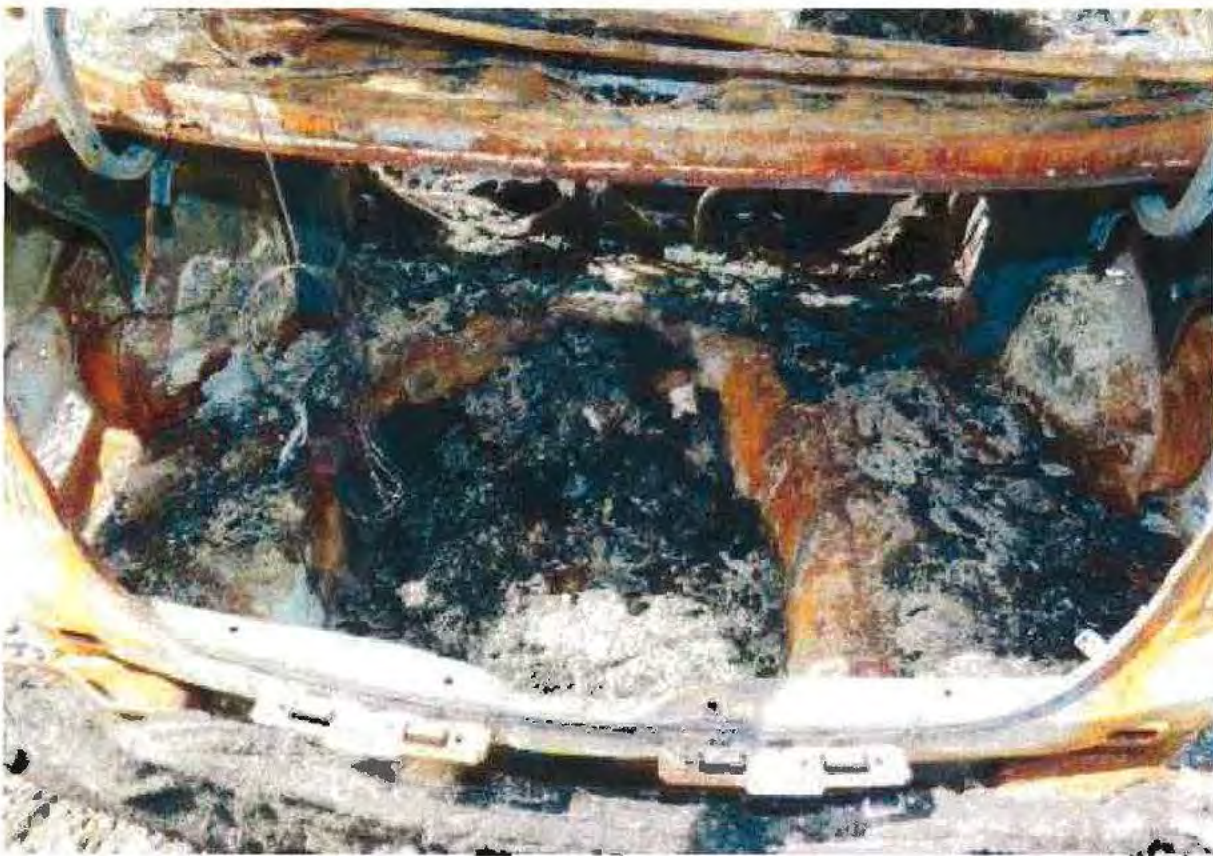
**Photo Information**

13. The trunk storage compartment showing extensive degradation. The spare tire was not found at its mounting location.

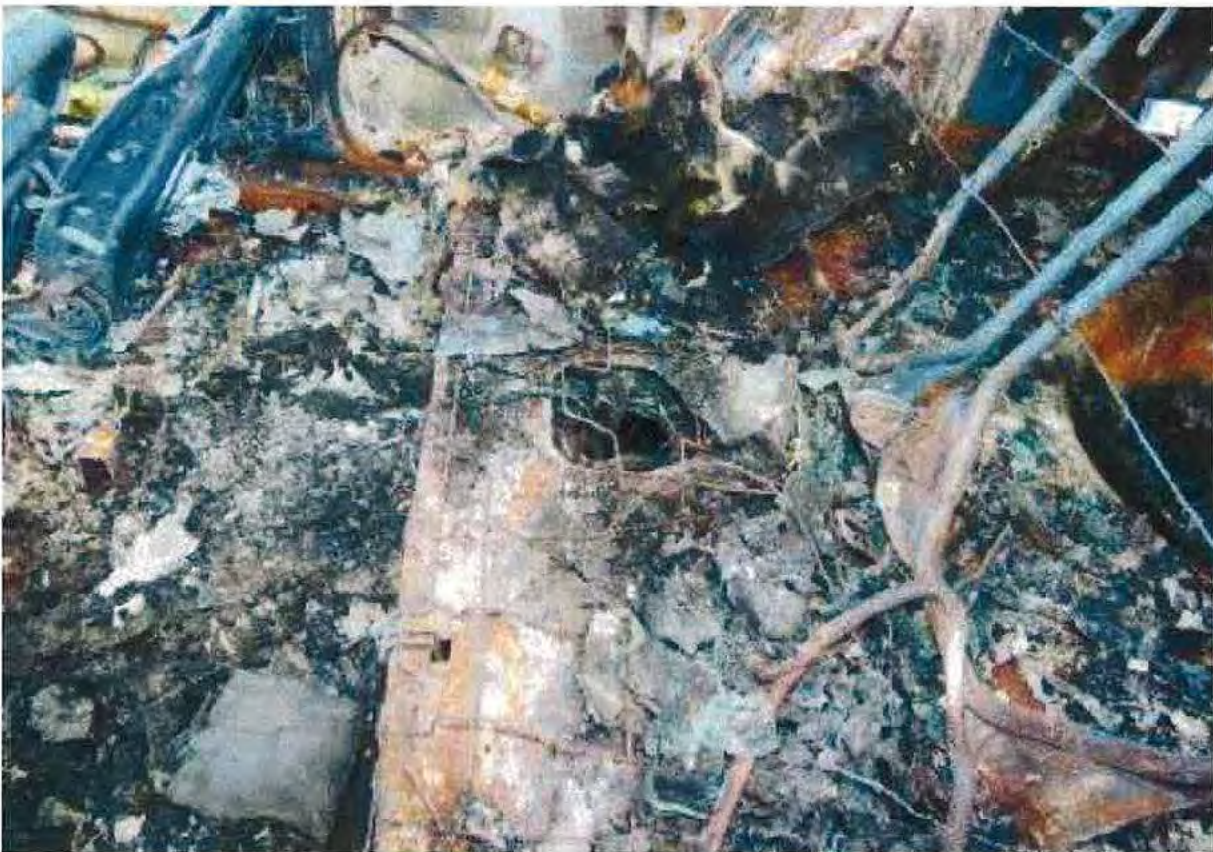
**Photo Information**

14. The back seating area showing extensive degradation of the seat assembly.

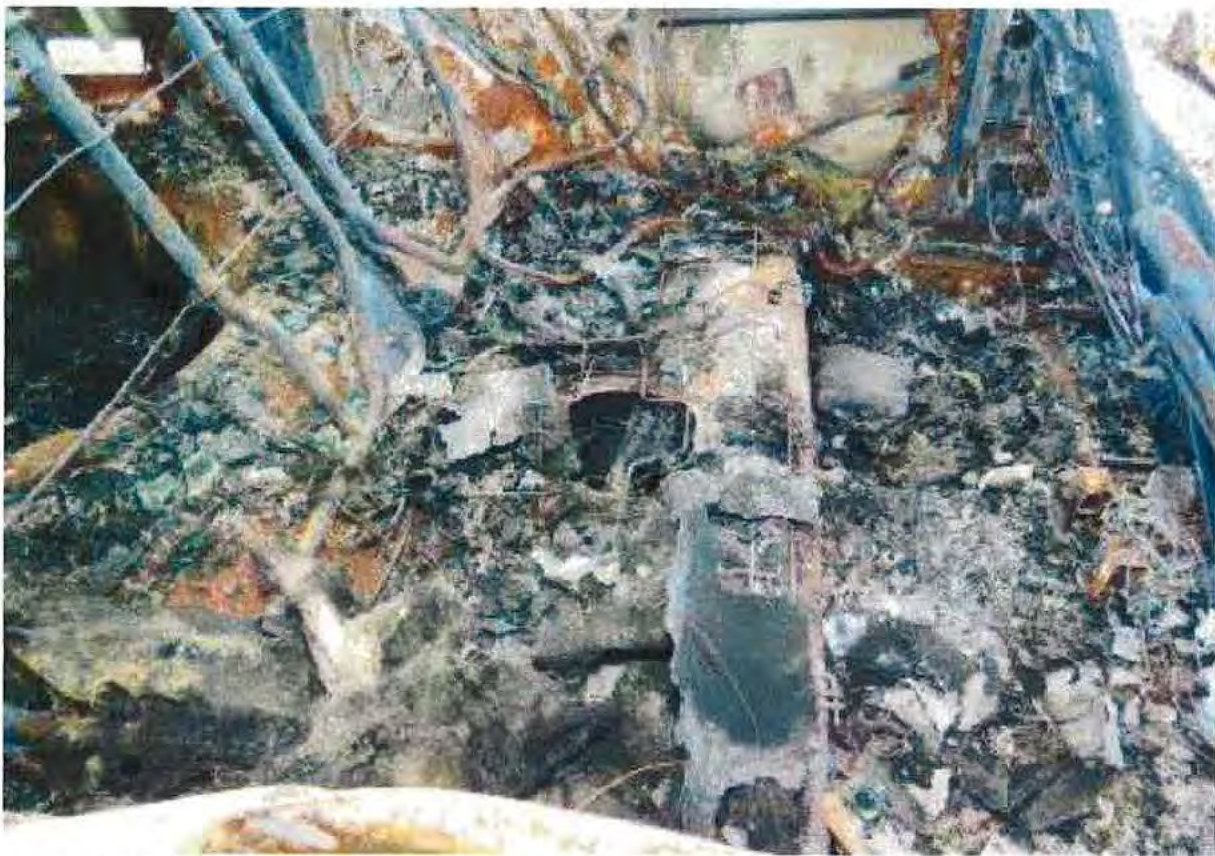
**Photo Information**

15. Additional view of the back seating area again showing extensive degradation of the seats as well as the door panels.

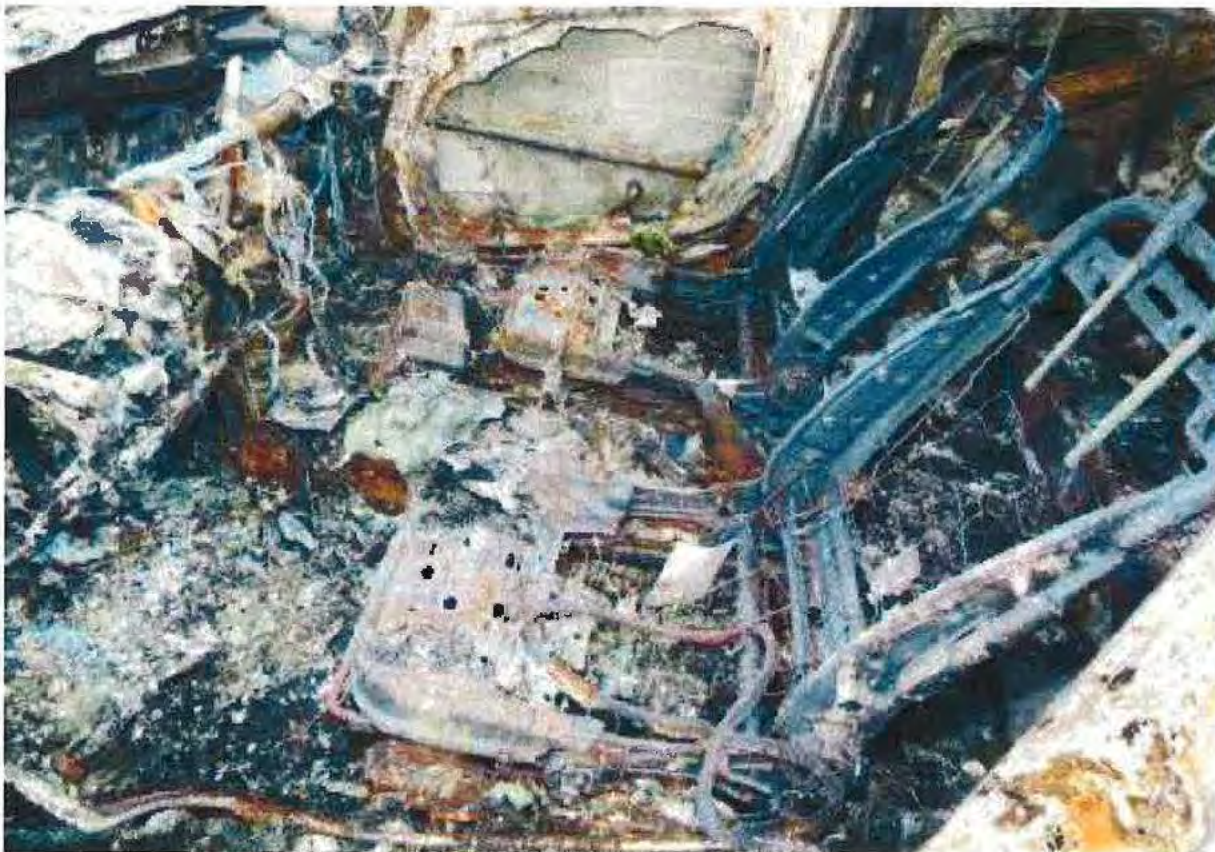
**Photo Information**

16. The front seating area. Extensive degradation of the seats as well as the adjacent door panels and overhead did occur during the course of the fire.

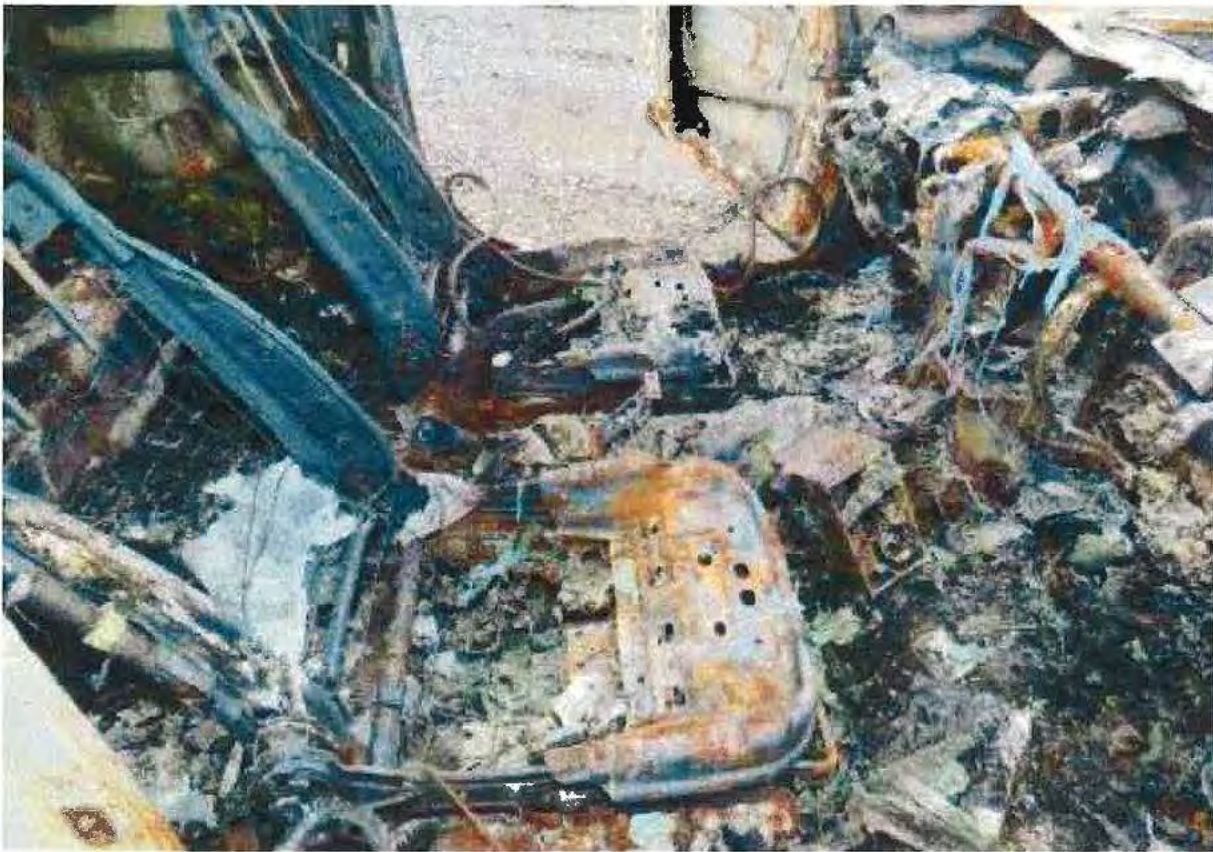
***Photo Information***

17. Additional view of the front seating area. Although extensively degraded, there is no evidence of the fires inception at the seat or floorboard area.

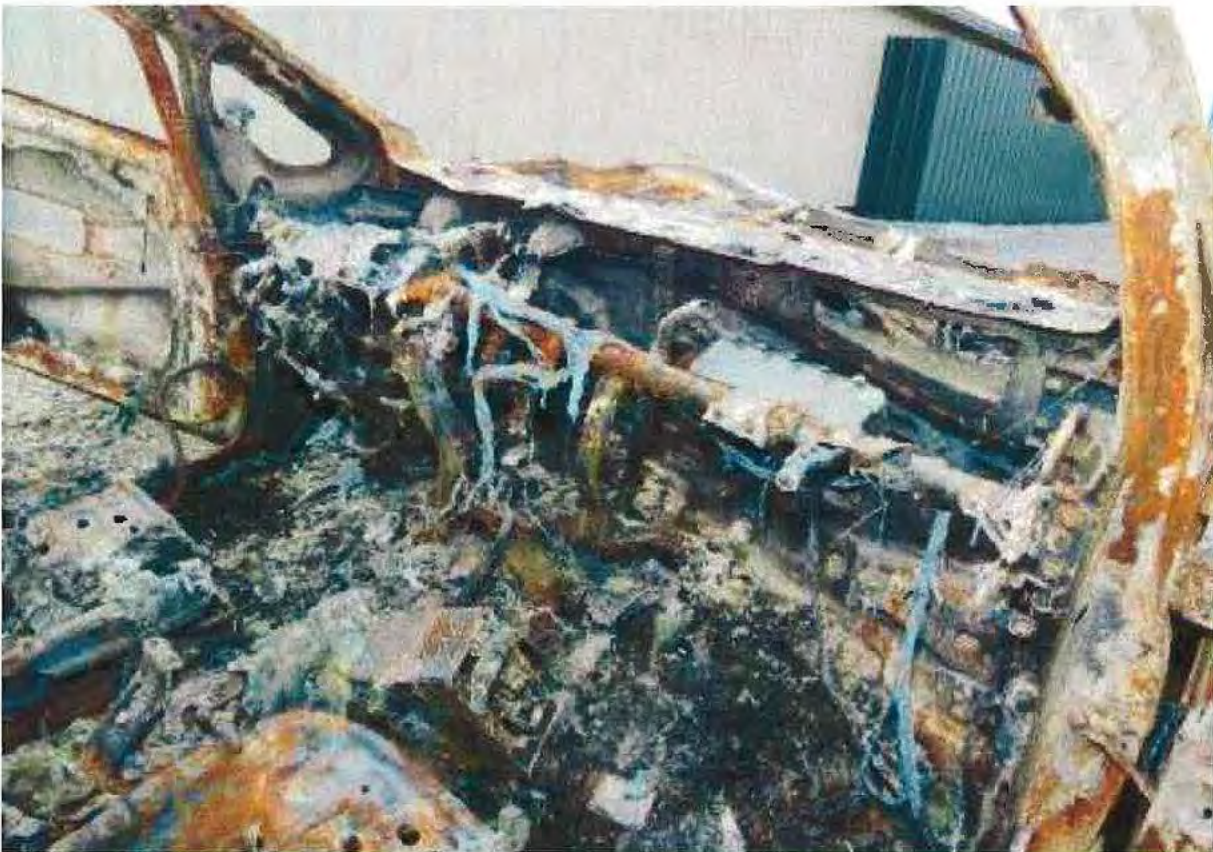
***Photo Information***

18. The dash. All components were found to have been in their appropriate locations at the time the fire occurred.

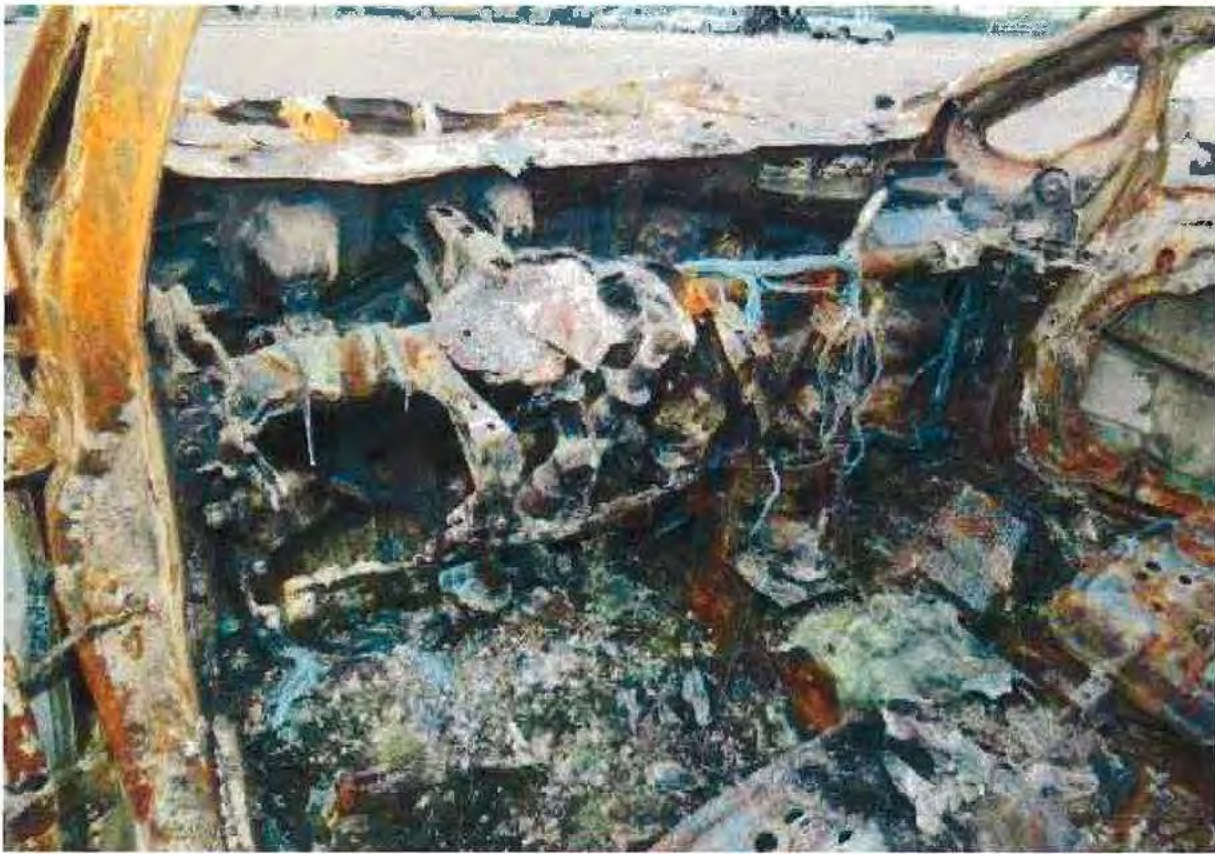
19. Additional view of the dash showing the remains of the instrument cluster at the driver side. The fire did begin within the interior dash at the driver side.

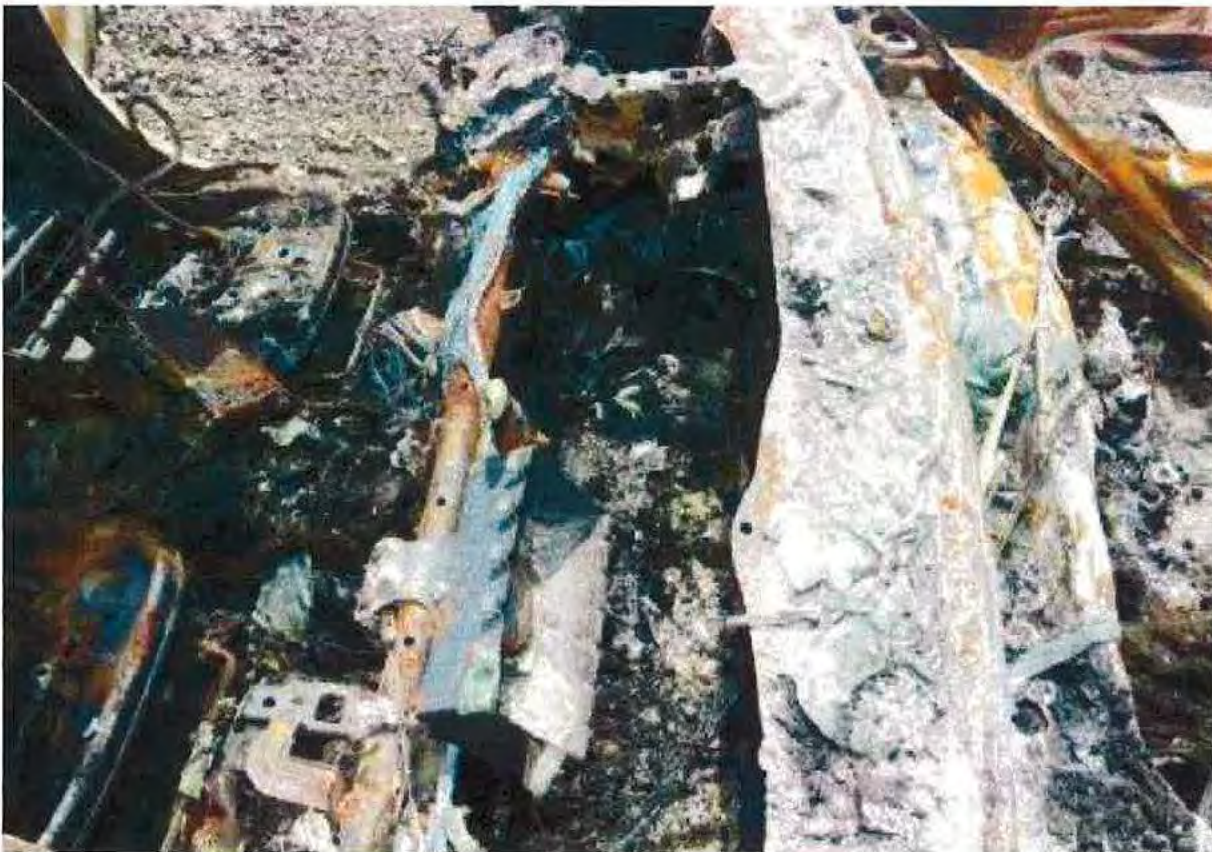
**Photo Information**

20. Additional view of the dash showing the dash frame and adjacent components and assemblies. Again, all components were found to have been in their appropriate location at the time the fire occurred.

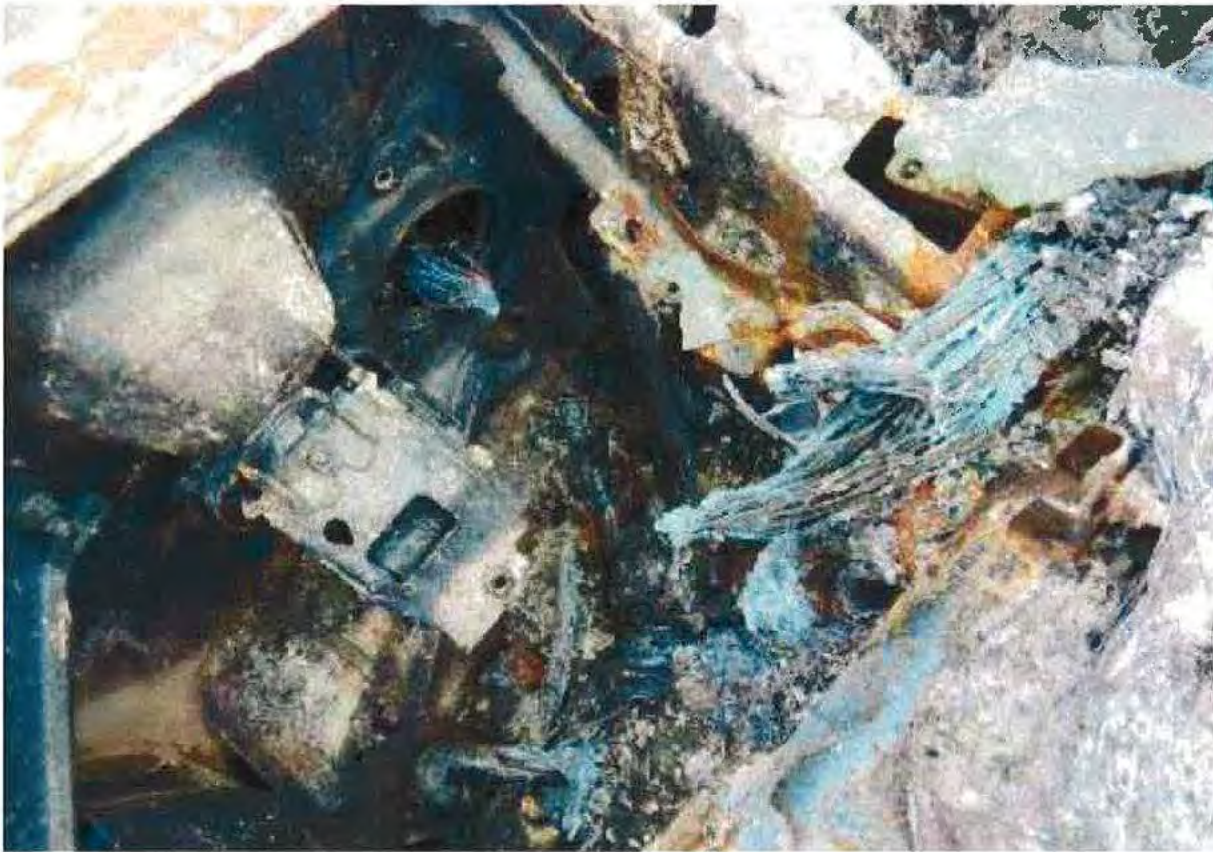
21. Close up view of the driver side dash showing the remains of the wiring harness conductors. There is evidence of localized shorting and arcing at the driver side interior dash area.

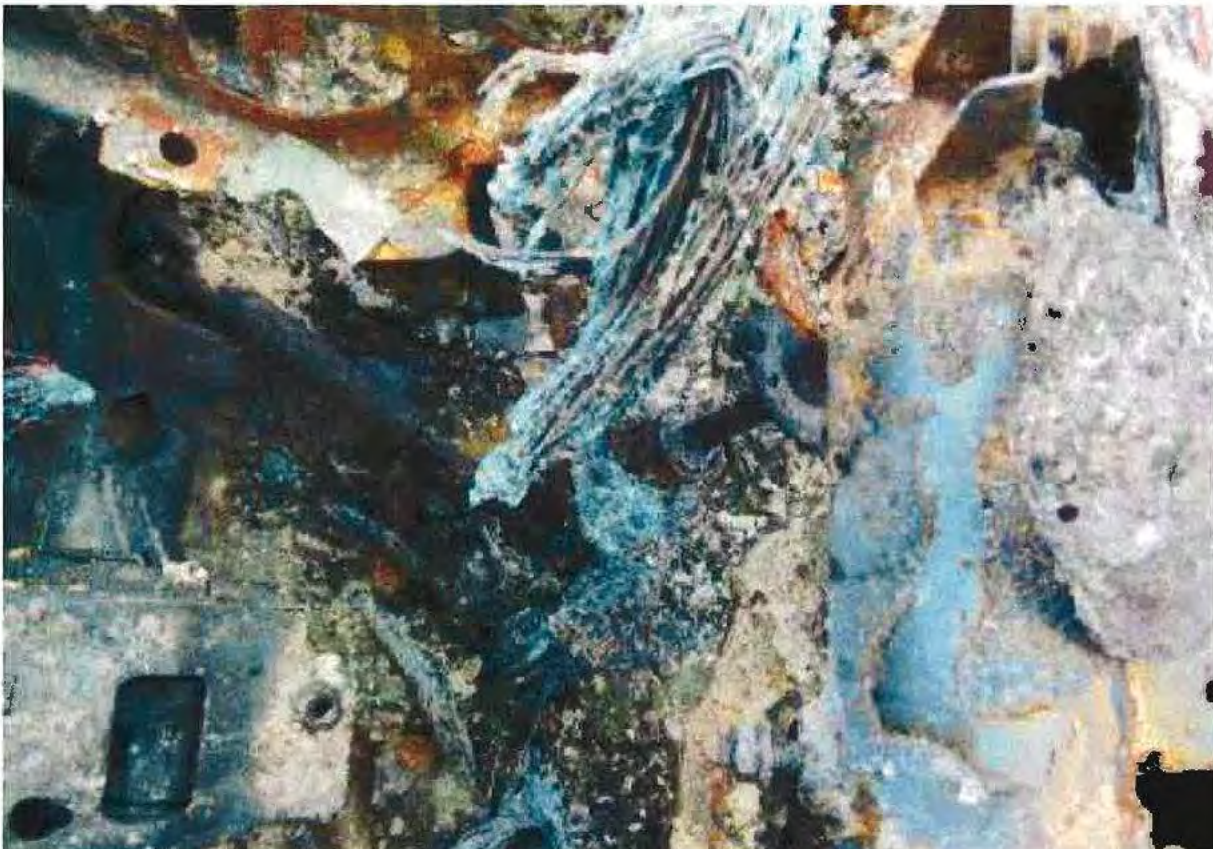
22. Close up view of the wiring conductors again showing evidence of shorting, arcing and melting. A failure of the conductors for unknown reasons is the most probable cause of the fire.

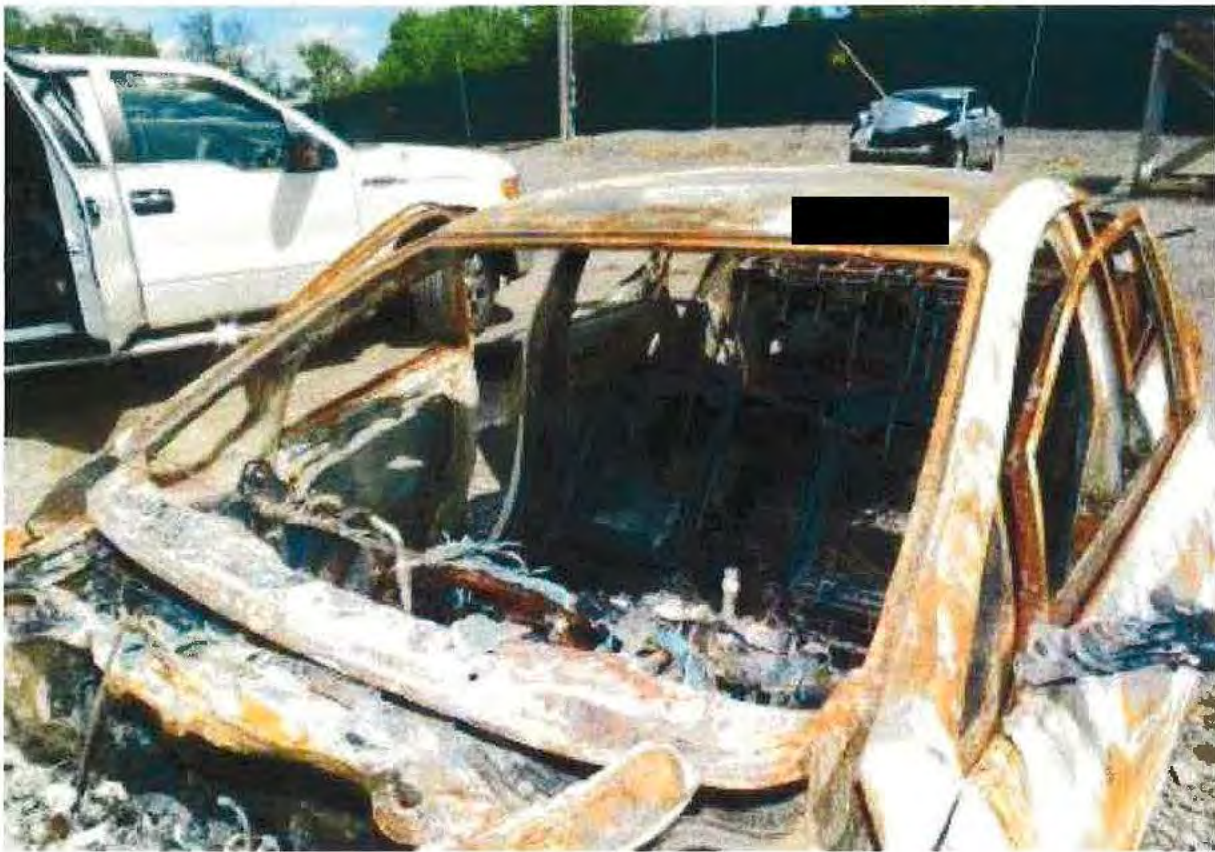
23. The windshield frame. The oxidation and demarcation patterns further demonstrate the fires development within the interior dash at the driver side.

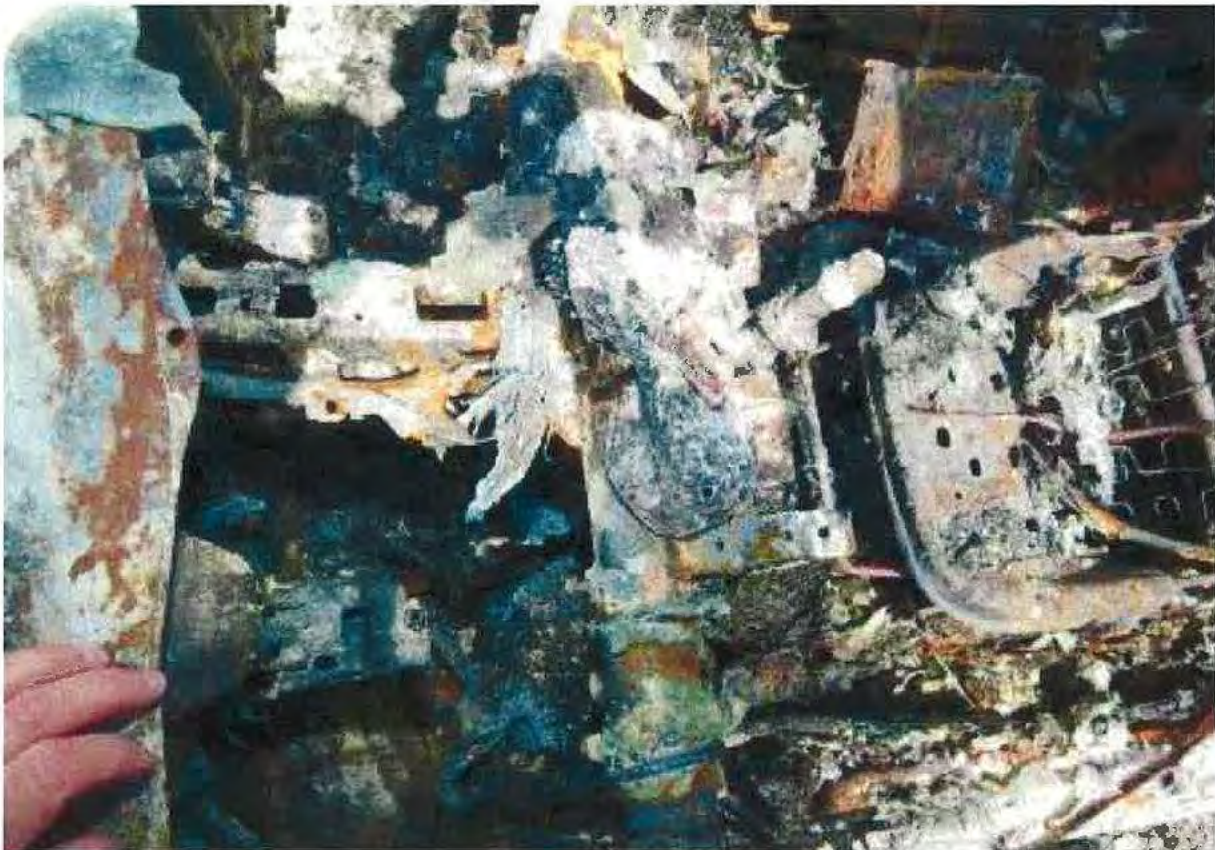
24. Additional close up view of the area of origin at the driver side dash. The oxidation, demarcation and burn patterns do demonstrate the fires development at the interior [redacted] the location of the wiring harness conductors and/or adjacent components.

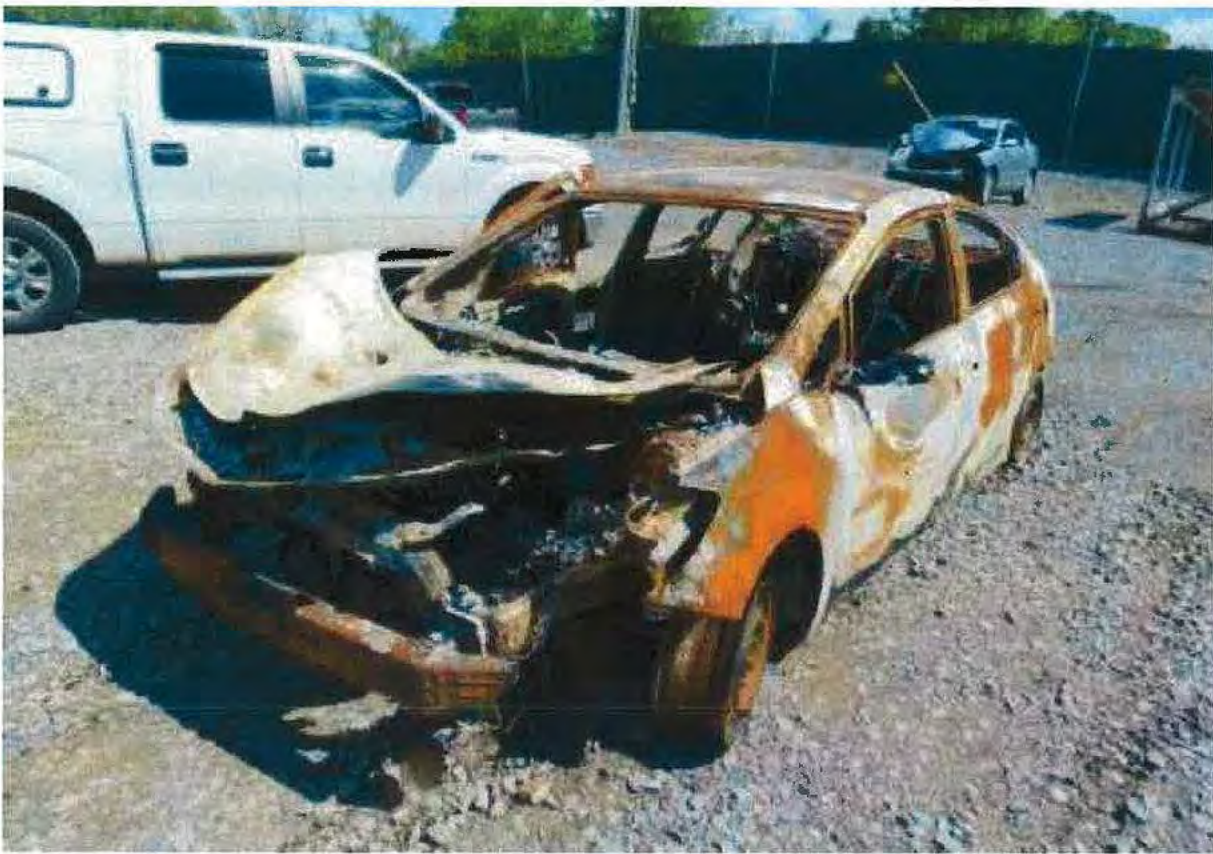
***Photo Information***

1. Front and driver side of the vehicle.

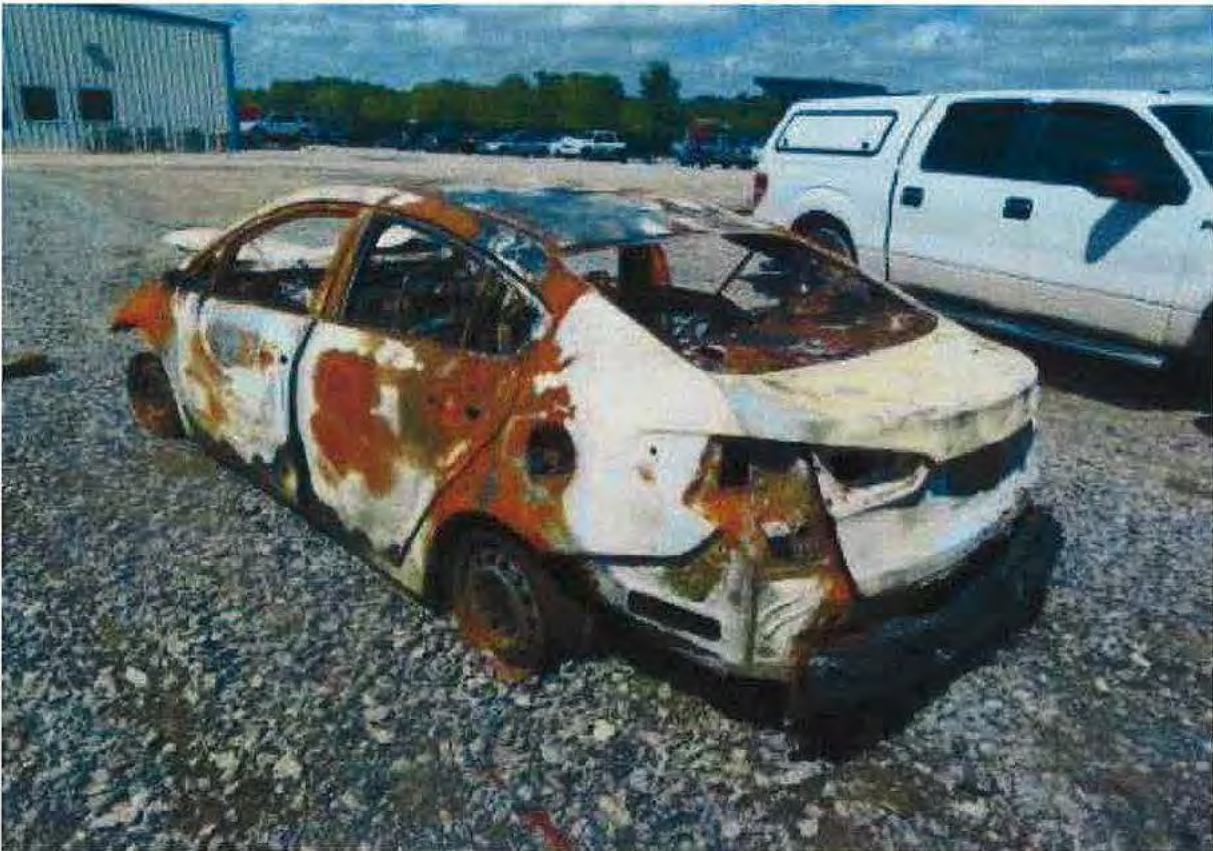
***Photo Information***

2. Rear and driver side of the vehicle.

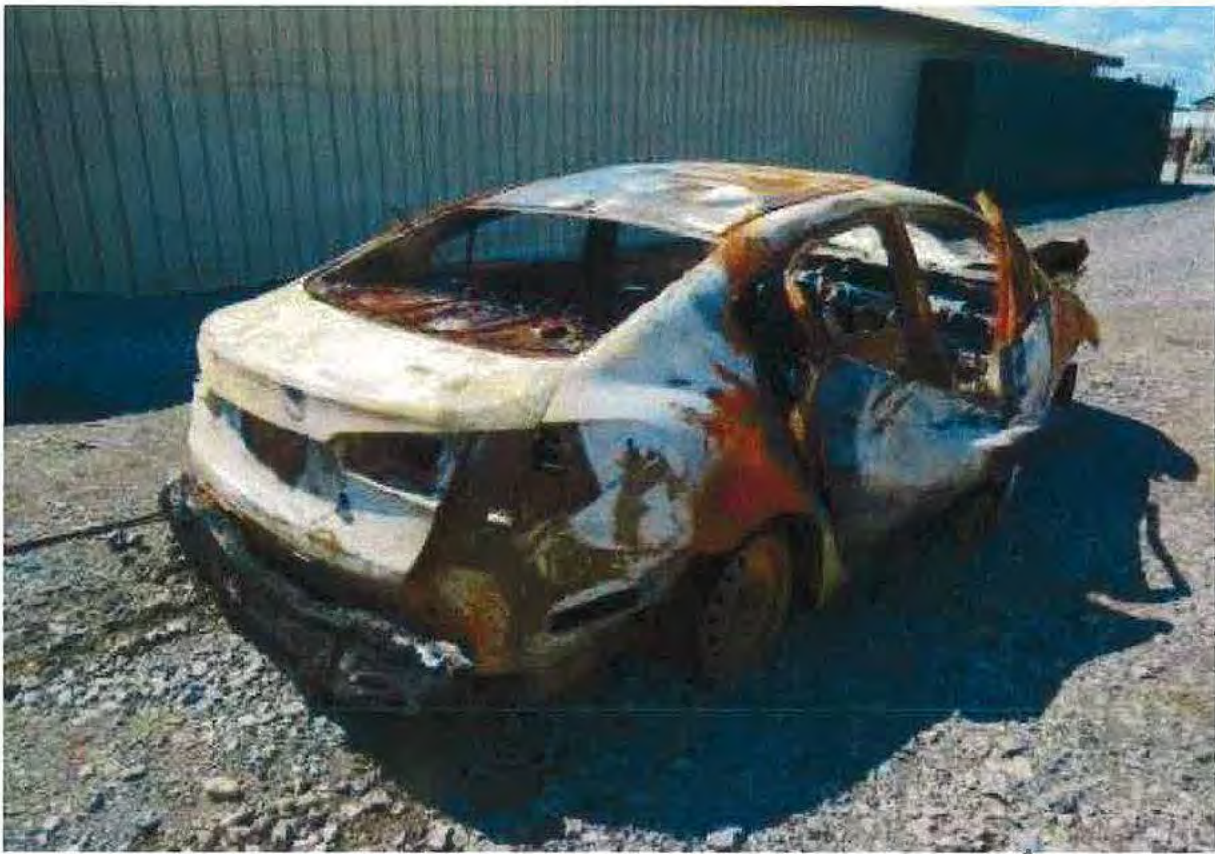
**Photo Information**

3. Rear and passenger side of the vehicle.

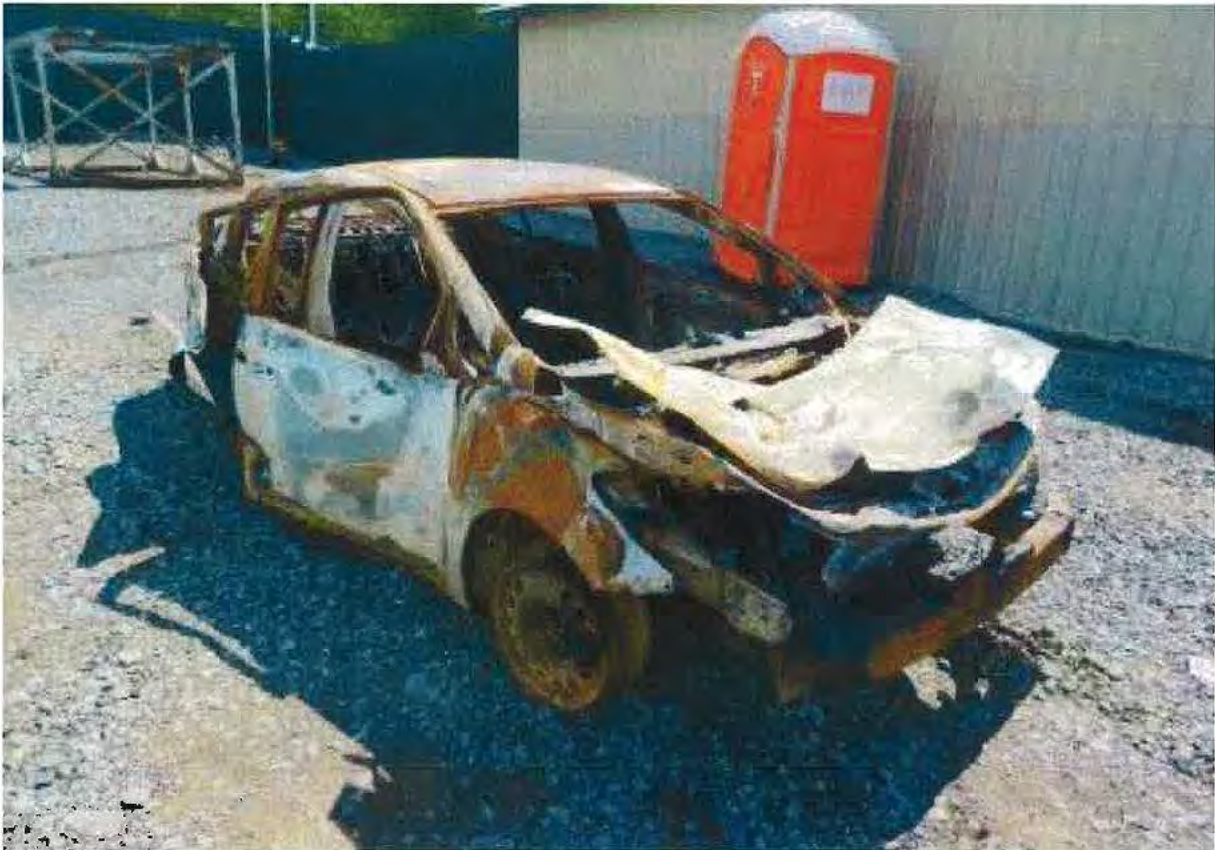
**Photo Information**

4. Front and passenger side of the vehicle. Note that extensive degradation of the vehicle did occur during the course of the fire.

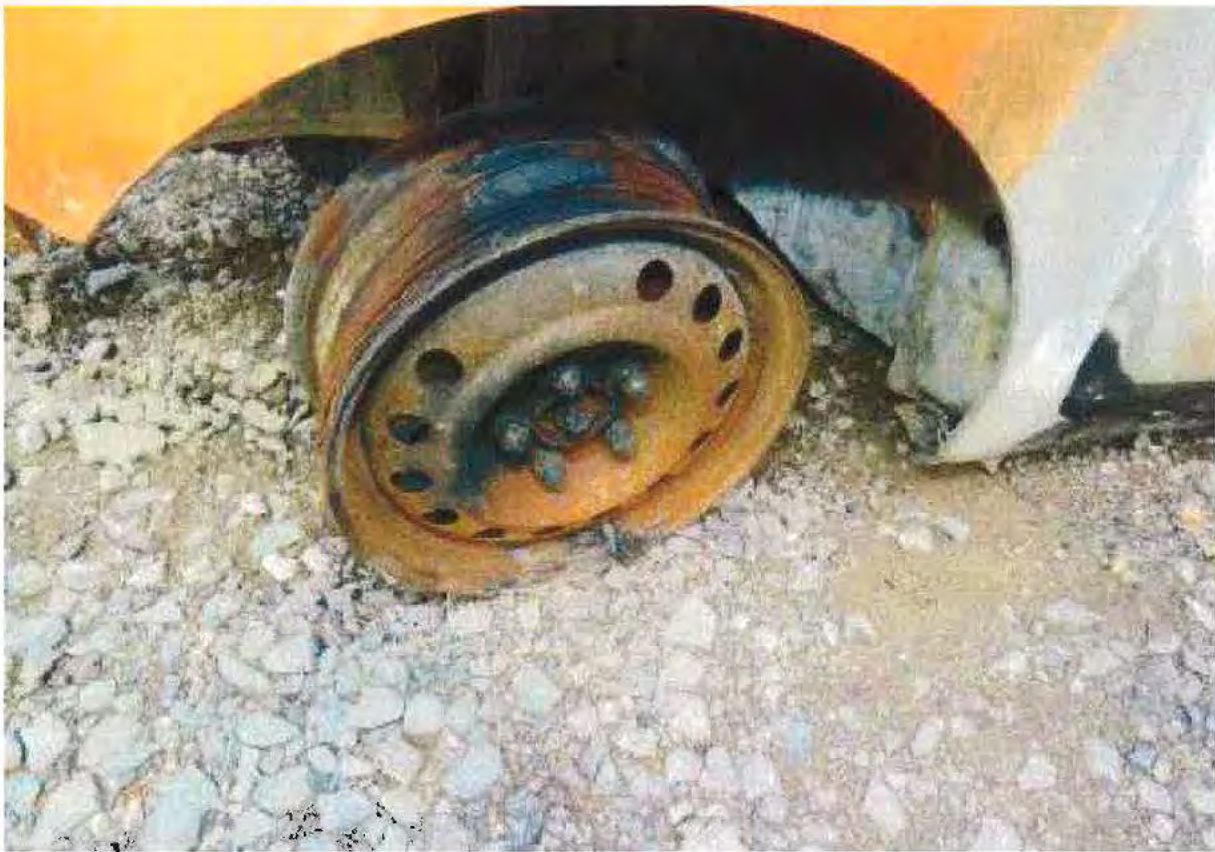
**Photo Information**

5. The left front wheel showing design.

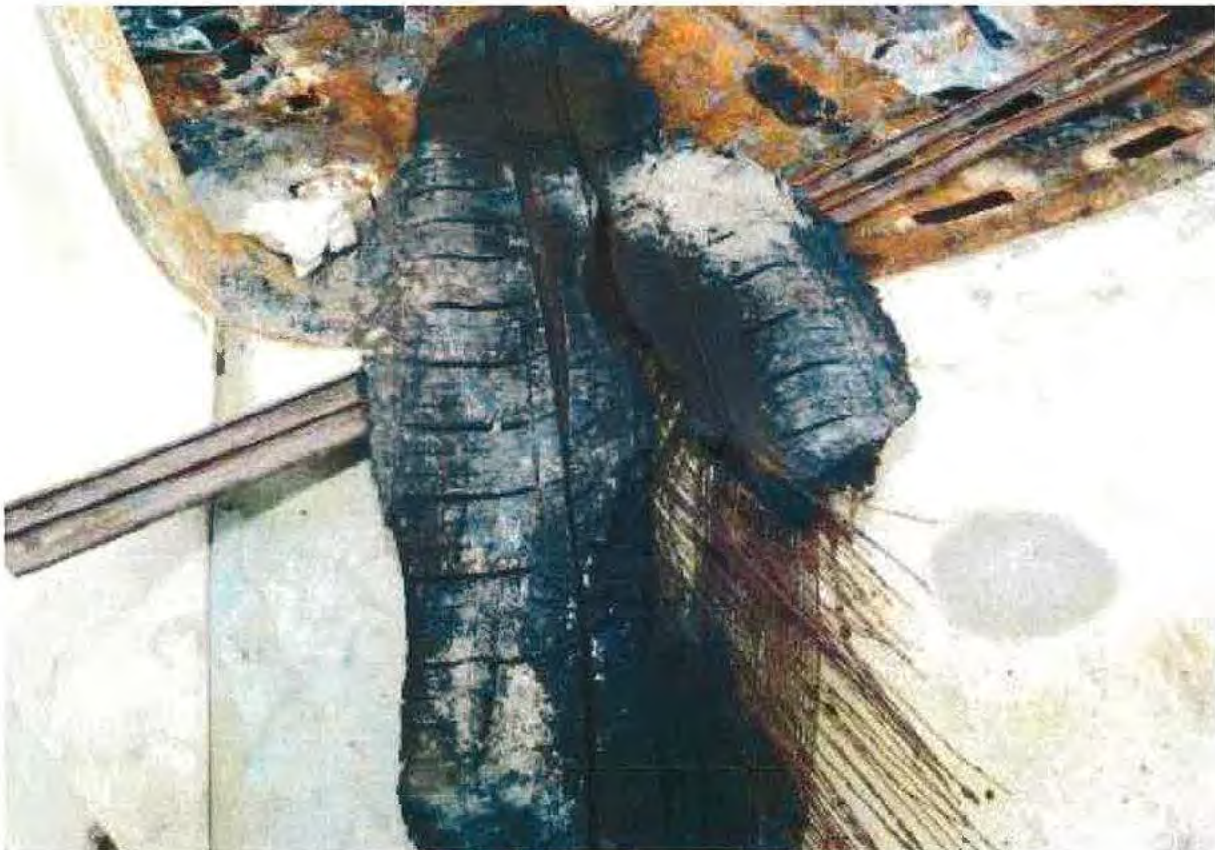
**Photo Information**

6. The tire pad showing tread design and condition.

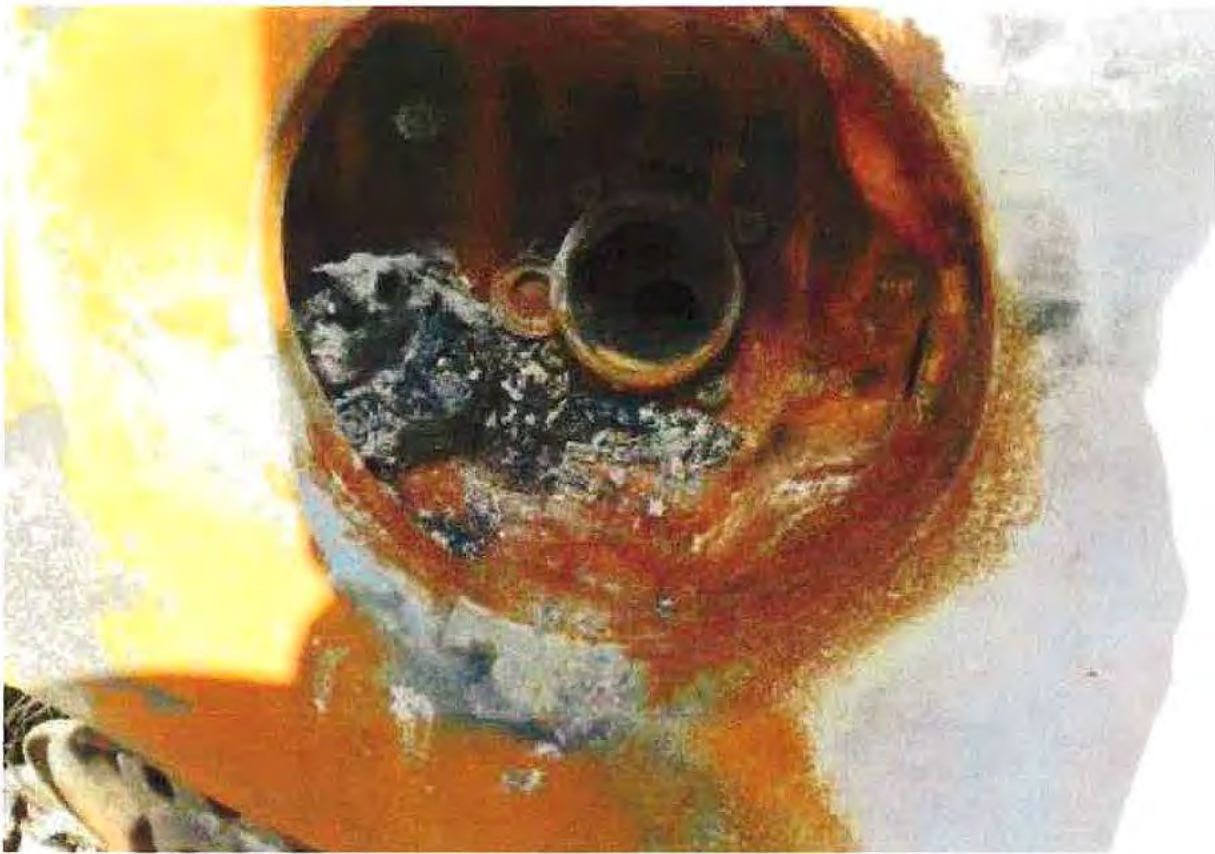
**Photo Information**

7. The fuel filler neck. The cap was in place at the time of the fire.

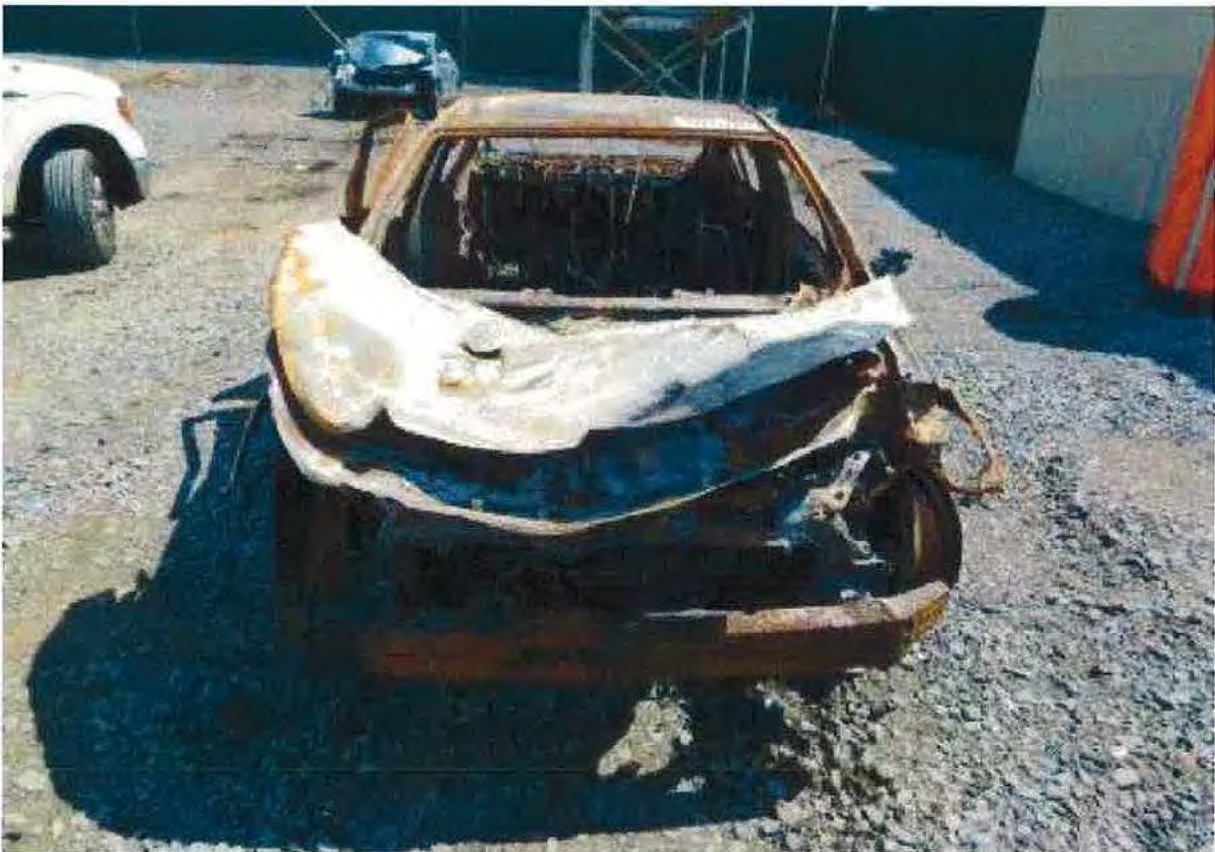
**Photo Information**

8. Overview of the hood and front grill area. The hood was down and latched at the inception of the fire.

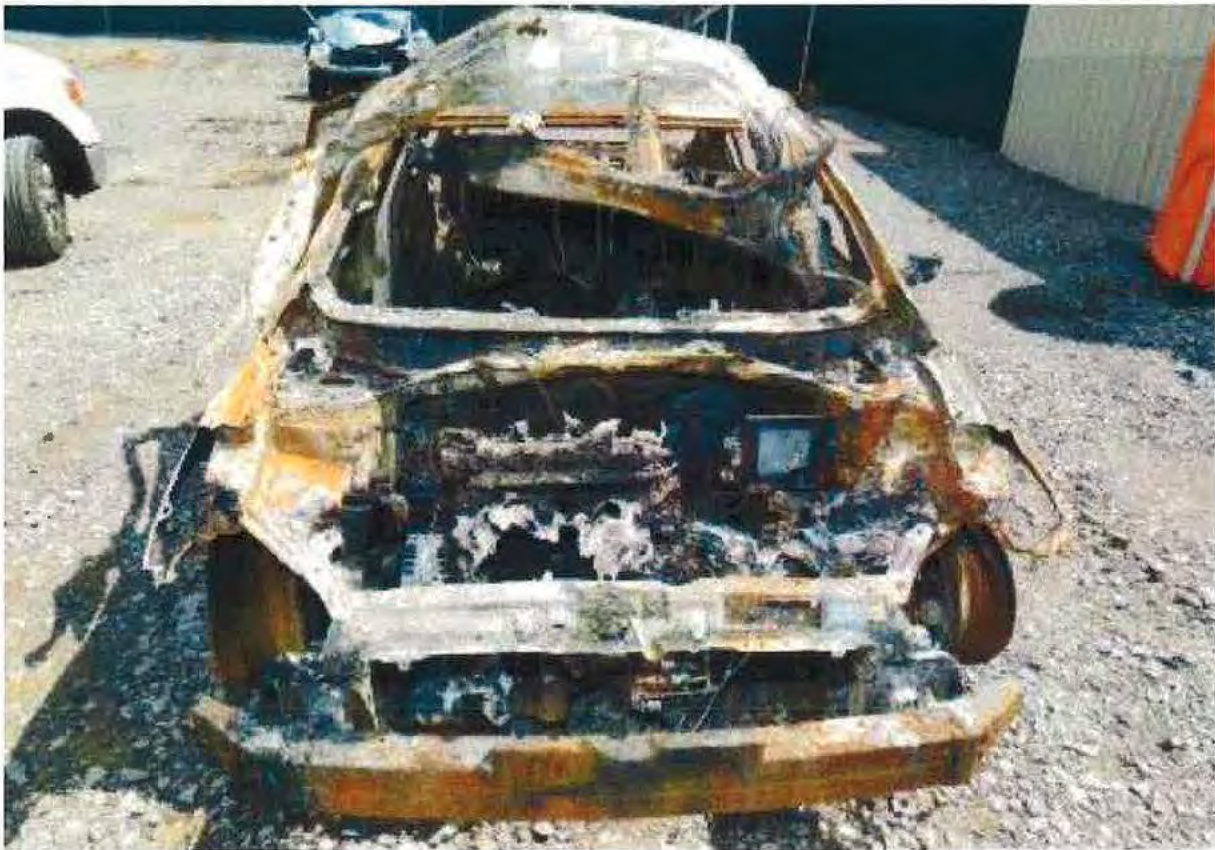
**Photo Information**

9. Overview of the motor compartment following removal of the hood. All components were found in their appropriate locations.
