# Consumer Assistance Center Case Report

**Title:** Dlr opened Service Alert Escalation because brakes locking up, dlr CND.

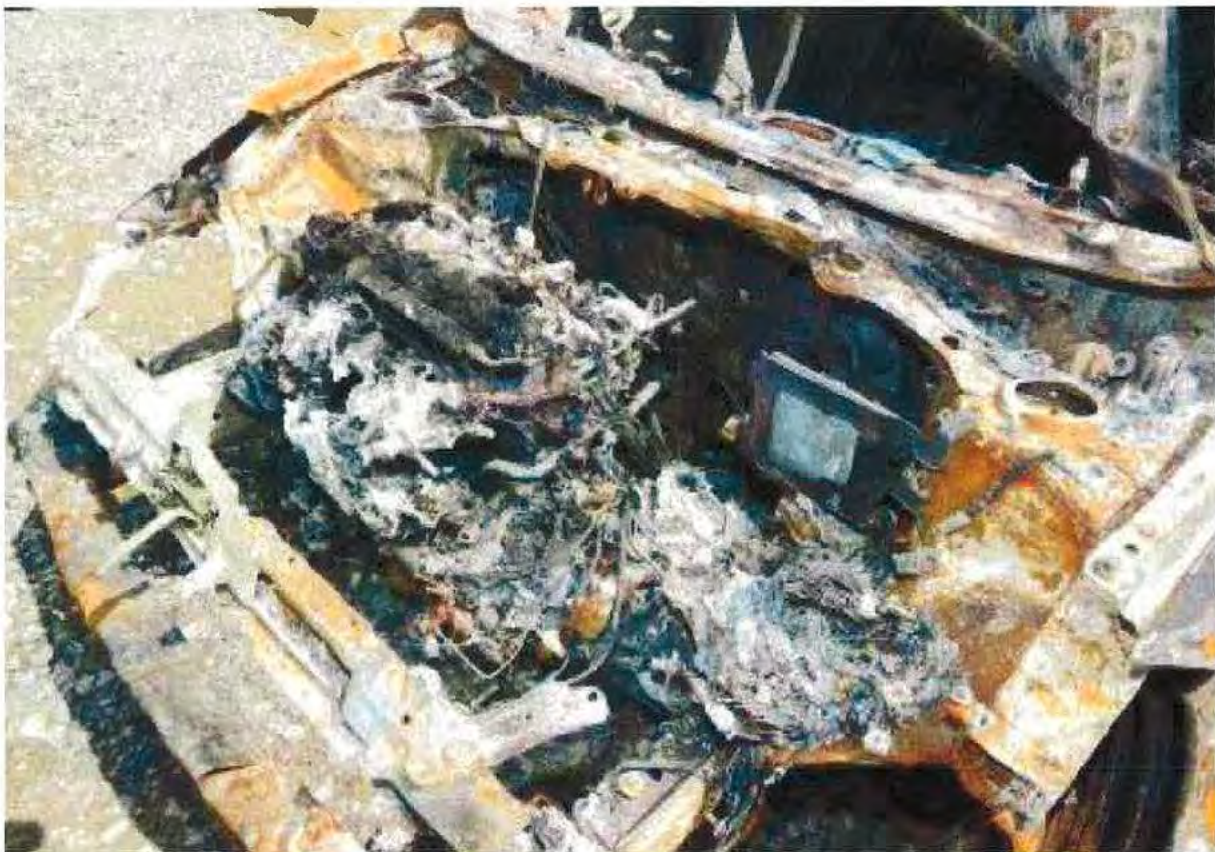
10. The driver side of the motor compartment. The damage configuration demonstrates the fire's movement from the passenger compartment through the firewall/bulkhead into the motor compartment.

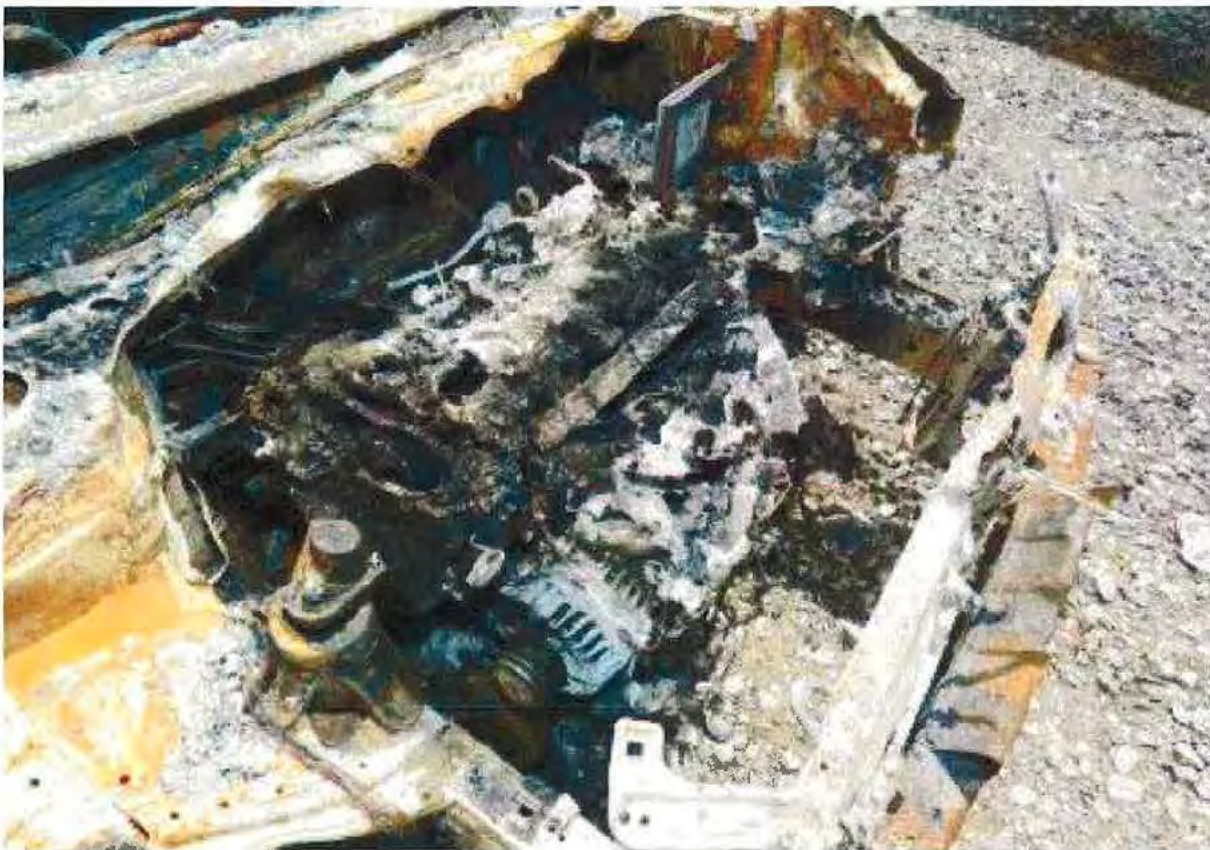
11. The passenger side of the motor compartment. There is no evidence of the fires initial inception within the motor compartment area.

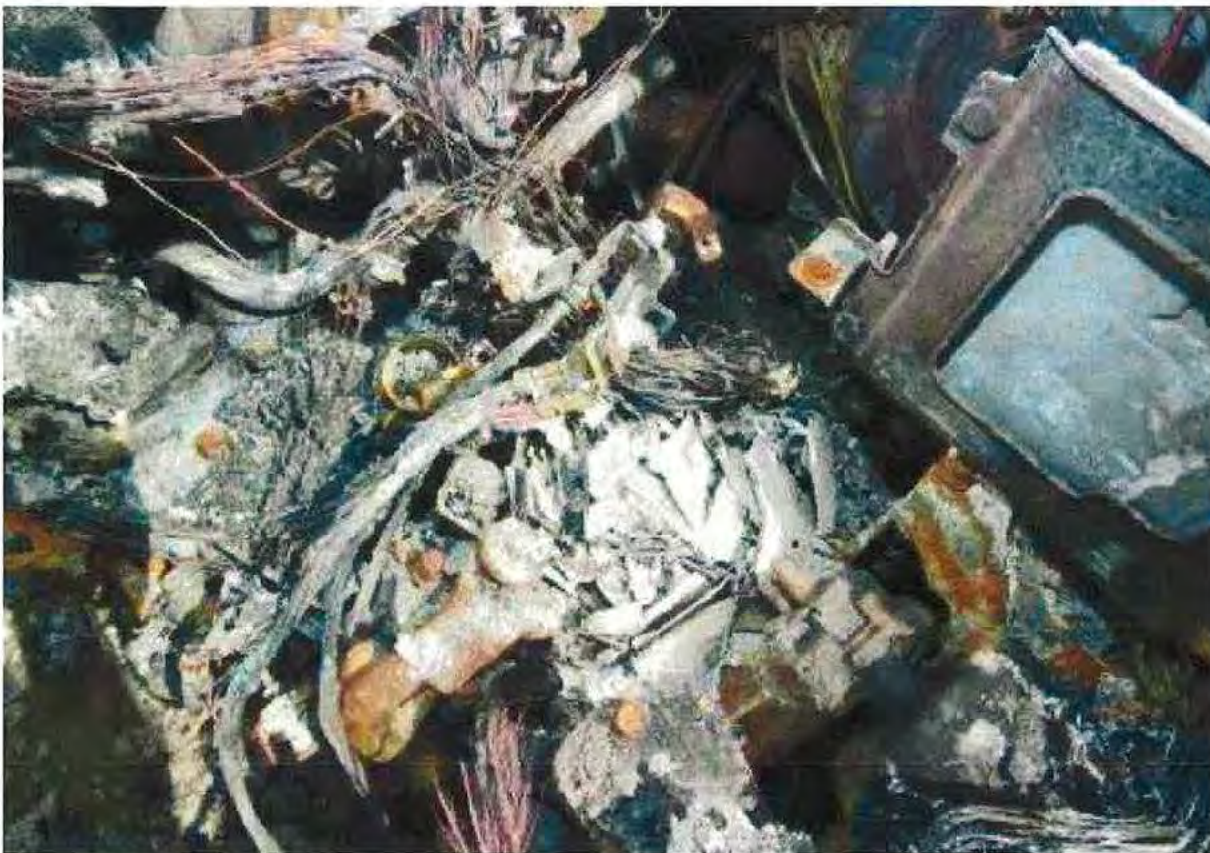
12. The remains of the battery and primary electrical wiring showing extensive damage due to heat and flame impingement. There is however no evidence of the fires inception at the battery location.

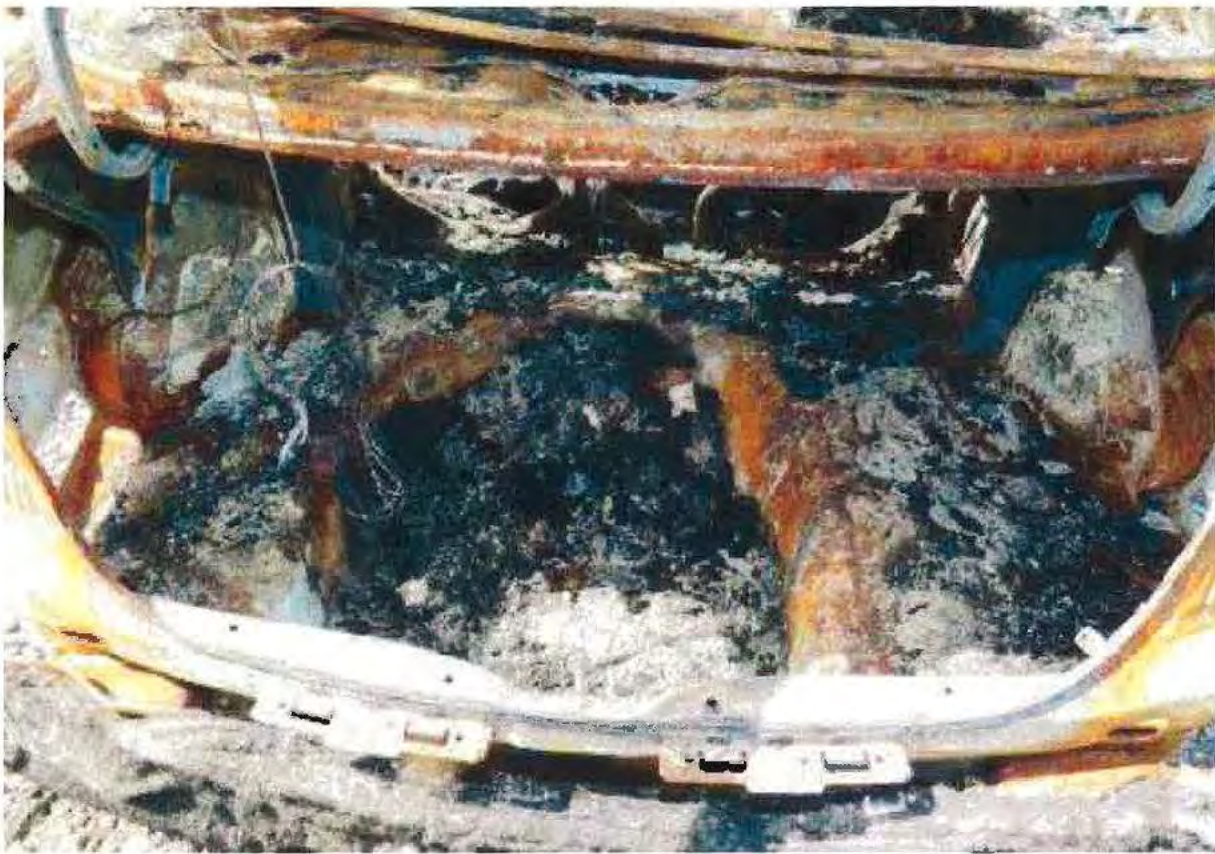
**Photo Information**

13. The trunk storage compartment showing extensive degradation. The spare tire was not found at its mounting location.

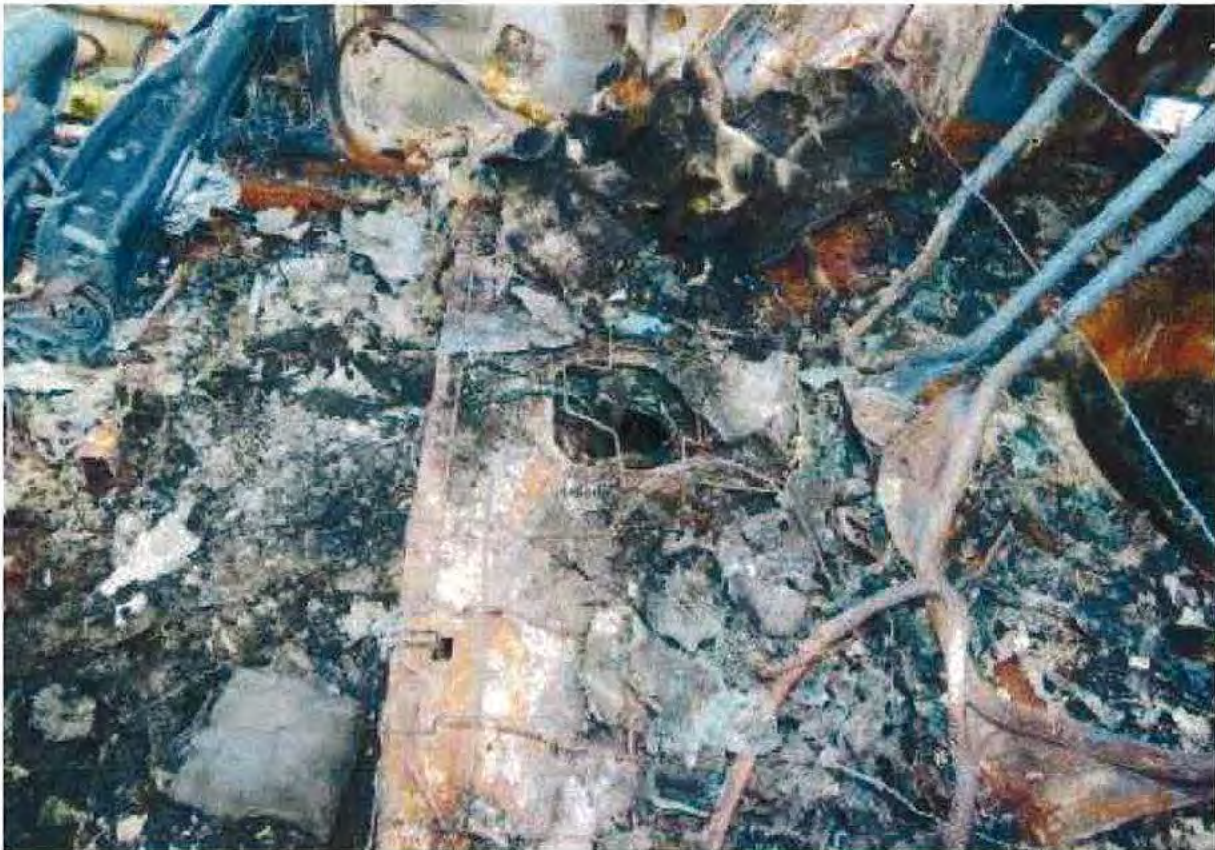
**Photo Information**

14. The back seating area showing extensive degradation of the seat assembly.

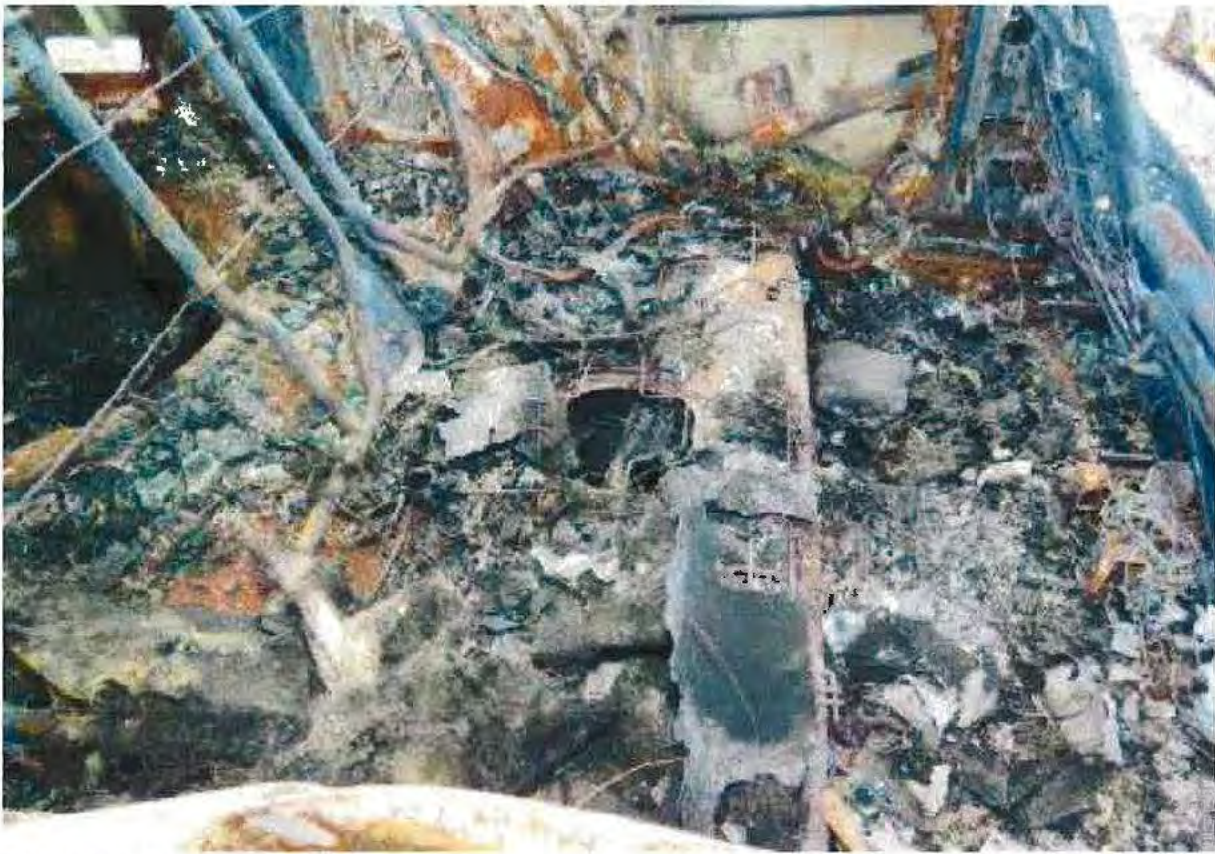
**Photo Information**

15. Additional view of the back seating area again showing extensive degradation of the seats as well as the door panels.

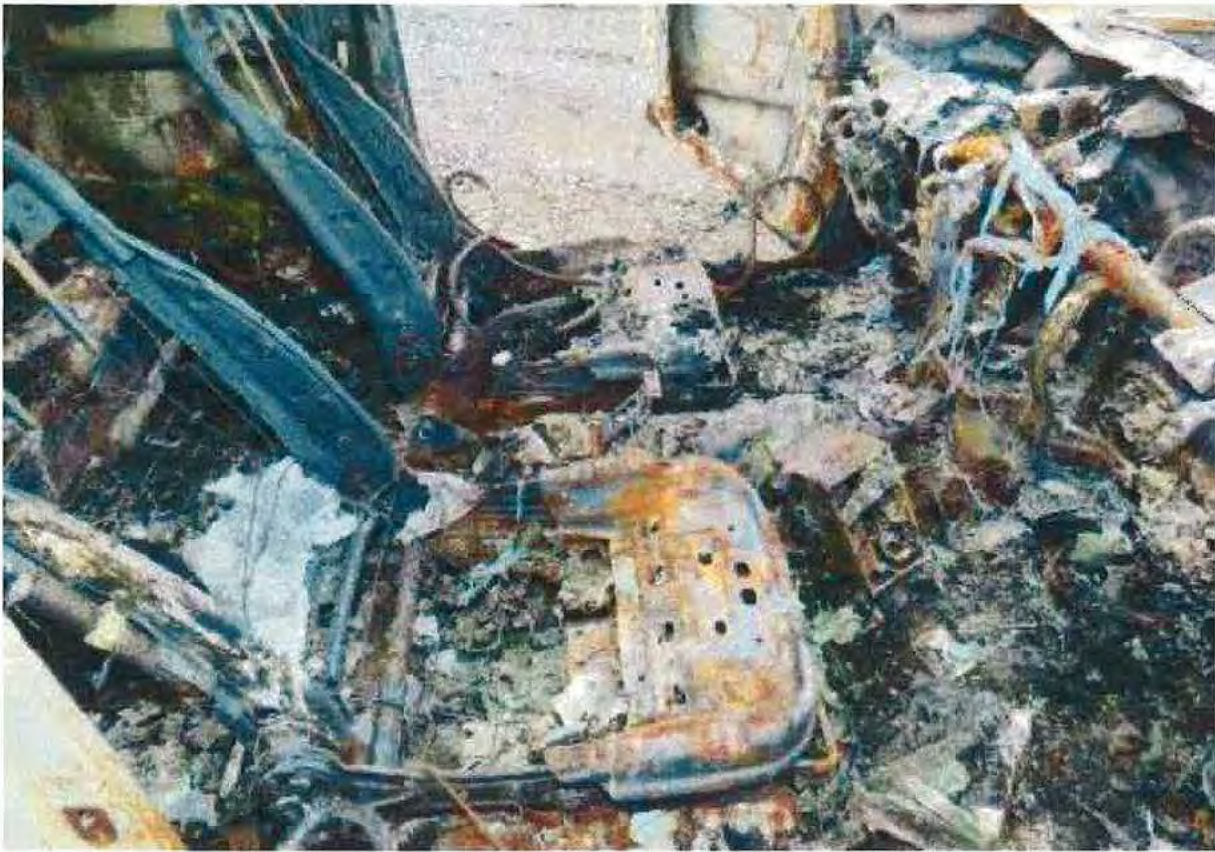
**Photo Information**

16. The front seating area. Extensive degradation of the seats as well as the adjacent panels and overhead did occur during the course of the fire. [REDACTED]

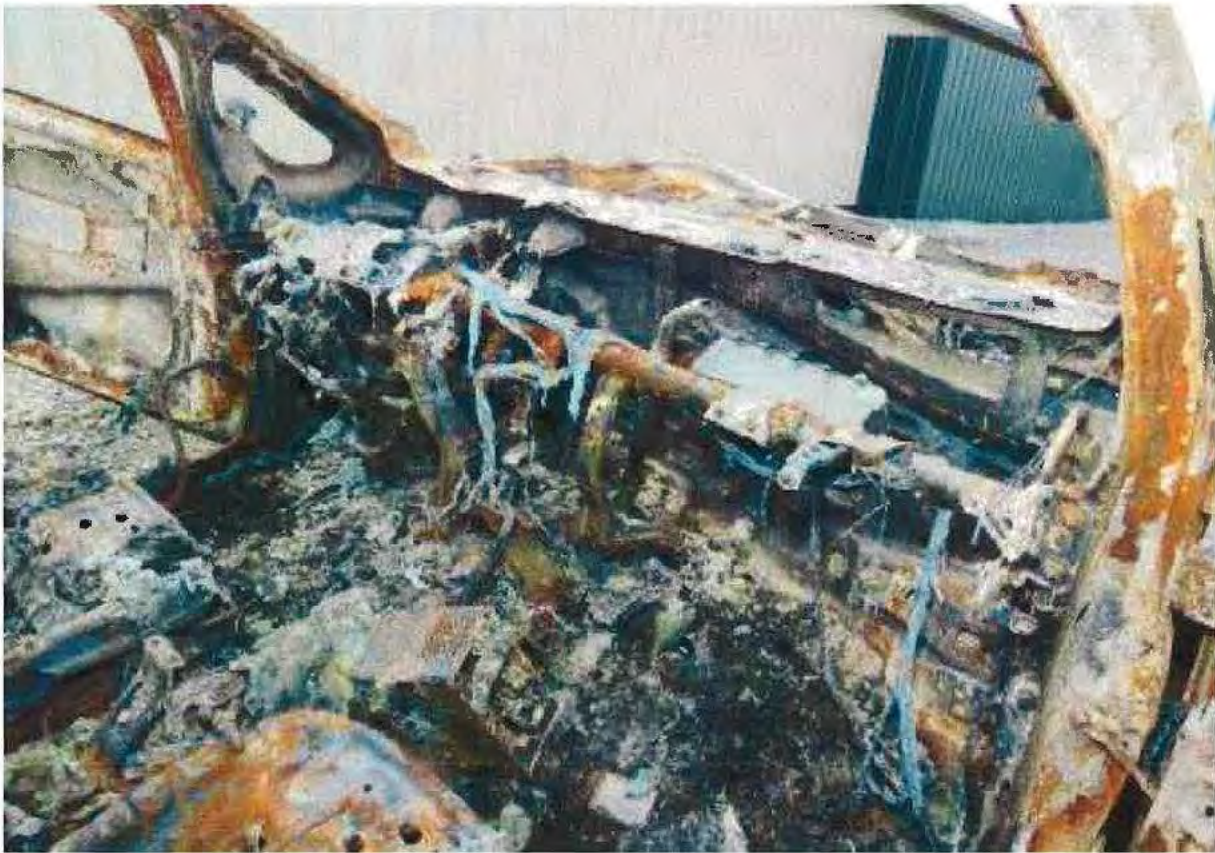
***Photo Information***

17. Additional view of the front seating area. Although extensively degraded, there is no evidence of the fires inception at the seat or floorboard area.

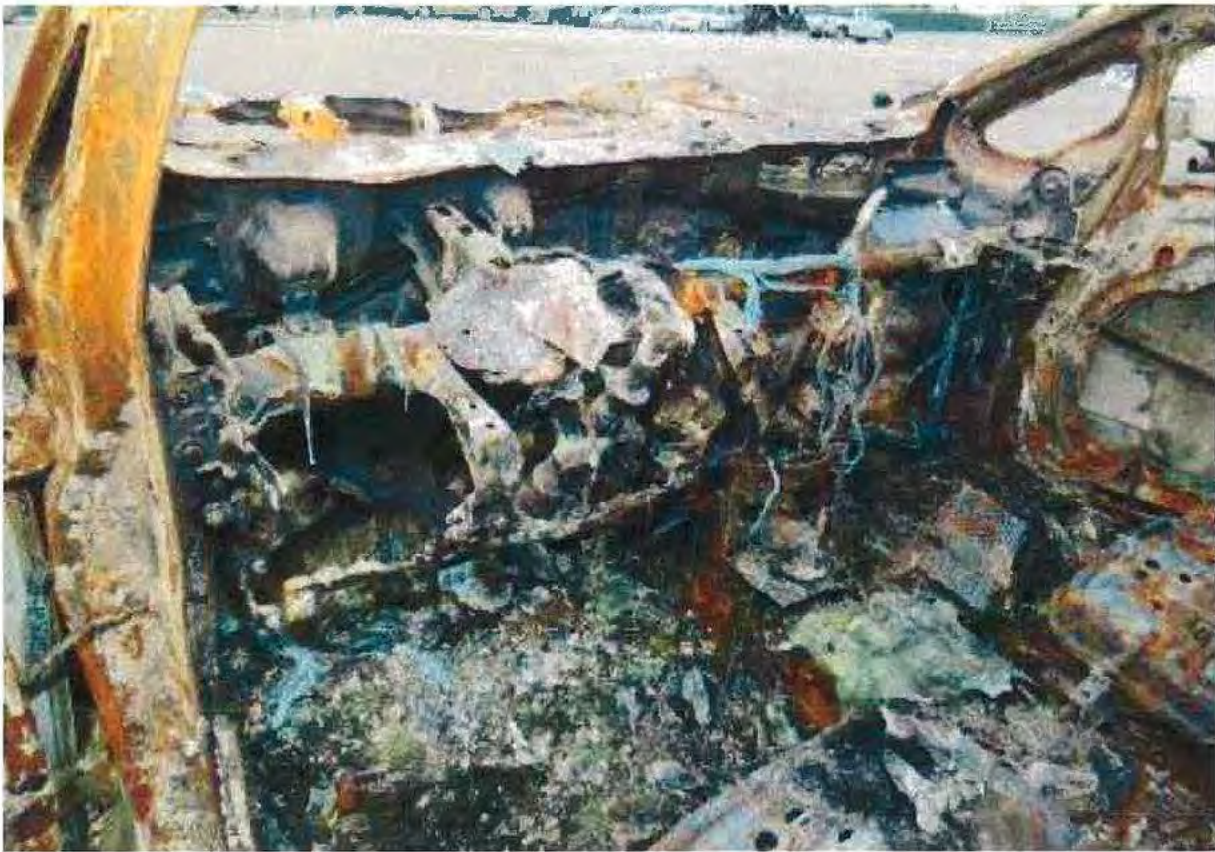
19. Additional view of the dash showing the remains of the instrument cluster at the driver side. The fire did begin within the interior dash at the driver side.

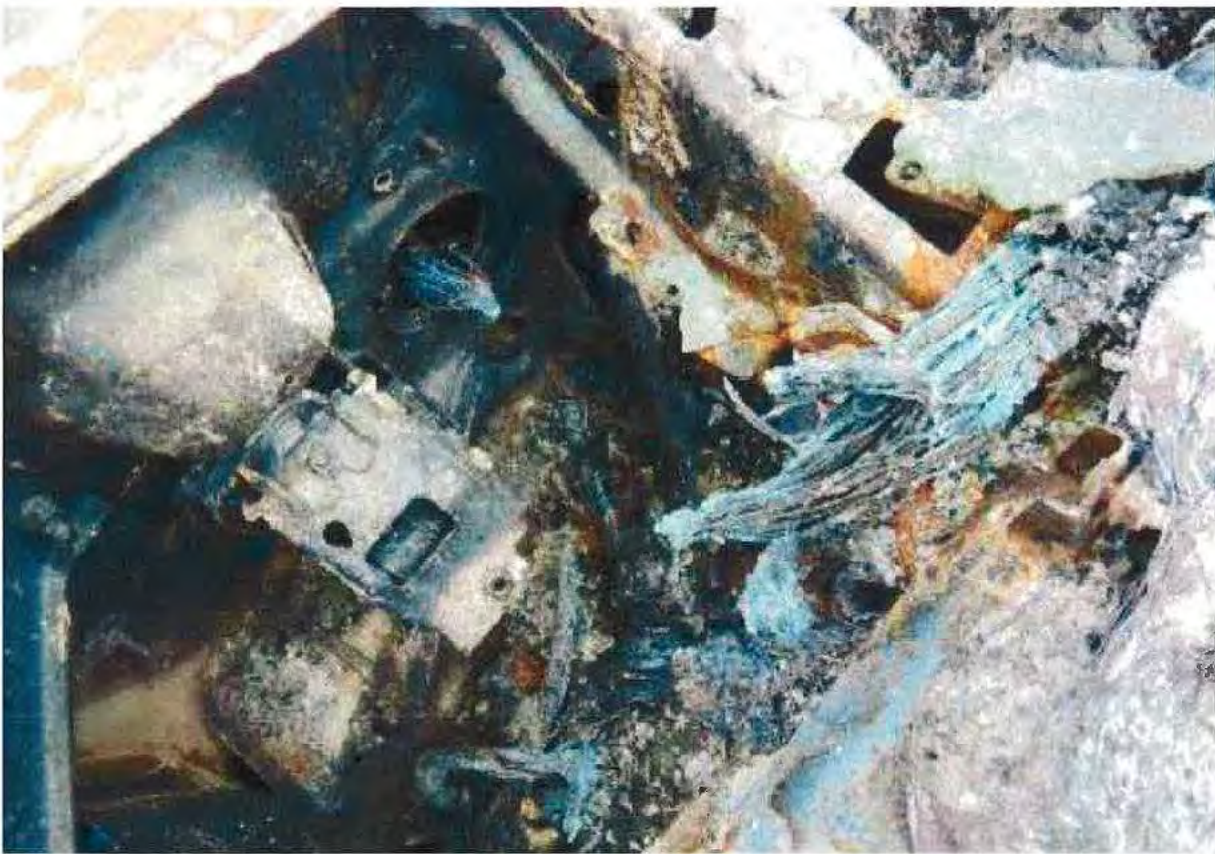
21. Close up view of the driver side dash showing the remains of the wiring harness conductors. There is evidence of localized shorting and arcing at the driver side interior dash area.

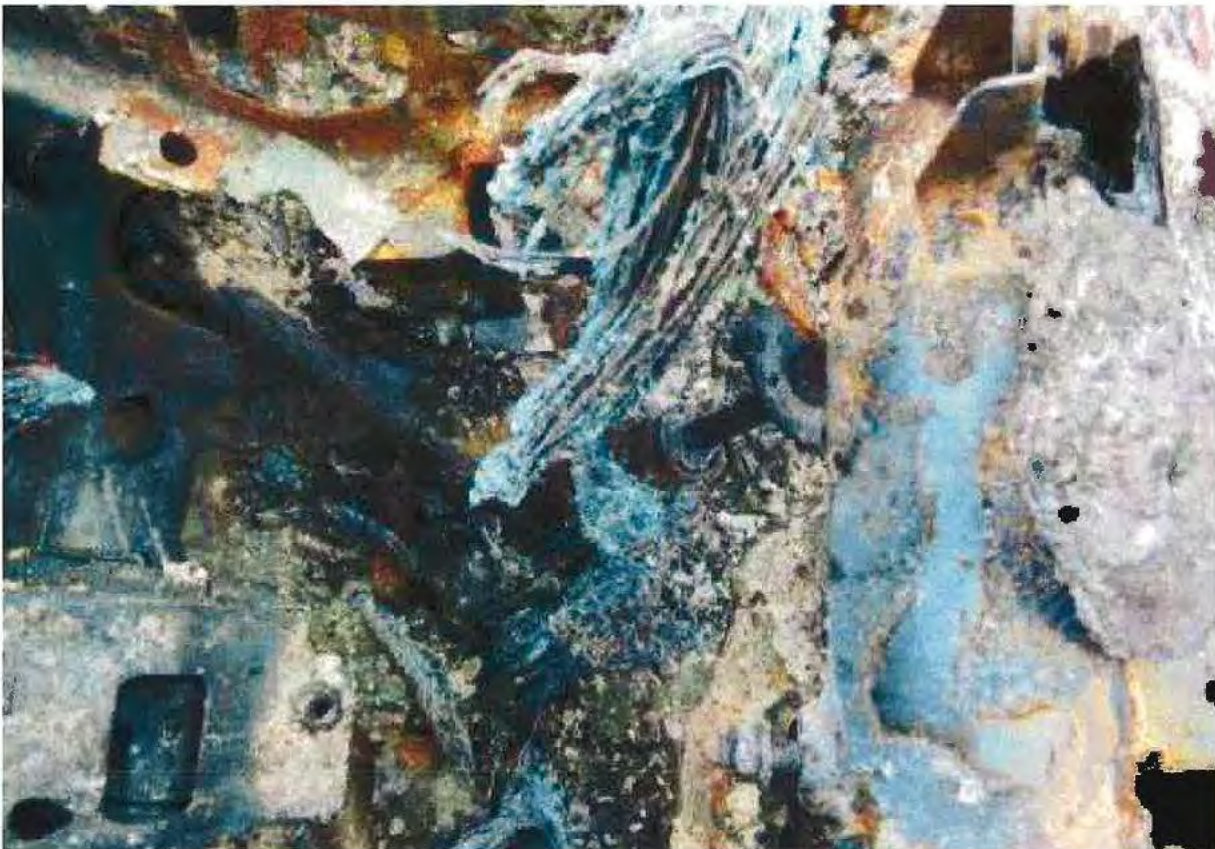
22. Close up view of the wiring conductors again showing evidence of shorting, arcing and melting. A failure of the conductors for unknown reasons is the most probable cause of fire.

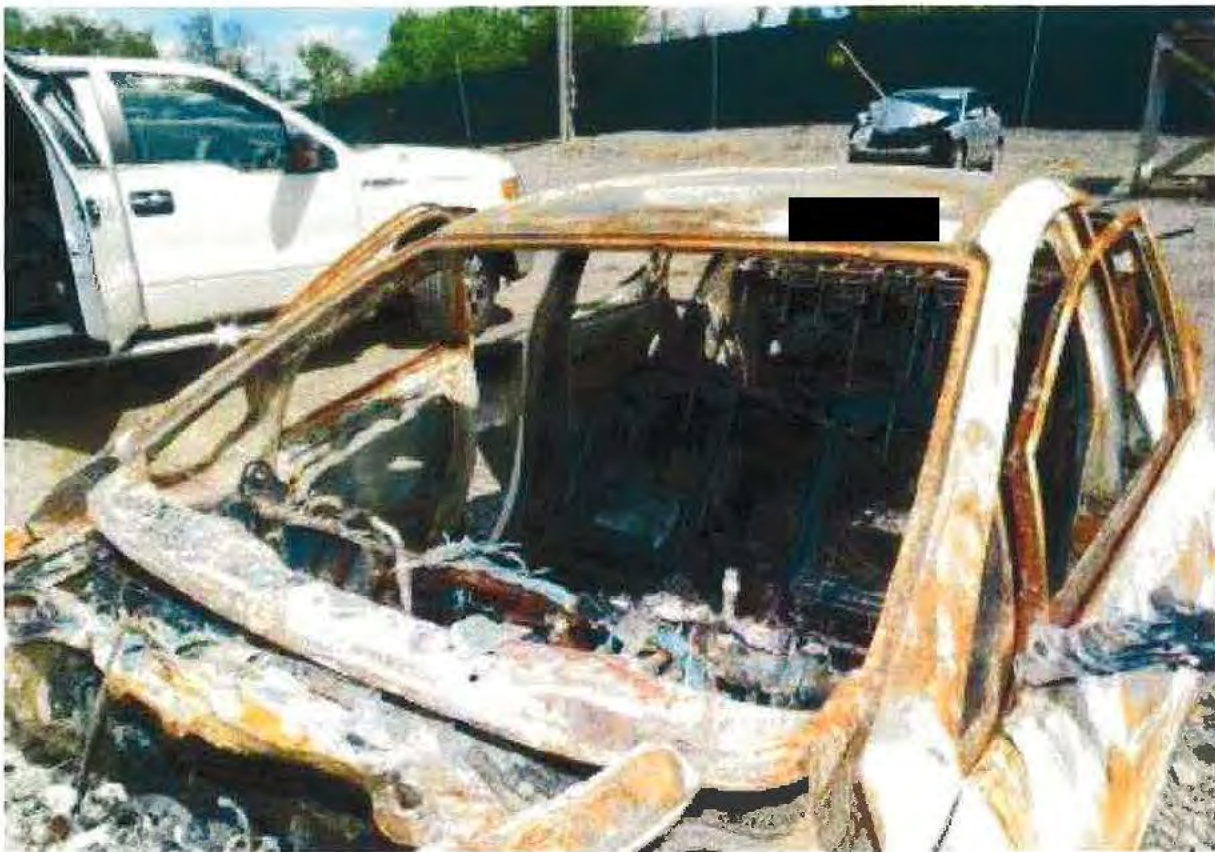
23. The windshield frame. The oxidation and demarcation patterns further demonstrate the fires development within the interior dash at the driver side.

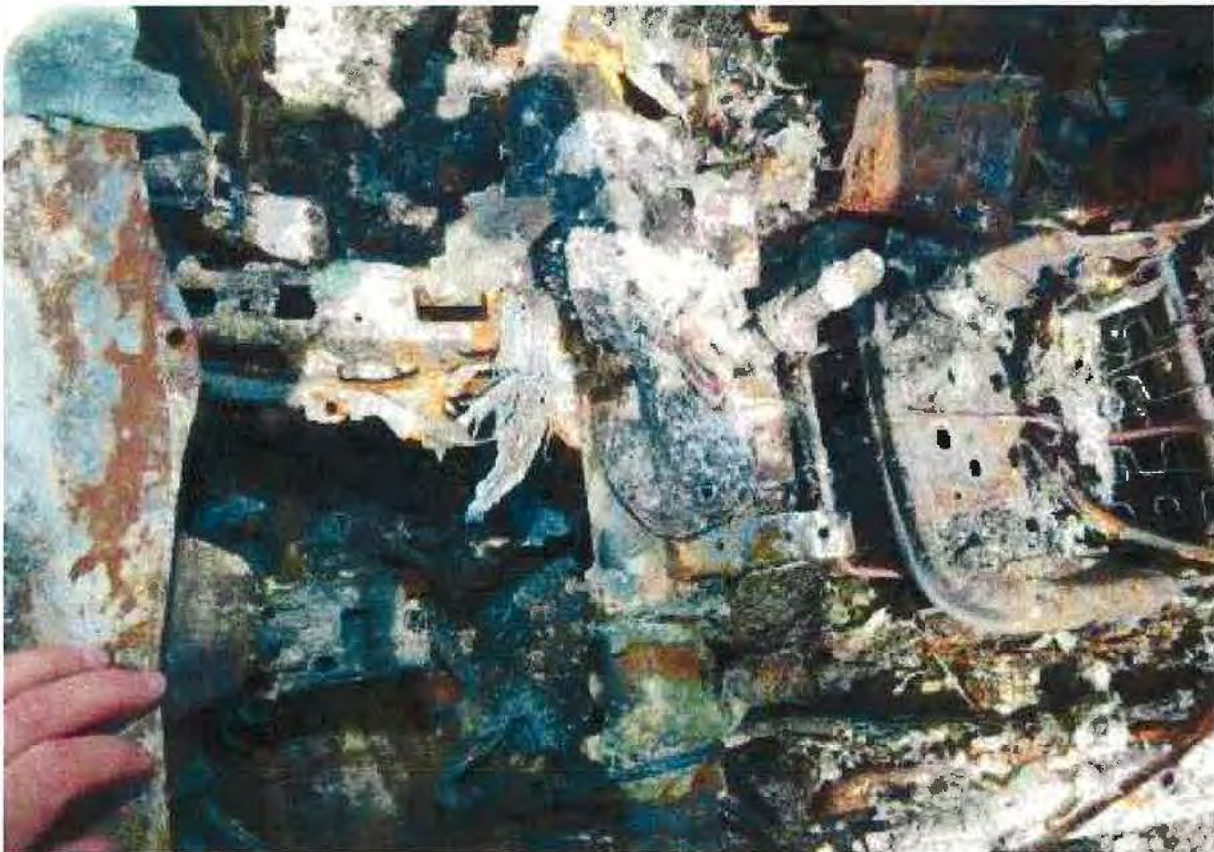
24. Additional close up view of the area of origin at the driver side dash. The oxidation demarcation and burn patterns do demonstrate the fires development at the interior [redacted] the location of the wiring harness conductors and/or adjacent components.

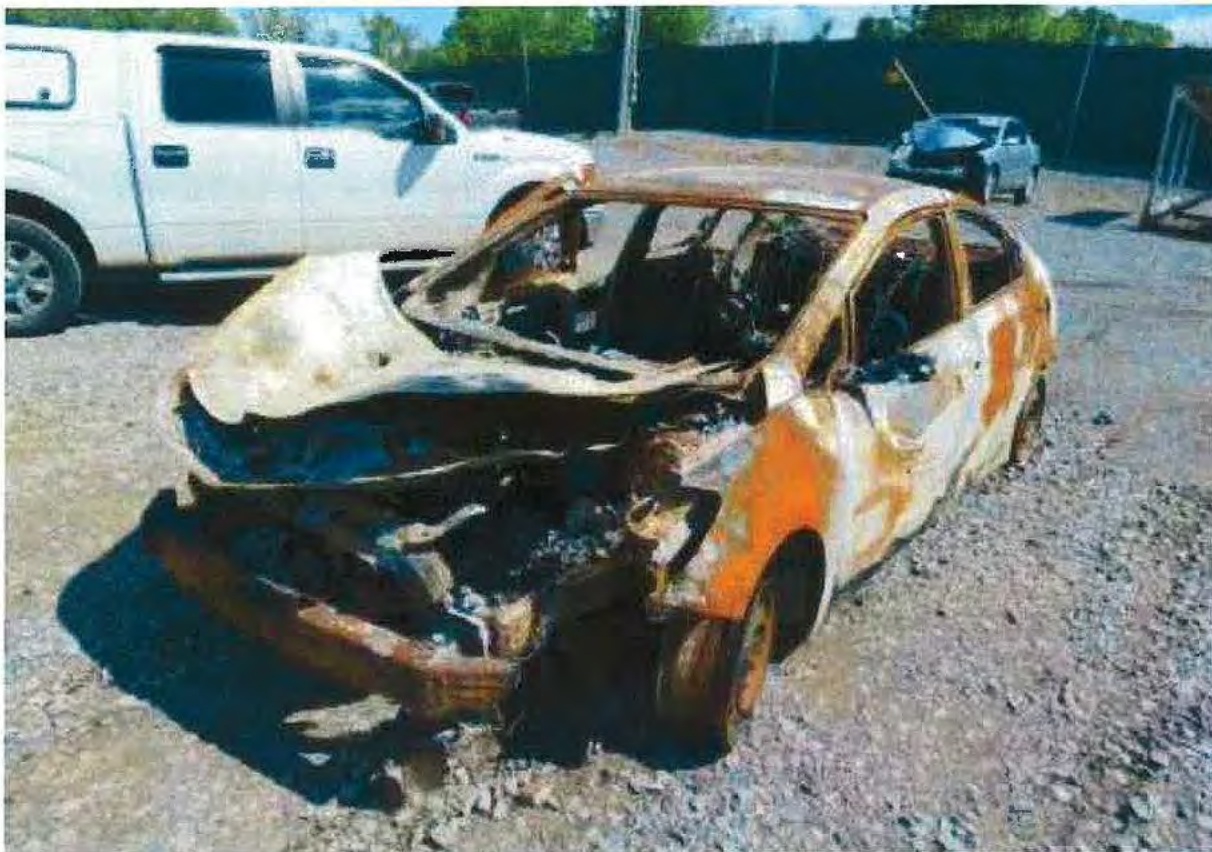
**Photo Information**

1. Front and driver side of the vehicle.

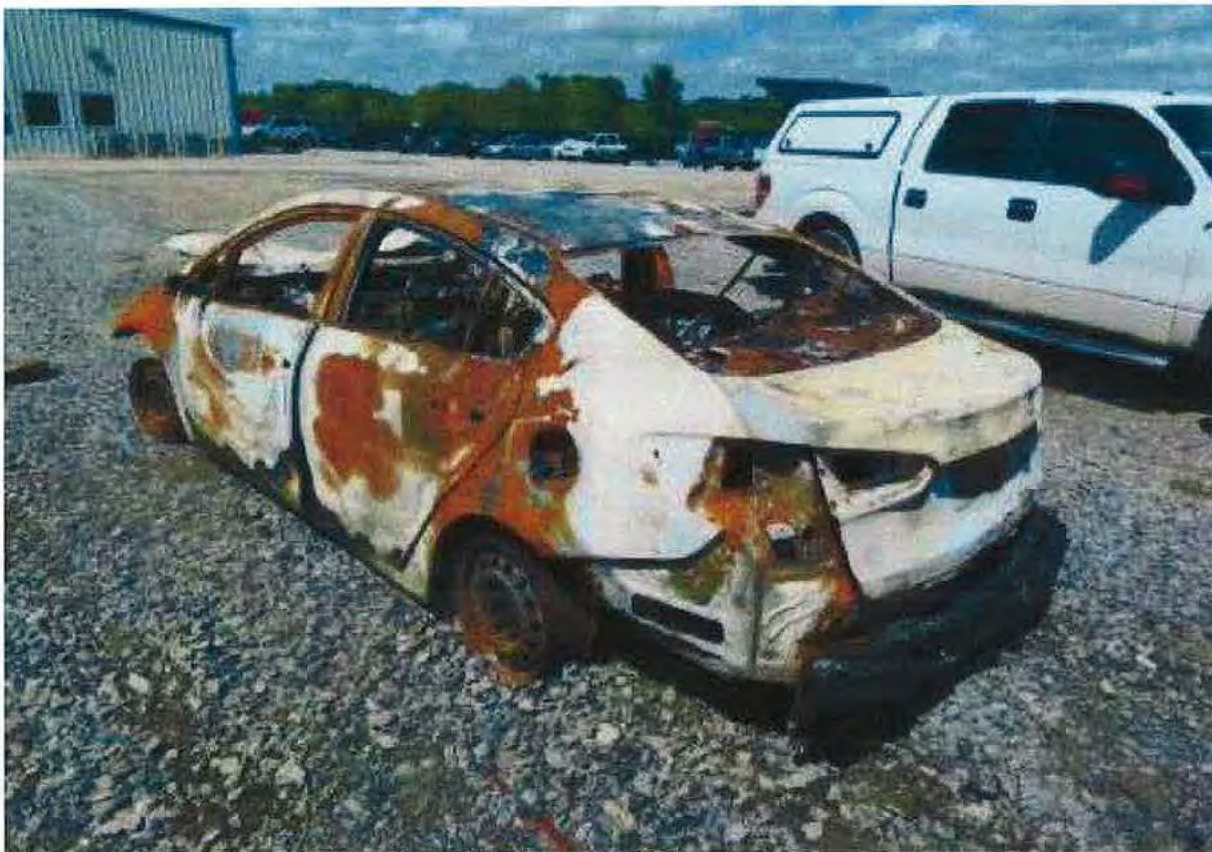
**Photo Information**

2. Rear and driver side of the vehicle.

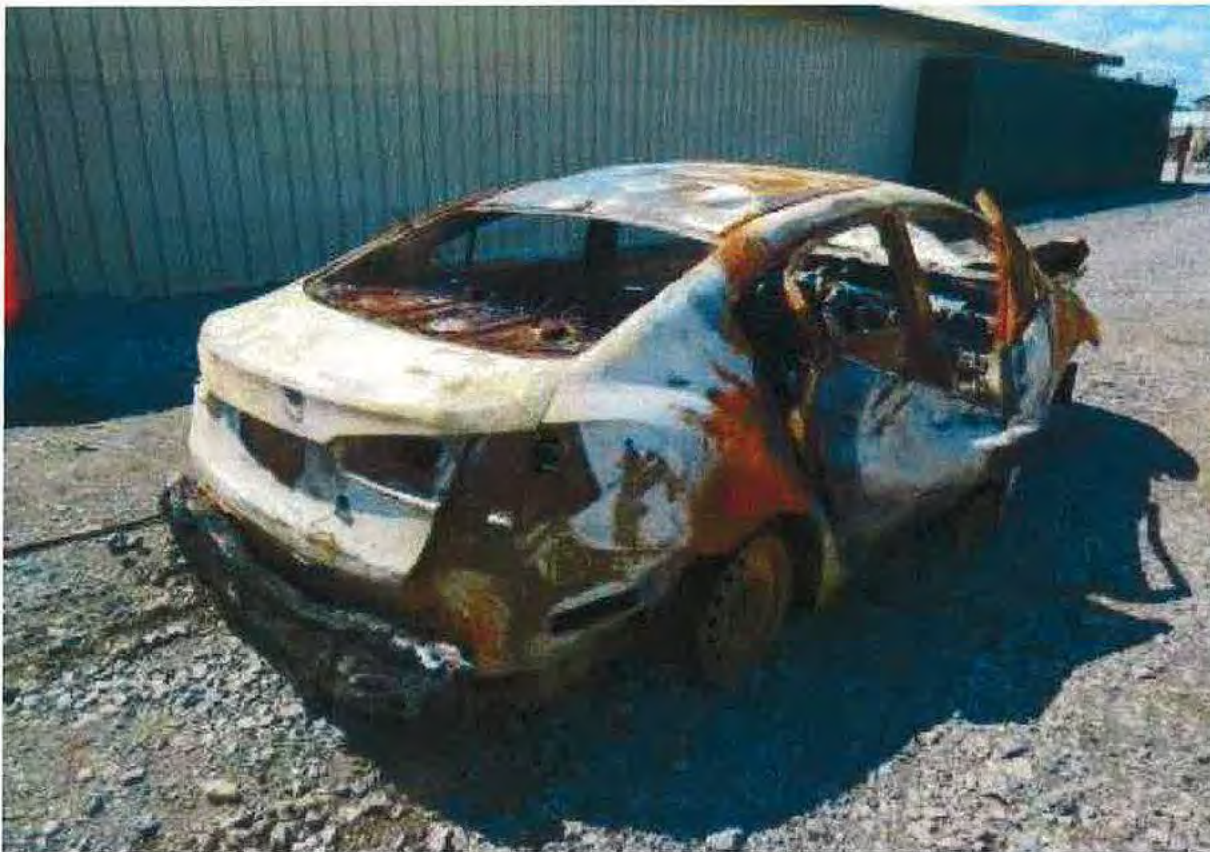
**Photo Information**

3. Rear and passenger side of the vehicle.

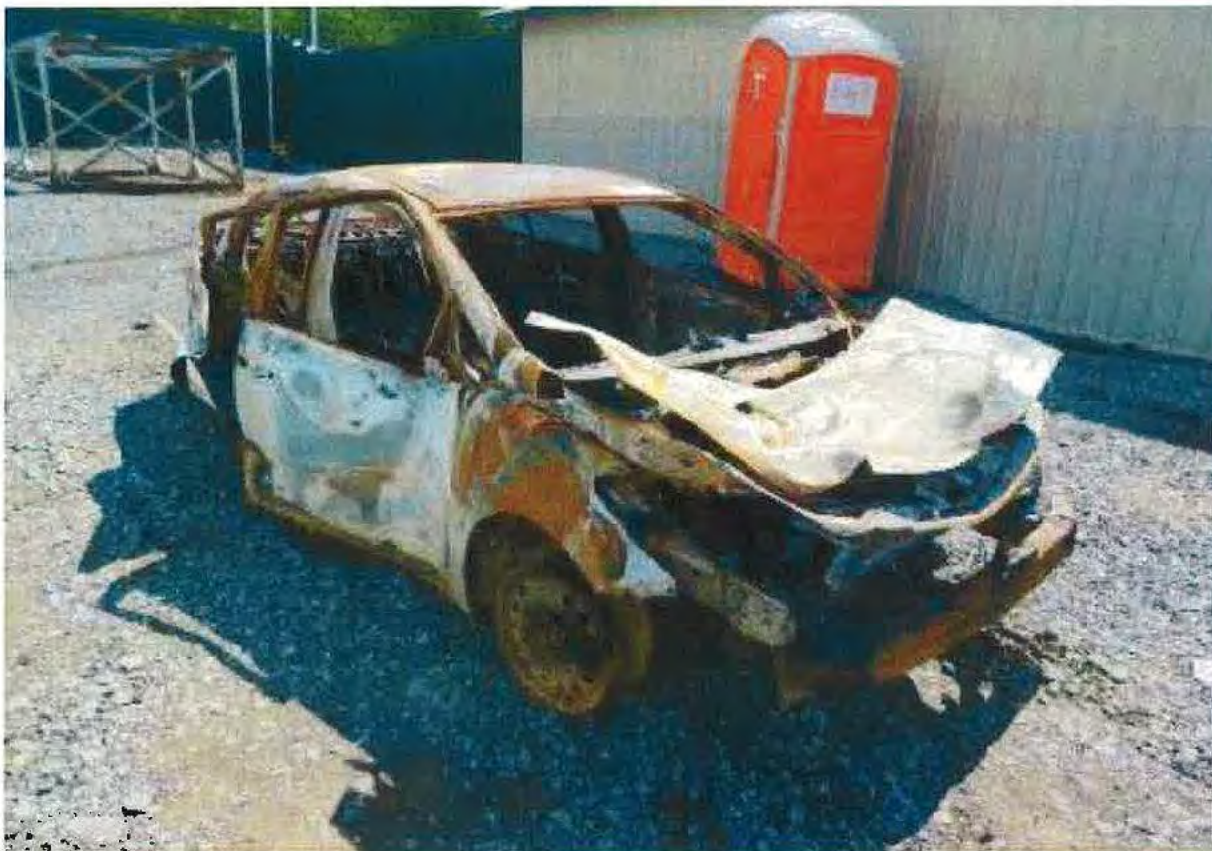
**Photo Information**

4. Front and passenger side of the vehicle. Note that extensive degradation of the vehicle did occur during the course of the fire.

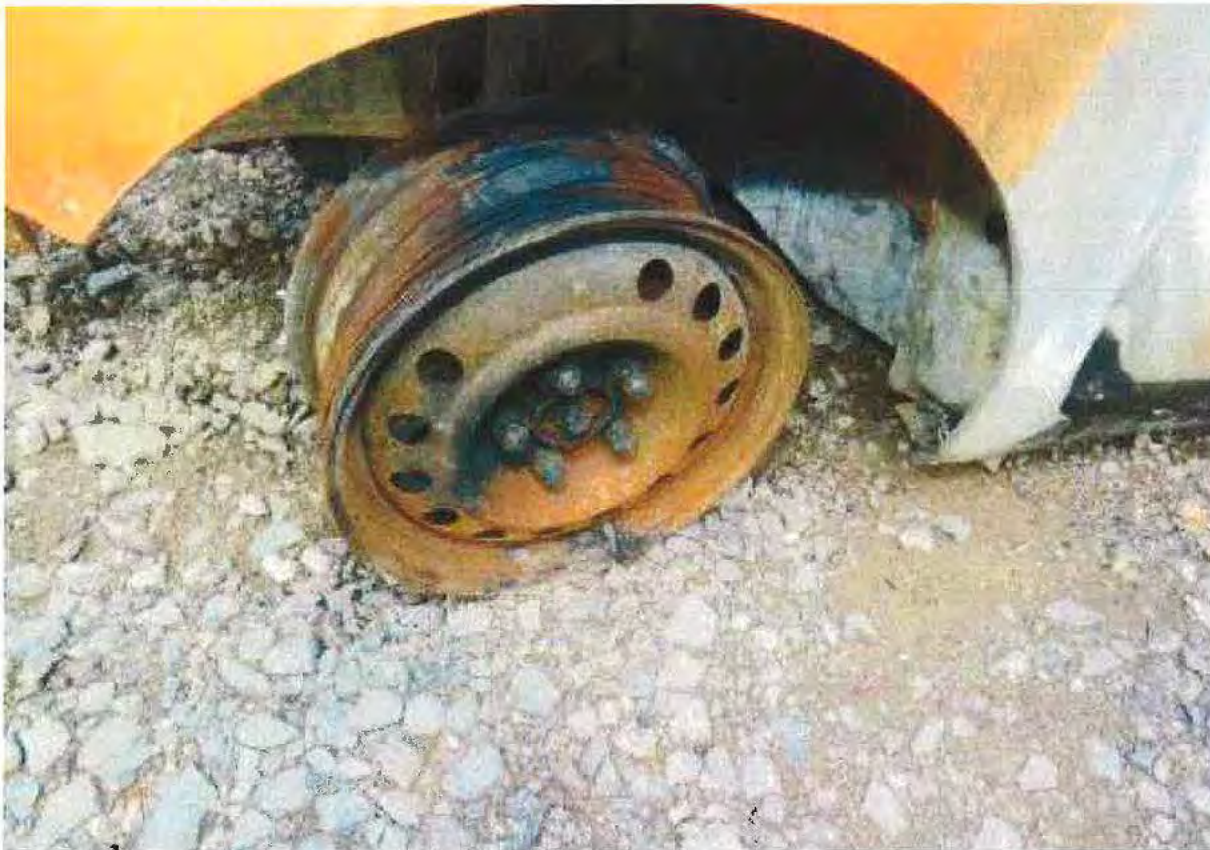
**Photo Information**

5. The left front wheel showing design.

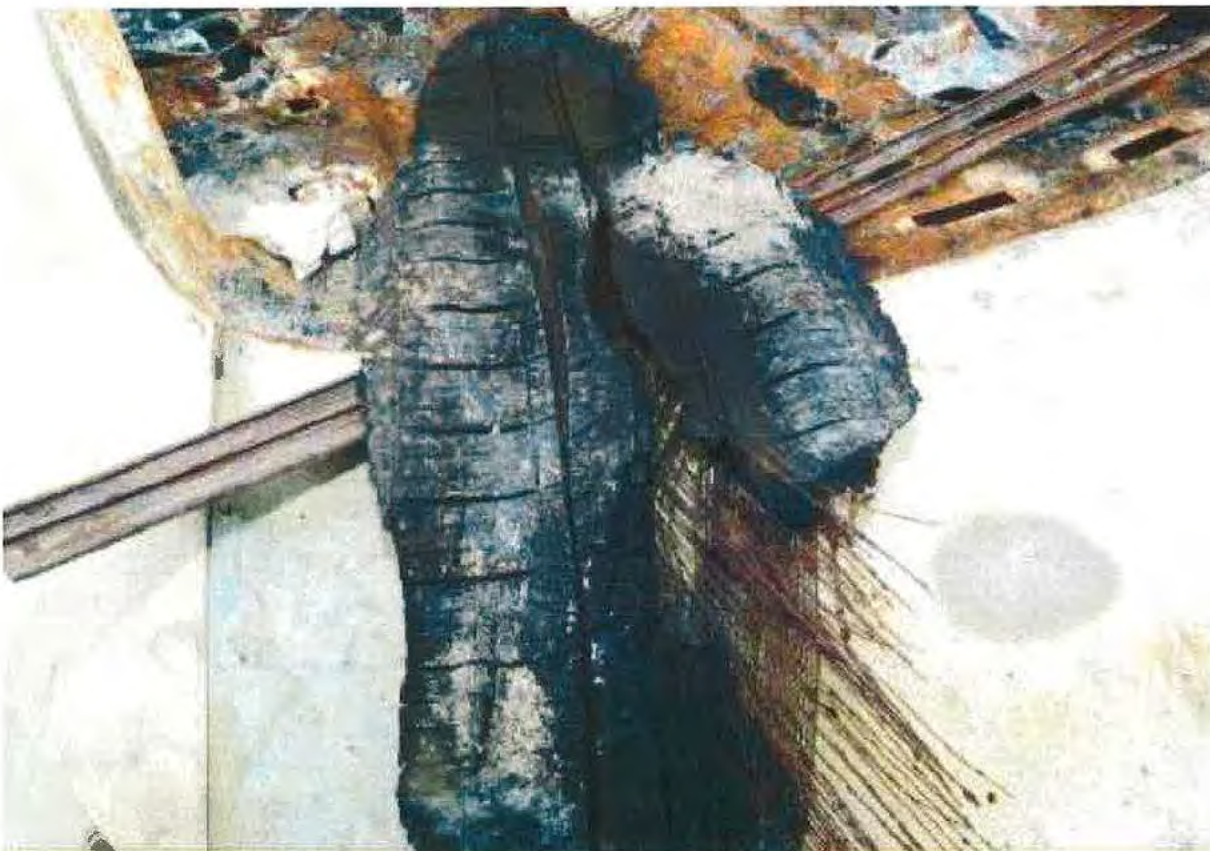
**Photo Information**

6. The tire pad showing tread design and condition.

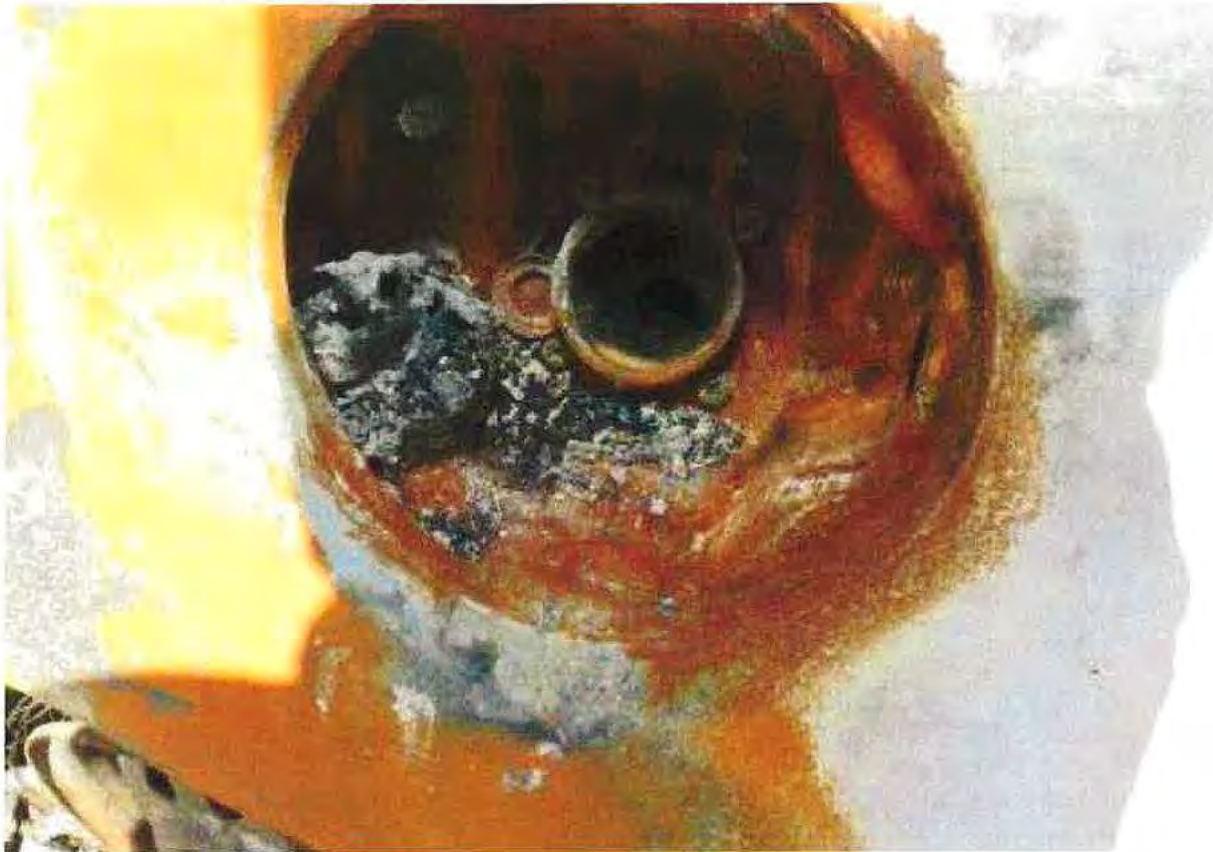
**Photo Information**

7. The fuel filler neck. The cap was in place at the time of the fire.

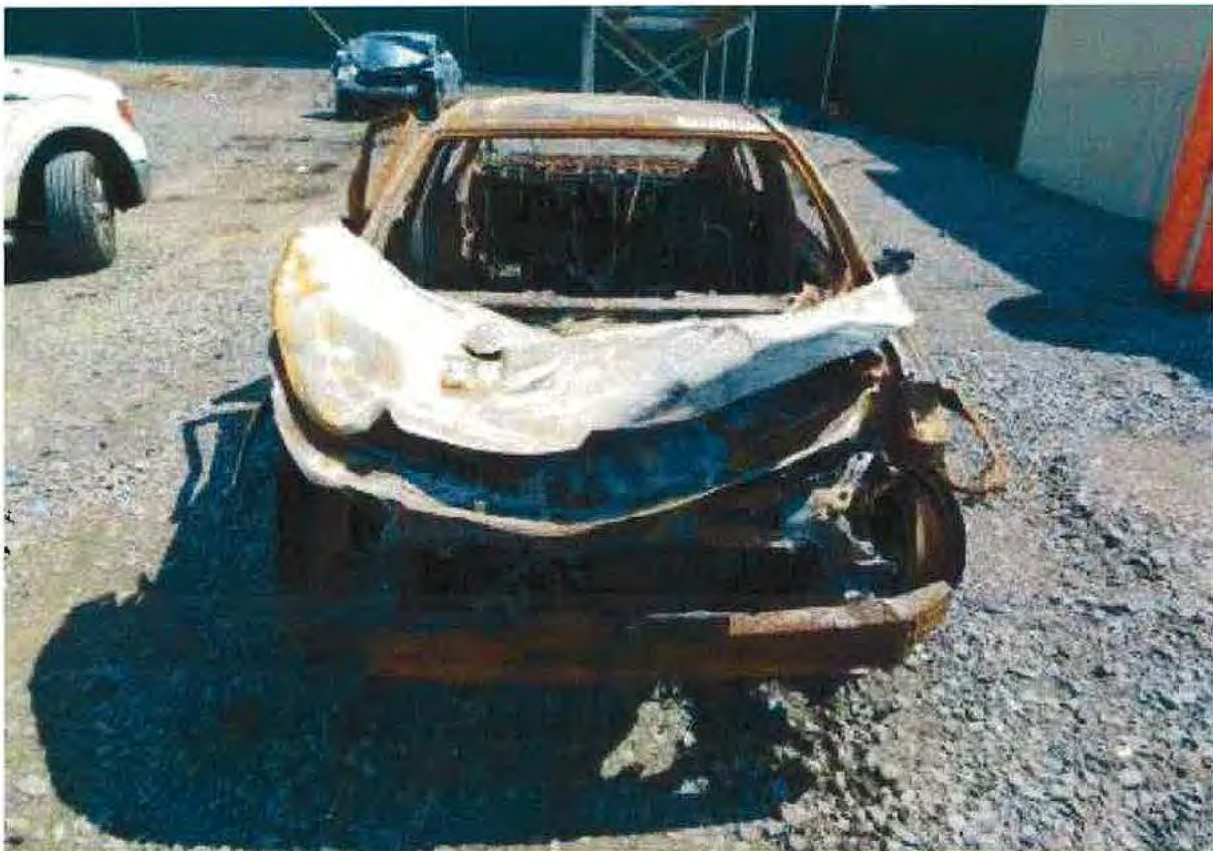
**Photo Information**

8. Overview of the hood and front grill area. The hood was down and latched at the inception of the fire.
