# Consumer Assistance Center Case Report

**Title:** Dlr opened Service Alert Escalation because brakes locking up, dlr CND.

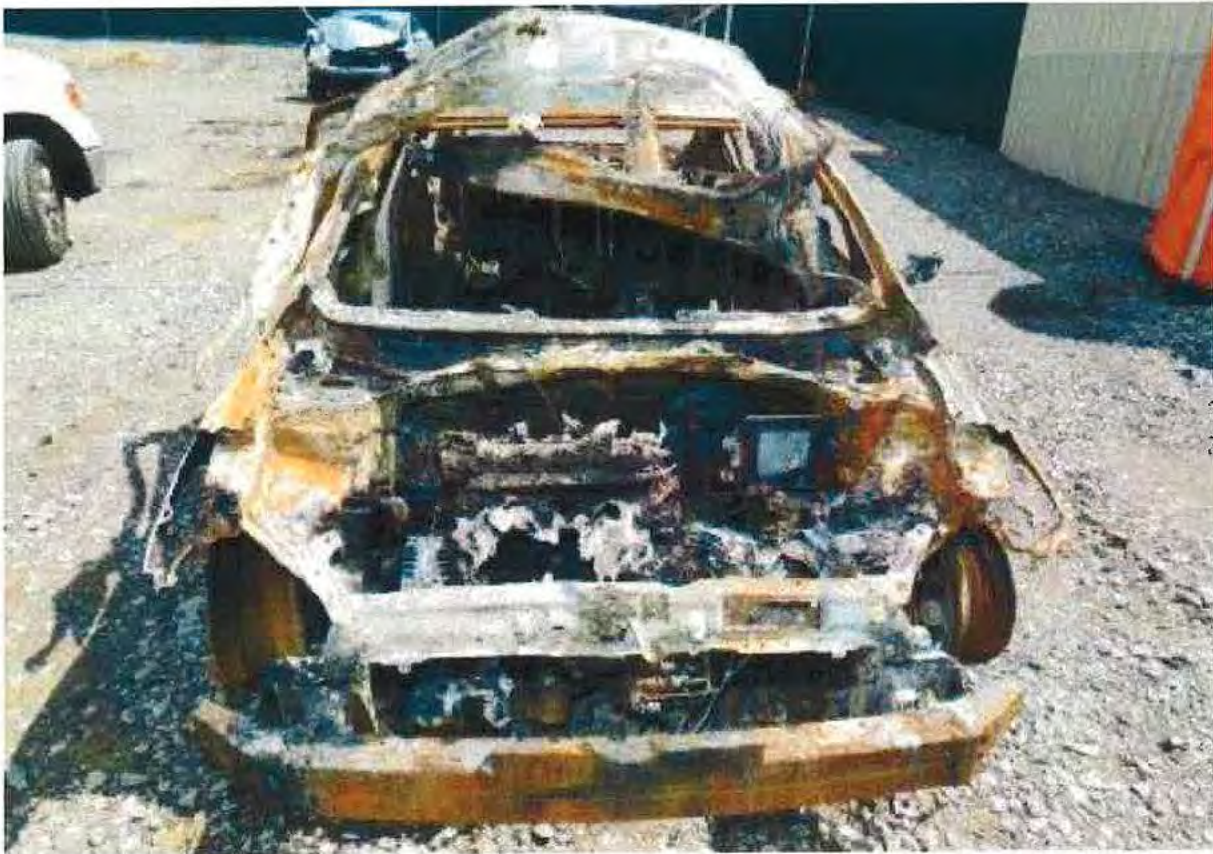
**Photo Information**

9. Overview of the motor compartment following removal of the hood. All components were found in their appropriate locations.

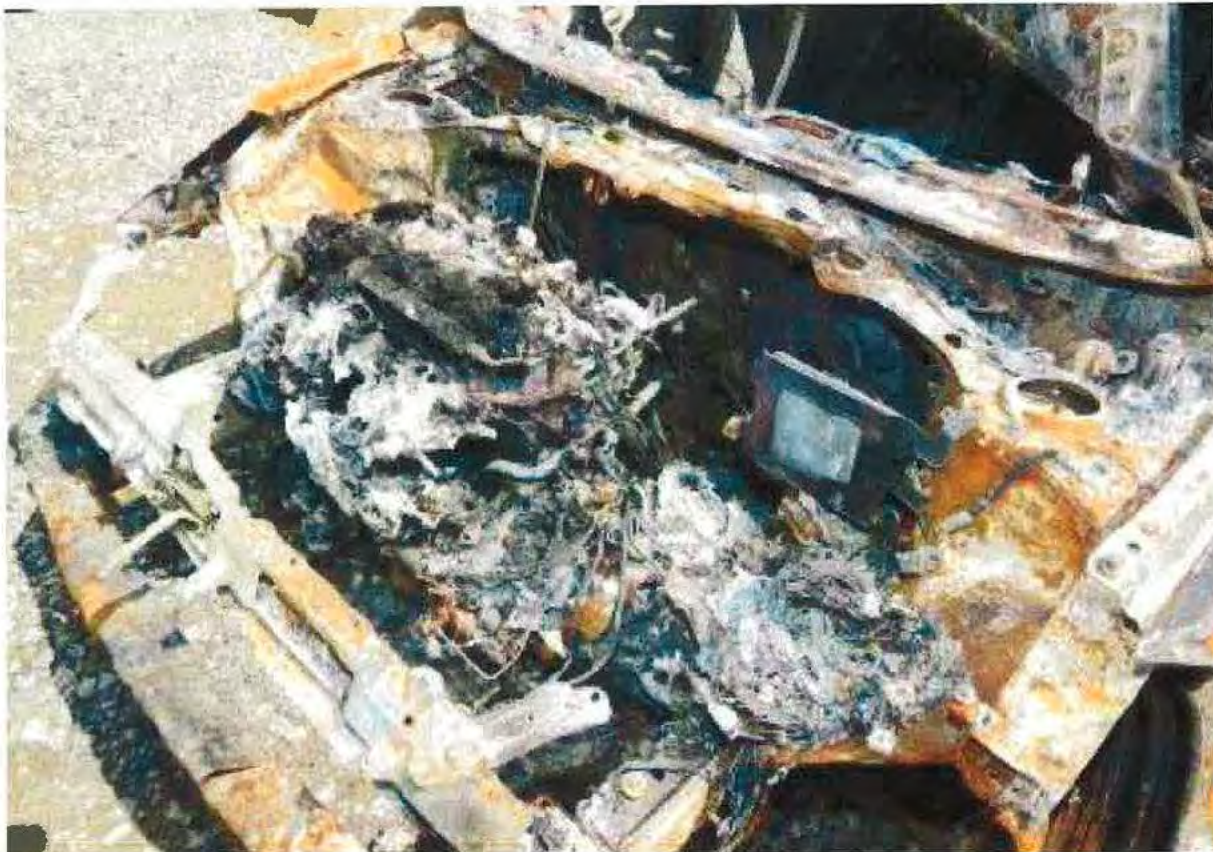
10. The driver side of the motor compartment. The damage configuration demonstrates the fire's movement from the passenger compartment through the firewall/bulkhead motor compartment.

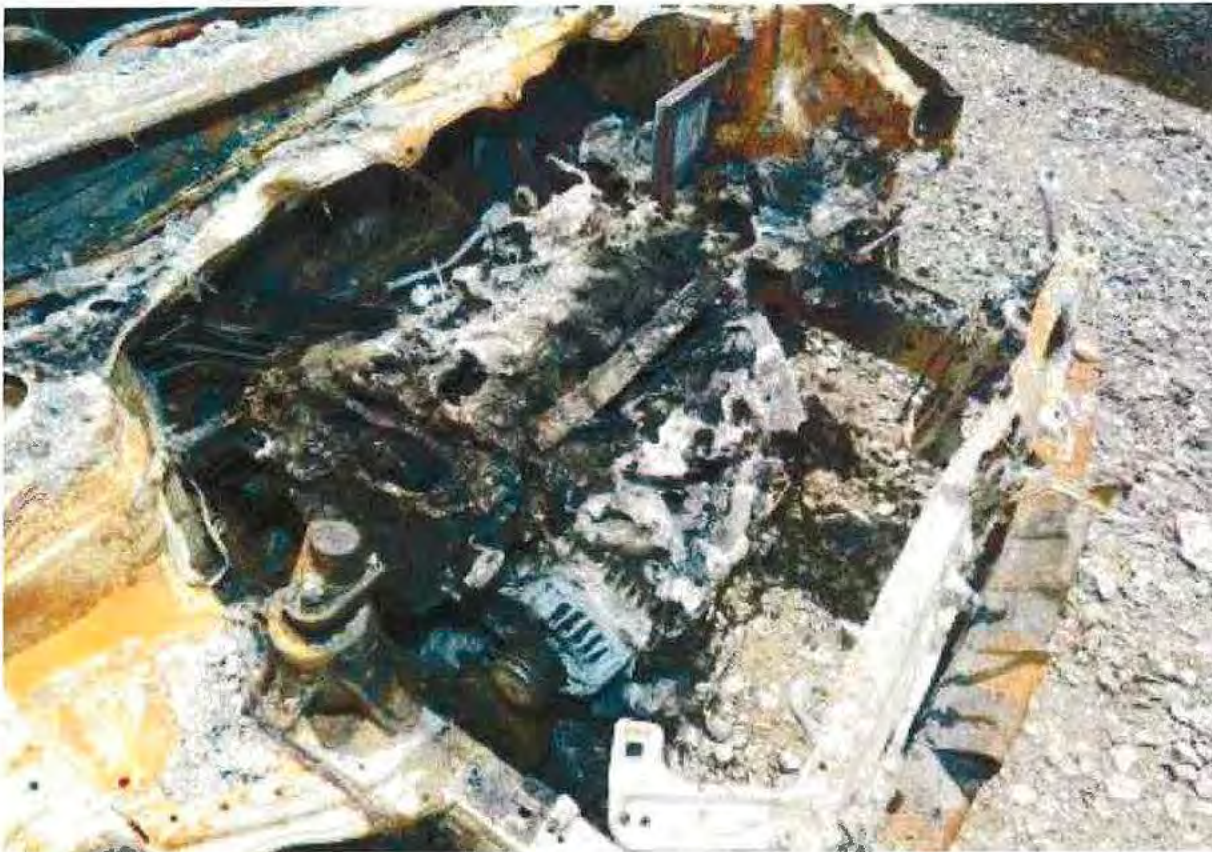
11. The passenger side of the motor compartment. There is no evidence of the fires initial inception within the motor compartment area.

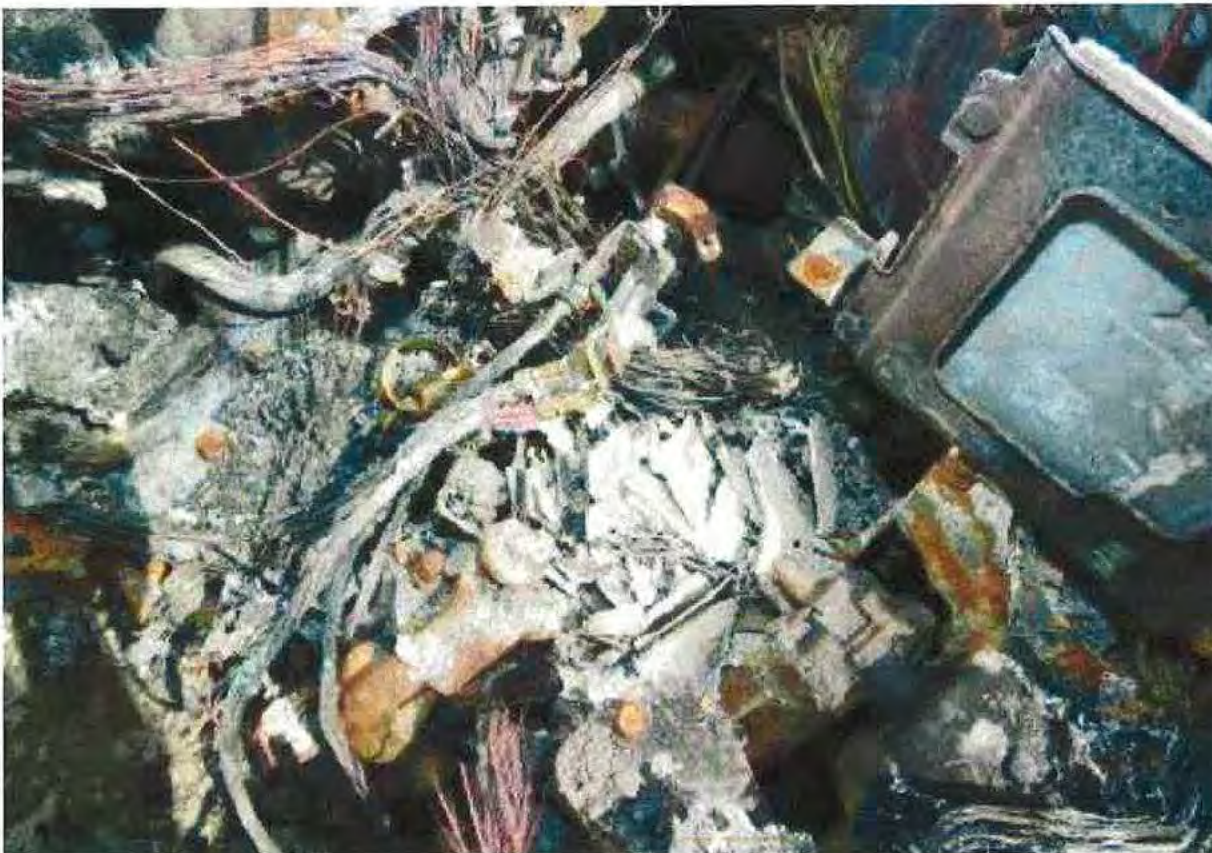
12. The remains of the battery and primary electrical wiring showing extensive damage due to heat and flame impingement. There is however no evidence of the fires inception at the battery location.

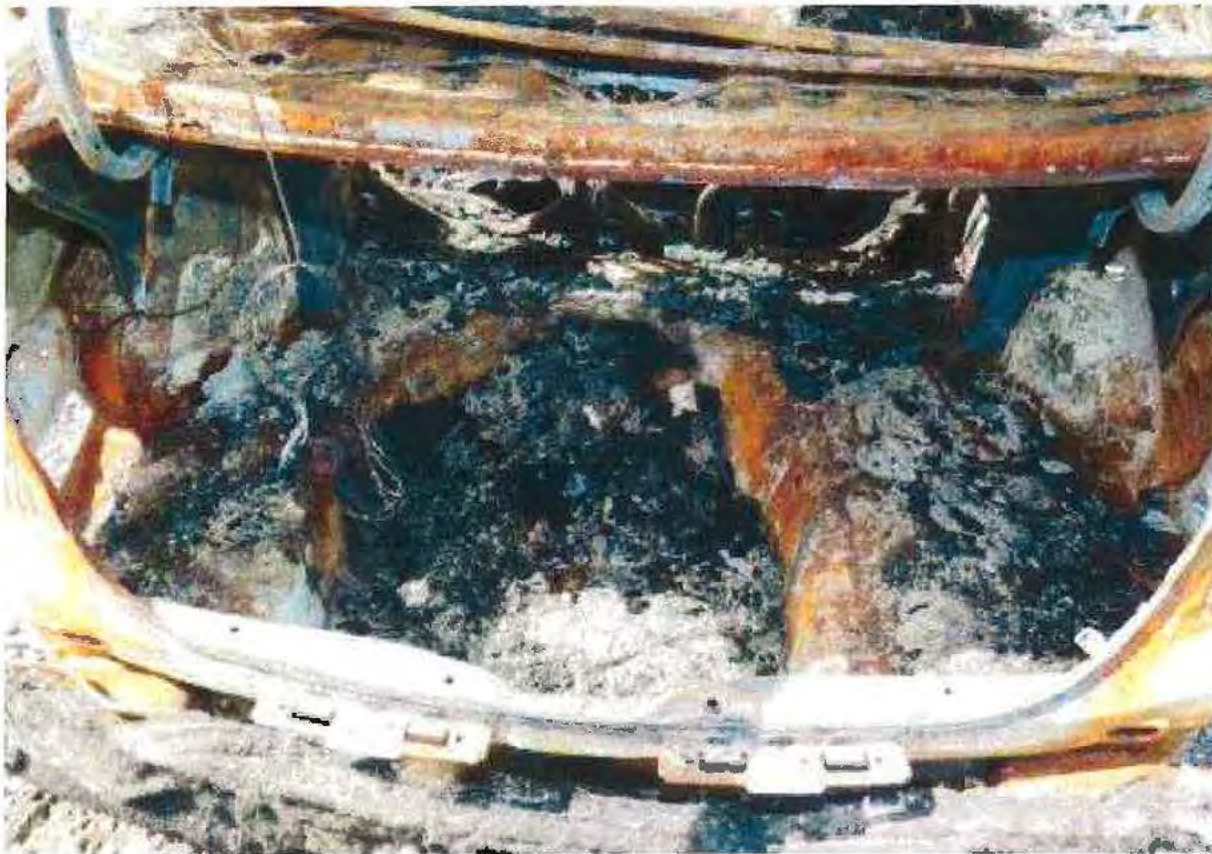
**Photo Information**

13. The trunk storage compartment showing extensive degradation. The spare tire was not found at its mounting location.

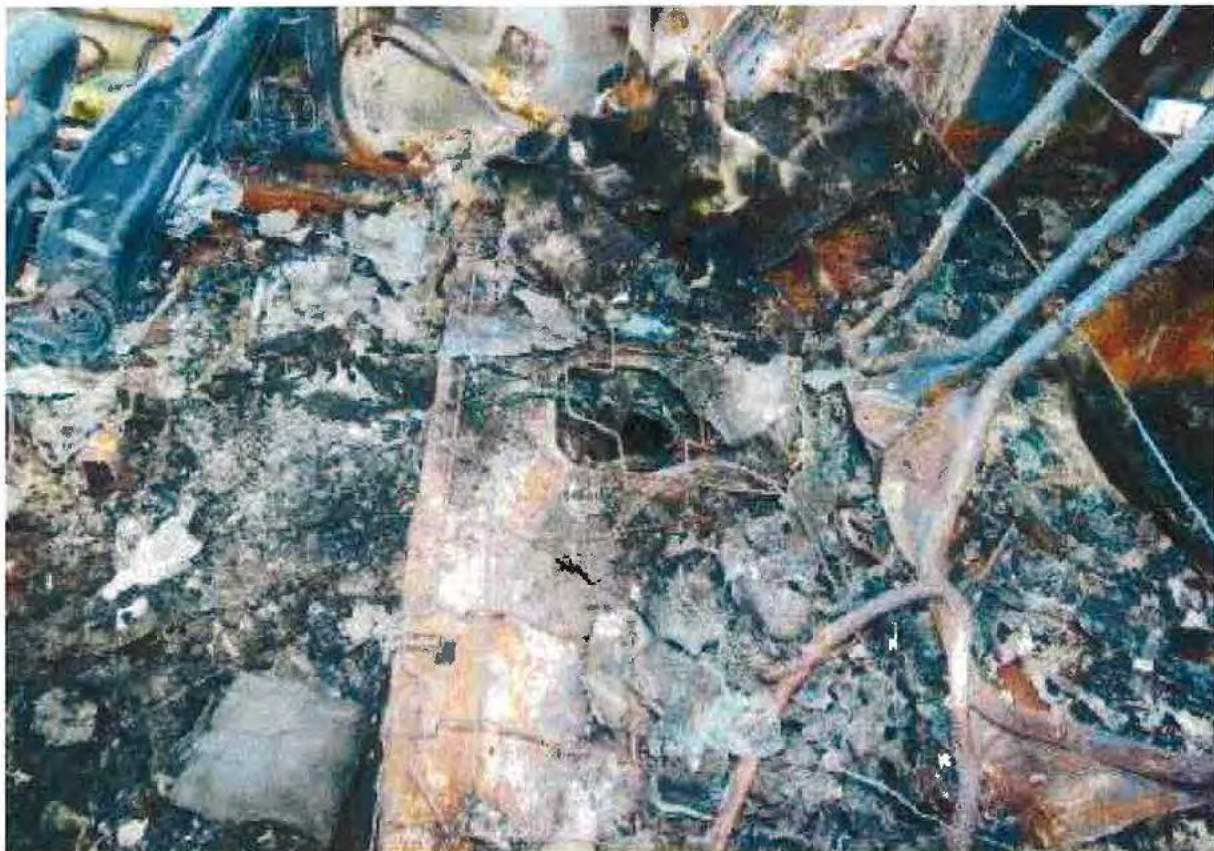
**Photo Information**

14. The back seating area showing extensive degradation of the seat assembly.

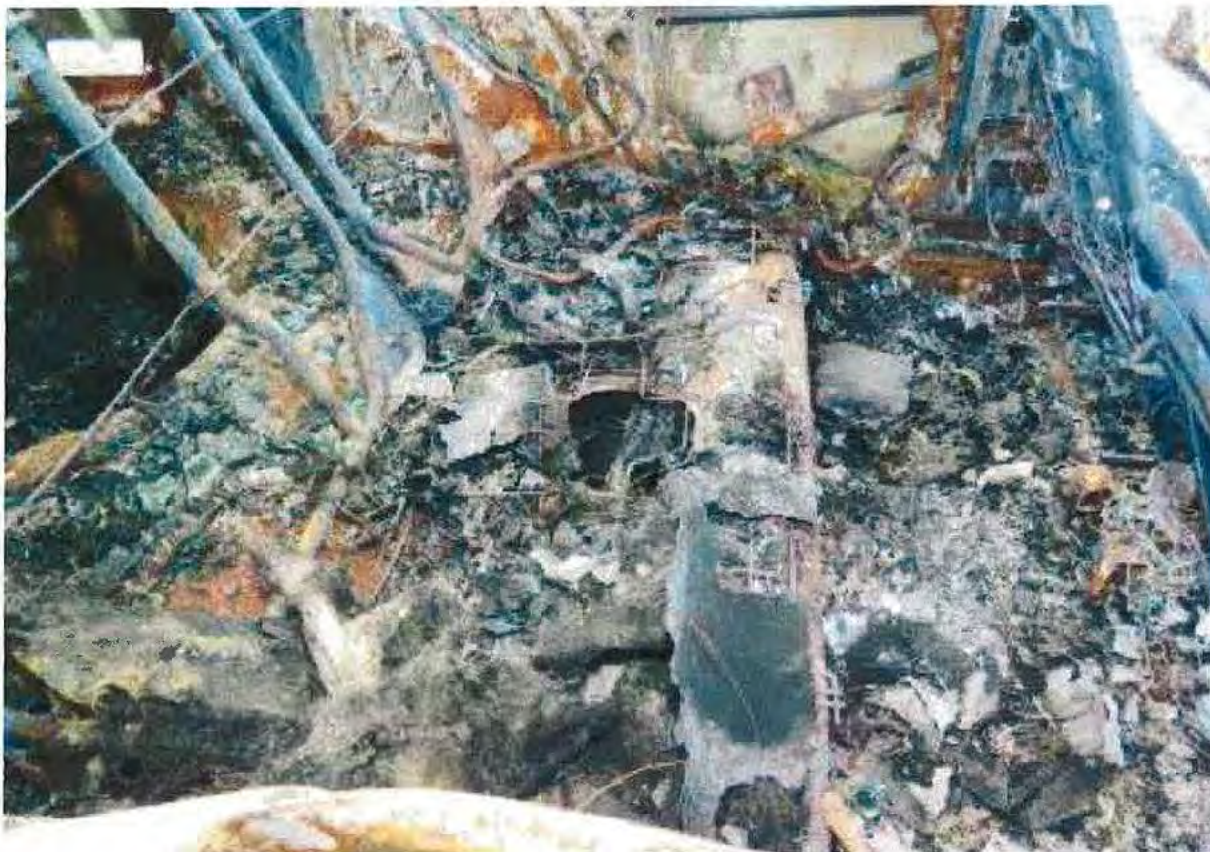
**Photo Information**

15. Additional view of the back seating area again showing extensive degradation of the seats as well as the door panels.

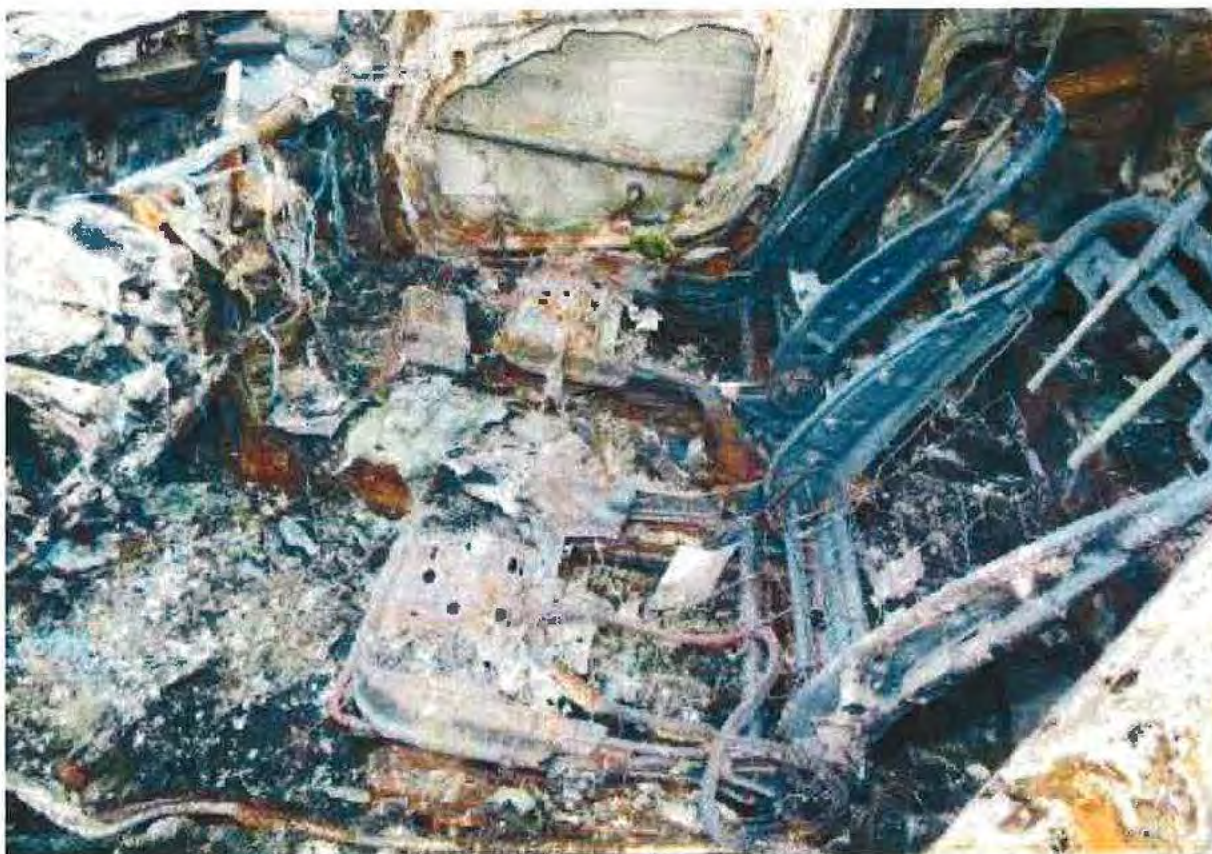
**Photo Information**

16. The front seating area. Extensive degradation of the seats as well as the adjacent door panels and overhead did occur during the course of the fire.

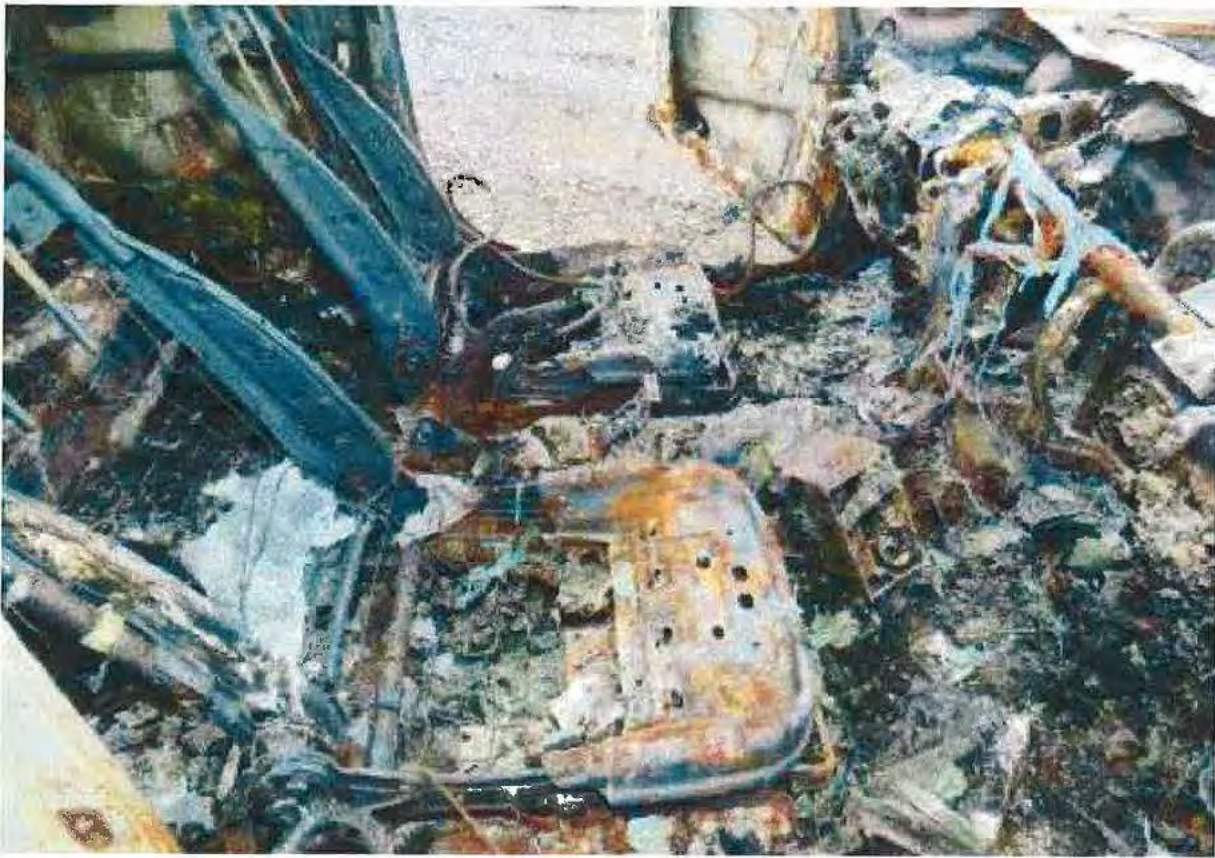
**Photo Information**

17. Additional view of the front seating area. Although extensively degraded, there is no evidence of the fires inception at the seat or floorboard area.

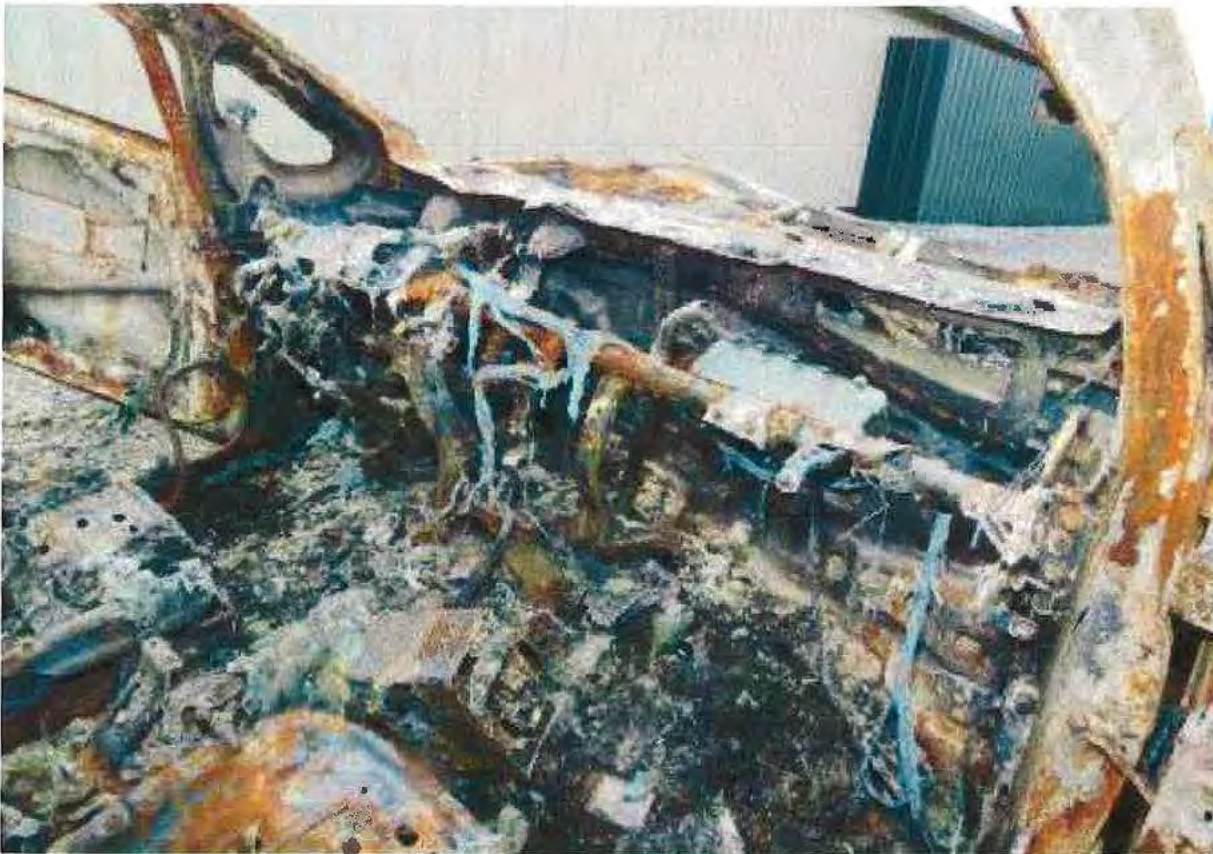
**Photo Information**

18. The dash. All components were found to have been in their appropriate locations at the time the fire occurred.

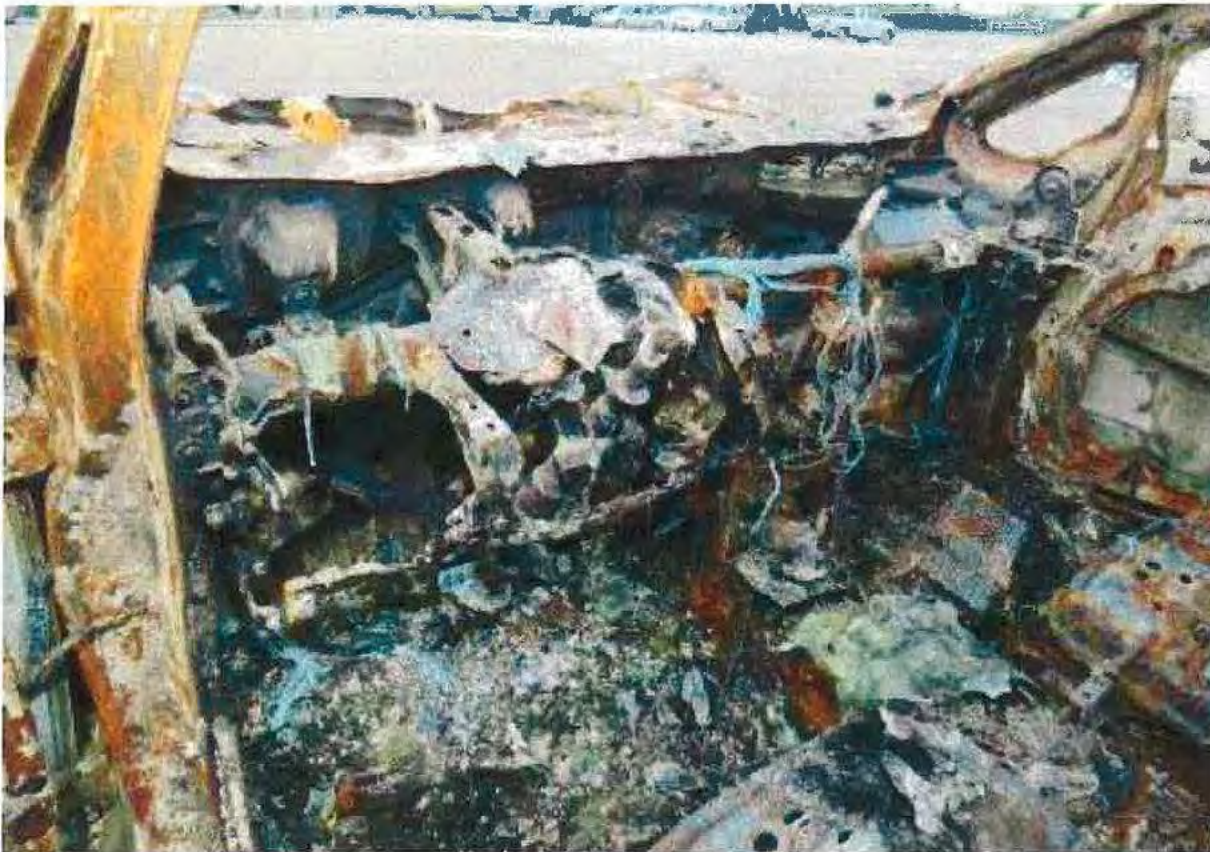
19. Additional view of the dash showing the remains of the instrument cluster at the driver side. The fire did begin within the interior dash at the driver side.

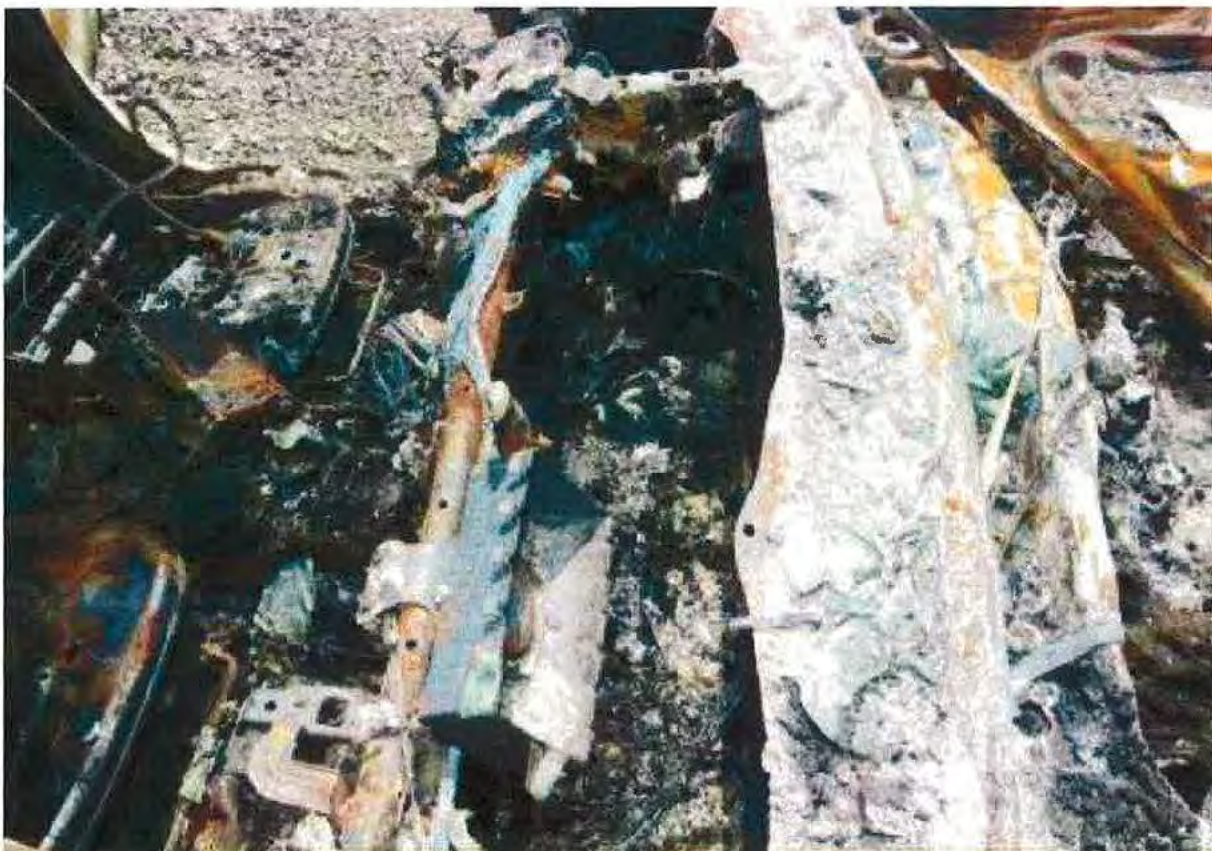
**Photo Information**

20. Additional view of the dash showing the dash frame and adjacent components and assemblies. Again, all components were found to have been in their appropriate location at the time the fire occurred.

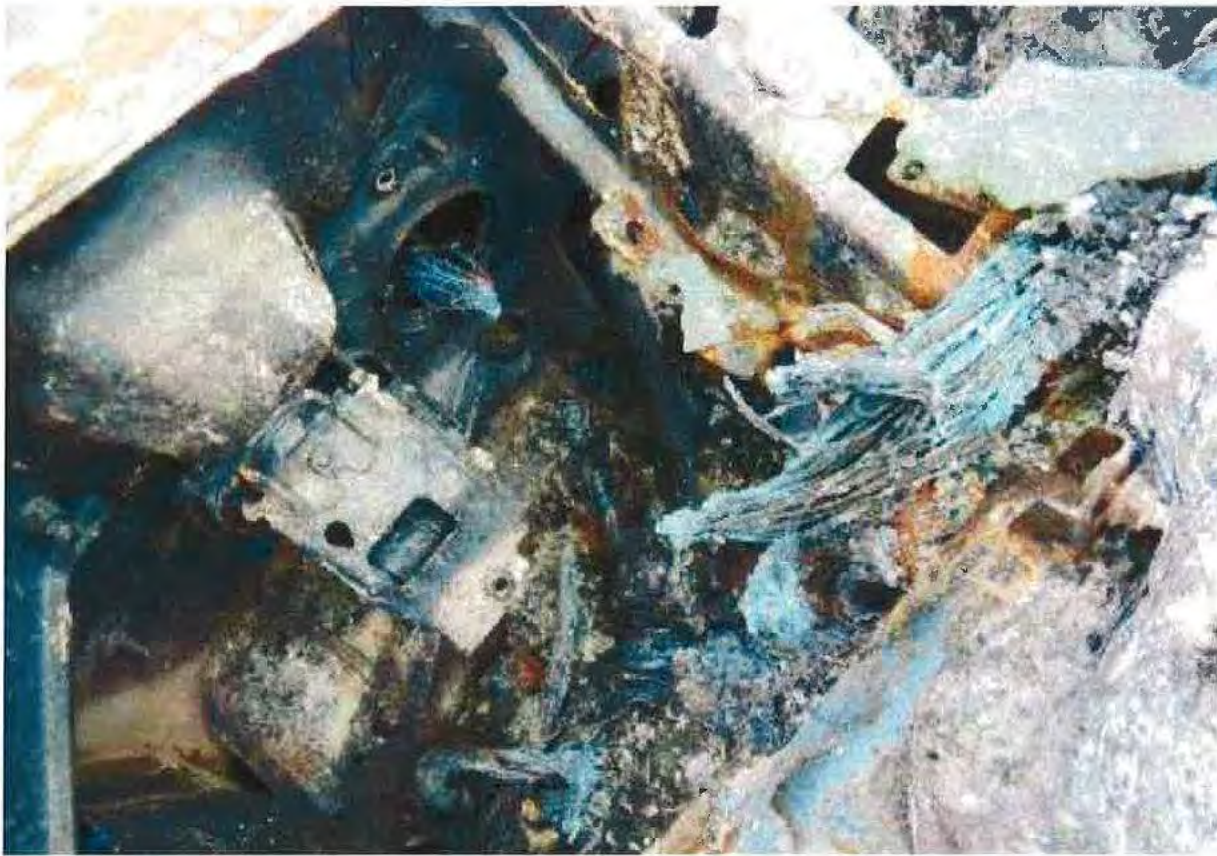
21. Close up view of the driver side dash showing the remains of the wiring harness conductors. There is evidence of localized shorting and arcing at the driver side interior dash area.

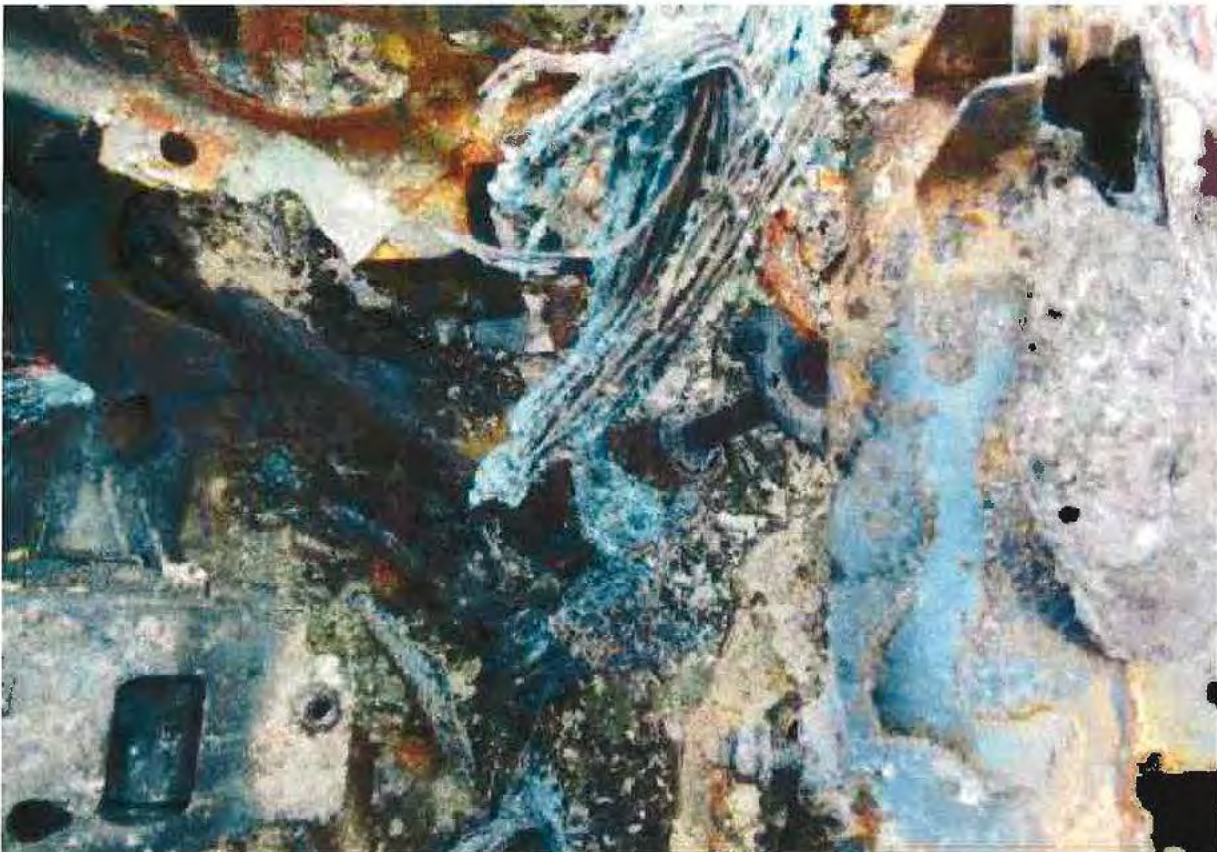
22. Close up view of the wiring conductors again showing evidence of shorting, arcing and melting. A failure of the conductors for unknown reasons is the most probable cause of fire.

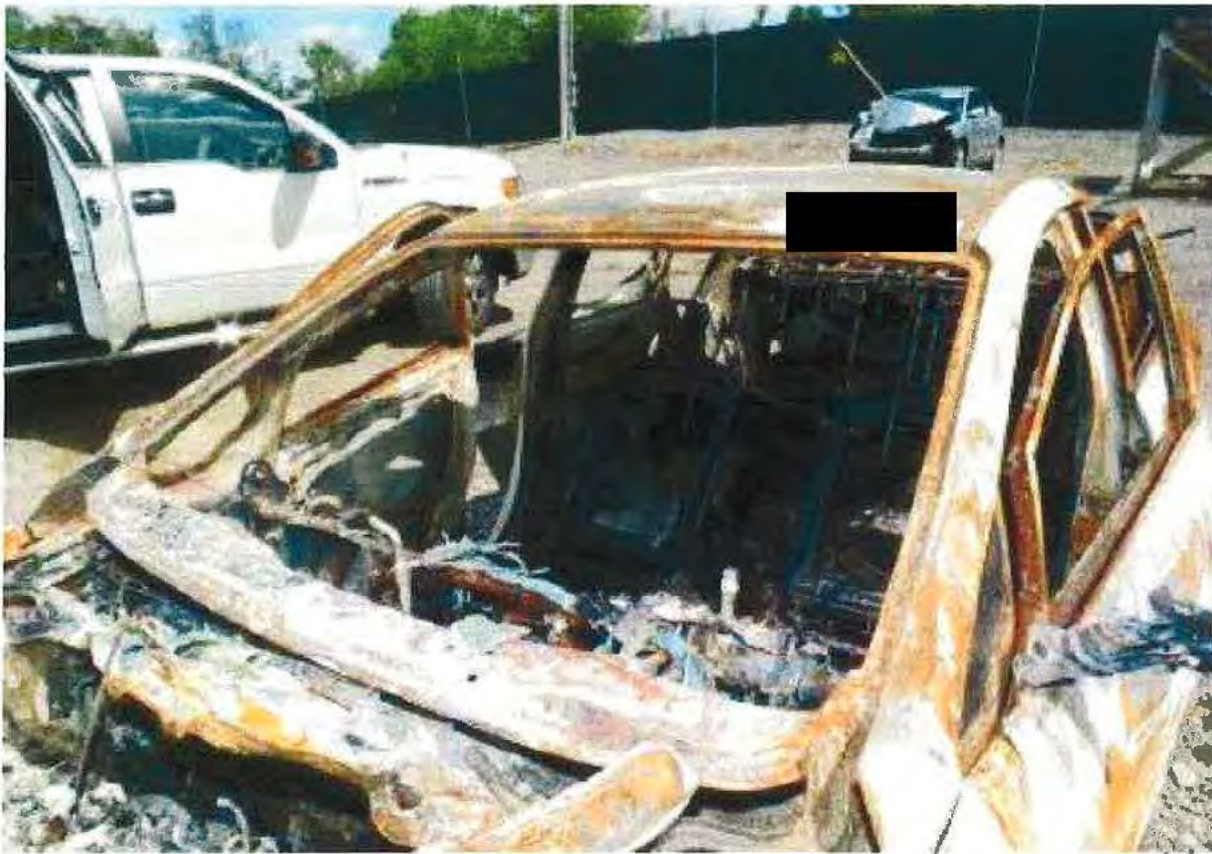
23. The windshield frame. The oxidation and demarcation patterns further demonstrate the fires development within the interior dash at the driver side.

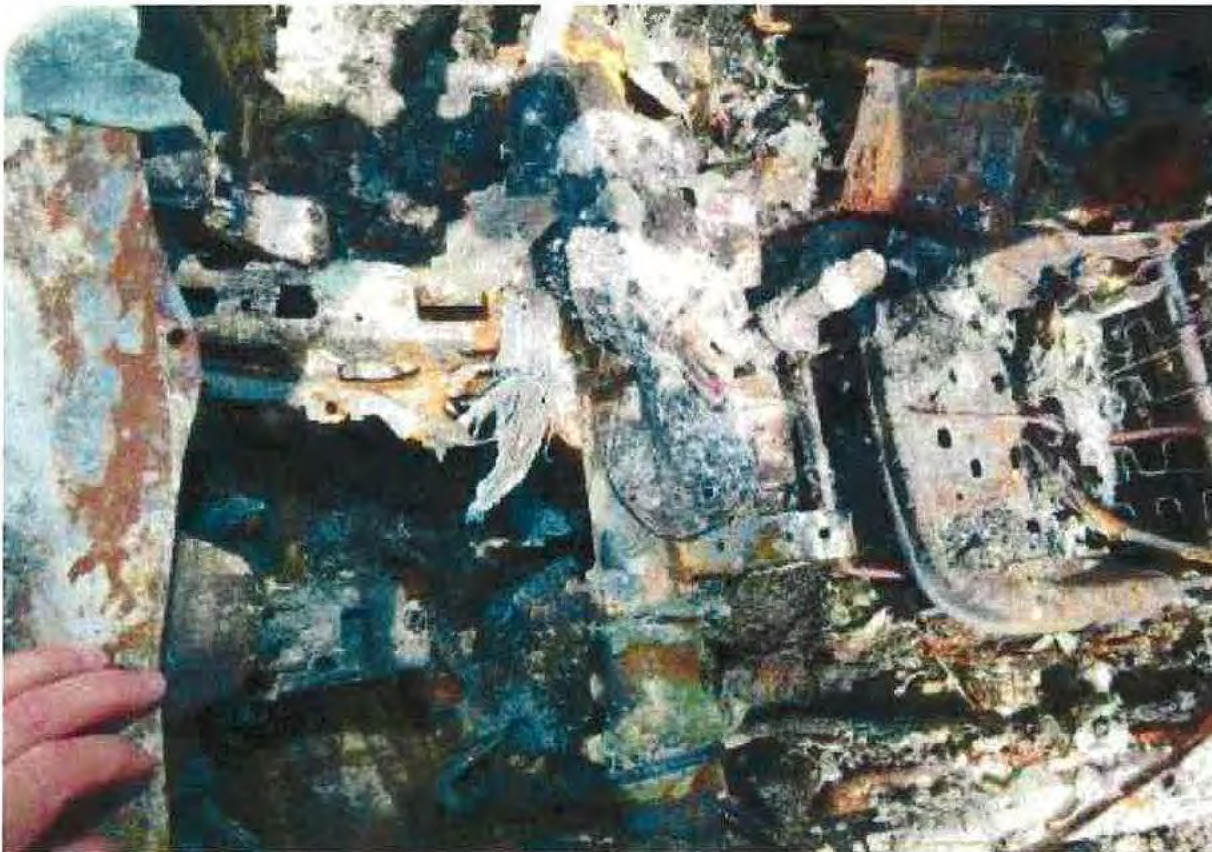
24. Additional close up view of the area of origin at the driver side dash. The oxidation, demarcation and burn patterns do demonstrate the fires development at the interior [REDACTED] the location of the wiring harness conductors and/or adjacent components.
