<b>HYUNDAI</b> <b>Technical Service Bulletin</b>	GROUP <b>RECALL</b>	NUMBER <b>18-01-006</b>
	DATE <b>JANUARY, 2018</b>	MODEL(S) <b>2011-2012MY SONATA (YF)</b>
<b>SUBJECT: SONATA GDI ENGINE INSPECTION / REPLACEMENT (RECALL CAMPAIGN 132)</b>

**This TSB supersedes TSB# 17-01-046-1 and modifies the Parts Information and Service Procedure sections.**

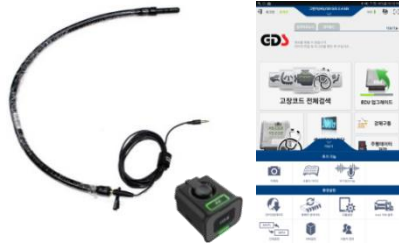
Description	Tool Part #	Image	Comment
Engine Noise Inspection Tool	G1XTD-CP005

For noise inspection
Torque Wrench Socket	09314-3Q100		Only needed if engine replacement required.
Injector Combustion Seal Ring Installer	09353-2B000		Refer to TSB 10-FL-019 for the detailed usage instructions

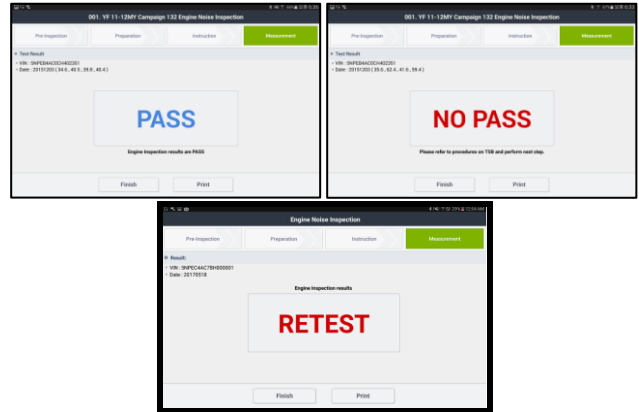
6. After the Inspection Procedure is complete, the application will display **PASS**, **NO PASS**, or **RETEST**.

For **PASS**, **NO PASS**, or **RETEST** proceed to the appropriate **Service Procedure** in the following pages that correspond to the **Inspection Results**.

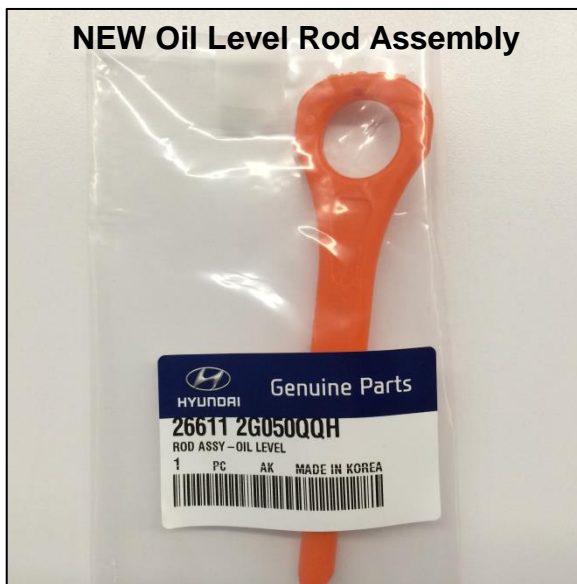
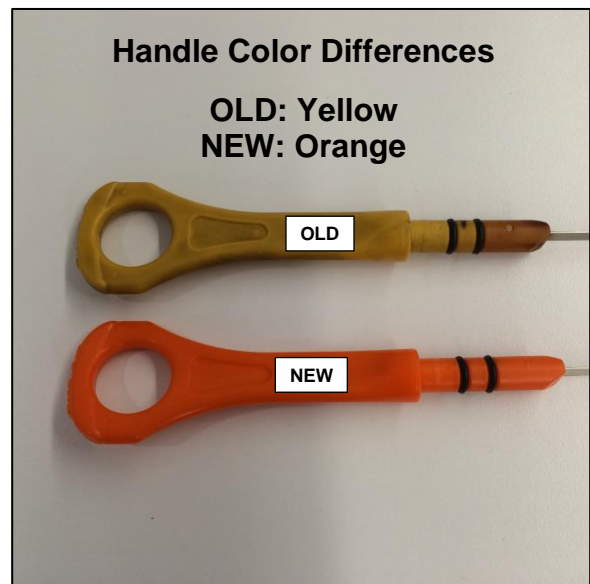
2. Replace the engine oil (4.8 quarts), oil filter, and drain plug gasket.
3. Replace the current Oil Level Rod Assembly with the new campaign part.
  - Remove and discard the existing Oil Level Rod Assembly (engine oil dipstick).
  - Install new ORANGE handle Oil Level Rod Assembly (P/N 26611-2G050QQH)

**Note:** Replace the dipstick **ONLY** if the current dipstick's handle is yellow. Do not replace if it's red.

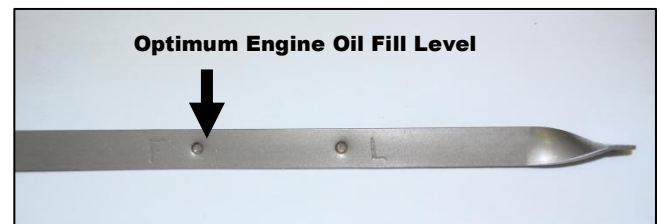
4. Start the engine and allow it to run for 10 seconds. Turn off the engine and after a few minutes adjust the engine oil level to near the "F" mark as shown in the picture.
  - Use Quaker State 5W-30 viscosity engine oil or other brand if not available (conventional type with API SM / ILSAC GF-4 or higher grade).
  - Do not overfill.

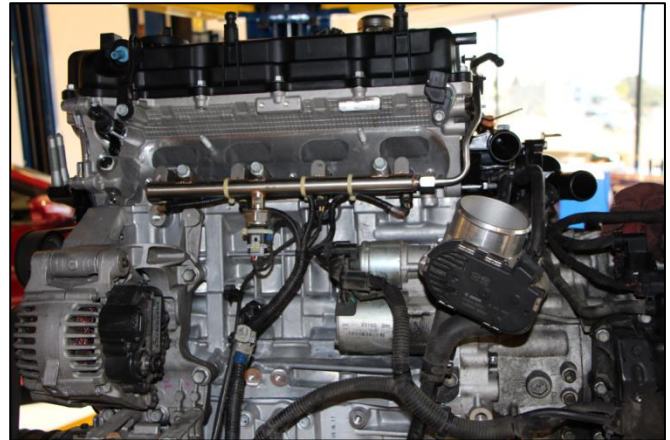
7. Install new oil cooler hoses.
8. Reconnect and reinstall the engine front harness as shown.
  - Be sure to properly route the opposite end of the harness end down towards the front of the engine.
9. Install newly supplied Oil Level Guide and Oil Level Rod Assemblies to the new engine.
  - Be sure to install the NEW Oil Level Guide (dipstick tube) to the NEW engine.
  - Install the NEW Oil Level Rod Assembly (dipstick) to the NEW engine.

**The engine is shipped without oil and engine oil must be added at a later step.**

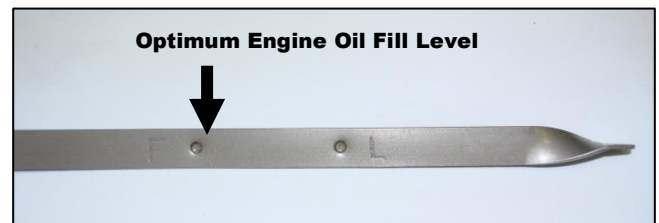
13. Start the engine to warm it up and begin the cooling system air bleeding process.
- During this time, check for any leaks.
  - After the engine has warmed up to normal operating temperature, turn the engine off, wait a few minutes, and then adjust the engine oil level to near the "F" mark as shown in the picture.
