<b>HYUNDAI</b> <b>Technical Service Bulletin</b>	GROUP <b>RECALL</b>	NUMBER <b>17-01-047-1</b>
	DATE <b>SEPTEMBER, 2017</b>	MODEL(S) <b>2013-2014MY SONATA (YF) SANTA FE SPORT (AN)</b>
	<b>SUBJECT: SONATA / SANTA FE SPORT GDI ENGINE INSPECTION / REPLACEMENT (RECALL CAMPAIGN 162)</b>

**This TSB supersedes TSB# 17-01-047 and modifies the Parts Information and Inspection/Service Procedure sections.**

**Description:** Certain 2013-2014 model year Sonata (YF) and 2013-2014 model year Santa Fe Sport (AN) vehicles equipped with 2.4L and 2.0T GDI engines require an inspection to confirm normal operation. The inspection procedure will help indicate if the engine is operating normally or if an excessive connecting rod bearing wear condition in the engine crankcase may be present. If the vehicle continues to be driven with a worn connecting rod bearing, the bearing can fail and the vehicle could stall.

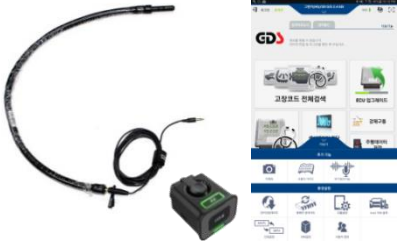
Description	Tool Part #	Image	Comment
Engine Noise Inspection Tool	G1XTD-CP001

For noise inspection
Torque Wrench Socket	09314-3Q100		Only needed if engine replacement required.
Injector Combustion Seal Ring Installer	09353-2B000		Refer to TSB 10-FL-019 for the detailed usage instructions

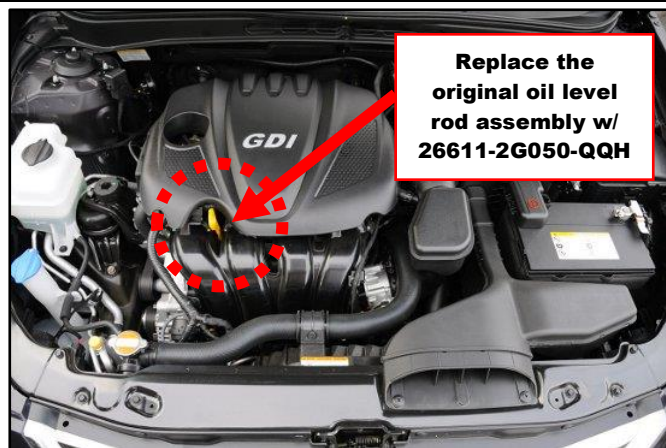
2. Replace the engine oil (4.8 quarts), oil filter, and drain plug gasket.
3. Replace the current Oil Level Rod Assembly with the new campaign part.
  - Remove and discard the existing Oil Level Rod Assembly (engine oil dipstick).
  - Install new ORANGE handle Oil Level Rod Assembly (P/N 26611-2G050QQH)

**Note: Replace the dipstick ONLY if the current dipstick's handle is yellow. Do not replace if it's red.**

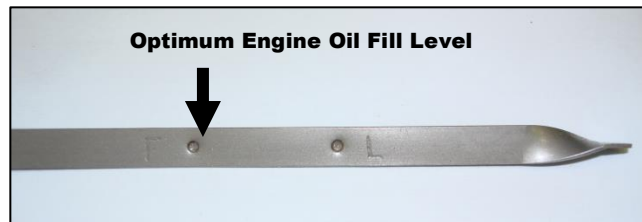
4. Start the engine and allow it to run for 10 seconds. Then adjust the engine oil level to near the "F" mark as shown in the picture.
  - Use Quaker State 5W-30 viscosity engine oil or other brand if not available (conventional type with API SM / ILSAC GF-4 or higher grade).
  - Do not overfill.

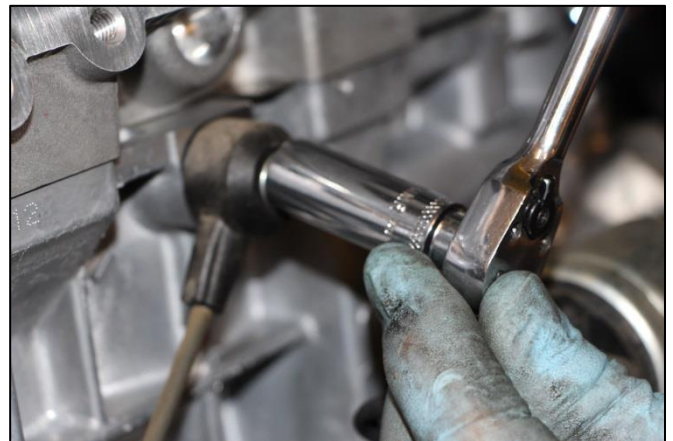
5. Remove and reinstall the engine Knock Sensor from the old engine to the new engine.

**(Knock Sensor Fastener)**  
**Tightening torque: 21Nm (15.5lb-ft)**

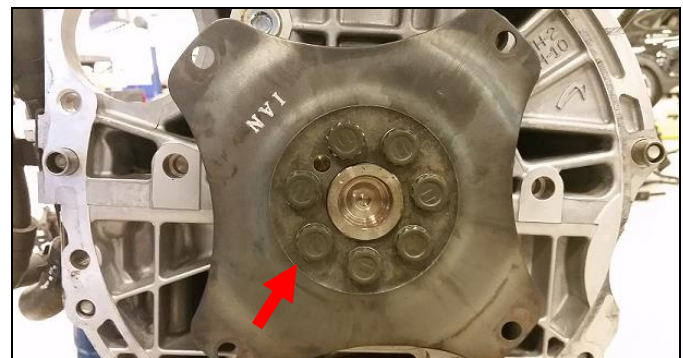
If the QQH replacement engine was packaged with new bolts, install the drive plate/flywheel on the QQH replacement engine using the new bolts (QTY 7).

**Tightening torque : 111.7 ~ 127.5 Nm**  
(86.8 ~ 94.1 lb-ft)

**Install new drive plate/flywheel bolts (ONLY if new bolts are included with the replacement engine)**

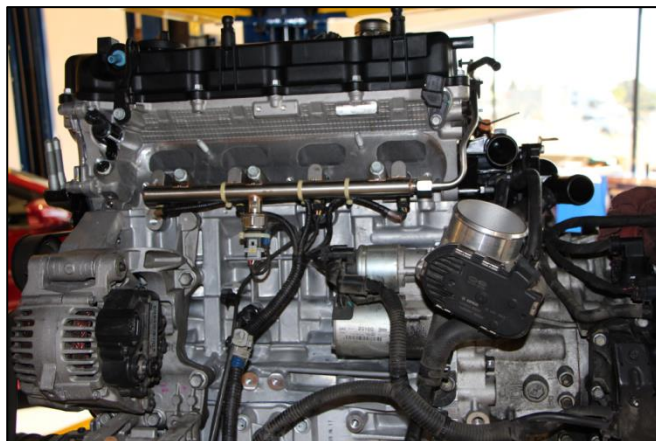
8. Reconnect and reinstall the engine front harness as shown.
- Be sure to properly route the opposite end of the harness end down towards the front of the engine.

9. Install newly supplied Oil Level Guide and Oil Level Rod Assemblies to the new engine.
- Be sure to install the NEW Oil Level Guide (dipstick tube) to the NEW engine.
  - Install the NEW Oil Level Rod Assembly (dipstick) to the NEW engine.

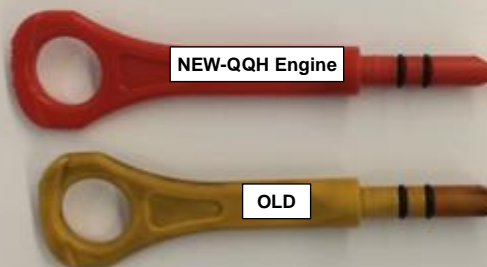
### Handle Color Differences

**NEW-QQH Engine: Red**  
**OLD: Yellow**

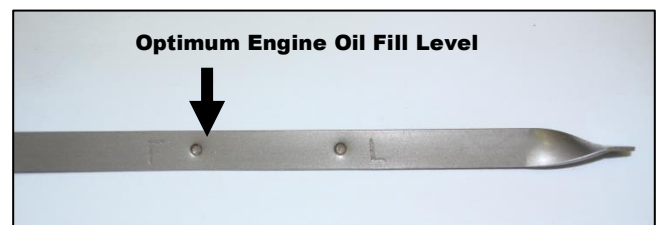
13. Start the engine to warm it up and begin the cooling system air bleeding process.
- During this time, check for any leaks.
  - After the engine has warmed up to normal operating temperature, turn the engine off, wait a few minutes, and then adjust the engine oil level to near the "F" mark as shown in the picture.
