HYUNDAI Technical Service Bulletin	GROUP CAMPAIGN	NUMBER 21-01-024H
	DATE MARCH 2021	MODEL(S) APPLICABLE VEHICLES BELOW
SUBJECT: DTC P1326 - ENGINE INSPECTION / REPLACEMENT (SERVICE CAMPAIGN T6G)

Description: Certain vehicles listed below may experience the Check Engine warning lamp illuminated with DTC P1326. Follow the procedure to inspect the vehicle and replace the engine and/or update the engine ECU software (if new ROM is available) based on the inspection results.

Certain 2016 MY Sonata HEV (LFE) vehicles with Nu 2.0L GDI Hybrid engines
 Certain 2012-2017 MY Veloster (FS) vehicles with Gamma 1.6L GDI engines

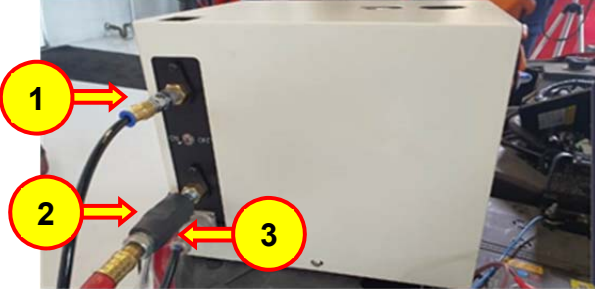
Part Name	Part Number / Figure	Note
BEARING CLEARANCE TESTER SET (BEARING TOOL)

<p>(1) TEST HOSE (2) MAIN HOSE (3) POWER SUPPLY CABLE</p> <p>One BEARING CLEARANCE TESTER SET provided to dealers. (Additional units can be ordered.)</p>	<p>Confirm the following pressures meet requirements. The correct ranges for AP/VC air pressures are also indicated with red/blue decals on the gauges:</p> <p>Shop air supply: 50 psi minimum</p> <p>AP: 0.1 ~ 0.11MPa VC: -73 ~ -83Kpa (Refer to TSB 20-GI-009H or later for calibration procedure)</p>

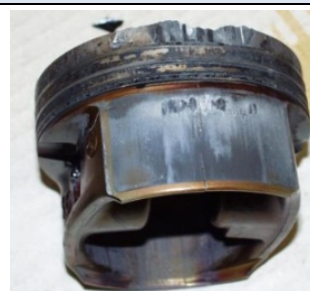
Poor oil maintenance reduces the engine oil lubrication and cooling capacities. As a result, internal engine parts can be damaged resulting in abnormal wear to internal engine parts, excessive carbon deposits, sludge, and other various conditions. An inspection for these conditions and others may be required prior to engine approval.

**Piston Ring Deposits**

**Oil Sludge**

**Excessive Wear**

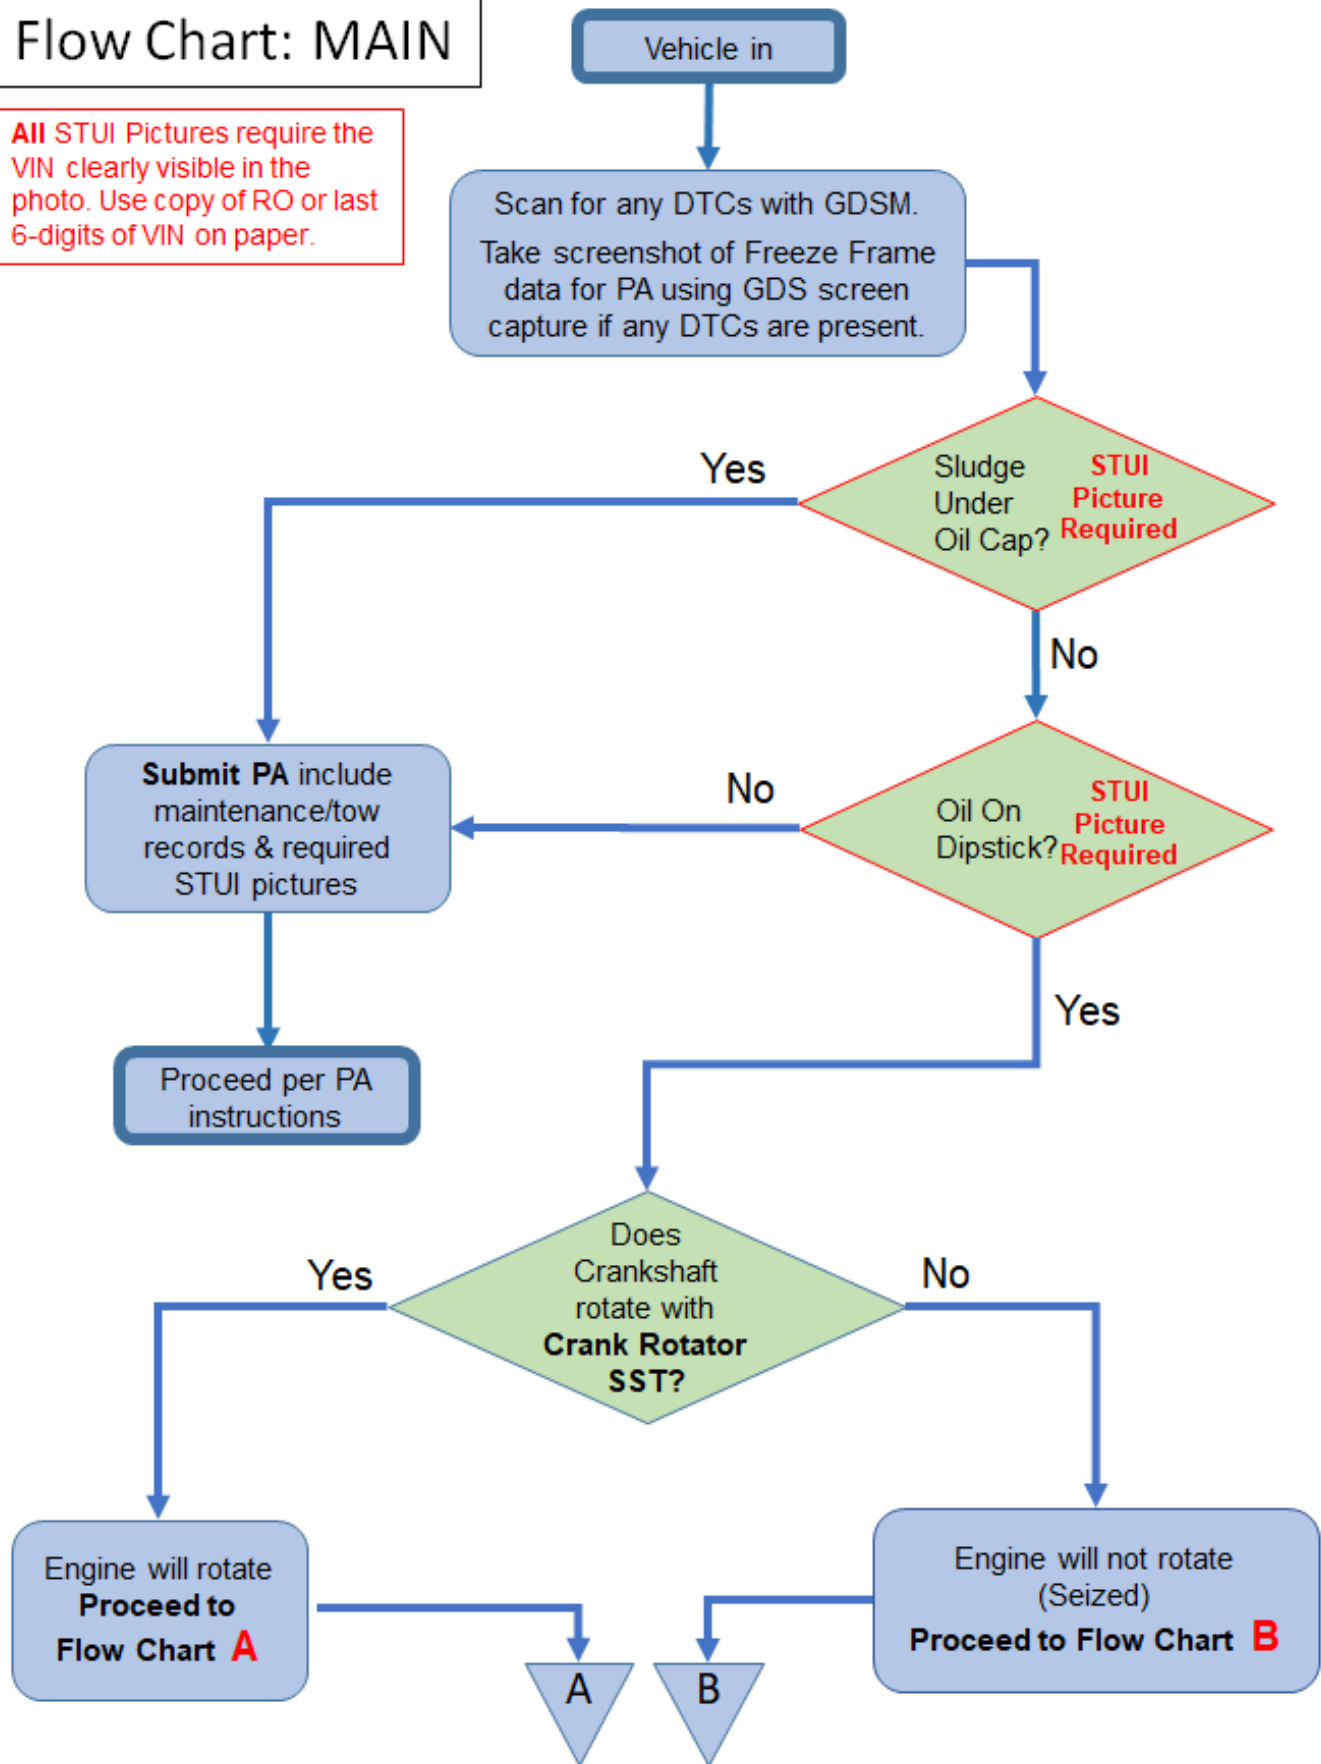
Flow Chart: MAIN

All STUI Pictures require the VIN clearly visible in the photo. Use copy of RO or last 6-digits of VIN on paper.

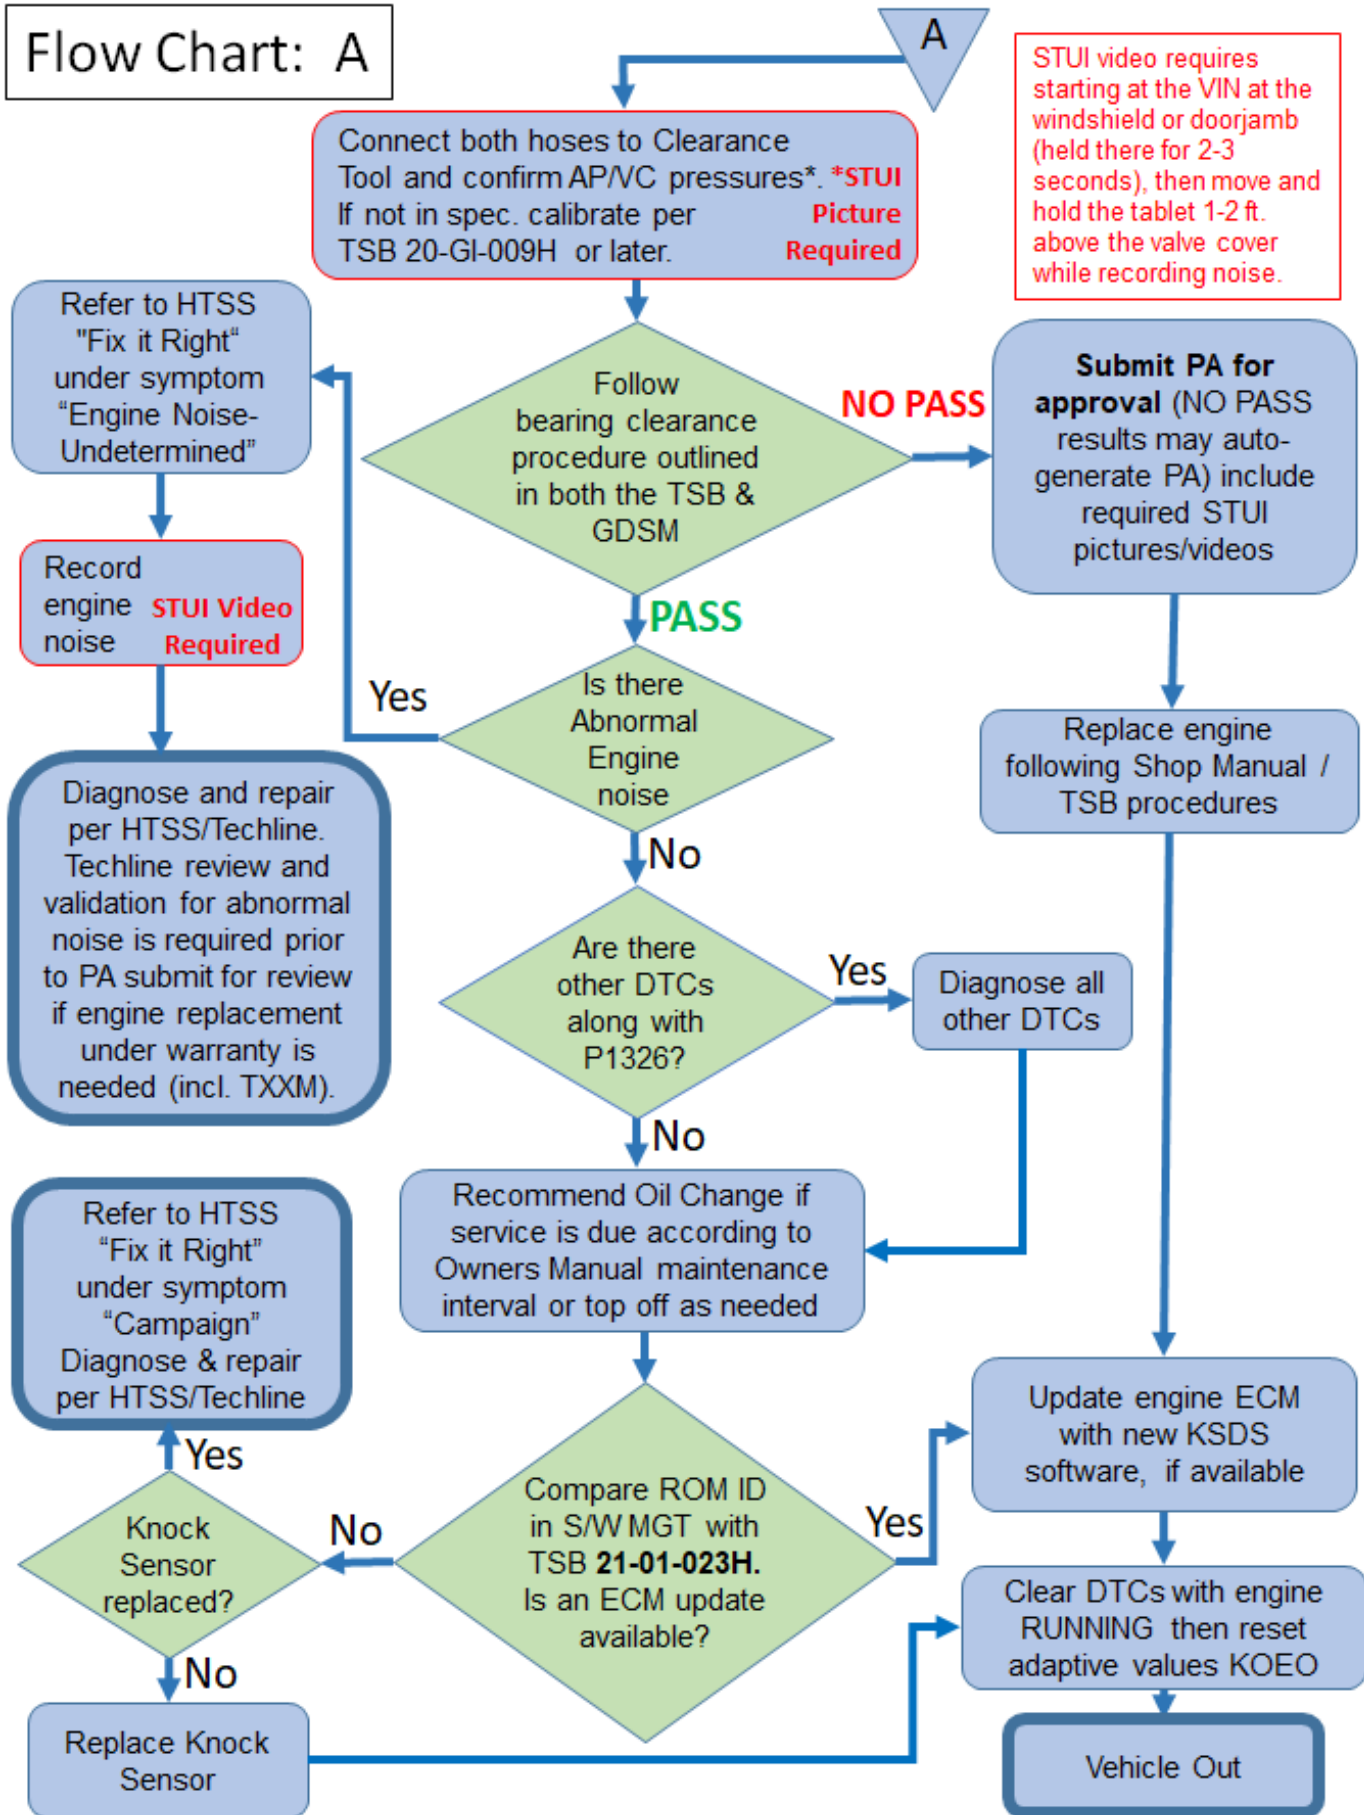
Flow Chart: A

STUI video requires starting at the VIN at the windshield or doorjamb (held there for 2-3 seconds), then move and hold the tablet 1-2 ft. above the valve cover while recording noise.

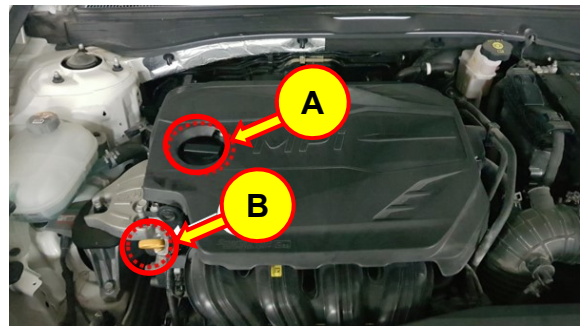
1. Remove the engine oil filler cap (A) and engine oil level gauge (B).

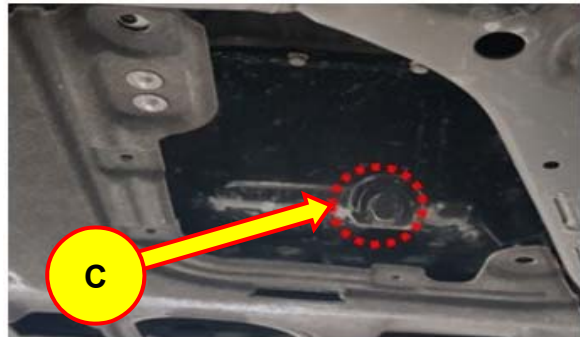
2. Lift up the vehicle and remove the oil drain plug (C).

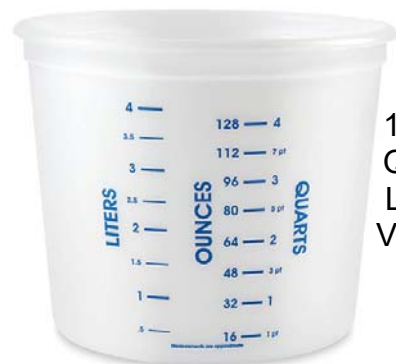
1 to 4
Quart
Level
Visible

3. Drain the engine oil into a container. The 1-4 quart level should be clearly marked and visible on the container. Using STUI in the GDS, take and submit a picture of the oil container with the drained oil level clearly visible and the VIN in the background of the photo (RO or last 6 digits written on paper) for records, if needed. **VIN must be legible.**

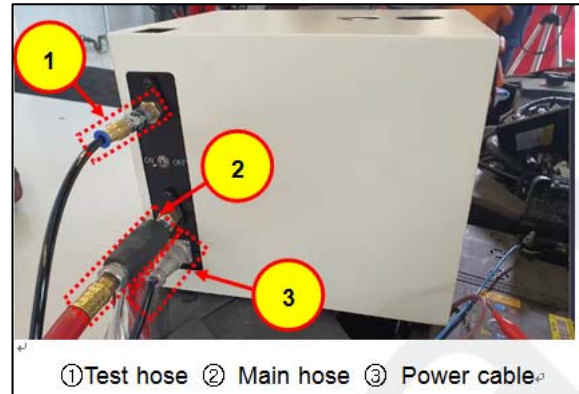
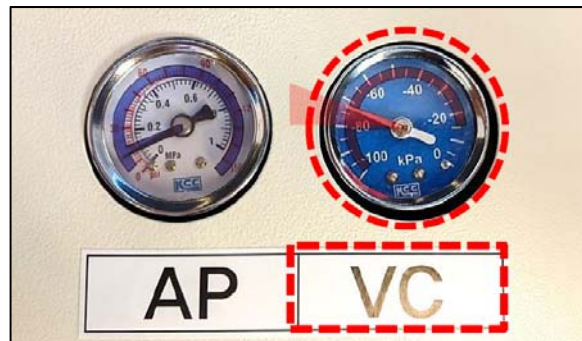
Confirm the shop air pressure and AP/VC pressures on the bearing tool meet requirements. The correct ranges for AP/VC air pressures are also indicated with red/blue decals on the gauges. Using STUI in the GDS, take and submit a picture of the gauges with the pressure levels clearly visible and the VIN in the background of the photo (RO or last 6 digits written on paper) for records.

Shop air supply: 50 psi minimum

- a) Connect the main air compressor hose.
- b) Connect the test hose. (The other end of the test hose should be left disconnected from the spark plug rod.)
- c) Confirm that the AP/VC toggle switch at top is in the middle position.
- d) Inspect the AP/C gauge indicators and compare to the specification range:
 - **AP:** 0.1 ~ 0.11MPa
 - **VC:** -73 ~ -83Kpa

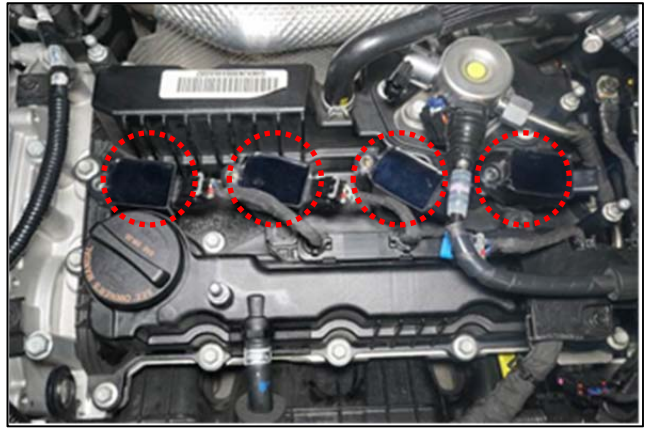
2. Remove the engine cover and the 4 ignition coils.

Tightening Torque (ignition coils):
9.8 - 11.8 N·m
(1.0 - 1.2 kgf·m, 7.2 - 8.7 lb·ft)

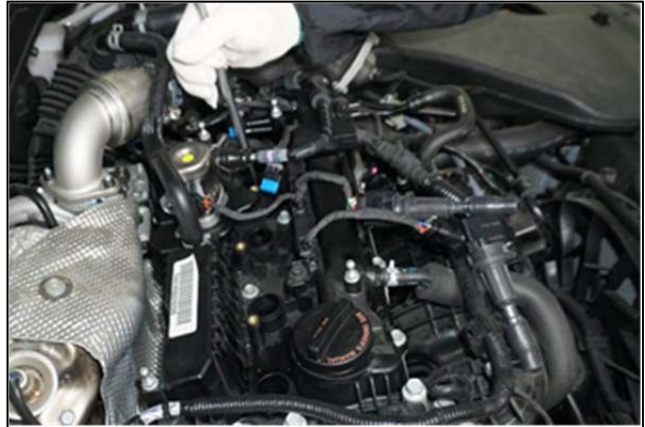
3. Remove the 4 spark plugs.

Tightening Torque:
14.7 - 24.5 N·m
(1.5 - 2.5 kgf·m, 10.9 - 18.0 lb·ft)

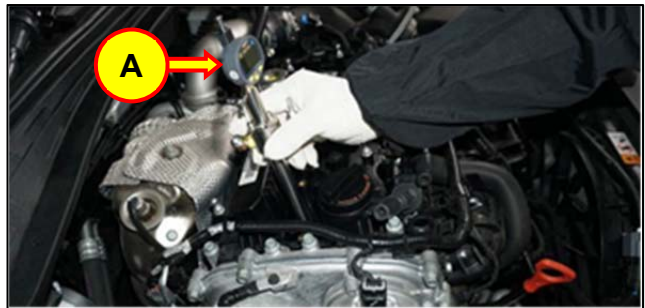
4. Insert the appropriate (use **M12 for GDI and Theta MPI Hybrid** engines or **M14 for all other MPI** engines) spark plug rod SST (A) into Cylinder #1 spark plug hole and turn until hand tight. Insert the clearance gauge SST into the spark plug rod and tighten using the thumb screw.

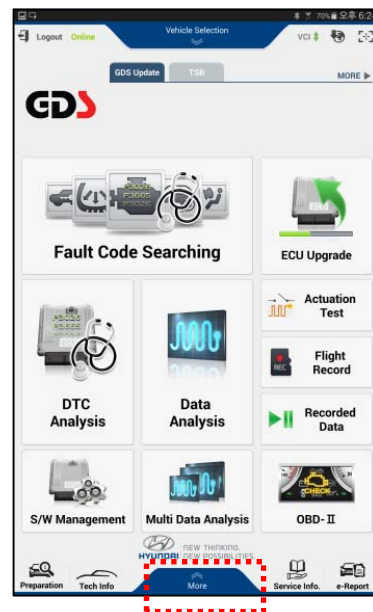
6. Swipe up on the 'More' tab at the bottom of the GDS home screen. Select the 'Special Inspection' function.

7. Enter the vehicle info into the GDS as prompted then select 'Next'.

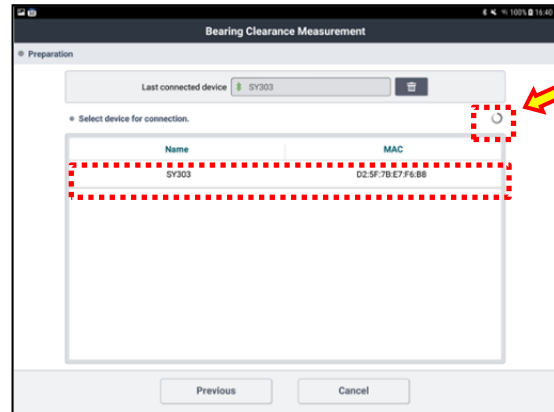
- Press the “Set” button (B) on the gauge to turn it on.
- Press the “Set” (B) and “Mode” (C) buttons at the same time for about 4 sec until the “reset” message is displayed.
- Select the gauge in the list of devices on the GDS. Select the ‘Refresh’ icon (D) if the gauge doesn’t appear automatically.

- Check that the ball point tip (E) of the clearance gauge SST is securely installed to the tool as shown. **Do not continue if ball point tip (E) is loose or missing.**

If loose, apply Blue Loctite (or equivalent) to the tip thread and retighten securely to the gauge plunger.

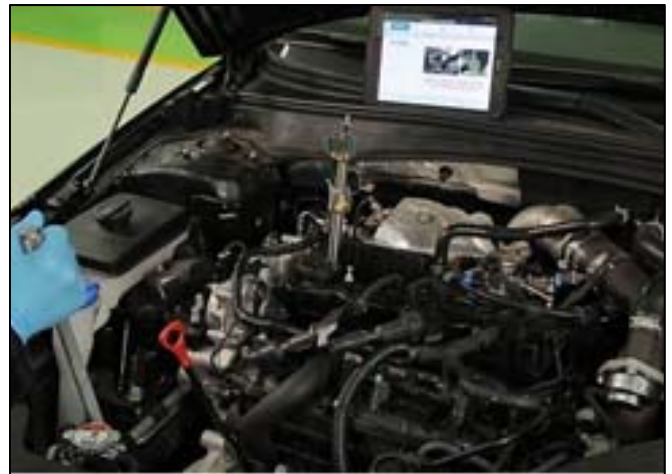
- ❖ Monitor the piston height value on GDS screen or the clearance gauge SST while rotating the engine clockwise using the Crank Rotator Tool.
 - Rotate the engine **SLOWLY** as the value increases towards a MAX value. (BTDC → TDC)
 - When the value changes direction (increasing/BTDC → TDC → decreasing/ATDC), stop rotating the crank when the piston height is at MAX value minus 0.03mm.

The testing point is slightly towards ATDC from TDC when the piston has moved down 0.03mm from its highest position.

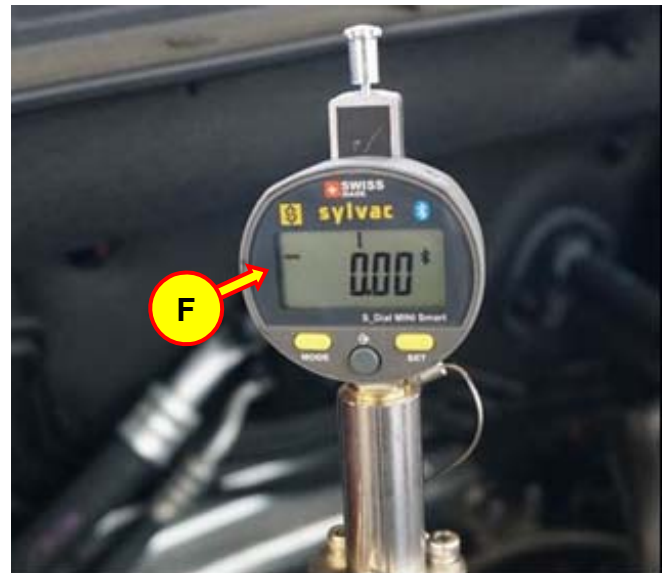
12. Select 'Next' when TDC is found.
- ❖ Ideal set point for testing from TDC is found when the maximum value minus 0.03mm is reached on the clearance gauge SST (F).
 - ❖ The value is also displayed on the GDS.
13. Once the set point for bearing testing is found, select 'Start' in the GDS screen and proceed directly to the next step below.
- Do not turn the crank rotator SST until instructed to do so.

The value at TDC varies depending on the specific vehicle and engine type.

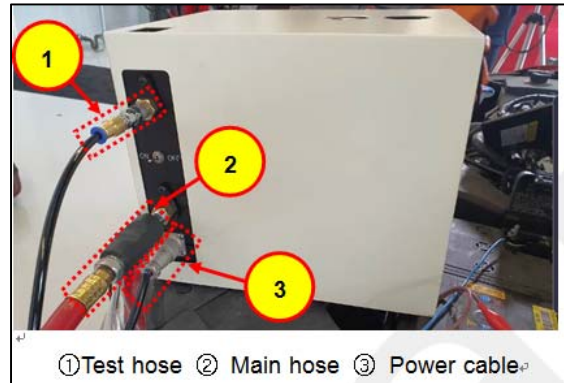
14. Connect the test hose (1) to the spark plug rod SST and to the bearing tool SST.

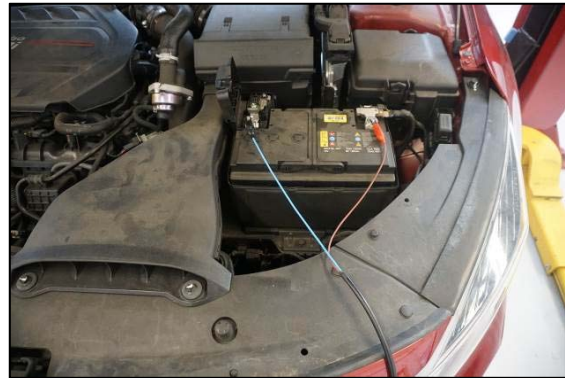
15. Connect the SST power cables to a fully charged 12V battery or to an external AC/DC power supply.

- Turn the bearing tool SST power switch 'ON'.

- a) Supply 12 volts (or an alternate external AC/DC 13.8 volt power supply with at least ~2 amp output) to the power cable (3) connected to the bearing tool SST.
- b) Turn power switch to ON.
- c) Toggle AP/VC transfer switch between AP <> VC.
 - ❖ The solenoids should "click" while switching between AP/VC when the unit is ON.
 - ❖ If the solenoids are not switching, then check the power cable or the power supply.

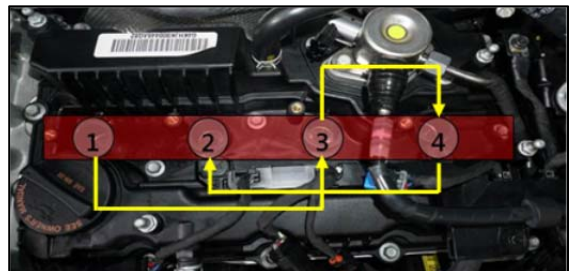
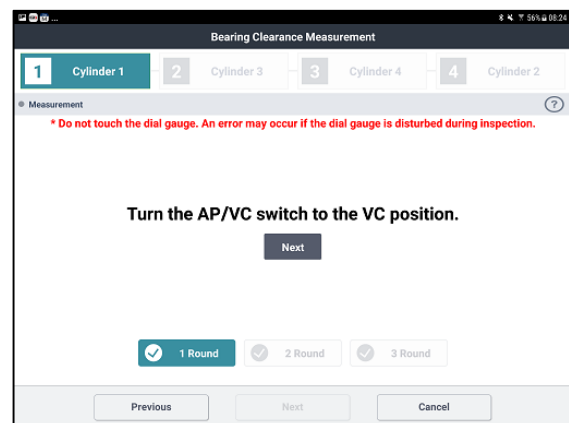
18. On the bearing tool SST, change the AP/VC switch to the VC position when instructed by the GDS.

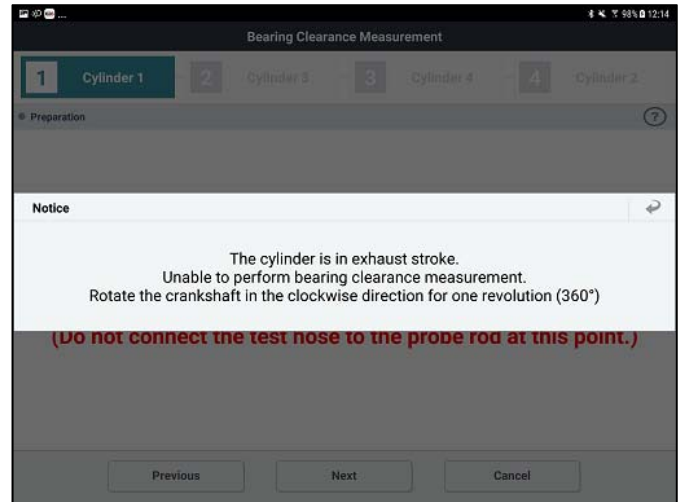
If the bearing measurement value does not change when the AP/VC is switched or the “Unable to measure” message appears on the GDS, rotate the crankshaft further as the exhaust valves could be open. Set the crankshaft to TDC again (Step 11).

Ensure the test hose is disconnected from the clearance gauge SST when finding TDC.

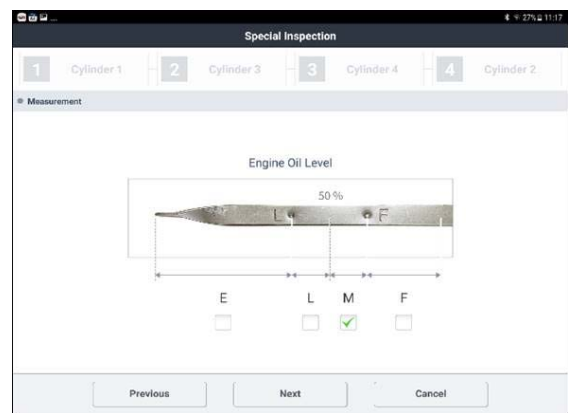
19. Continue following the instructions on the GDS to complete the bearing inspection. Check the engine oil level and select the level in the GDS.

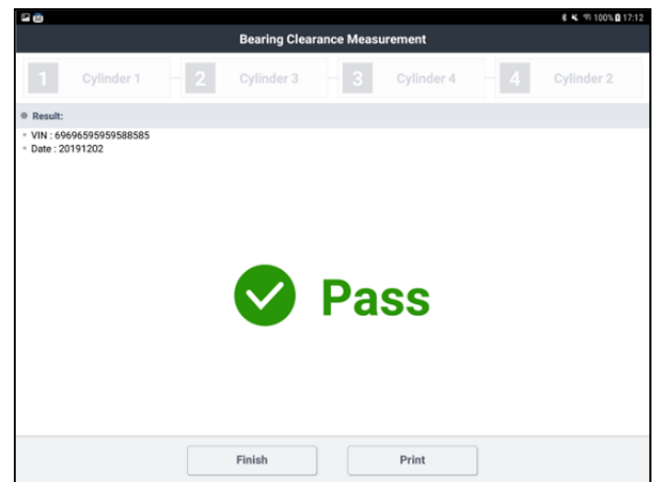
20. If the test result is “PASS”:

a) Save a screenshot of the results screen.

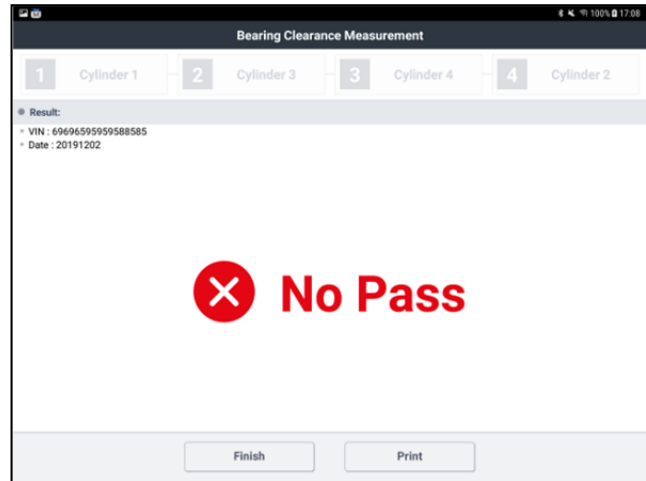
If the test result is “NO PASS”:

- Save a screenshot of the results screen.
- Submit PA for engine replacement approval.
- Follow remainder of Flow Chart A and Engine Replacement section of this TSB to complete the service procedure.
- Check for DTCs and perform the appropriate diagnostic service. Ensure no warning lights are present to complete the procedure.

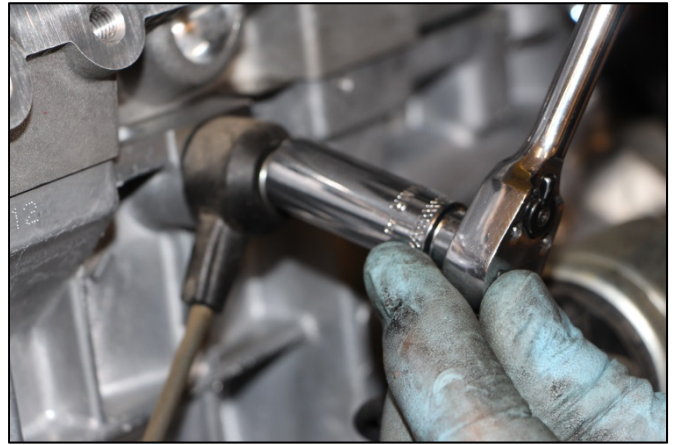
4. Remove and reinstall the engine knock sensor from the old engine to the new engine.

Knock Sensor Fastener Tightening torque:
21Nm (15.5lb-ft)

Ensure the knock sensor is torqued to specification using a torque wrench.

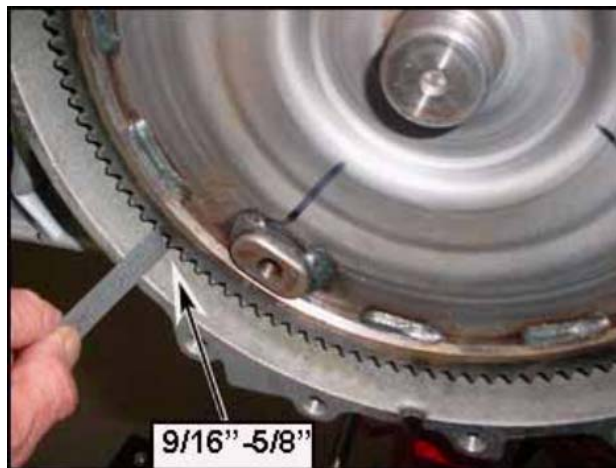
(For Automatic Transmissions equipped w/ torque converters only) If the torque converter has moved from the fully inserted position, carefully push inward and rotate the torque converter until the converter is recessed approximately 5/16" - 9/16" (8 -14 mm) into the transaxle case when reinstalling the automatic transaxle.

Check the depth of the torque converter to confirm it's fully installed in the transmission otherwise the oil pump may be damaged resulting in transmission failure.

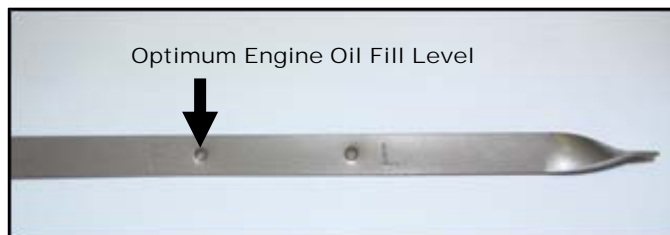
- Check for any leaks during this time.
- After the engine has warmed up to normal operating temperature, turn the engine off, wait a few minutes, and then **adjust the engine oil level to near the "F" mark as shown.**
