HYUNDAI Technical Service Bulletin	GROUP CAMPAIGN	NUMBER 22-01-023H-1
	DATE APRIL 2022	MODEL(S) APPLICABLE VEHICLES BELOW
SUBJECT: DTC P1326 - ENGINE BEARING INSPECTION / ENGINE REPLACEMENT (SERVICE CAMPAIGN T6G)

Description: Certain vehicles listed below may experience the Check Engine warning lamp illuminated with DTC P1326 and/or an engine concern/noise related to connecting rod bearing wear or damage. Follow the procedure to inspect the vehicle and replace the engine and/or update the engine ECU software (if new ROM is available) based on the inspection results.

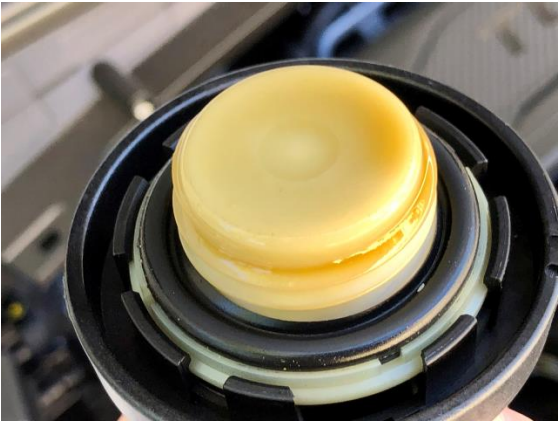
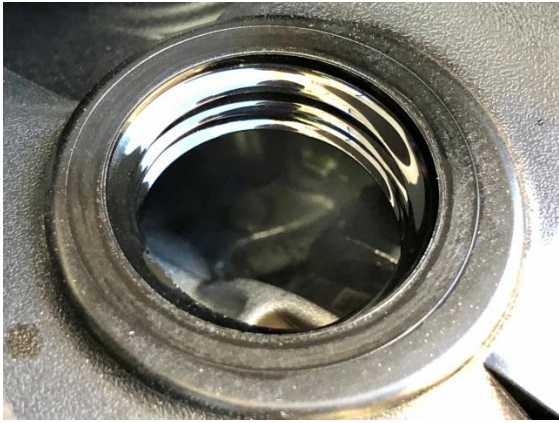
Oil filler cap: Clear view of cap underside	Oil filler opening: Clear view inside opening.

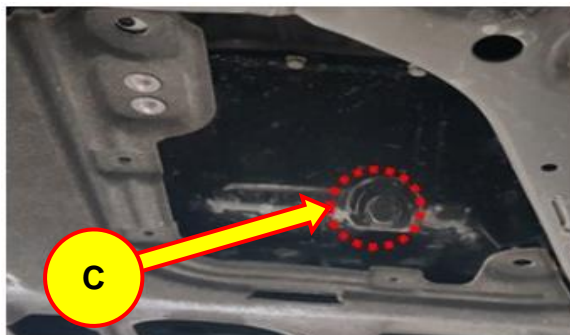
2. Lift up the vehicle and remove the oil drain plug (C).

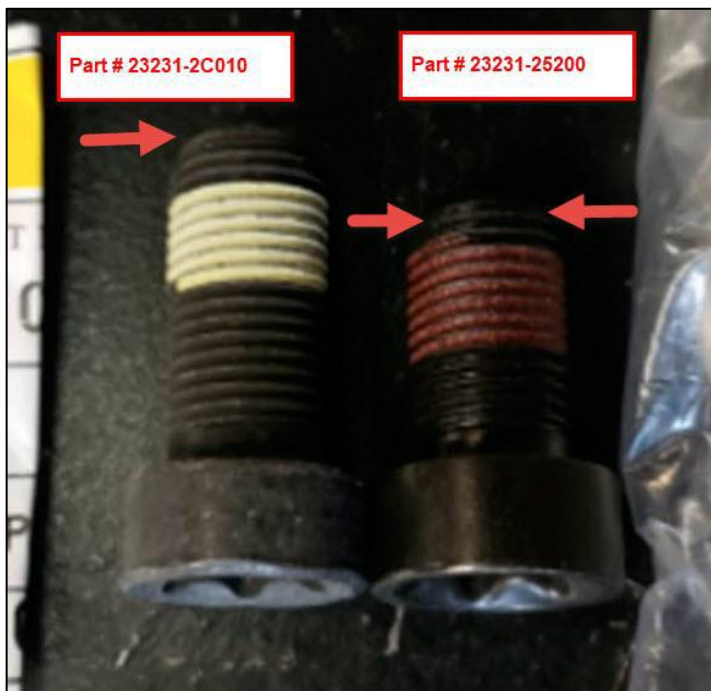
When installing a new engine, the drive plate bolts must be replaced with P/N 23231-25200.

- ❖ Due to changes to the crankshaft design, the existing bolts are ~2mm too long and will result in improperly fastened drive plate if reused.
- ❖ The 13-15MY version drive plate bolts (P/N 23231-25200) are correct length for the new engine and will provide proper fastening during engine installation.

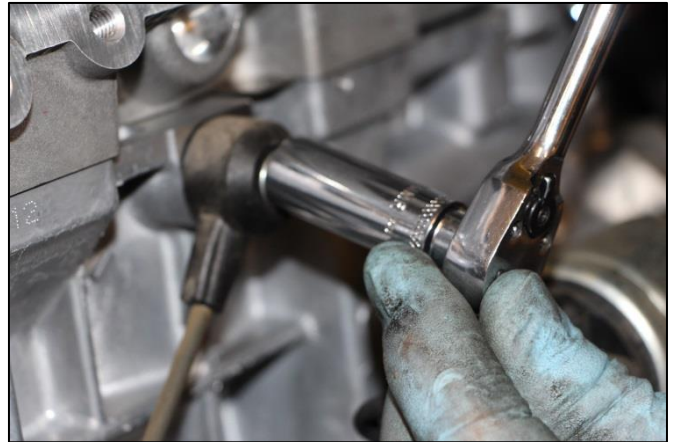
3. Remove and reinstall the engine knock sensor (if not newly supplied) from the old engine to the new engine.

Knock Sensor Fastener Tightening torque:
21Nm (15.5lb-ft)

Ensure the knock sensor is torqued to specification using a torque wrench.

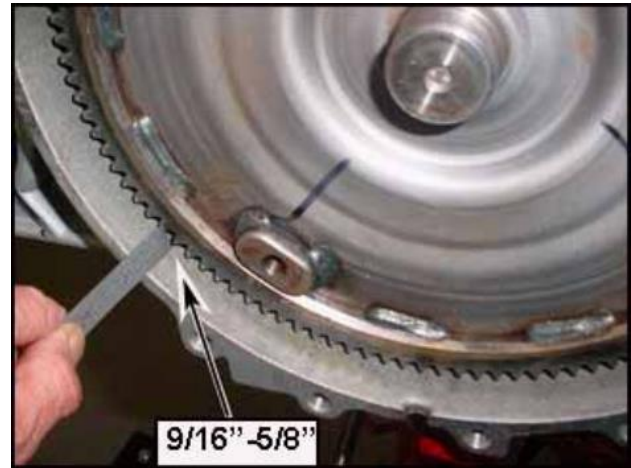
(For Automatic Transmissions equipped w/ torque converters only) If the torque converter has moved from the fully inserted position, carefully push inward and rotate the torque converter until the converter is recessed approximately 5/16" - 9/16" (8 -14 mm) into the transaxle case when reinstalling the automatic transaxle.

Check the depth of the torque converter to confirm it's fully installed in the transmission otherwise the oil pump may be damaged resulting in transmission failure.

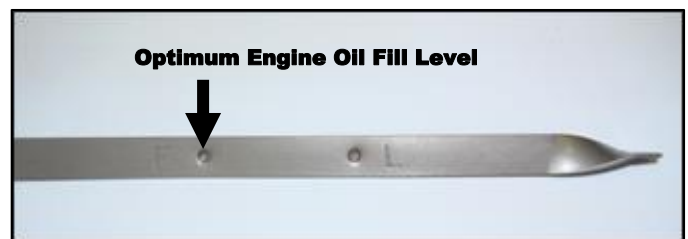
- Check for any leaks during this time.
 - After the engine has warmed up to normal operating temperature, turn the engine off, wait a few minutes, and then **adjust the engine oil level to near the "F" mark as shown.**
