# Service Bulletin

**Subject:** Airbag Malfunction Warning and Airbag Malfunction Indicator Illuminated with DTC B0001-1B or B0012-0D

Bulletin 21-NA-005 - Released on 03/18/21

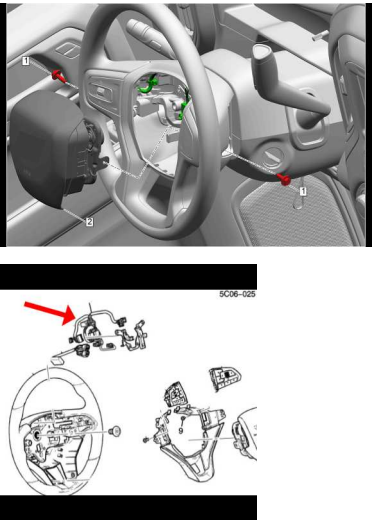
| <b>Condition</b> | Some customers may comment on an airbag malfunction warning and airbag malfunction indicator illuminated. During diagnosis a technician may find DTC B0001-1B or B0012-0D set. |
| <b>Cause</b> | <p>The cause of the condition may be rust particles in the connection terminal interface causing excessive resistance.</p> |

| <b>Correction</b> | In order to correct the condition, both halves of the interface (Driver Side Airbag Module and the Steering Wheel Wiring Harness) must be replaced to restore a proper connection. |

If you encounter a vehicle with the above concern, replace the steering wheel airbag and steering wheel harness. Refer to *Steering Wheel Airbag Replacement* in SI.
