**Subject:** Follow-up Discussion: Super Duty Vehicle Reviews Tailgate Next Steps

dealership contacted Ford, vehicle exhibiting unintended tailgate opening

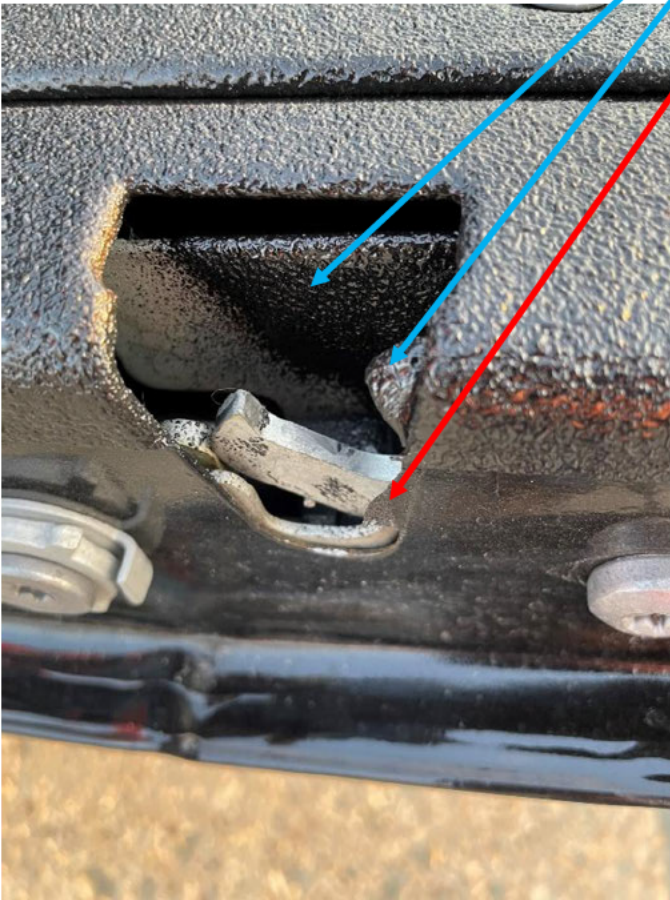
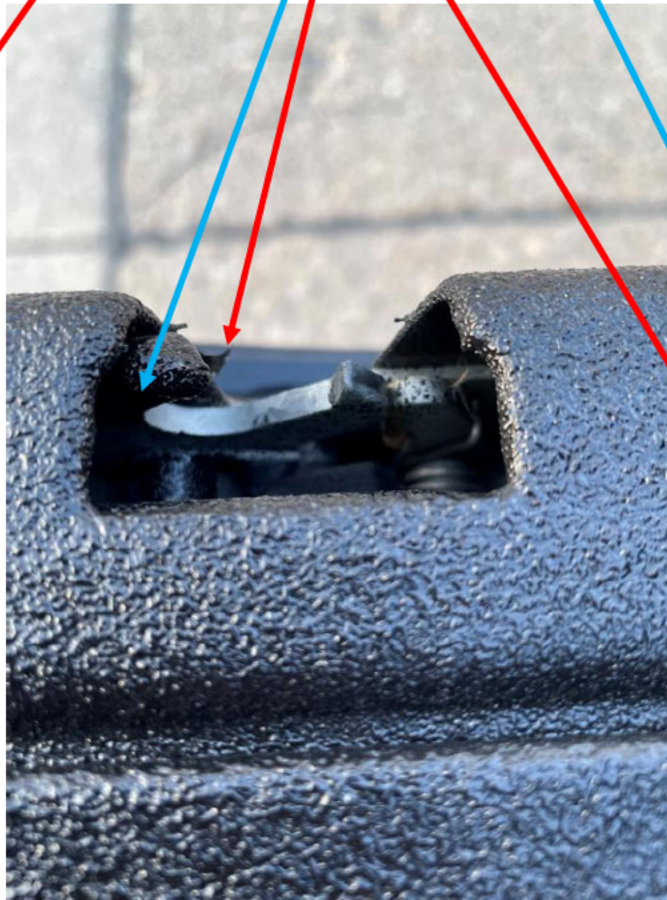
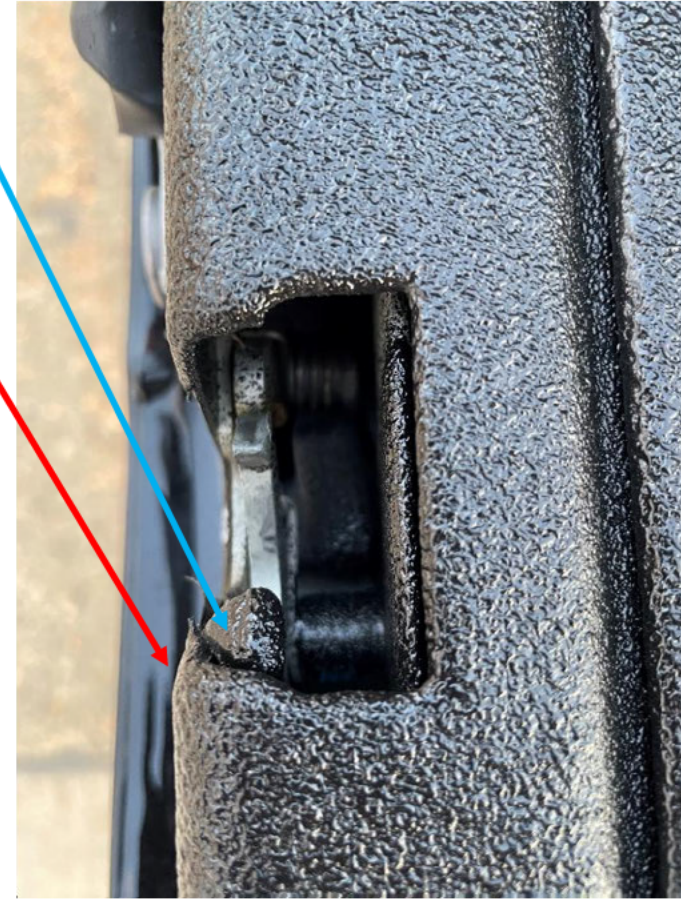
LH Side  
Tailgate Latch

Overspray of bedliner treatment  
directly on latch components

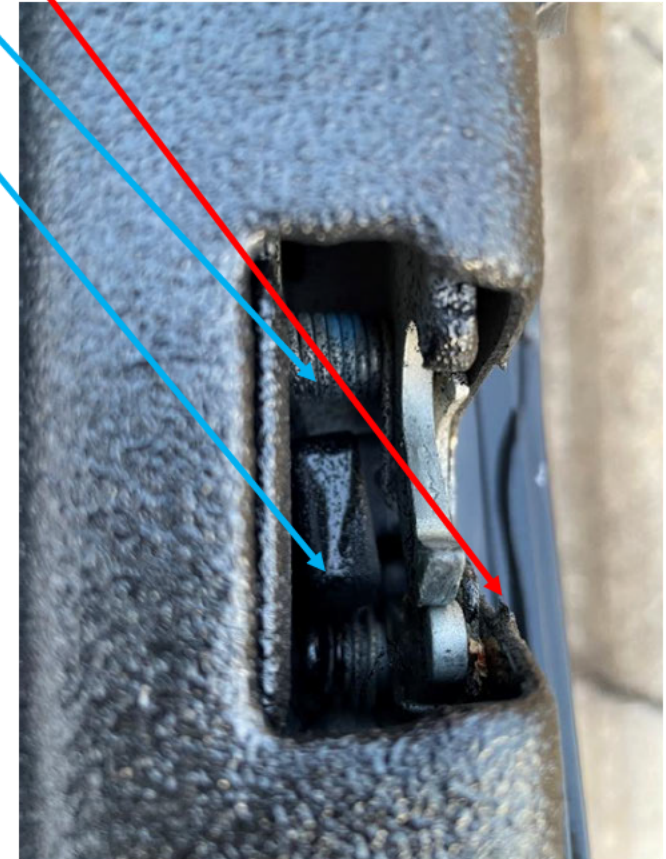
RH Side  
Tailgate Latch

Overspray of bedliner treatment  
directly on latch components

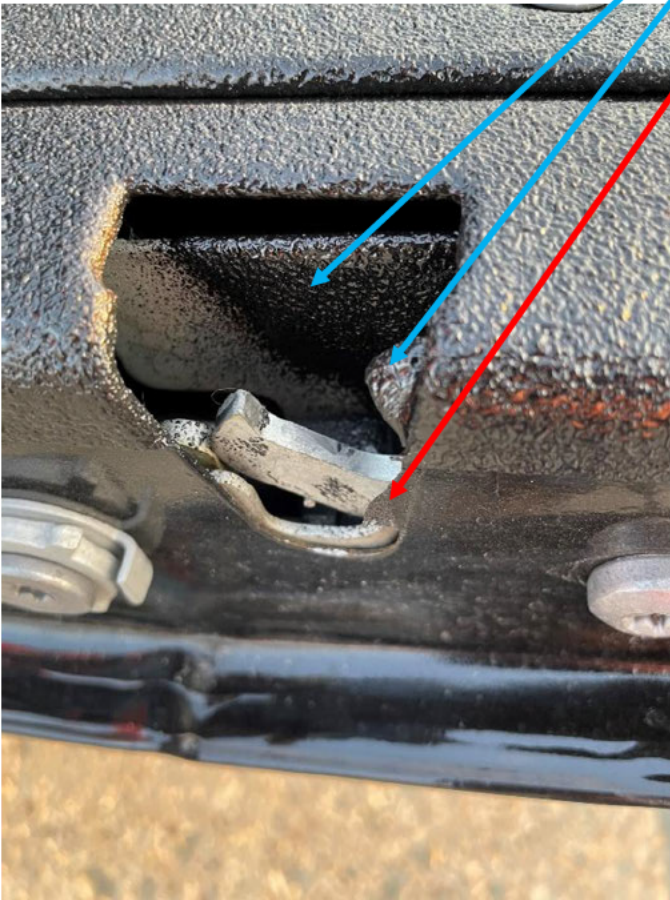
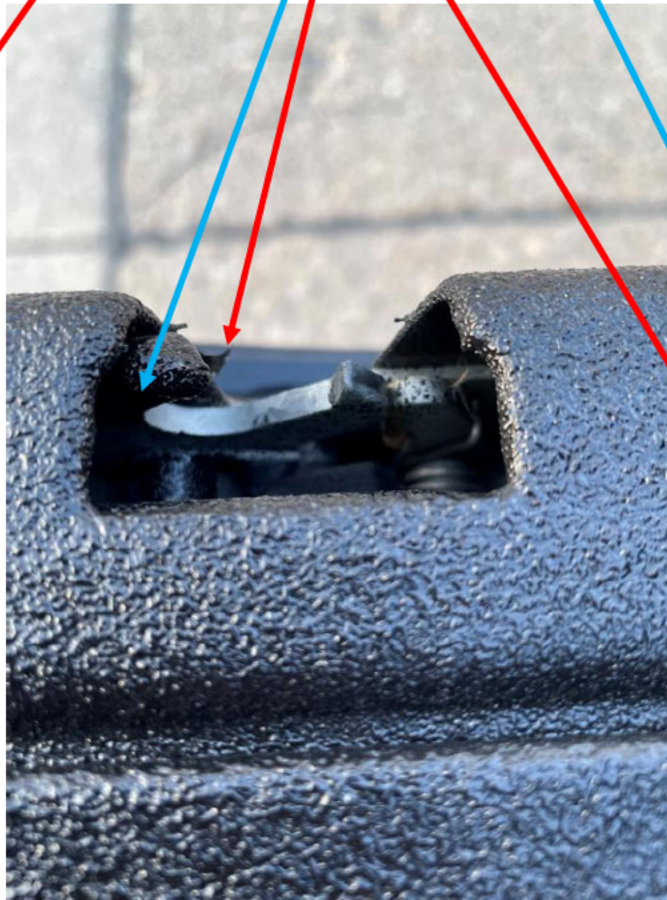
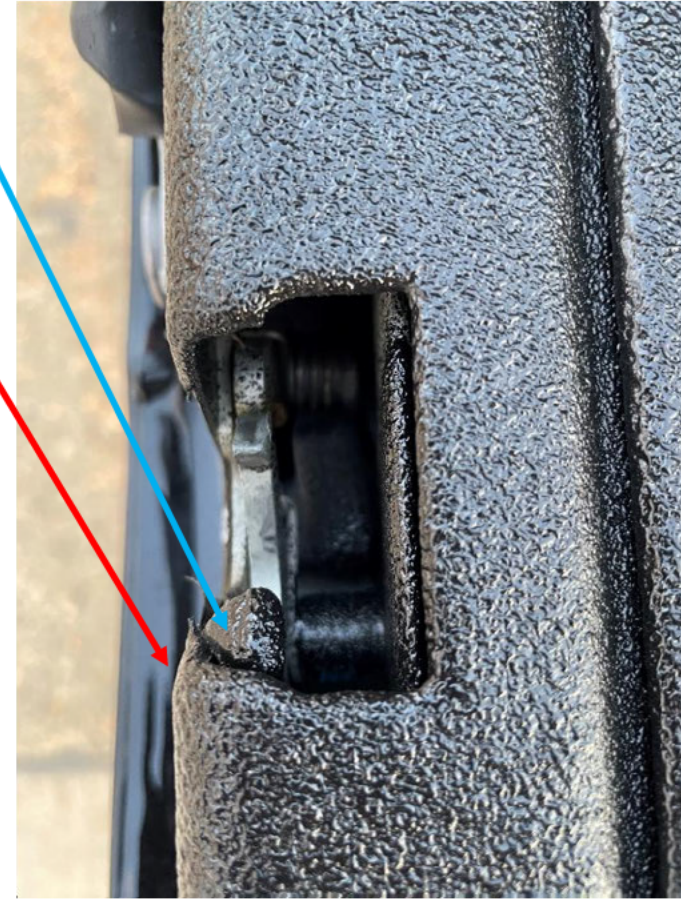
LH Side  
Tailgate Latch

Overspray of bedliner treatment  
directly on latch components

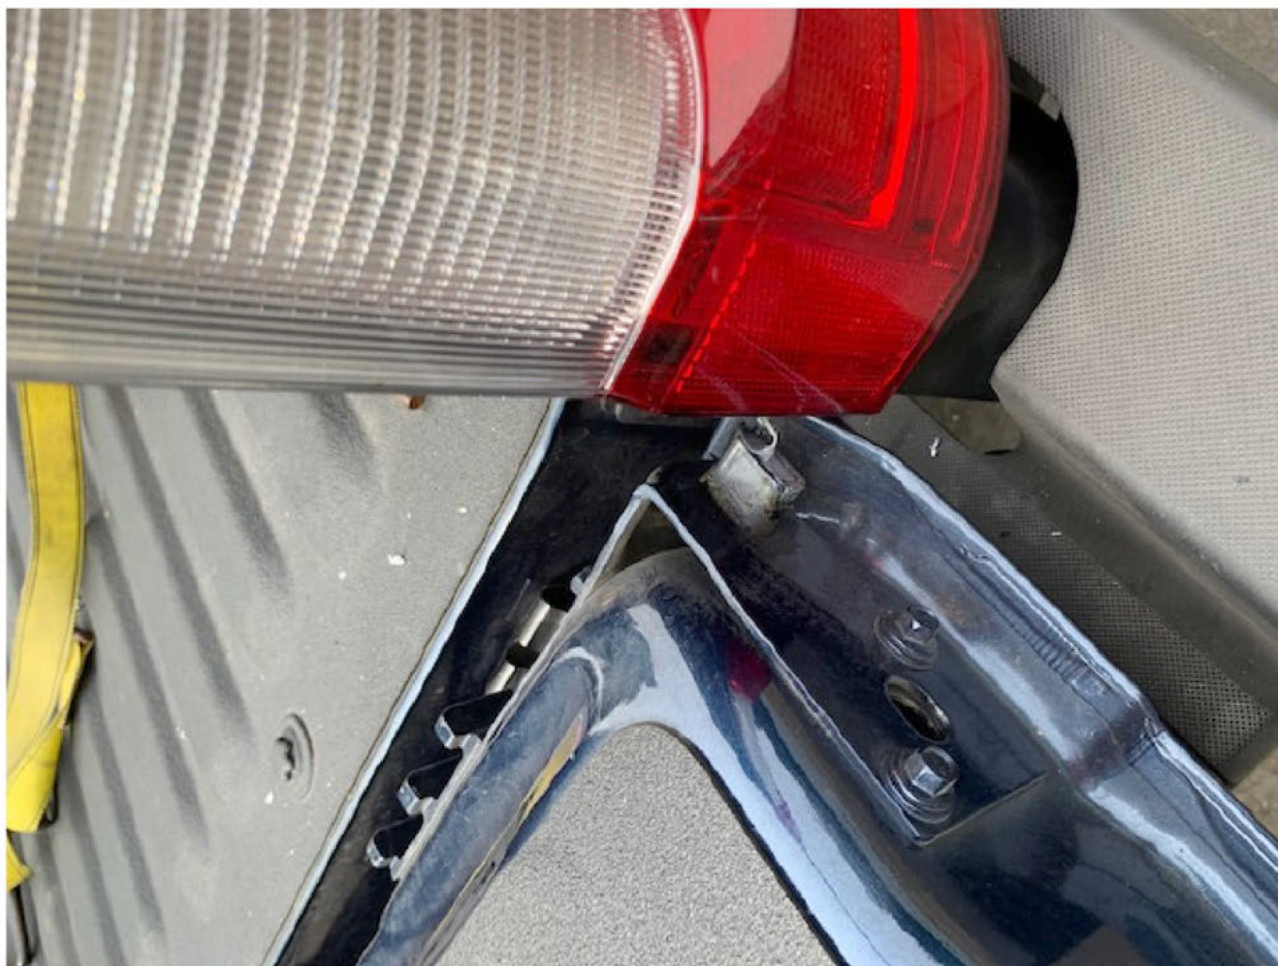
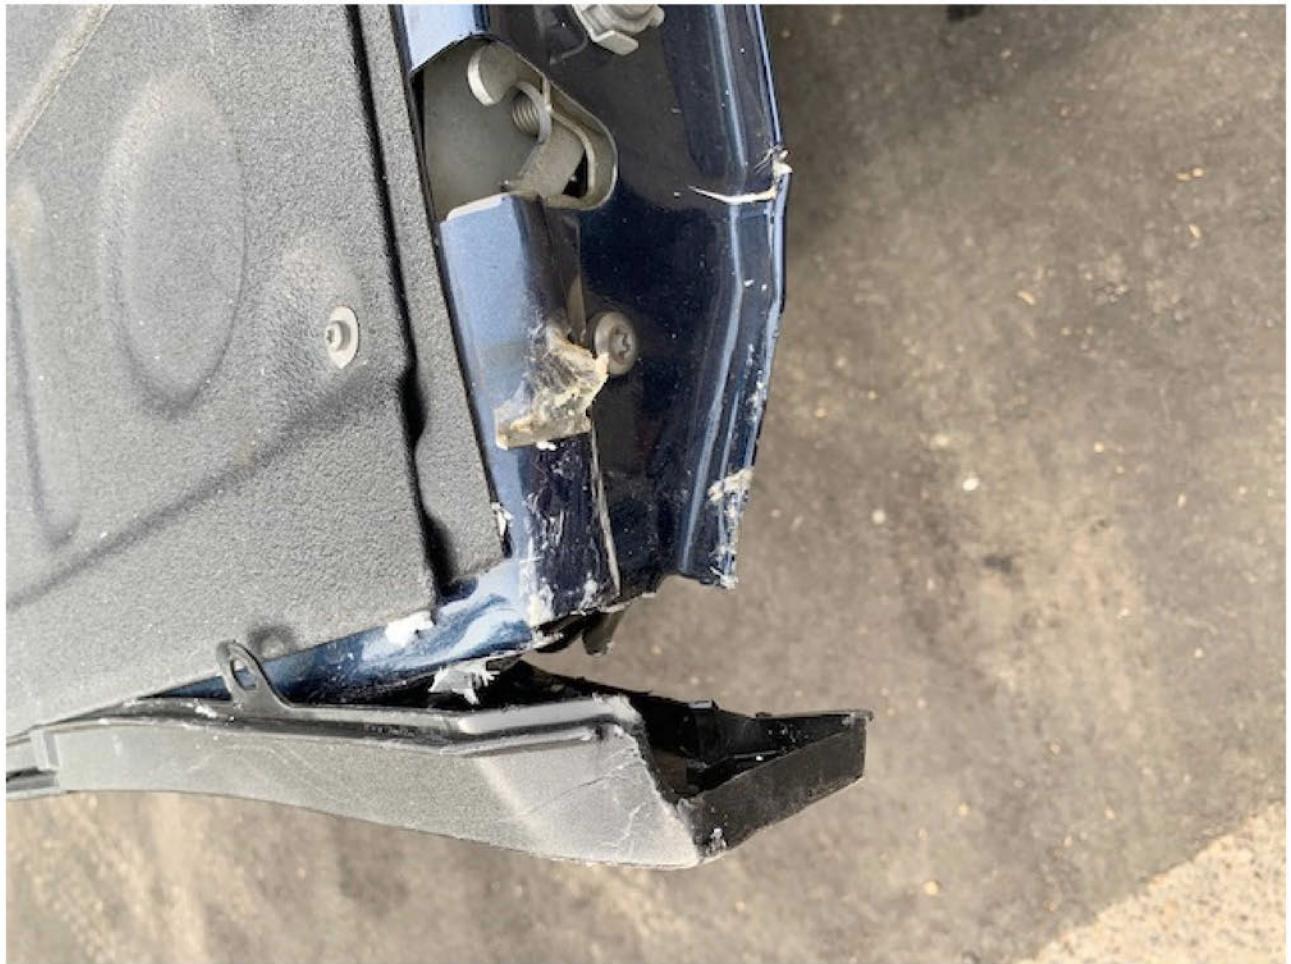
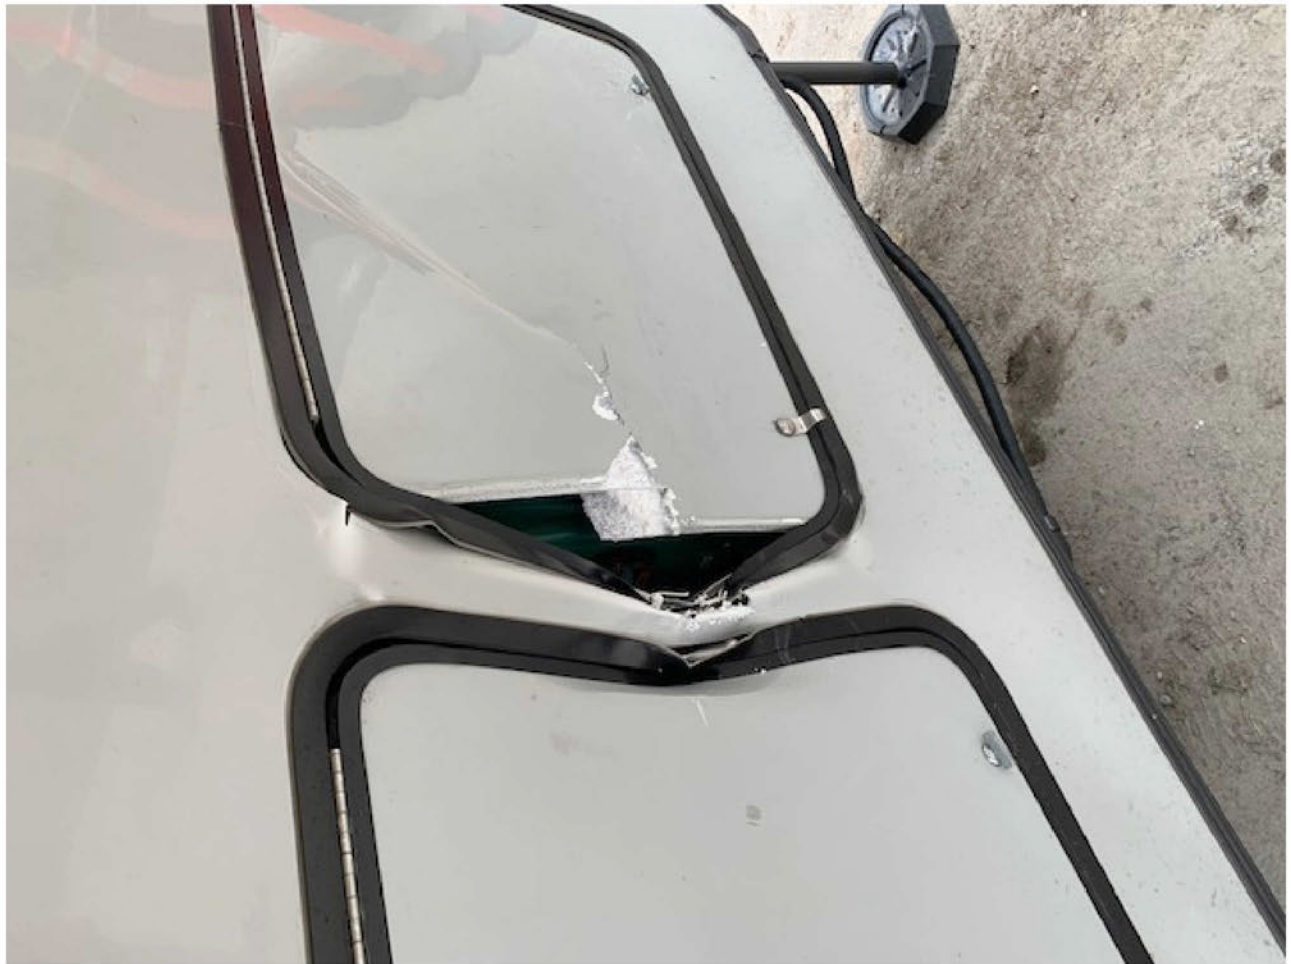
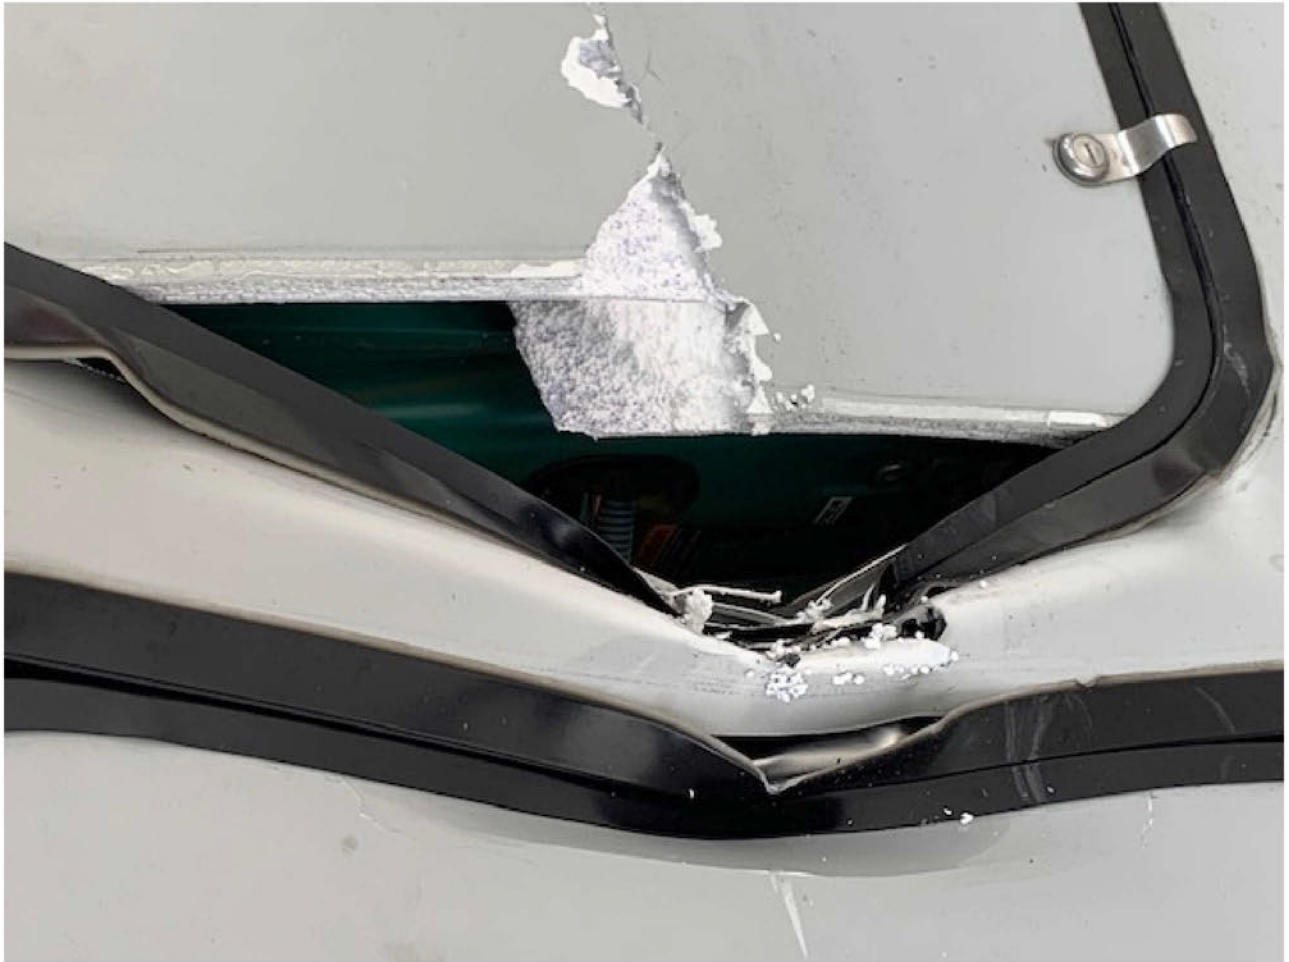
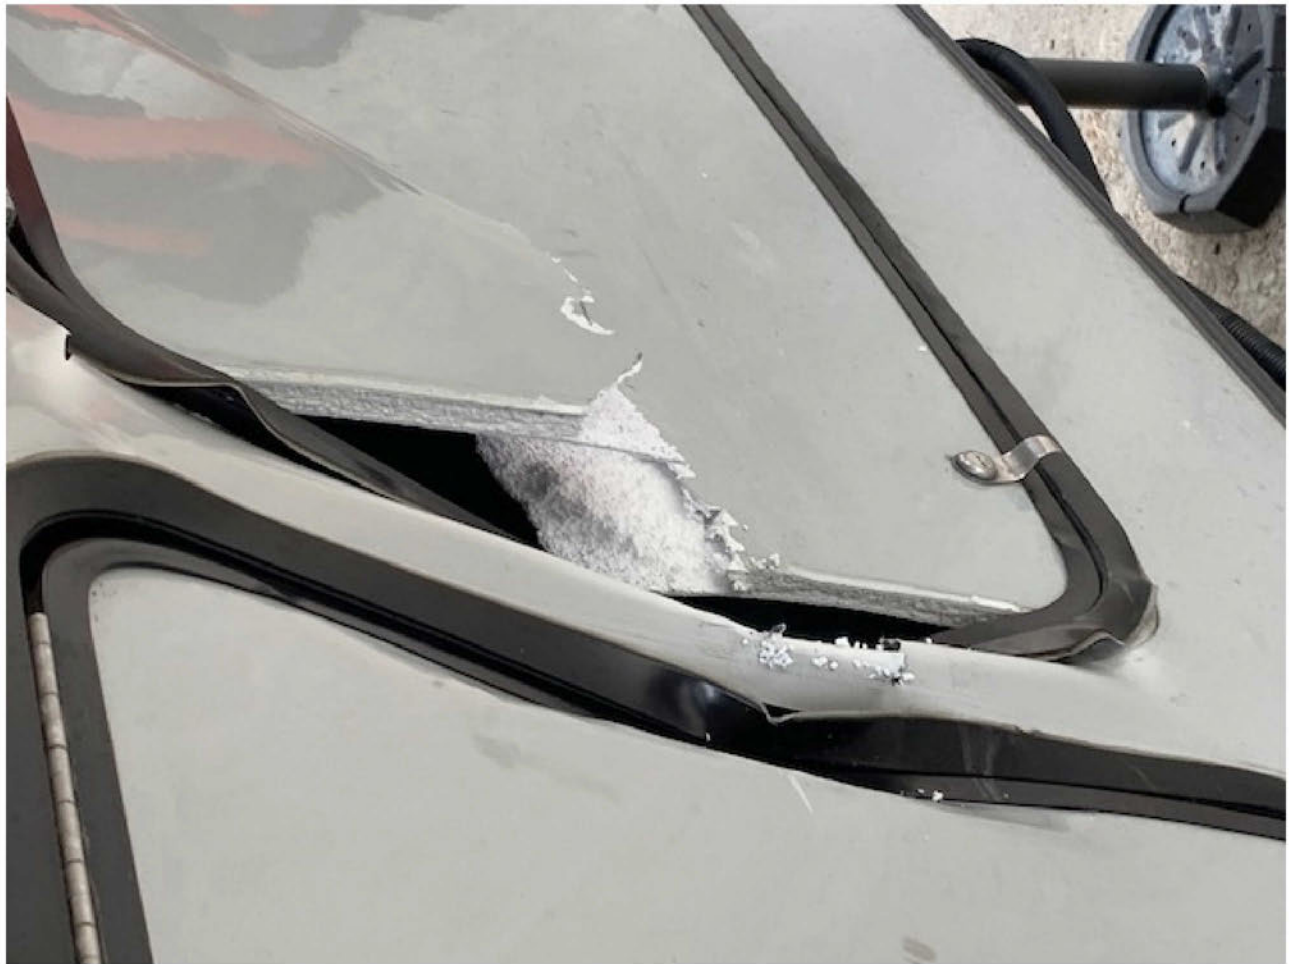
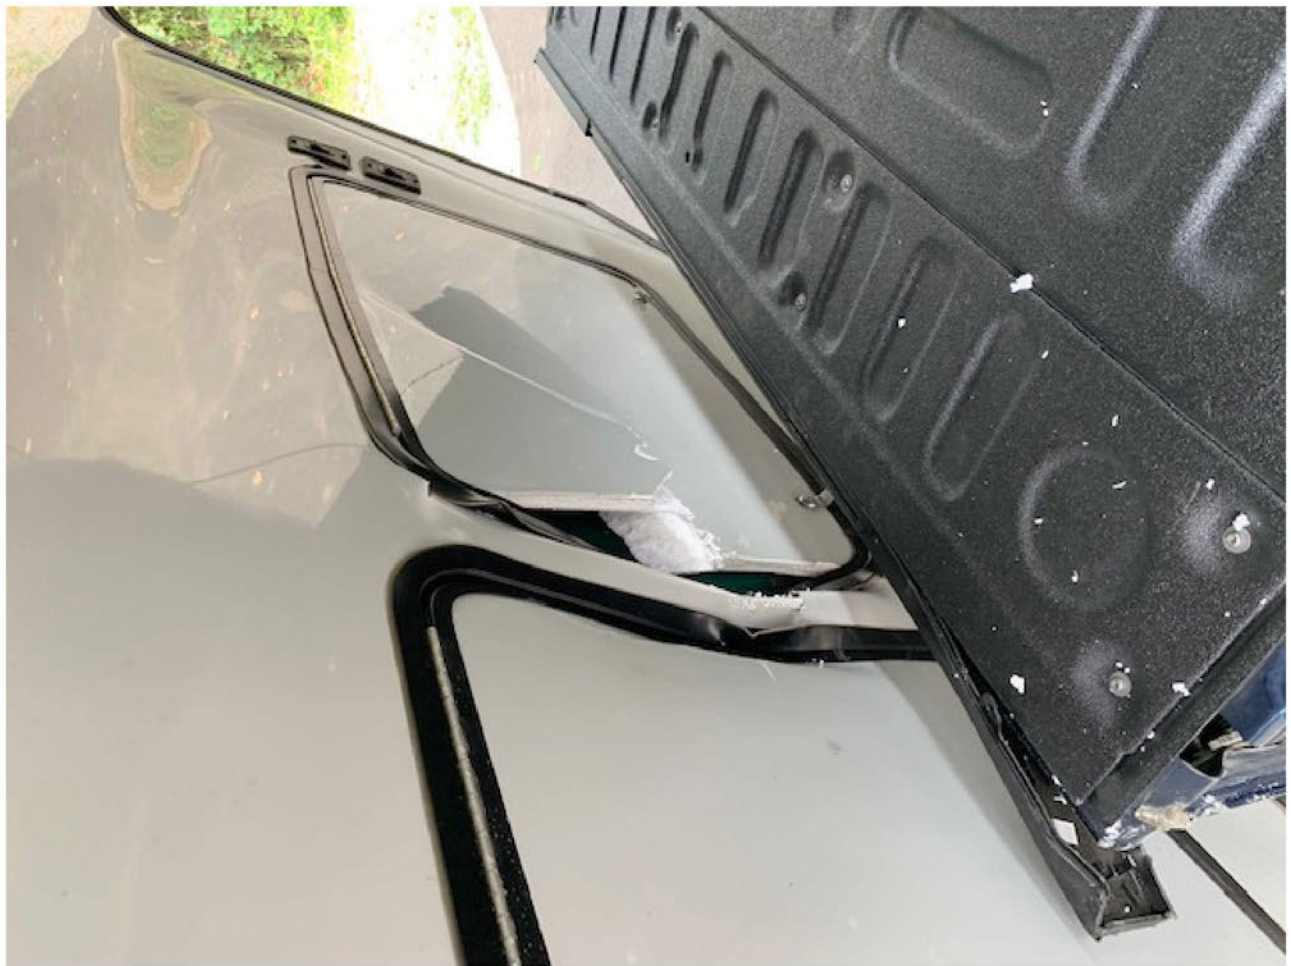
That's my 2017 40foot raptor that got damaged from the tail gate dropping.
