Re: 5th Set of New Cases for DP22-003; defect investigation of Hyundai/Kia oil drain pan assemblies

The Two Most Common Oil Drain Pan Assemblies in DP22-003 Cases & *In re: Hyundai and Kia Engine Litigation*

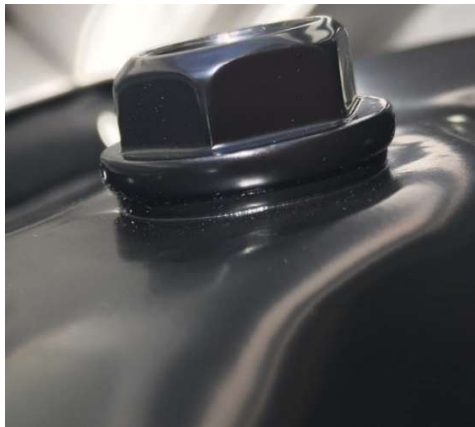
H/K factory oil drain pan 21510-2G500 is listed by the manufacturers as fitting 83 vehicles: 2006-2019 Hyundai Sonata, 2011-2015 Hyundai Sonata Hybrid, 2013-2018 Hyundai Santa Fe Sport, 2010-2012 & 2019-2020 Hyundai Santa Fe, 2010-2015 & 2018-2019 Hyundai Tucson, 2011-2021 Kia Sportage, 2005-2020 Kia Optima, 2011-2016 Kia Optima Hybrid, 2011-2020 Kia Sorento, 2010-2013 Kia Forte, 2010-2013 Kia Forte Coup, & 2007-2010 Kia Rondo.

Overall, two Hyundai/Kia oil drain pan assemblies show up in 73% of reported cases: 21510-2E023 (36%) and 21510-2G500 (37%). They also comprise 77% of oil drain pan assemblies on the models in the consolidation of multiple product liability class actions now known as *In re: Hyundai and Kia Engine Litigation* (Case 8:18-cv-02223-JLS-JDE)ⁱ at 37% and 40%, respectively. The next most common part in our case submissions is 21510-2E022 at 6%. Three parts represent 3% each: 21510-2J001, 21510-2B700, and 21510-2B040. Three parts represent 2% each: 21510-3C201, 21510-2M800, and 21510-2S100. Three parts represent 1.3% each: 21510-3LFB0, 21510-25001, and 21510-3C153. Parts that occurred once in our case submissions include 21510-2J600, 21510-3CKB0/3F521, 21510-2E040, 21510-3C150, 21520-3LFA0, and 21520-23604.

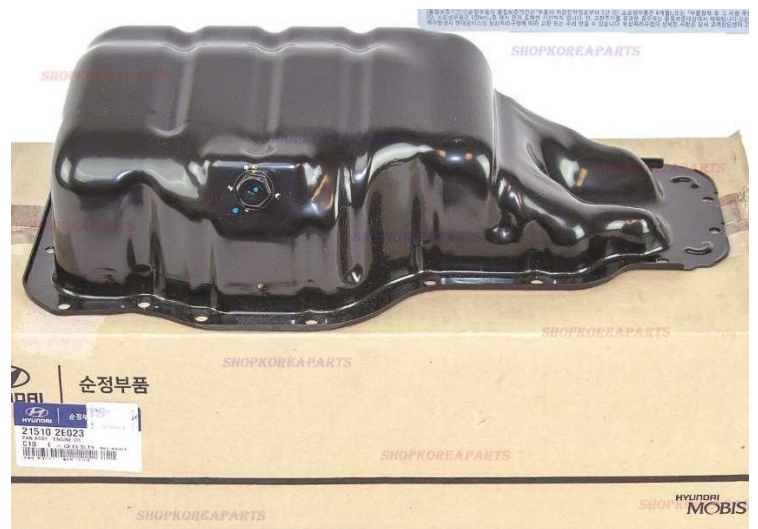
H/K factory oil drain pan 21510-2E023 is listed by the manufacturers as fitting 53 vehicles: 2014-2020 Hyundai Elantra, 2015-2020 Hyundai Elantra GT, 2018-2021 Hyundai Kona, 2016-2019 Hyundai Sonata, 2016-2021 Hyundai Tucson, 2019-2021 Hyundai Veloster, 2014-2021 Kia Forte, 2015-2018 Kia Forte 5, 2015-2016 Kia Forte Koup, 2017-2020 Kia Optima, 2017-2020 Kia Optima Hybrid/Plug-in, 2021-2022 Kia Seltos, and 2015-2021 Kia Soul.
