# EDR Accelerator Pedal Data Can Be Wrong With This Cause of Sudden Acceleration

Ronald A. Belt

1 June 2023

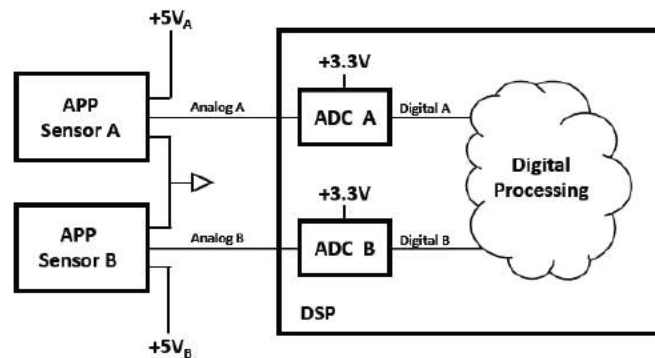
Figure 1. Initial concept of the digitization process

At first glance, the digitization process may appear to be the simple process shown in Figure 1. Two accelerator pedal position sensors having separate +5V power supplies are digitized by two separate analog-to-digital converters (ADC's) included on a single DSP. This redundancy adds robustness when operating in the presence of single point faults. The ADC's convert the two analog sensor outputs into a digital format for use by the digital signal processing algorithms within the DSP. The accelerator sensor outputs change with pedal position as shown in Figure 2. Having the output of sensor A equal to two times the output of sensor B is preferred by many auto manufacturers because it provides a sensitive way of detecting faults in the sensor outputs while simplifying the fault detection algorithms.

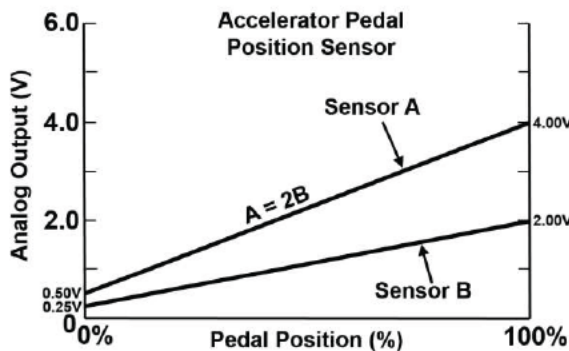
Figure 2a. Generalized accelerator pedal position sensor with outputs  $A = 2B$ .

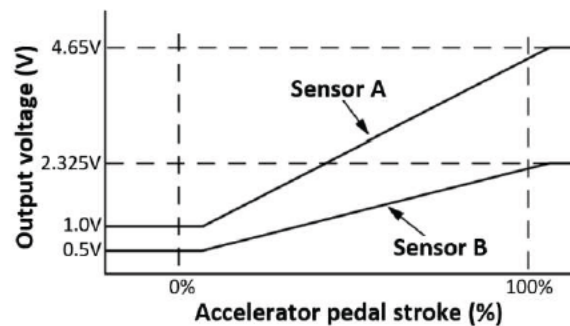
Figure 2b. Actual accelerator pedal position sensors with different transfer functions.

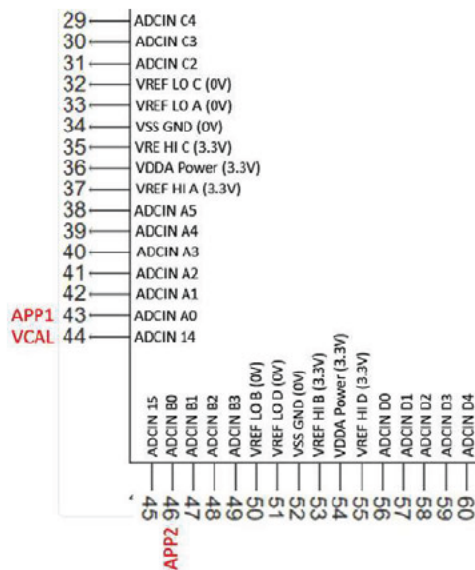
Figure 5. Analog portion of a DSP pin diagram showing the assignment of ADC inputs to DSP pins. By probing these pins one can determine which analog signals go to each ADC. In this case the two APP sensor signals go to different ADC's while the  $V_{CAL}$  signal goes to all four ADC's.

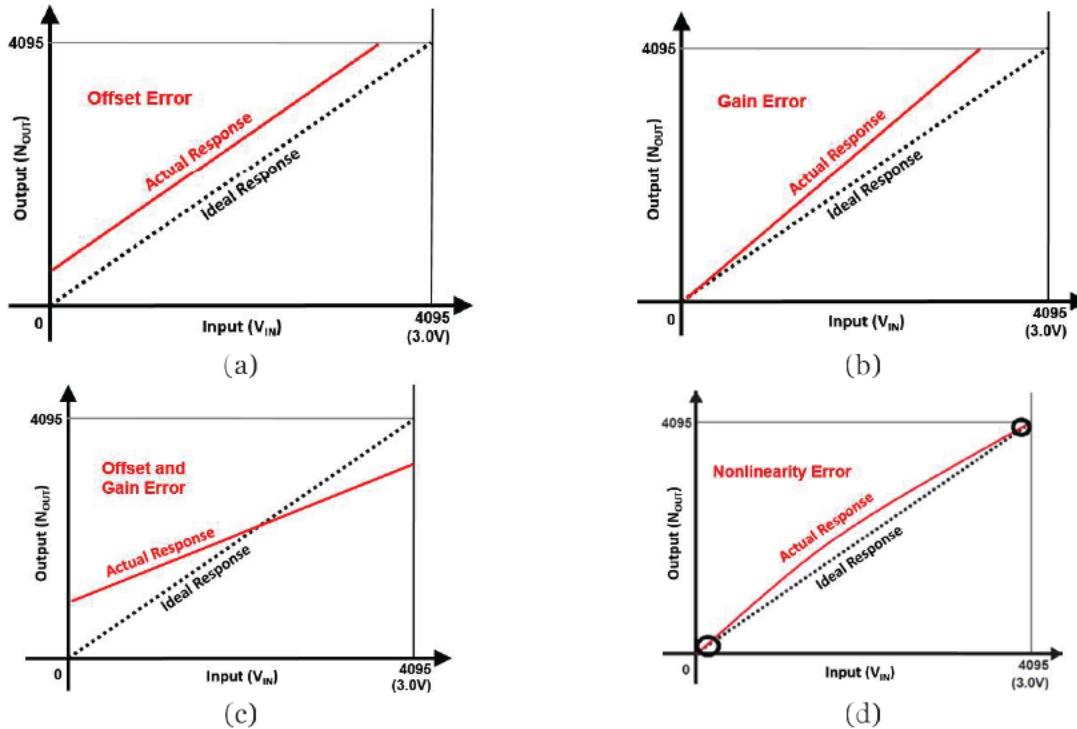
Figure 6. ADC channels can have offset, gain, and nonlinearity errors as shown in red above. The errors shown here are exaggerated for clarity. Calibration minimizes these errors by digitizing two known points on the actual response curve to determine the slope and offset of a linear approximation to the response curve, and then using the inverse slope of this linear approximation to calculate an unknown ADC input value from its measured ADC output value.

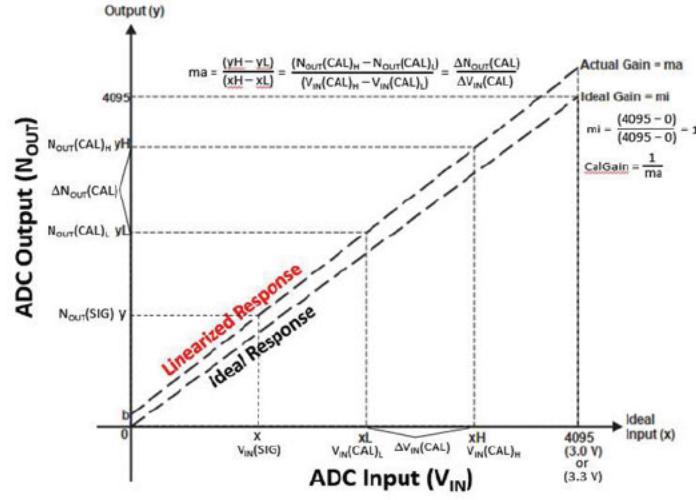
Figure 7.

First, TI uses Figure 7 to show the relationship between an ideal ADC response curve and a linearized version of an actual ADC response curve. It then shows how the slope  $ma$  of this linearized response curve is calculated by using two calibration inputs  $xH$  and  $xL$ , which give two ADC outputs  $yH$  and  $yL$ . These inputs and outputs are defined further by:

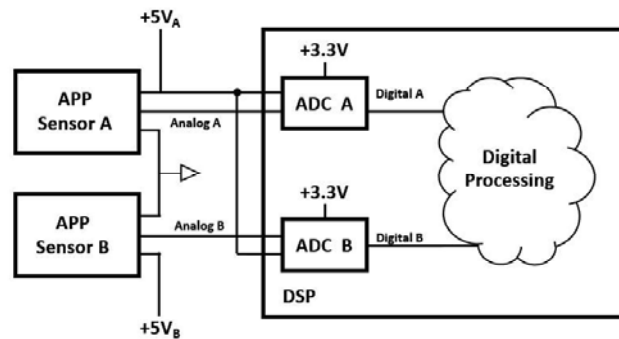
Figure 8. Ratiometric sensors correct for time and temperature errors in the sensor supply voltage that increase or decrease the supply voltage by a given ratio, causing the sensor outputs to increase or decrease by the same ratio.

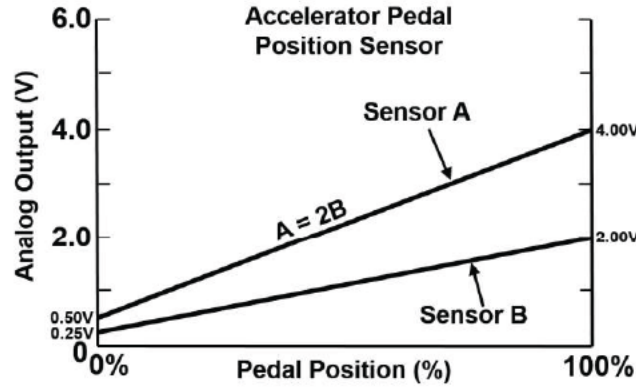
Figure 10. Transfer functions of the APP sensor signals from a typical accelerator pedal.<sup>[8]</sup> The top sensor is always twice the voltage of the bottom sensor, with the top sensor increasing from 0.50V to 4.0V as the pedal is pressed from 0% to 100% while the bottom sensor increases from 0.25V to 2.0V as the pedal is pressed from 0% to 100%.

Based on the information discussed thus far, which relies on the ADC interface circuitry, the ADC calibration technique, and the information on ratiometric sensors, we can now create a flow diagram showing all the operations performed on the two APP sensor signals by both the hardware and the software. This flow diagram is shown in Figure 9. It assumes that the two APP sensor signals have amplitudes that vary as shown in Figure 10, which applies to many vehicles on the market today.

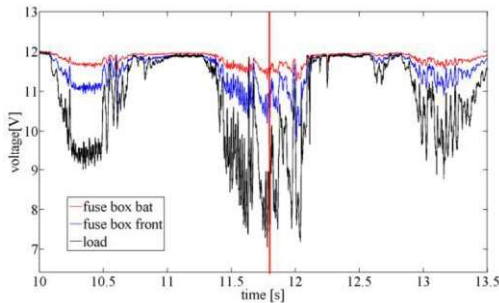
Fig. 11. Voltage spikes on the “12V” supply line of an ICE vehicle as caused by an electronic power steering (EPS) system during a slalom maneuver.<sup>[9]</sup>

So, how can a negative-going voltage spike occur on the attenuated 5V calibration voltage while it is being digitized by the ADC? First, the negative-going voltage spike can occur on the "12V" supply line because it is used by the electric power steering booster motor, which draws a whopping 100A or greater DC current in some heavy vehicles. Then, when the power assist motor in this system is suddenly turned on by turning the vehicle's steering wheel while making a sharp low-speed turn in a parking lot, the assist motor suddenly draws an inrush current three to five times higher than the DC current for several hundred microseconds. This higher inrush current can't be supported by the "12V" battery, which can supply a maximum current of only 100A or less, or a DC/DC converter, which can only supply about 200A or less. Therefore, the "12V" supply line is pulled down to near zero volts for several hundred microseconds. See Figures 12 and 13 which provide evidence on the existence these voltage dips.

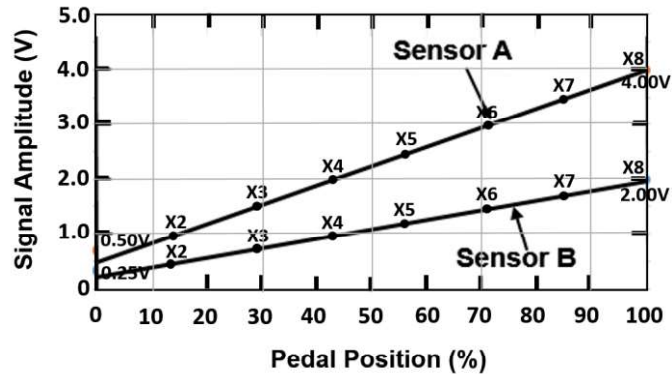
Figure 13. APP signal transfer functions showing that multiplying the released pedal values by the factors xN produces values that lie on the same curves as the original transfer functions, allowing the corrected signals to pass all tests performed on the original APP signals.

Figure 13 shows the values X in Table 4 that multiply the released APP sensor signals after they have been calibrated superimposed on the transfer function (APP sensor voltage vs pedal depression) of the normal APP sensor signals. One can see that the released APP sensor signals, when corrected for a decrease in the ADC calibration voltage, lie on the same transfer function as the original APP sensor signals, making it clear that they will pass all tests performed on the original APP sensor signals.

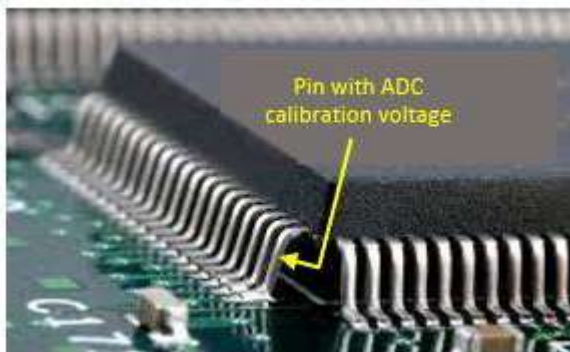
Figure 14A. DSP pin for the ADC calibration voltage which uses a ratio of the APP sensor supply voltage

One can verify that the proposed cause of sudden acceleration is correct by opening the ECU to access the motor controller PWB as shown in Figure 14A. Then, one can lift the DSP pin for the ADC calibration voltage from its PWB pad and attach a wire to the lifted pin as shown in Figure 14B below. This wire can then be passed through the ECU connector on one of its three unused pins. If this wire is then accessed on the other side of the ECU connector when the ECU is closed back up, one can then impose a variable voltage on the wire. If one keeps this voltage

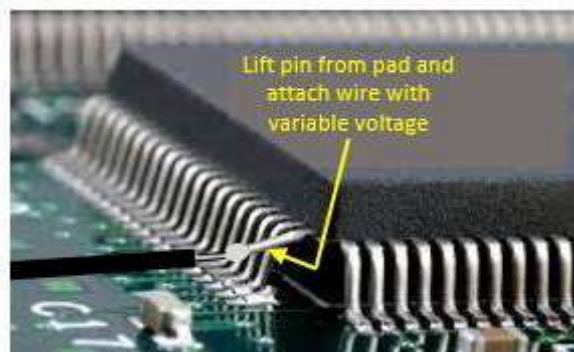
Figure 14B. Lift the DSP pin with the ADC calibration voltage and attach a wire with a variable voltage.

constant at 5V scaled down to 1.65V, then the vehicle will run normally with torque being varied by pressing on the accelerator pedal. But if one changes this voltage to 0.206V or less, which can happen when the 12V supply dips temporarily to 1.5V, then the APP sensor outputs will read 4V and 2V, which is equivalent to flooring the accelerator pedal. This causes sudden unintended acceleration without the driver pressing on the accelerator pedal.
