Von / From: GM		Kunde / <input checked="" type="checkbox"/> Customer Lieferant / <input type="checkbox"/> Supplier	Auftraggeber / Datum / Date: 29.11.2018	
Grund / Reason: - Complaint "diameter mix" - Error part from customer dated 29.11.2018		LS-Nr. / Delivery note No. unknown	Wettbewerb / <input type="checkbox"/> Competitor Erstmuster / <input type="checkbox"/> Initial Sample	
Drahtlieferant / Charge / Supplier of wire / Charge: Missing traceability by customer and missing charge and delivery data.		Lieferung vom / Delivery date: unknown	Sonstige / <input type="checkbox"/> Others	
Kugel / Ball Ø [mm]: 4,556	Klasse / Grade: Kd.-Spezifikation / Customer specification:	Werkstoff / Material: PA	Auftr.-Nr. / Order No.: unknown	Sorte / Gauge [µm]: unknown

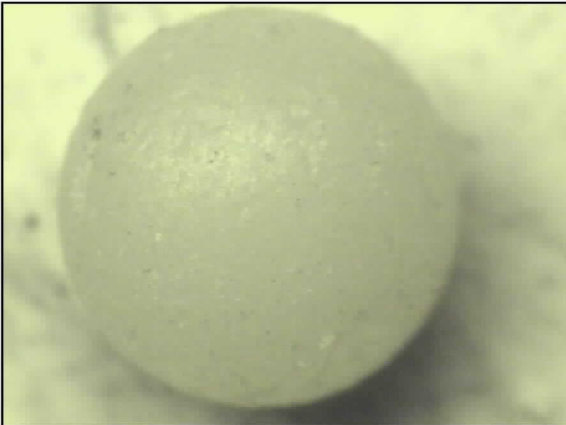
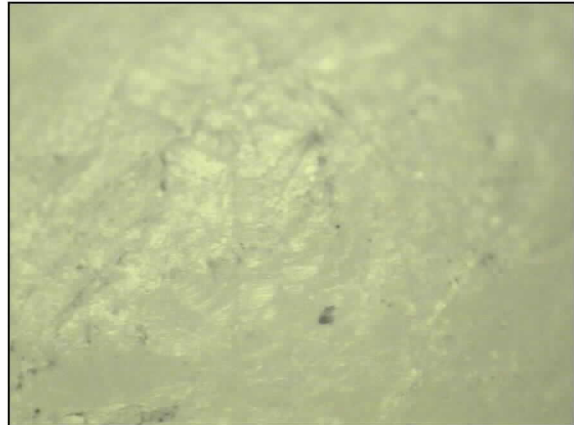
Bild / Picture 1

V = Leica MZ 12,5_20fach

V = Leica MZ 12,5_80fach

Pictures 1 and 2: Ball diameter from error part is 4,556 mm

Surface of the error part (see pictures 1 and 2) doesn't correspond to surfaces of finished grinded balls, balls in intermediate state and/or raw balls (injection molding surface).

We don't produce balls in diameter 4,556 mm. It seems that the ball diameter was reduced in application.

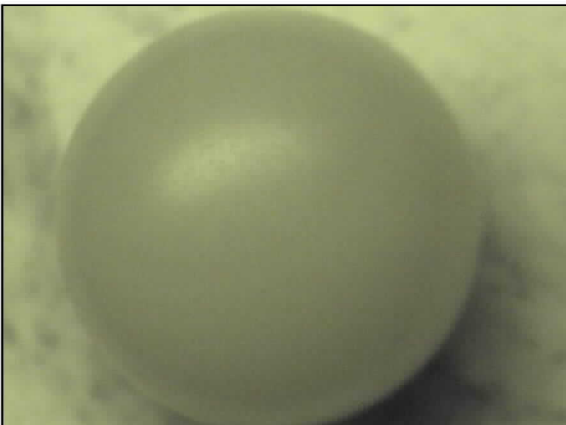
Bild / Picture 3

V = Leica MZ 12,5_16fach

V = Leica MZ 12,5_80fach

Pictures 3 and 4: Ball diameter 6,35 mm
