July 2018

Dealer Service Instructions for:

## **Safety Recall U56 / NHTSA 18V-398**

### **Rear View Mirror**

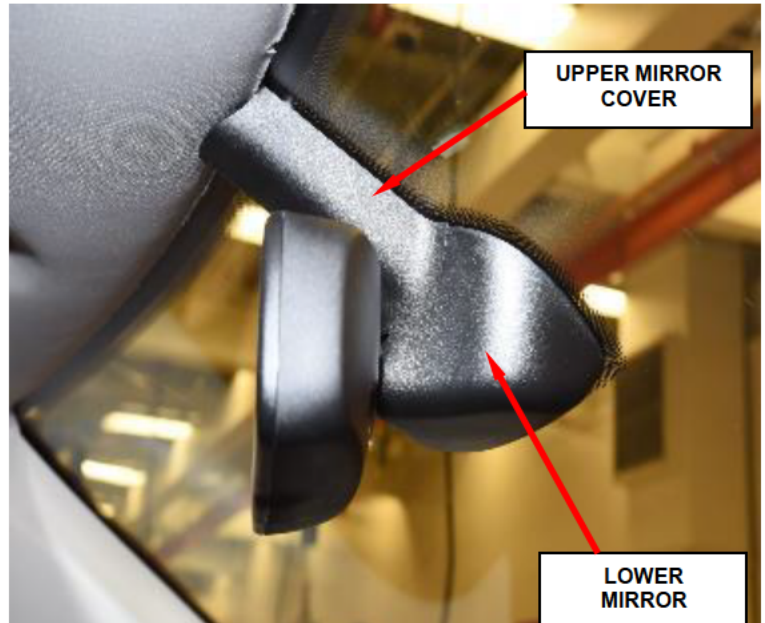
**Figure 1 – Upper Mirror Cover**

1. Disconnect the negative battery cable.
2. Using a trim stick or equivalent, remove the upper mirror cover (Figure 1).

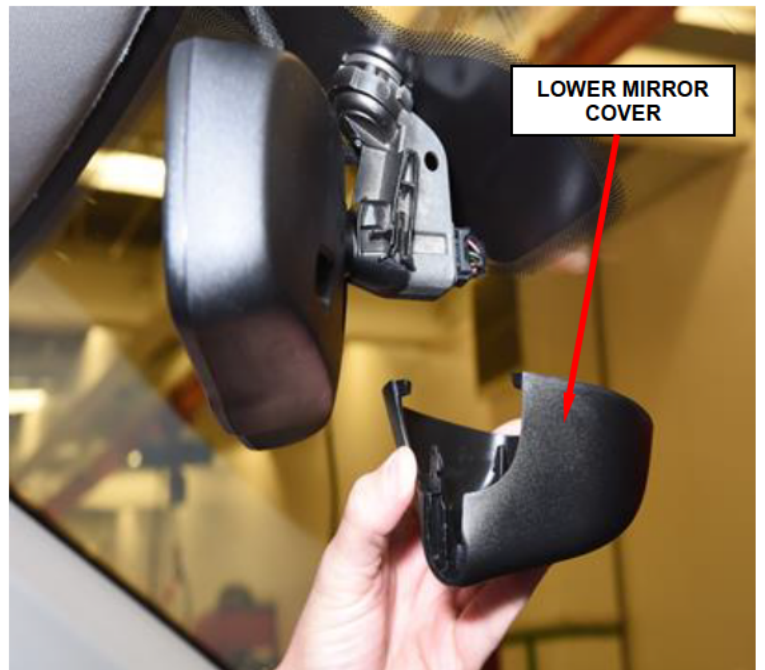
**Figure 2 – Lower Mirror Cover**

3. Remove the lower mirror cover (Figures 1 and 2).
