Safety Recall: 2023–24 HR-V Front Seat Belt Pretensioner Inspection

Supersedes 23-099, dated November 29, 2023, to revise the information

BACKGROUND

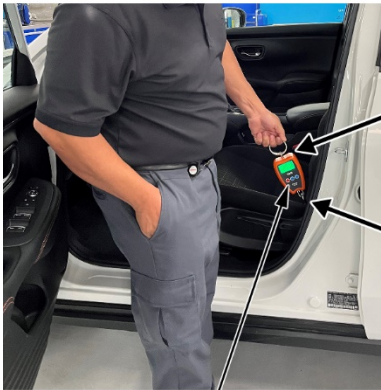
DRIVER AND PASSENGER SEATBELT PRETENSIONER INSPECTION

- Inspect both right and left side seatbelt buckles.
 - Images shown are the driver's side.
1. Insert the S-hook of the pull force gauge into the seatbelt pretensioner loop to inspect the driver's and passenger's sides.

PULL GAUGE
30 kgf (70 lbs.)

2. While wearing eye protection, carefully pull up and apply a load of **30kgf (70 lbs)**

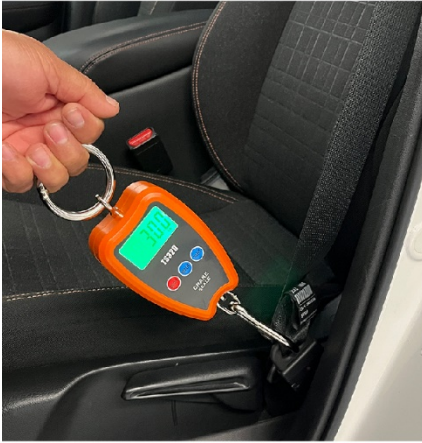
GOOD

- If the pretensioner quick connector remains intact and **DOES NOT** separate from the pretensioner assembly, no further action is required.
- If the pretensioner quick connector separates from the pretensioner assembly from either the driver or passenger's side, go to the REPAIR PROCEDURE.

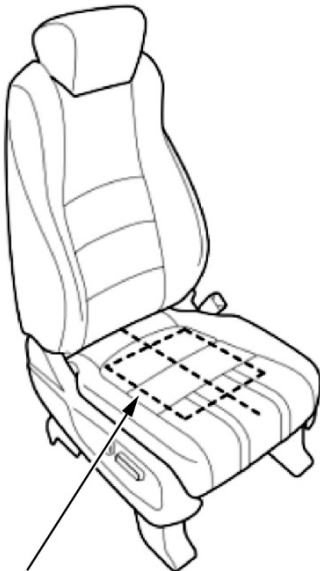
6. Precisely place the prepared weight on center of the front passenger's seat as shown.

The weight must be placed precisely on the center line of the seat.
