Safety Recall: 2023–24 HR-V Front Seat Belt Pretensioner Inspection

Supersedes 23-099, dated December 19, 2023, to revise the information highlighted in **yellow**.

During manufacturing, some front seat belt pretensioners may have been assembled without a rivet securing the quick connector and wire plate, resulting in front seat belts not functioning as designed, increasing the risk of injury.

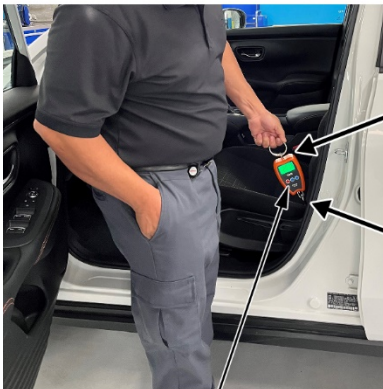
DRIVER AND PASSENGER SEATBELT PRETENSIONER INSPECTION

- Inspect both right and left side seatbelt buckles.
 - Images shown are the driver's side.
1. Insert the S-hook of the pull force gauge into the seatbelt pretensioner loop to inspect the driver's and passenger's sides.

PULL GAUGE
30 kgf (70 lbs.)

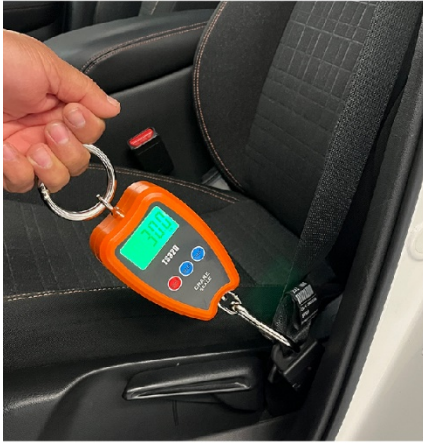
GOOD

- If the pretensioner quick connector remains intact and **DOES NOT** separate from the pretensioner assembly, no further action is required.
- If the pretensioner quick connector separates from the pretensioner assembly from either the driver or passenger's side, go to the REPAIR PROCEDURE.

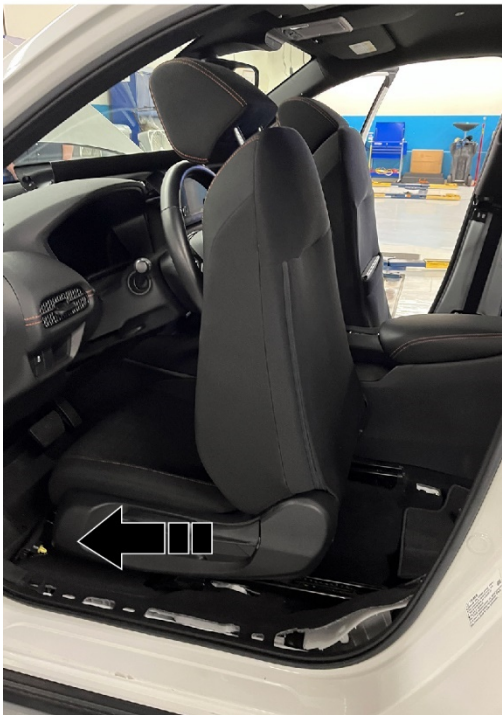
DRIVER OR PASSENGER'S SEAT

2. Move the driver's and/or passenger's front seat to the forwardmost position and remove the rear seat bolts. (Do Not discard the bolts).

3. Slide the seat forward.

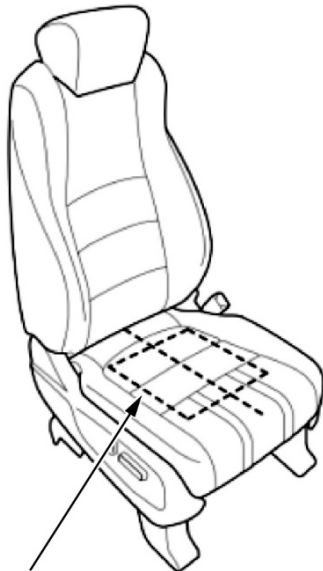
6. Precisely place the prepared weight on center of the front passenger's seat as shown.

The weight must be placed precisely on the center line of the seat.
