HYUNDAI
Technical Service Bulletin

GROUP RECALL	NUMBER 17-01-046-1
DATE SEPTEMBER, 2017	MODEL(S) 2011-2012MY SONATA (YF)

SUBJECT: SONATA GDI ENGINE INSPECTION /
REPLACEMENT (RECALL CAMPAIGN 132)

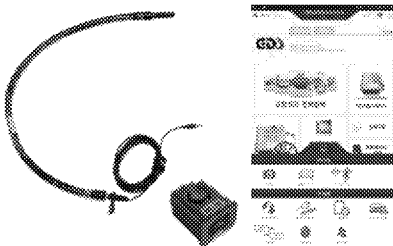
Description	Tool Part #	Image	Comment
Engine Noise Inspection Tool	G1XTD-CP001

For noise inspection
Torque Wrench Socket	09314-3Q100		Only needed if engine replacement required.
Injector Combustion Seal Ring Installer	09353-2B000		Refer to TSB 10-FL-019 for the detailed usage instructions

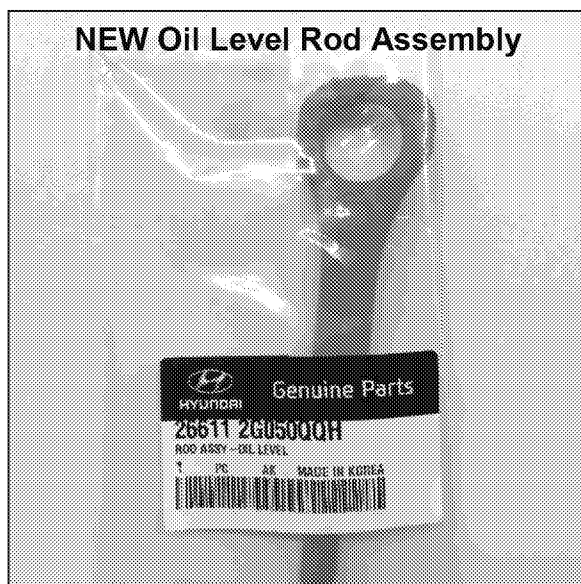
2. Replace the engine oil (4.8 quarts), oil filter, and drain plug gasket.
3. Replace the current Oil Level Rod Assembly with the new campaign part.
 - Remove and discard the existing Oil Level Rod Assembly (engine oil dipstick).
 - Install new ORANGE handle Oil Level Rod Assembly (P/N 26611-2G050QQH)

Note: Replace the dipstick **ONLY** if the current dipstick's handle is yellow. Do not replace if it's red.

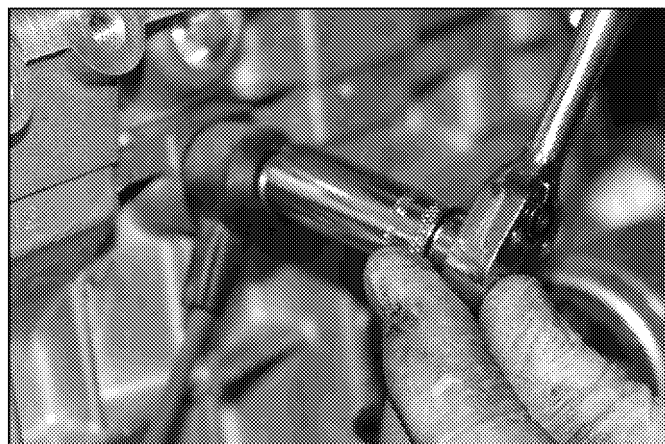
5. Remove and reinstall the engine Knock Sensor from the old engine to the new engine.

(Knock Sensor Fastener)
Tightening torque: 21Nm (15.5lb-ft)
