Safety Recall

N252494002 L87 Engine Loss of Propulsion

Release Date: May 2025

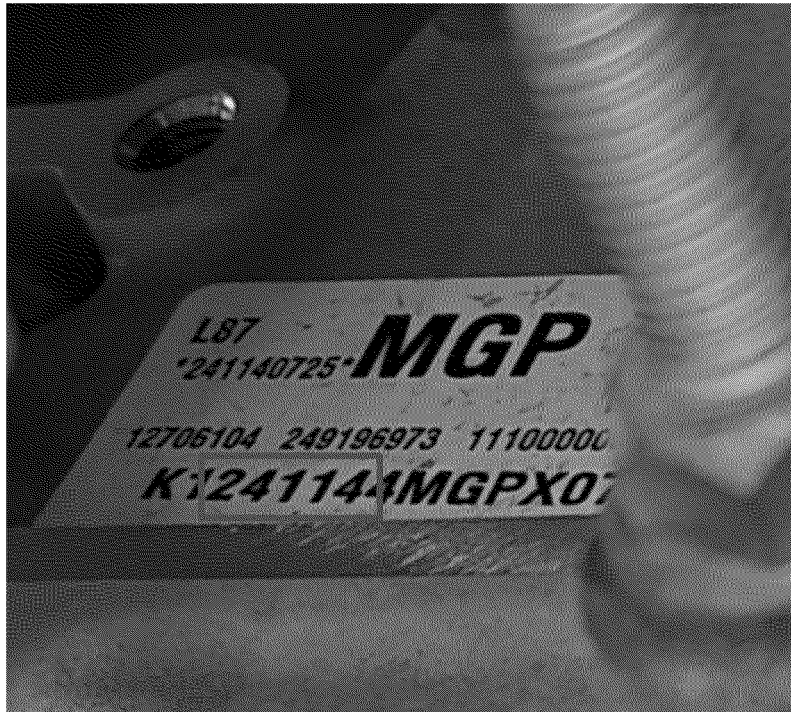
6908278

- Looking upwards from under the vehicle towards the rear of the Left Hand cylinder head, inspect the digits indicated on the sticker above to determine the build date of the engine. The first two digits circled are the build year ('24 in this example), and the next three digits are the build day (day 114 in this example). If the engine was built BEFORE 24183, proceed to step 2.
- If the engine was built on or AFTER 24183 no further action is required. Submit labor operation 9107922.

2. These vehicles have been identified as requiring an engine replacement. Proceed to *Engine Replacement* in SI.
3. Transfer the original 0W-20 Oil Cap to the NEW engine and fill the NEW engine with dexos 0W-20 oil.
