CQIS DETAIL REPORT

CQIS Report Number: M4EC3022 Program Type: H Orig Rpt #:
Report Source: MSS - FCSD - TECH ASSIT CENTER Report Date: 04/05/2021

VEHICLE: 2018 FOCUS,SE,4 DOOR ,SEDAN VIN:
Engine : 1.0L 12V DI TC I3 GS 120PS FOX Odometer: 56,406 MILES
Operating Environ: WCC :
Vehicle Use : Rsp. Act:

SYMPTOM: 5 54 2 02 DRIVING PERFORMANCE LACK/LOSS OF POWER
ACCELERATION ALWAYS

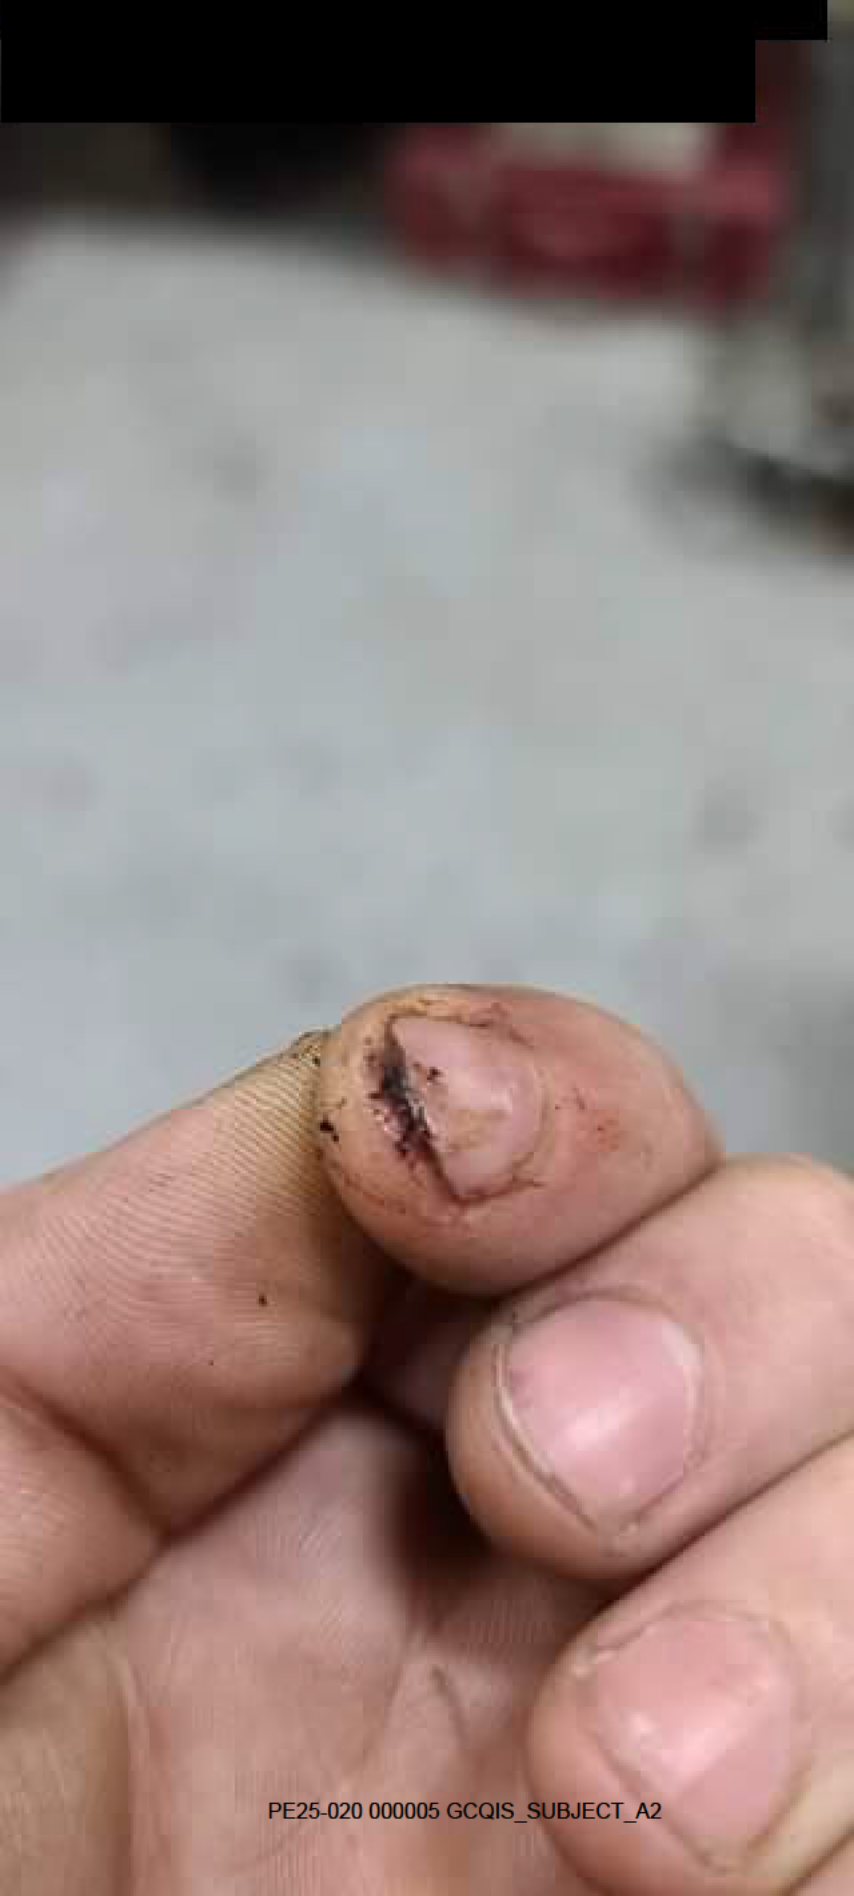
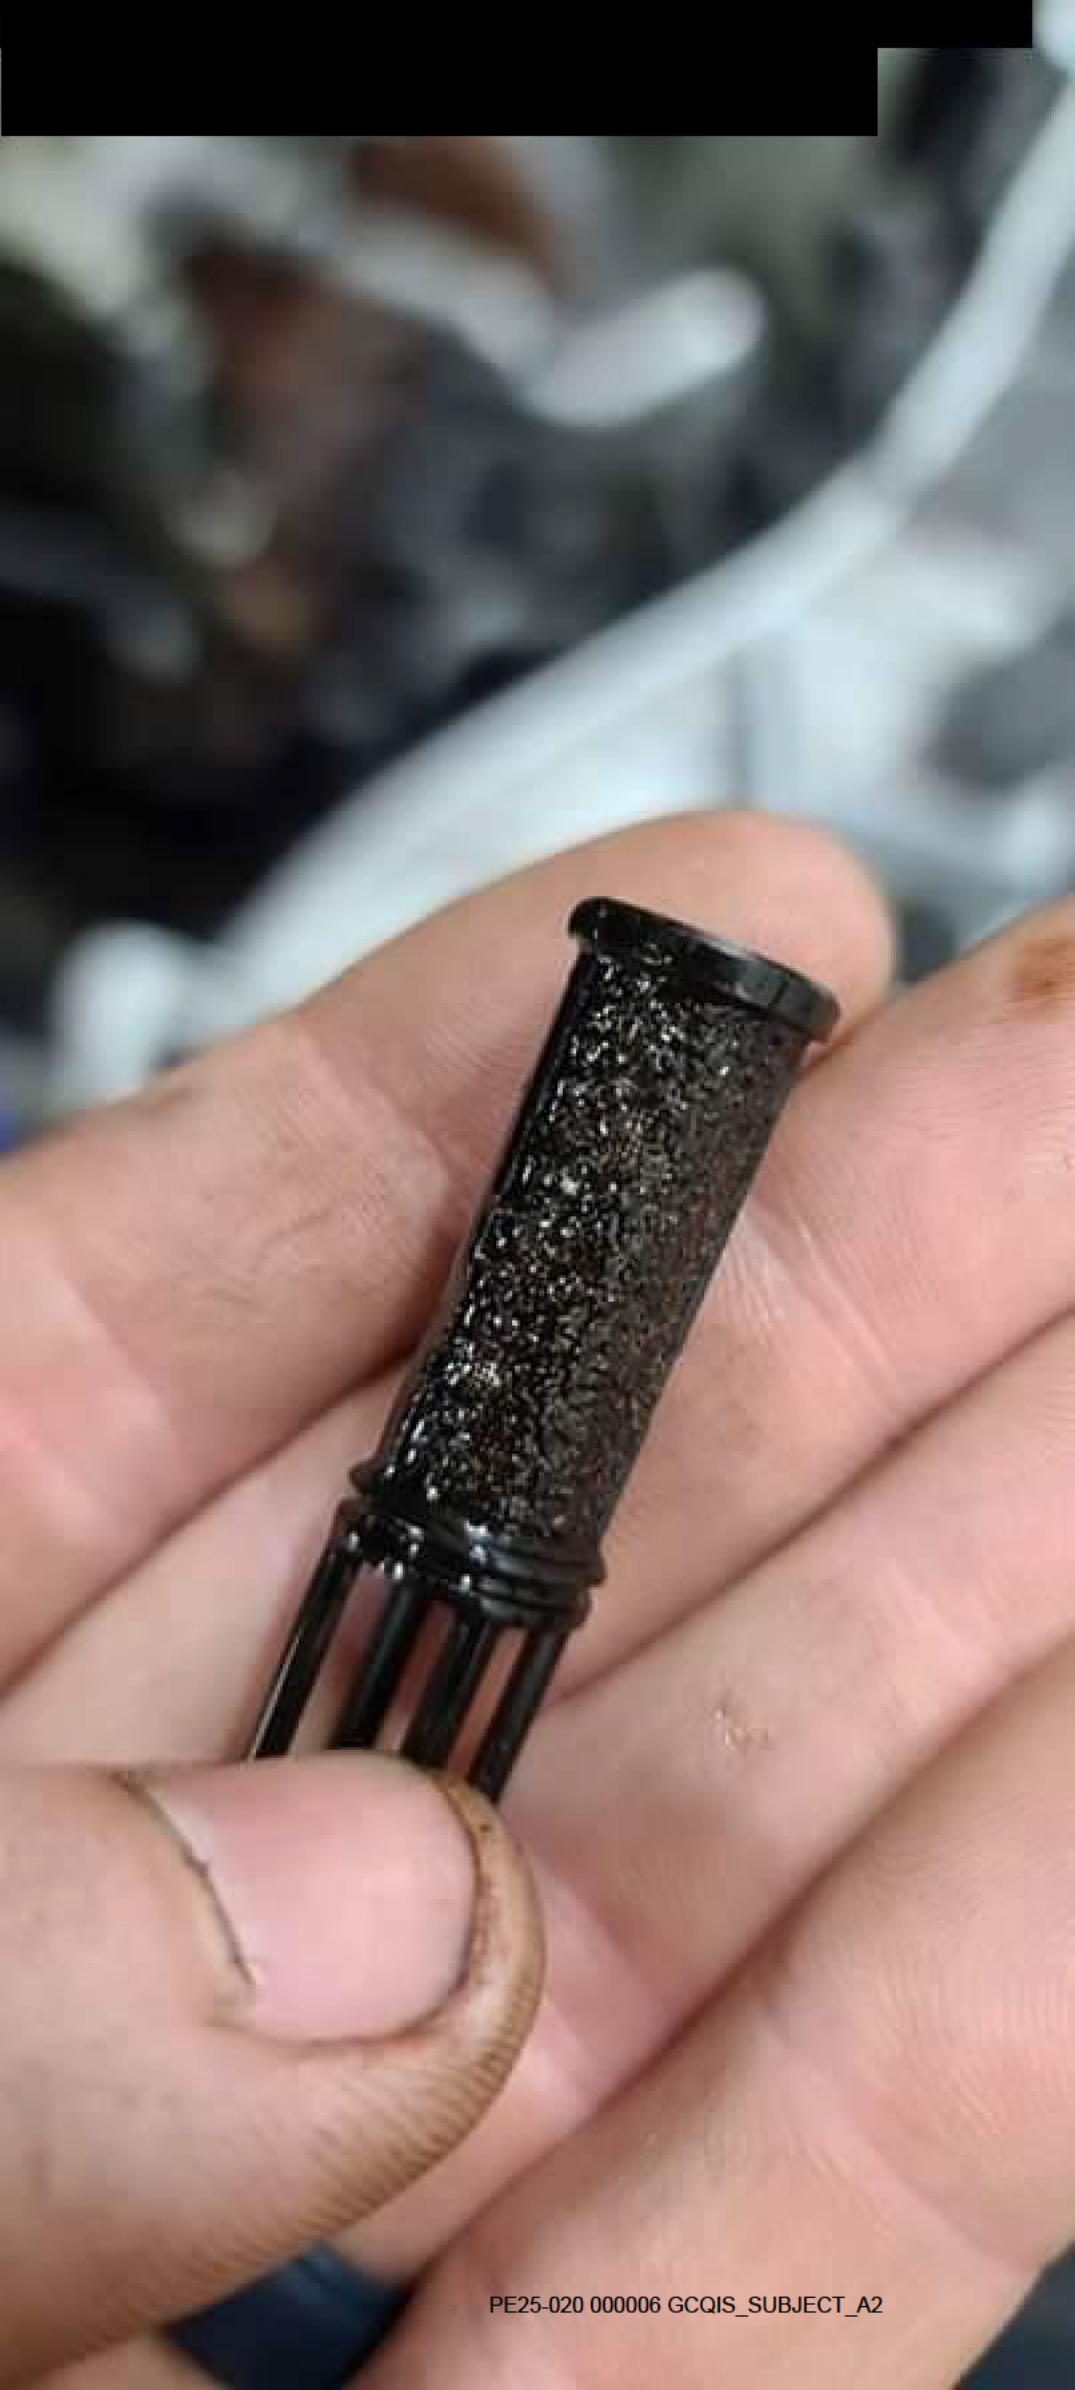
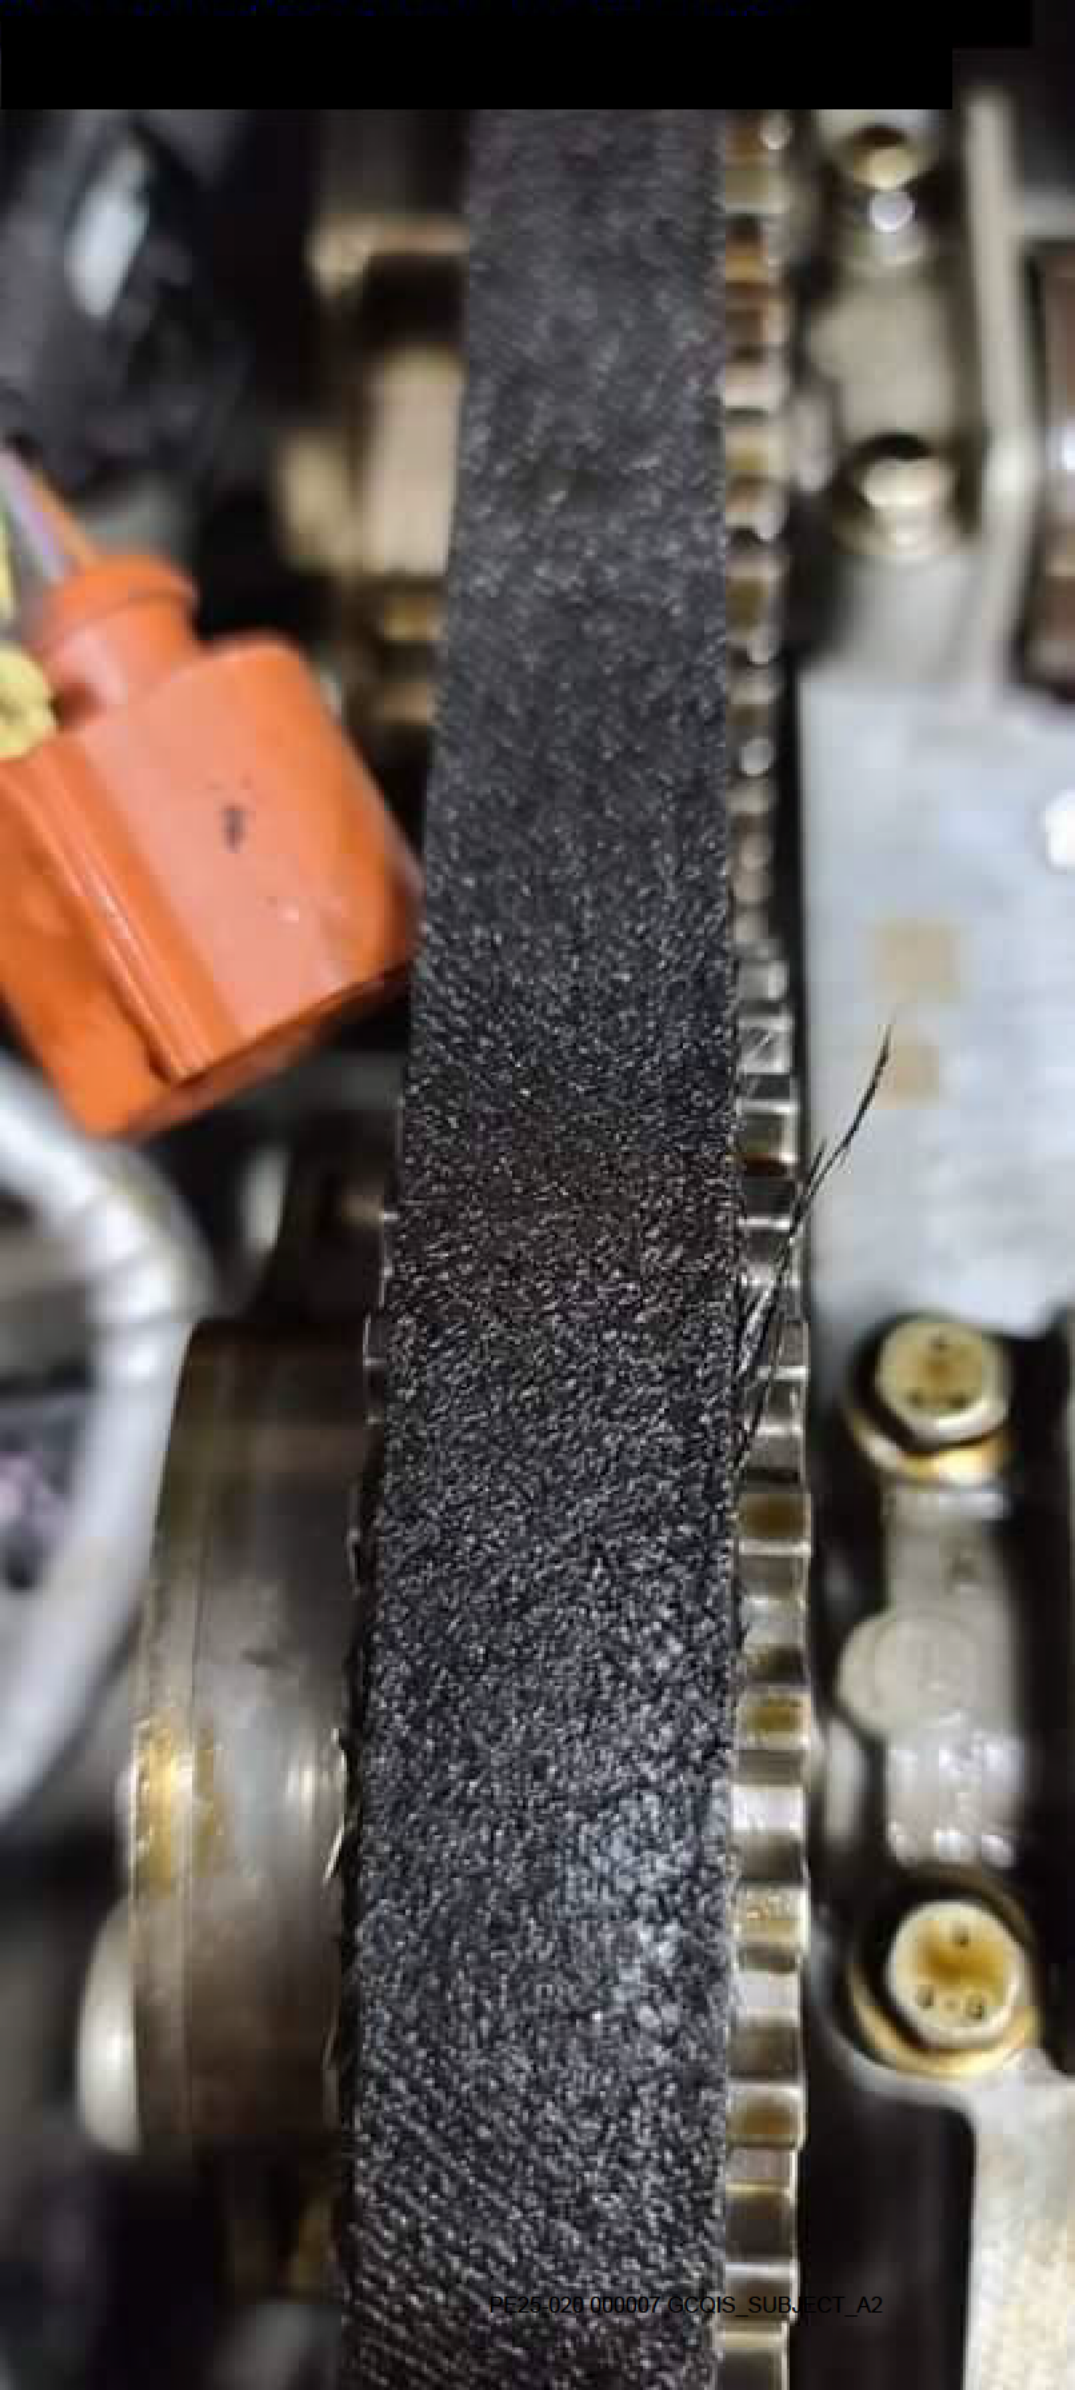
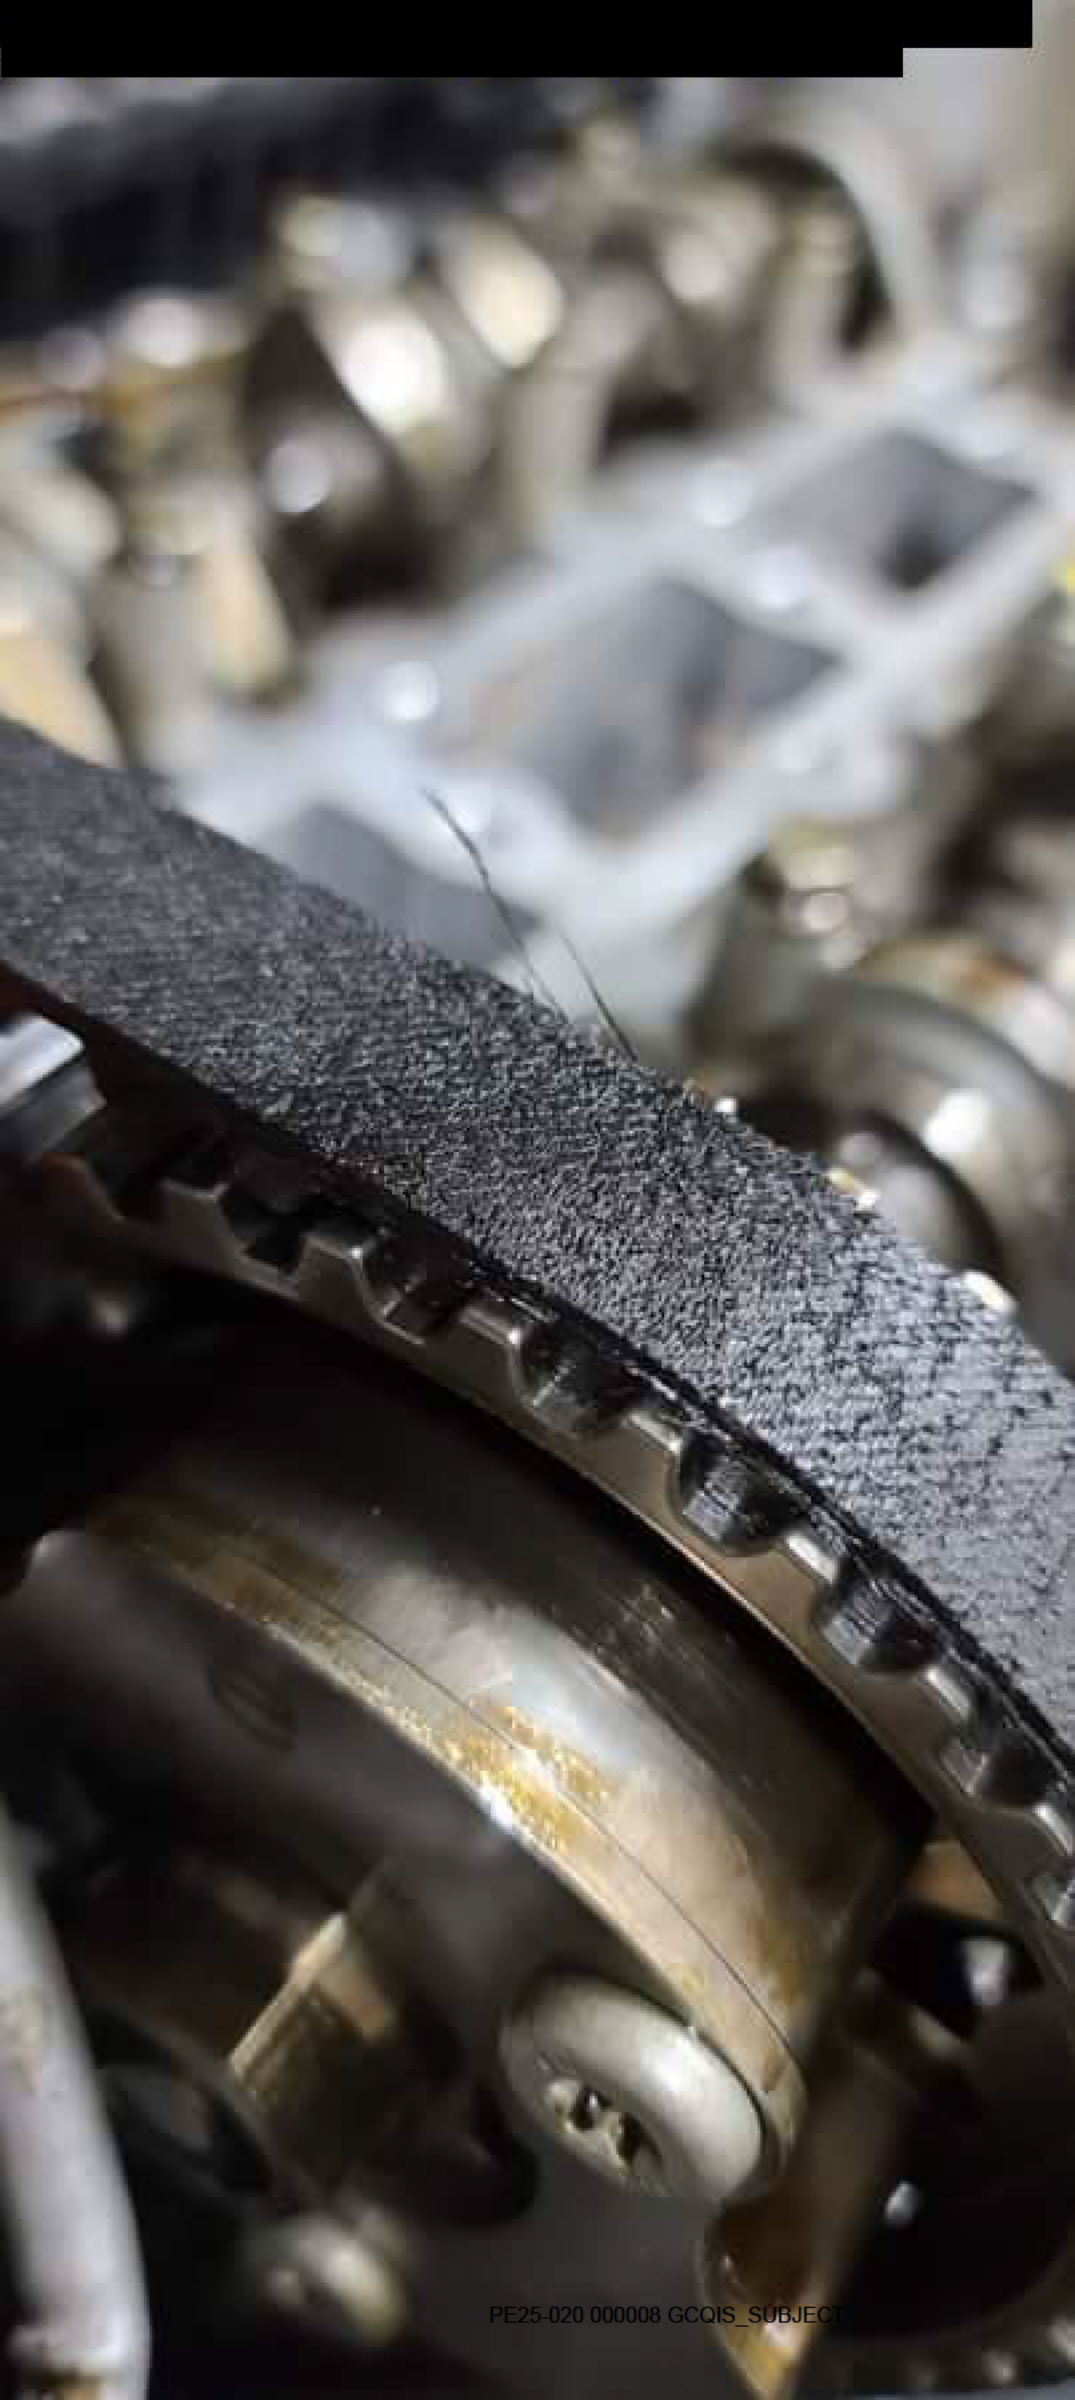
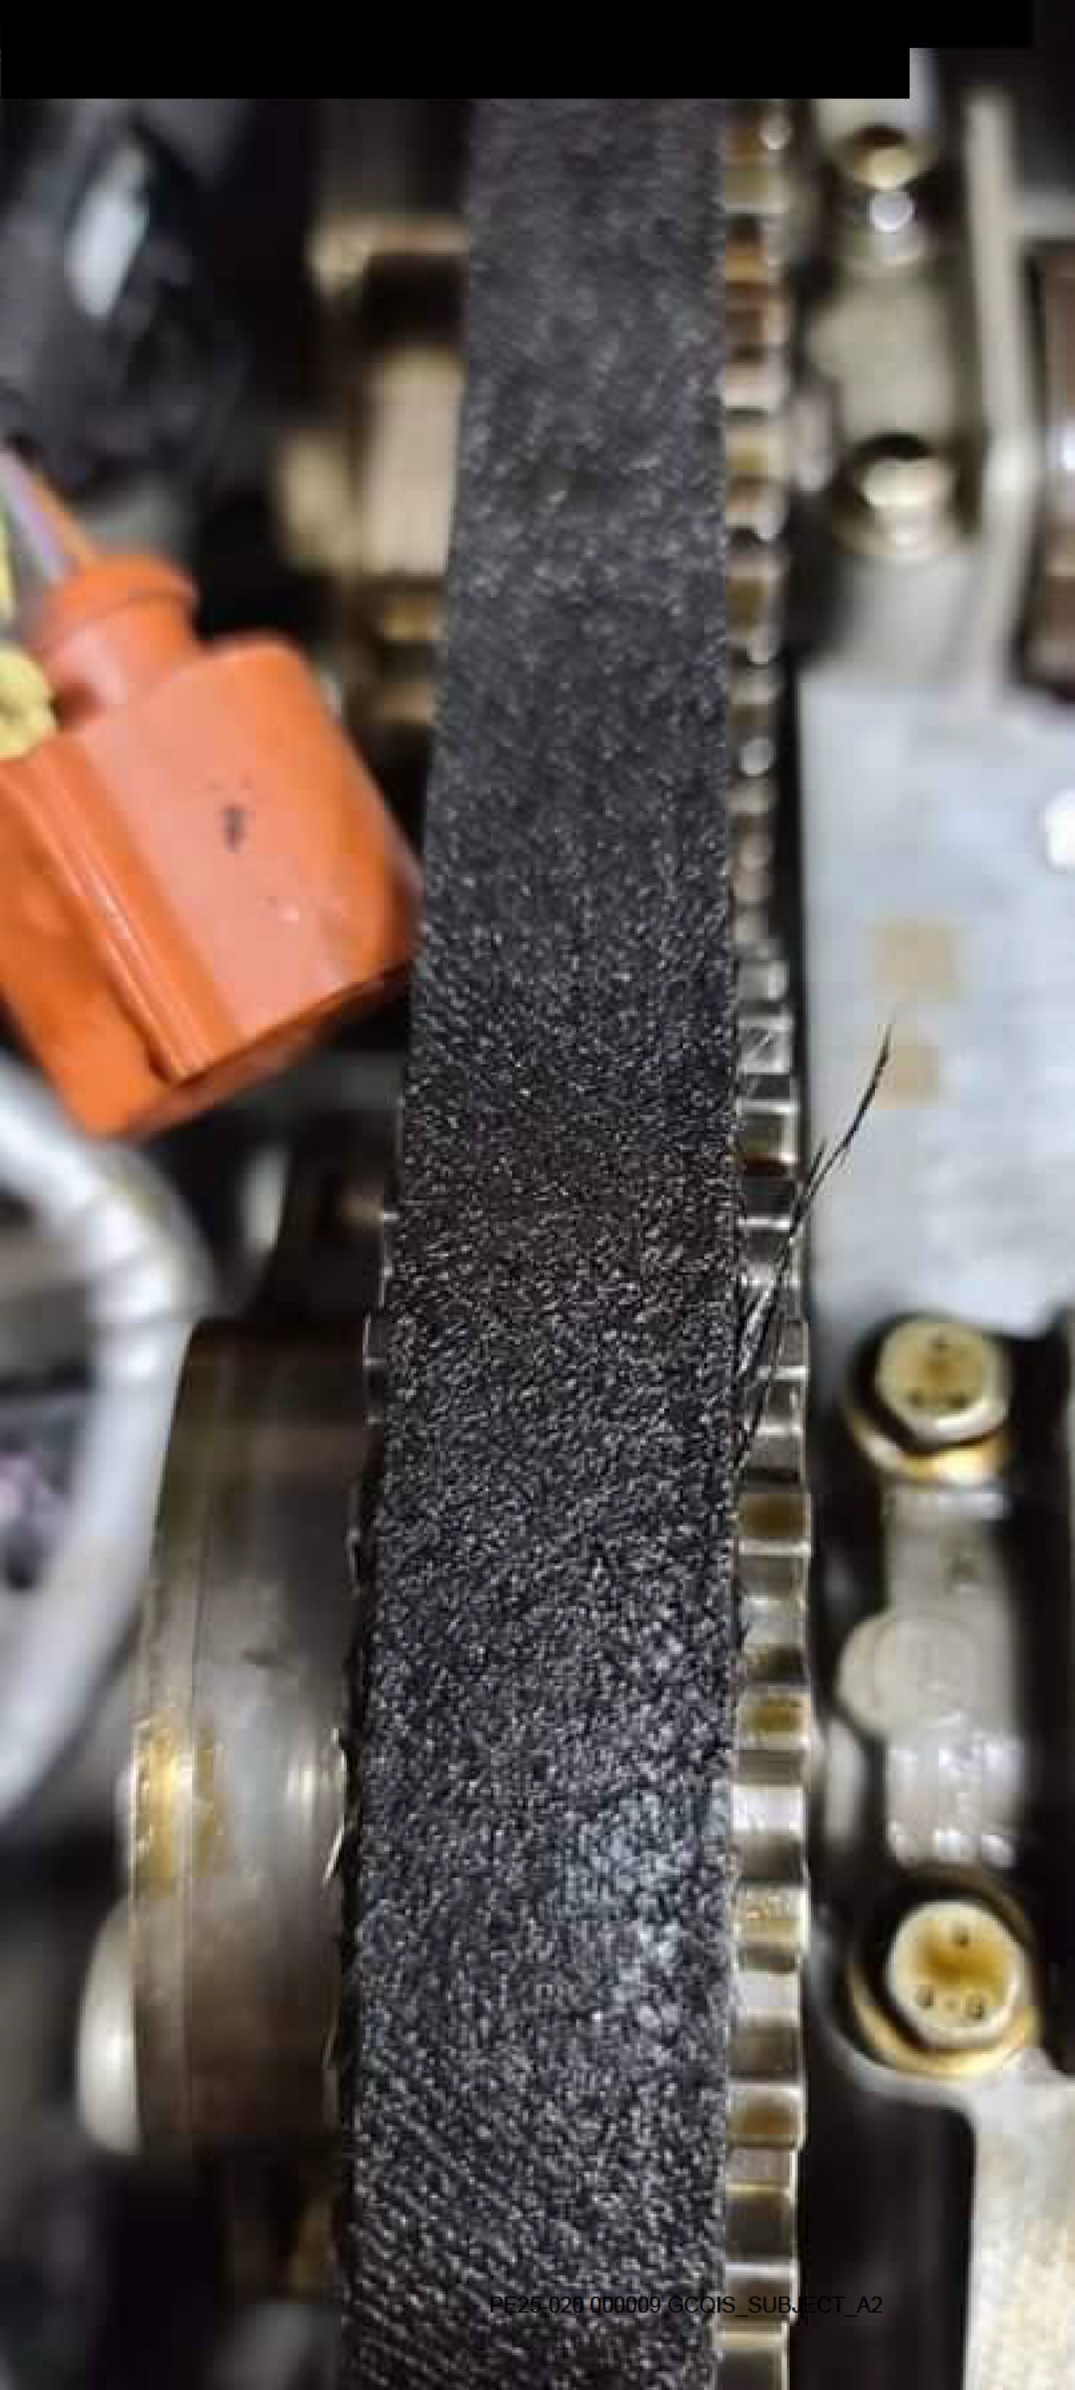
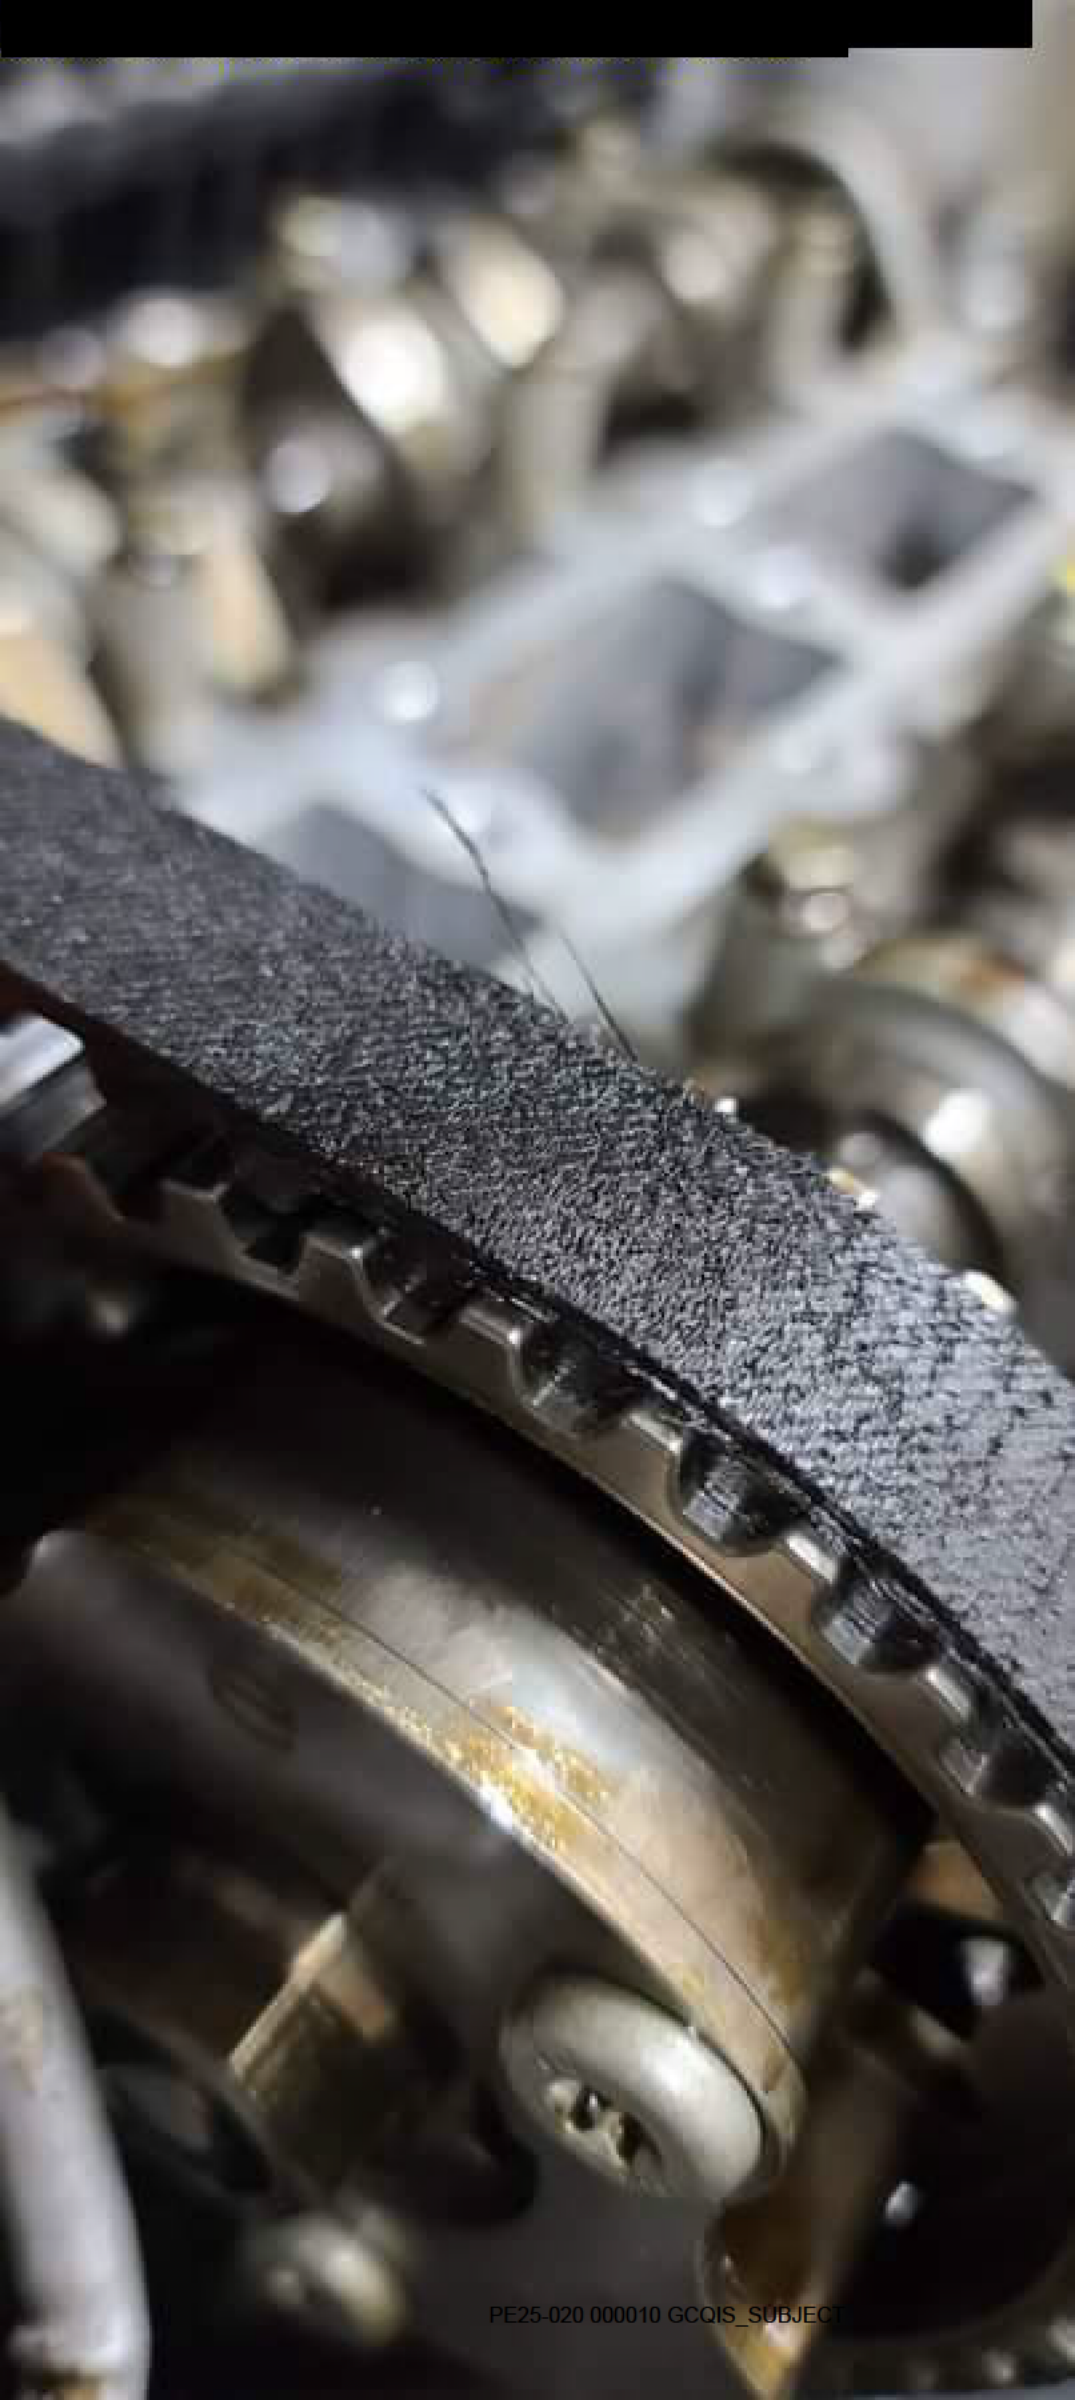
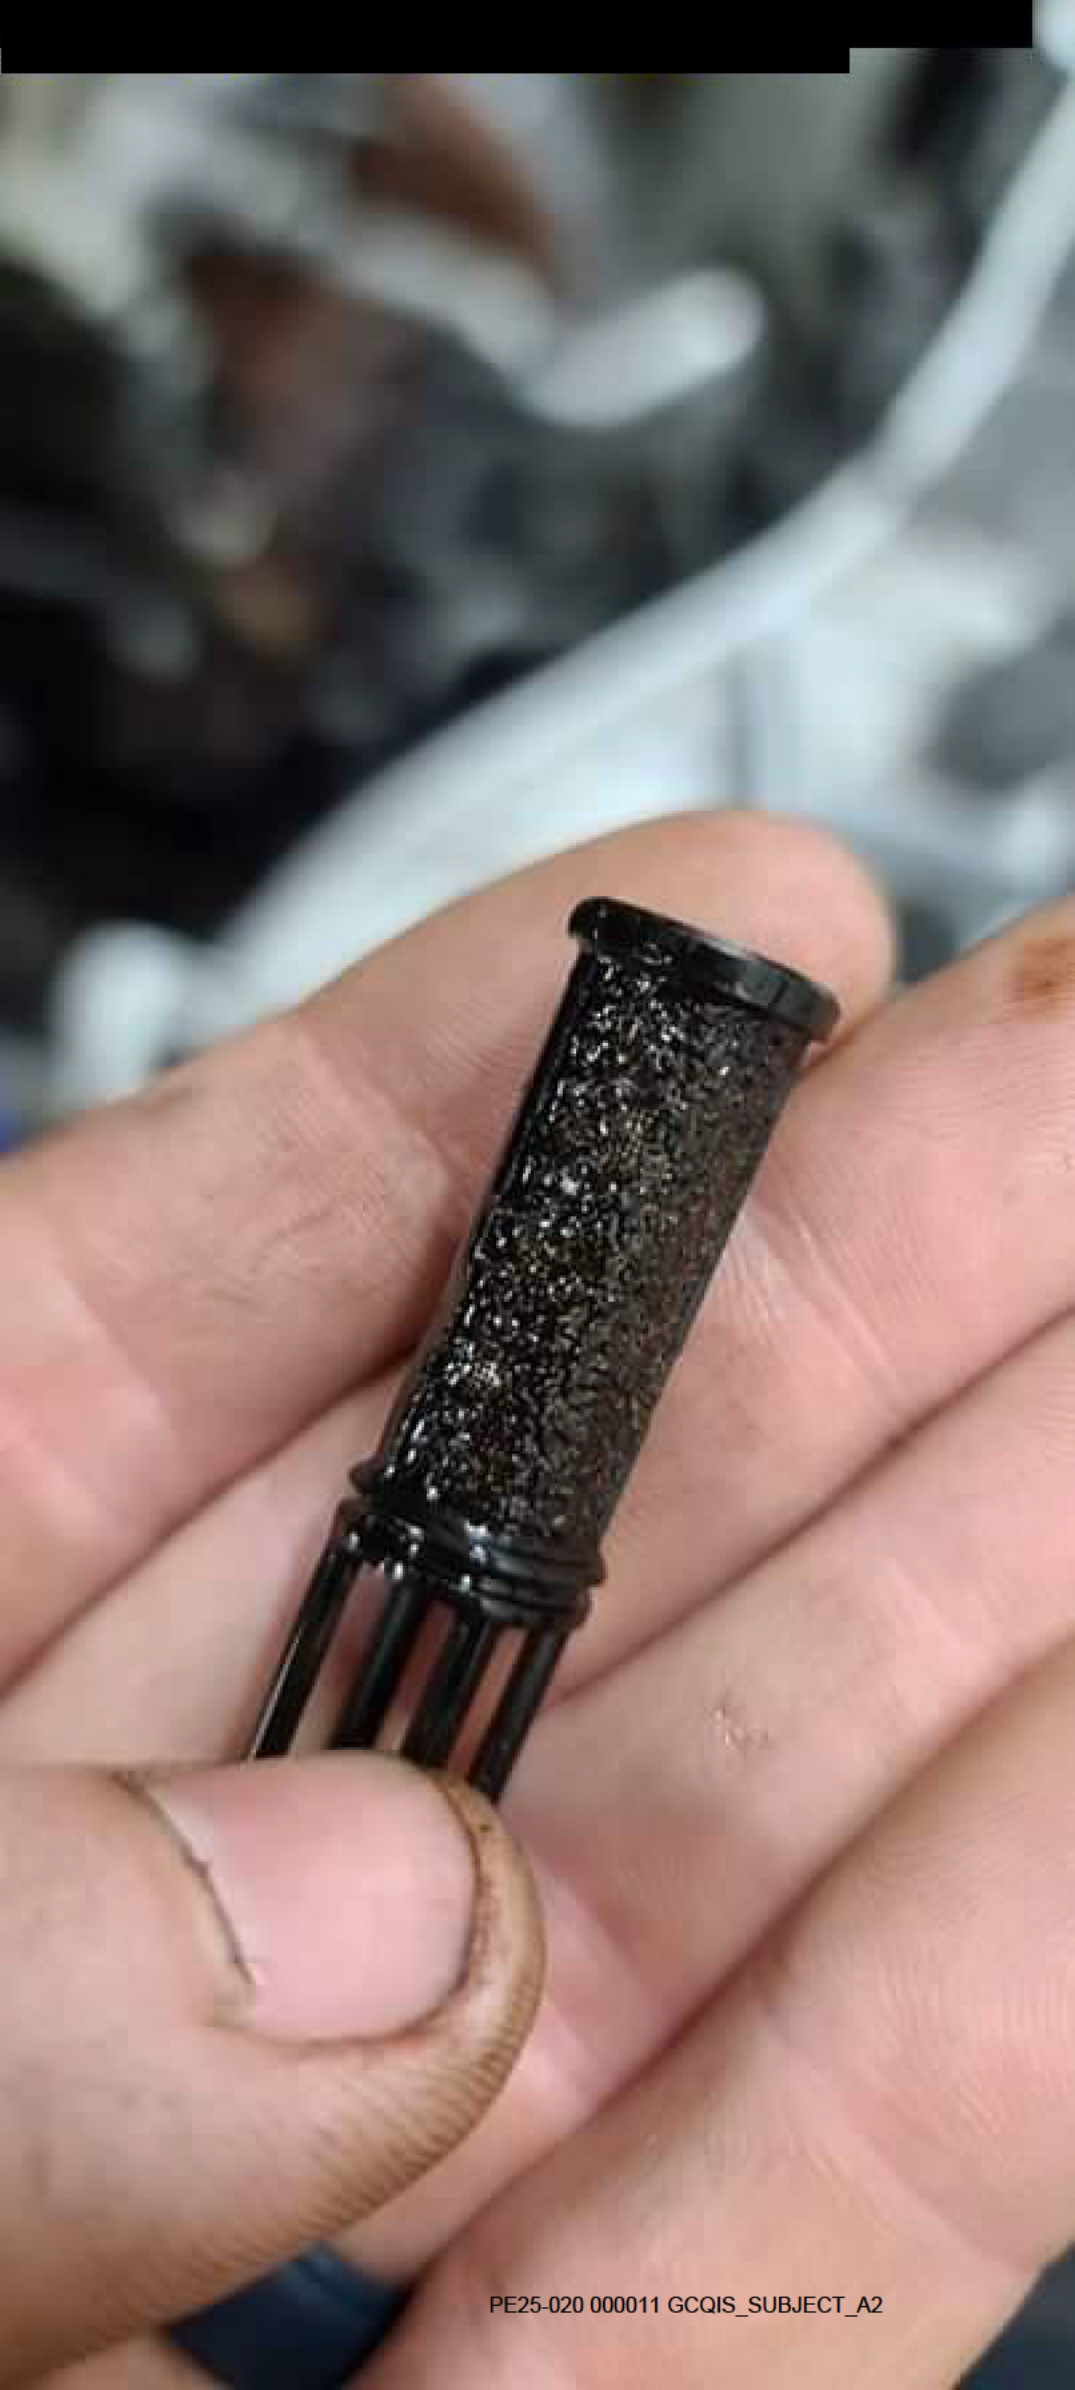
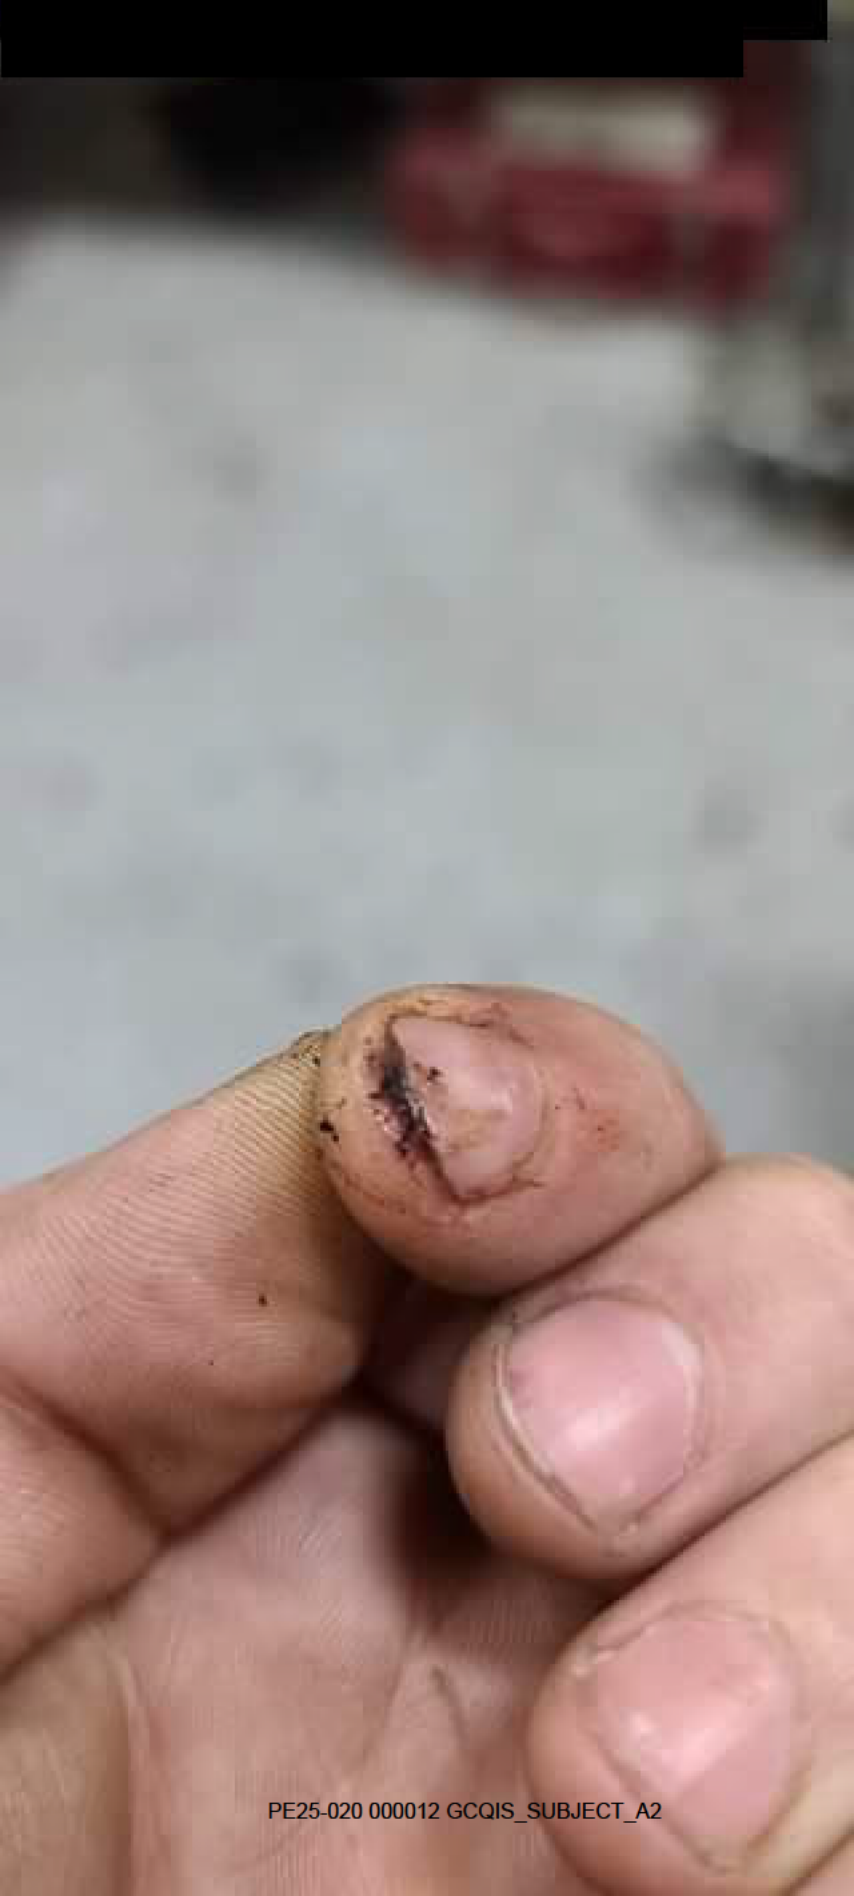
CONCER 04/05/2021 01:30PM DSTOKER2
Web Form Data(118035205) Description of Vehicle Concern: loss of power
cel on high pitch whine noise Please list any diagnostics already
performed: VERIFIED CEL EEC TEST KOEO-PASS KOEC-P0299 KOER-PASS RAN
OASIS FOLLOWED PPT OIL CHANGE OVERDUE BY 13K VERY DIRTY OIL INSPECTED
TURBICHARGER FOUND IT TO BE LOCKED UP / HAS EXCESSIVE RUNOUT NEEDS
TURBO LOF AND MAINT pulled valve cover to inspect for signs of lack of
maintenance, no sludge build up. per ppt diagnostic and findings of
turbo impeller damage continue with turbo replacement Parts Replaced:
none yet I have turbo removed and front cover to access turbo oil
filter and have filter removed Your Question: when I removed the turbo
oil filter it is appearant the turbo failed due to oil starvation bc
the filter is full of something. I noticed the timing belt looks
pretty rough and flakey. scratching the surface of the timing belt

with my finger nail I am getting black chunks coming off the belt.
this is what looks like is in the filter. I took pics of the filter,
the belt, and my finger nail with the black substance on it. what
should I do. should I check more on this engine. oil pick up? cam
caps? oil filter? should I replace timing belt?

were performed to determine that the assembly needed to be replaced.
Please list the pinpoint tests completed and include test results
(pressure readings, electrical measurements, etc.). found code p0299.
found mechanical failure of turbo impeller. impeller loose. needs
turbo List major components (by name, not part) needed for repair:
turbo Please list part (by name, not part) that was root cause of
failure: this vehicle was pushed out of my stall 3 month ago due to
finding the timing belt coming apart due to lack of oil changes. the
timing belt is flaking chunks of rubber off into the oil. when i
removed the oil filter for the turbo i found the filter is completely
full of the material coming off the timing belt. contacted hotline
about issue. according to hotline Contact ID:118035205. Engine oil
that goes past its service life will begin to breakdown and the
chemical buildup from blowby will continue collecting. In extreme

cases such as this one the oil breakdown eventually ends up a
corrosive fluid and causes breakdown of rubber components. Due to your
description and photographs there is no doubt this is the root cause
of the timing belt breakdown. my manager wants me to get submit prior
approval for this due to lack of maintenance. I thought we have made
the decision it is not warrantable due to the customer only providing
us with 2 oil change receipts. management wants ford to say its not
warrantable due to lack of maintenance. Are there indications of
Vehicle or Component Abuse, Modifications, or Lack of Maintenance?

RECOMM 04/05/2021 01:30PM DSTOKER2
Hello Aaron, Thank you for the information and the photographs. Engine
oil that goes past its service life will begin to breakdown and the
chemical buildup from blowby will continue collecting. In extreme
cases such as this one the oil breakdown eventually ends up a
corrosive fluid and causes breakdown of rubber components. Due to your
description and photographs there is no doubt this is the root cause
of the timing belt breakdown. Information on an engine oil maintenance
inspection can be found in GSB G0000149. Information on engine failure
inspection can be found in GSB 20-7062. Use these publications to
compare against and determine the condition of the engine. Any engine
components found damaged should be replaced. At minimum the
turbocharger, turbocharger drain and feed lines, and engine timing
belt will need to be replaced. It will also be worthwhile to inspect

the engine oil filter element for debris as well. GSB G0000165 refers
