J# 1 96BUZN252494000 L87 ENGINE LOSS OF P TECH(S):153 825 WARRANTY

OWNER STATES VEHICLE STALLED OUT WHILE DRIVING, NOW THE VEHICLE JUST CRANKS BUT DOES NOT START CHECK AND ADVISE REPLACE LONG BLOCK/TARGET ENGINE (ADD OIL & FILTER) CUSTOMER CONCERN CONFIRMED. WHILE ATTEMPTING TO START VEHICLE, EXTENDED CRANK WAS PRESENT WITH OCCASIONAL CYLINDERS FIRING, AFTER EXTENDED CRANKING (SINGLE BUTTON PUSH BUT EXTENDED) VEHICLE STARTED AND IMMEDIATE ENGINE NOISE WAS NOTED. SCANNED VEHICLE FOR DTC'S AND FOUND CAMSHAFT CORRELATION CODE P0016, AS WELL AS P0326 KNOCK SENSOR MODULE FAULT. NOISE ISOLATED TO BOTTOM END OF MOTOR. P0016 DETERMINES THAT THE ENGINE NEEDS TO BE REPLACED PER GM BULLETIN REGARDING 6.2L GASOLINE ENGINES. ENGINE HAS FAILED DUE TO CRANKSHAFT LUBRICATION FAILURE. REMOVE AND REPLACE LONG BLOCK. FOLLOW BULLETIN N252494000-05.OLD ID [REDACTED] ENGINE REPLACEMENT 9107930 ESCALADE/ TAHOE/SUBURBAN / YUKON / YUKON XL
2WD W / F47 18.3
2WD W/O F47 18.2
4WD W / F47 18.4

Engine Replacement CONFIGURATION AND SETUP COMPLETE
TOP OFF ALL FLUIDS AND TEST DROVE
LABOR CODE: 4067490 BASE 18.4 + 1.0 DIAG + A/C 1.2
OLH ON REMOVAL OF OIL PAN BECAUSE OF ENGINE LOCK UP ON ROD BEARINGS SEIZED UP 4.5

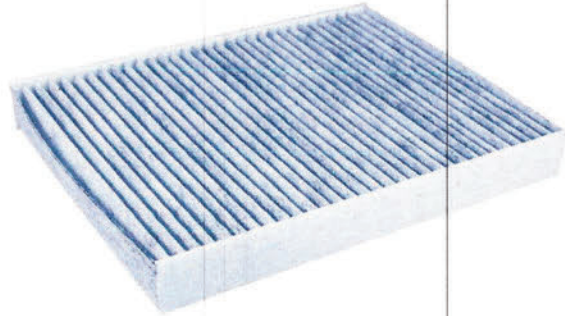
Example - Not Actual Part

A filter that sends clean air into the vehicle's heat and air conditioning system.

The cabin air filter is responsible for filtering air from outside of the vehicle, to the inside. This filter traps dust, pollen, and other fine debris, providing better quality air to you and your passengers. A dirty or clogged filter can limit air flow, putting strain on your climate system. A dirty filter left unchanged can introduce a dusty, dirty, or musty smell to your interior.

Replace Your Cabin Air Filter

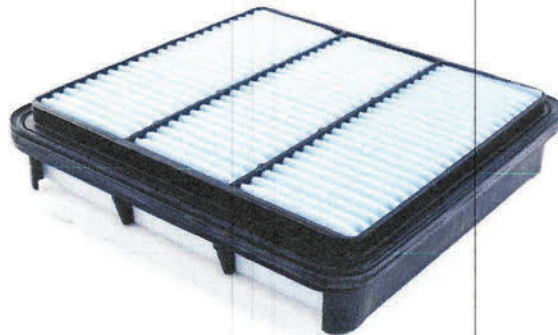
Example - Not Actual Part

A filter that keeps out dust and debris and sends clean air to your engine intake.

The engine air filter is responsible for keeping dust and debris from entering your engine's intake. A dirty or clogged air filter will restrict the amount of air entering your engine. This can cause a decrease in fuel mileage, reduced horsepower, and possible misfiring. A missing air filter can allow dust, rain, and other debris, like leaves and insects, to enter your engine and damage internal components.

Replace Your Engine Air Filter

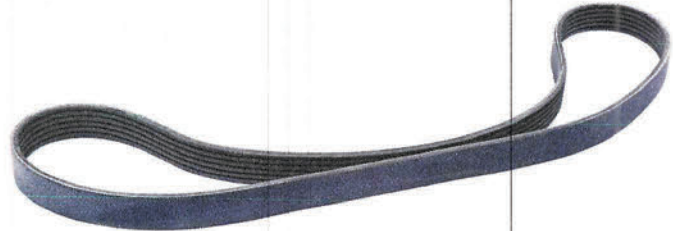
Example - Not Actual Part

A grooved belt that transfers engine power to multiple vehicle systems.

A serpentine or drive belt provides power to systems such as your air conditioning, alternator, power steering, and/or cooling system. This critical part allows these systems to operate. A worn belt may squeal, or slip. When it does this it is unable to provide the proper power to vital components. A damaged or failed belt can lead to engine overheating, loss of power steering, or cause your air conditioning system to be inoperable. Belts should be immediately replaced if there are any visible signs of wear such as cracks, abrasions, or damaged ribs.

Replace Your Serpentine/Drive Belt(s)

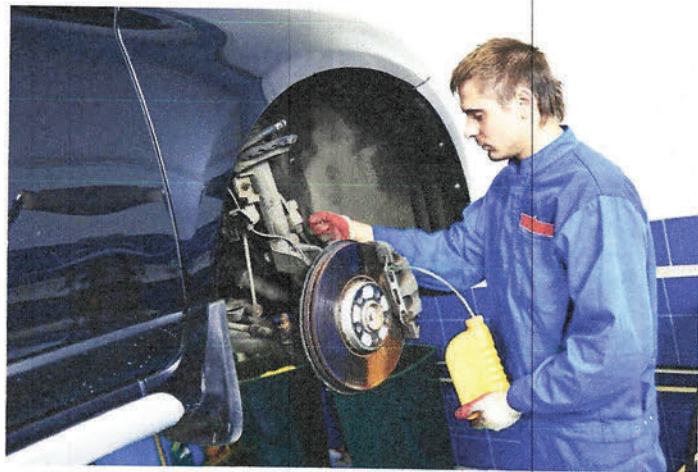
A service that replaces dirty and contaminated brake fluid with fresh and clean fluid to provide the best performance for stopping your vehicle.

Your brake fluid builds up with contaminants and excess moisture from being used, which cause it to break down and become ineffective. As the fluid breaks down it can begin to damage rubber seals and cause rust to form in your brake system. Dirty brake fluid can't provide the right amount of pressure to stop your vehicle, endangering your safety. Replacing this contaminated fluid with new brake fluid will help make sure your vehicle can stop safely and will increase the lifespan of other components of your brake system.

Flush Your Hydraulic Brake System
