**SAFETY RECALL RVXX0406
SECOND NOTICE SEPT. 2005**

Volvo Trucks North America, Inc. has decided that a defect, which relates to motor vehicle safety, exists in certain Volvo VN and Volvo VHD model vehicles built between July 1, 2000 and June 18, 2004.

SAFETY DEFECT: The windshield wiper motor may be susceptible to road salt spray intrusion that could possibly lead to a wiper motor connector malfunction.

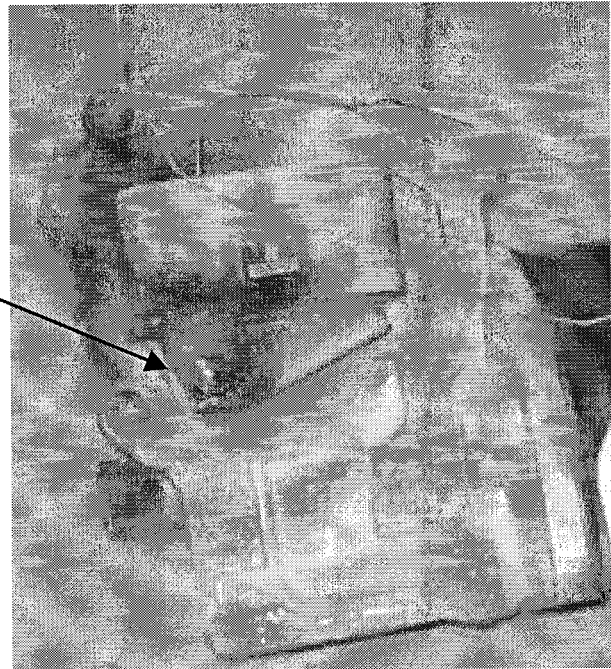
POTENTIAL RISK: If a wiper motor connector malfunction exists, the connector may begin to overheat, which could lead to a vehicle fire. This condition may exist with the wipers in the parked position (i.e. not in motion).

The two images below show connectors that exhibit signs of overheating:

Example of melted connector:
(Plastic melted and charred)

REPAIR: A Volvo Truck Dealer will replace the connector on the wiper motor at no charge to you regardless of your vehicle's age or mileage. The labor time required to repair your vehicle is approximately 30 minutes.

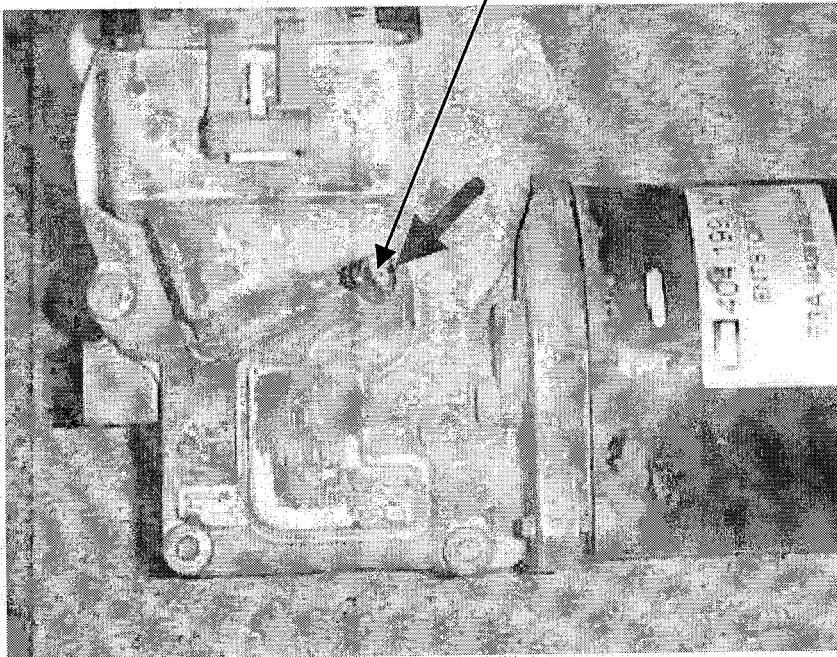
Example of melted connector (plastic deformed)
