IC Corporation

REVISED INSTRUCTIONS For VANDAL LOCK WARNING RECALL

**IC CORPORATION RECALL # 04305
NHTSA RECALL # 04V- 498**

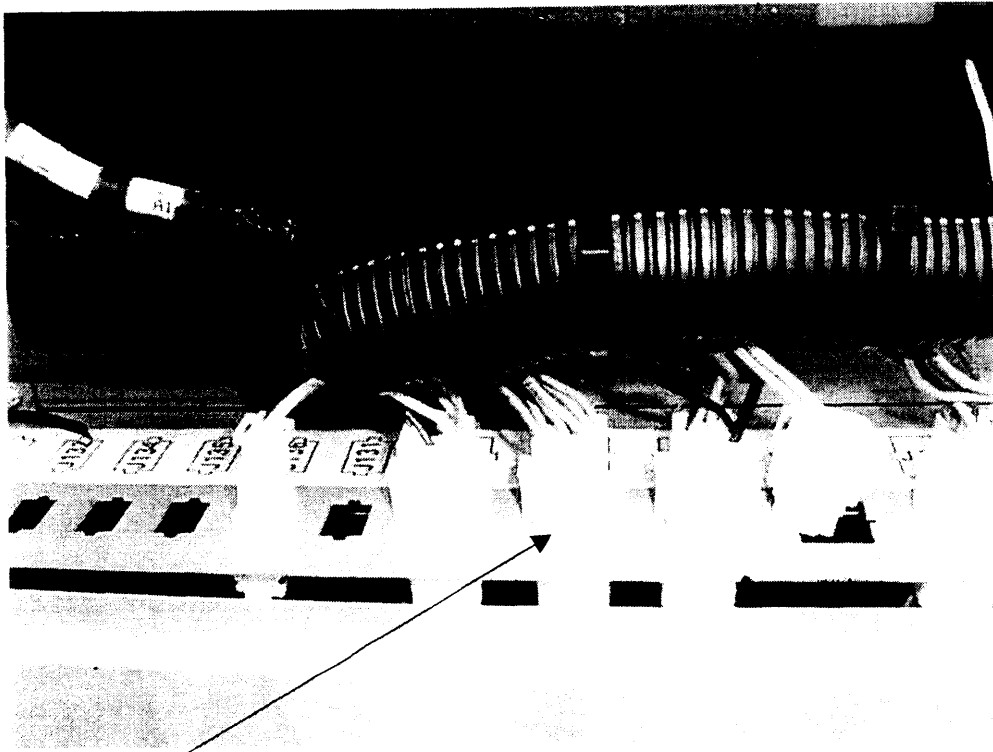
The J6 connector should be located in this slot identified as J6

Find #58 pink wire that connects between the starter interrupt relay pin #86 at one end and to the lower left hand body connector J6. See backside for picture of J6 connector. (NOTE: There are four (4) number 58 wires connected to this relay so pay special attention and verify that you select the correct one). Performing a continuity check will confirm that the right wire is chosen. The relay with the pink number 58 wires may be located on either side of the body fuse block.
