Technical Bulletin

Section Title: Engine TSB No. TS 02 09214R

SUBJECT: SAFETY RECALL CAMPAIGN "KE", ECM SOFTWARE UPDATE

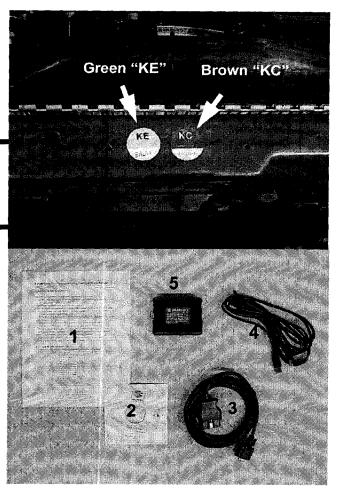
- 2. In order to complete the Campaign you need a PC and the following items pictured to the right: Operator's manual (1), the Software CD (2), the diagnostic System Cable (3), the USB Cable (4) and the SDS Interface Box (5). Extra SDS Tool's and Software CD's are available on suzukipitstop.com
- The software includes a detailed operator's manual which fully explains PC minimum requirements, software installation, USB driver installation, the vehicle reprogramming procedure and trouble shooting charts. Please follow the instructions carefully and completely.
- 4. After successfully completing reprogram be sure to affix the "KE" sticker with the dealer number to the radiator core support as shown above. For vehicles that do not have the "KC" sticker please affix the included "KC" sticker along with the "KE" sticker. This update includes the "KC" Campaign fixes.
