## RECALL REPAIR NOTIFICATION Passenger Airbag Replacement

No: RB186  
FGN  
Ref:  
Issue: 1  
Date: 20 December 2004

Freelander (LN)

## REPAIR PROCEDURE

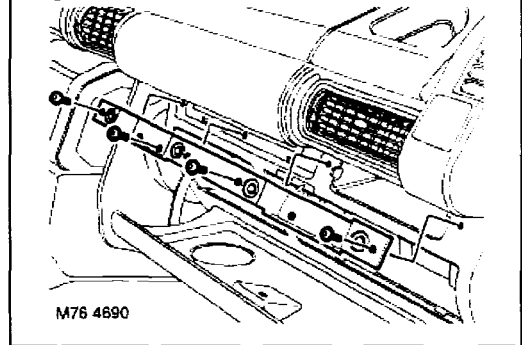
Figure 1

1. Refer to GTR Workshop Manual Section 76.74.02. Remove the original airbag assembly and install a new assembly. (Figure 1)

A concern has been identified on specific 2005MY Freelander vehicles where the passenger airbag installed at production may have been manufactured with a substandard component.

Prior to retail sale replace the Passenger Airbag with a correctly manufactured part. **Federal law requires Retailers to complete any outstanding safety action service before a new vehicle is delivered to the buyer or lessee. Violation of this requirement by a Retailer could result in a civil penalty of up to \$5,000 per vehicle.**
