Honda Motor Co., LTD has announced a safety recall campaign for certain 2005 Civic Si vehicles.

Applies To: 2005 Civic Si – From VIN SHHEP3...5U500001 thru SHHEP3...5U500345

Safety Recall: Civic Si Seat Belt Lower Anchors (Supersedes preliminary service bulletin 04-071, dated November 19, 2004)

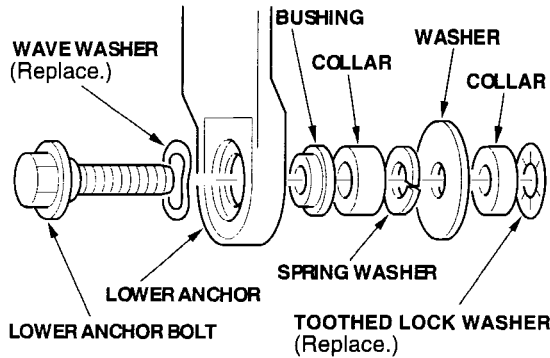
Lower anchor bolt installation

- Remove the lower anchor cap and the lower anchor bolt. Keep the anchor bolt washers and collars in their exact order.

NOTE: The seat belt anchor bolts are installed with several washers and collars that must be kept in exact order for the anchor to work. Before you remove an anchor bolt, study the anchor bolt diagram carefully.

- Disassemble the anchor bolt, then discard the wave washer and the toothed lock washer.
- Reassemble the anchor bolt in the correct order with a new wave washer and a new toothed lock washer.
- Make sure there are no twists or kinks in the seat belt.
- Apply Hondalock 2 Threadlock to the anchor bolt threads. Reinstall the bolt by hand, and then torque it to 32 N·m (24 lb-ft).
- Reinstall the lower anchor cap.
- If needed, repeat steps 2 thru 7 on the other lower seat belt anchor.
- Center-punch a completion mark above the first character of the engine compartment VIN.

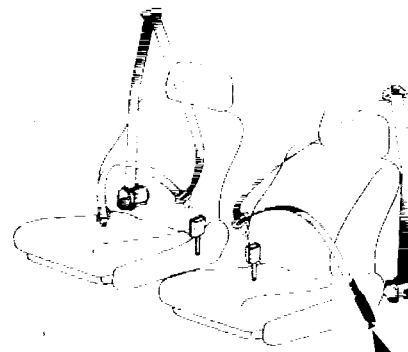
LOWER ANCHOR

As soon as possible, check the movement of the driver's and front passenger's seat belt lower anchors. The lower anchors are between the seat and the door, bolted below the door (see the illustration below). Both anchors should move freely without binding or sticking. If either anchor binds or sticks, your vehicle needs to be repaired.
