In our continuing effort to ensure your safety and the safety of your passengers and others, Nissan became aware of a potential safety defect with the tow hitch on some 2005 Xterra vehicles. As a result, we initiated a Safety Recall Campaign to replace the tow hitch on the affected vehicles.

Subject: 2005 Xterra Tow Hitch Voluntary Safety Recall Campaign Update #3

INTERIM REPAIR INSTRUCTIONS 2005 XTERRA TOW HITCH REMOVAL / DISPOSITION

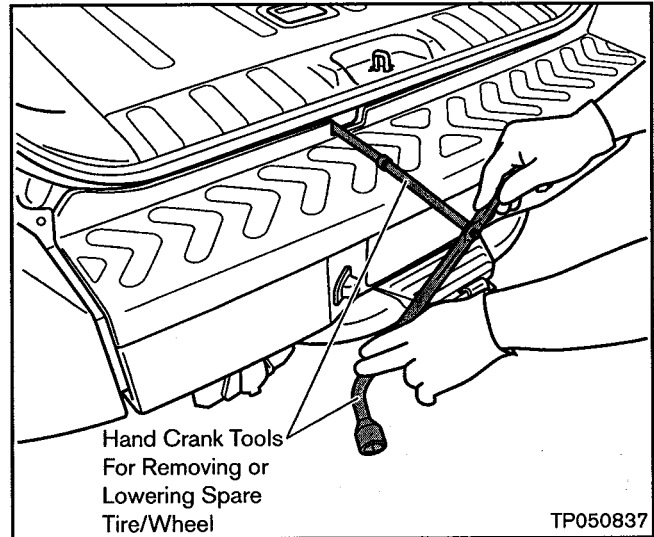
Figure 1

1. Remove or lower the Spare Tire/Wheel using the Hand Crank tools from the tool kit (see Figure 1).

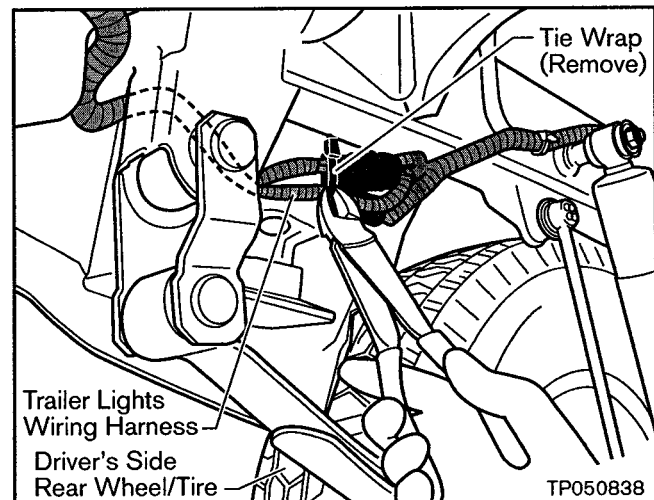
Figure 2

3. Cut and discard the Tie Wrap that holds the Trailer Lights Wiring Harness Connectors (see Figure 2).

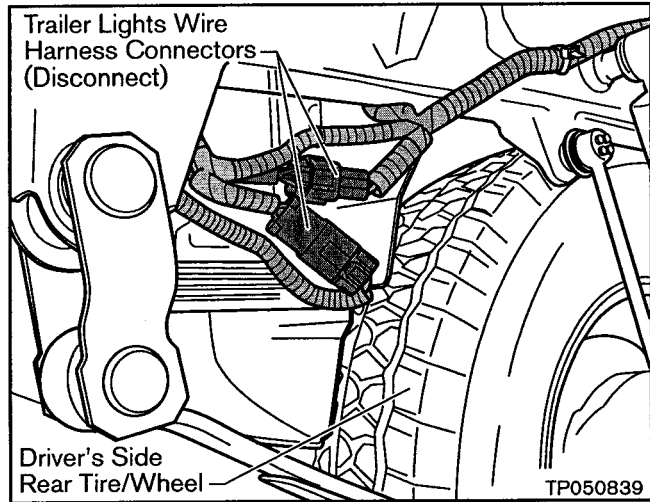
Figure 3

4. Disconnect the Trailer Lights Wiring Harness Connectors (see Figure 3).

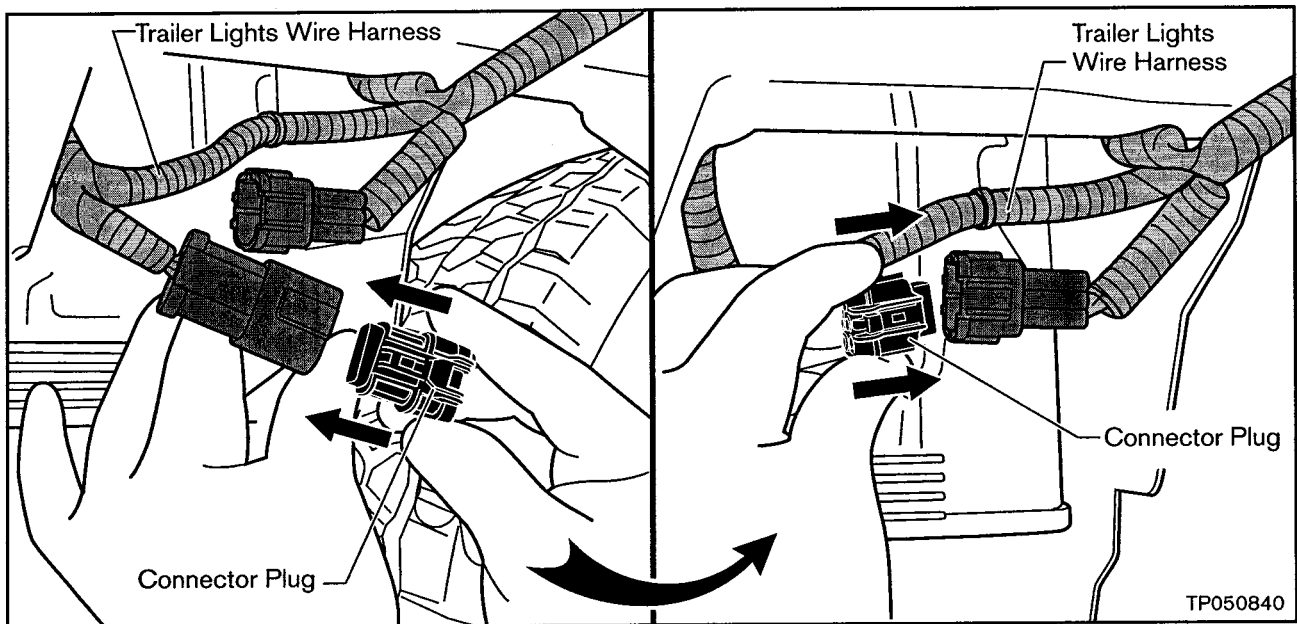
Figure 4

5. Install Plastic Connector Plugs into the vehicle side of the Trailer Lights Wiring Harness Connectors (see Figure 4).
- Nissan will send the Connector Plugs directly to your dealership.
 - To obtain additional Connector Plugs, see Parts Information.

CAUTION: Failure to install the Plugs could allow contamination of the electrical terminals and may affect vehicle electrical system functions.

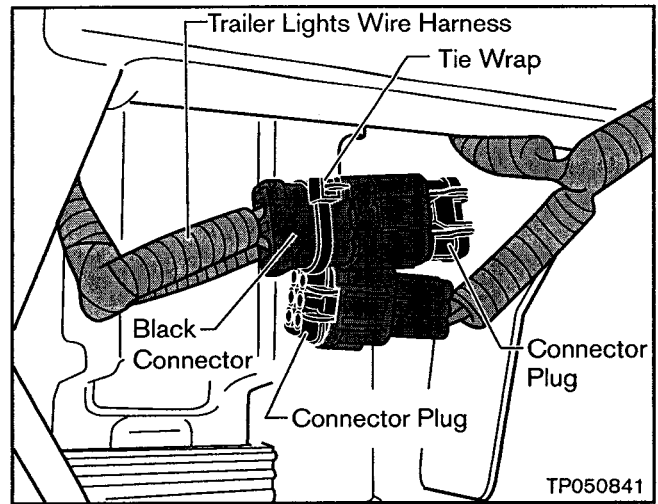
Figure 5

6. After the Connector Plugs are installed, secure the Black Connector to the harness with a Tie Wrap as shown in Figure 5.

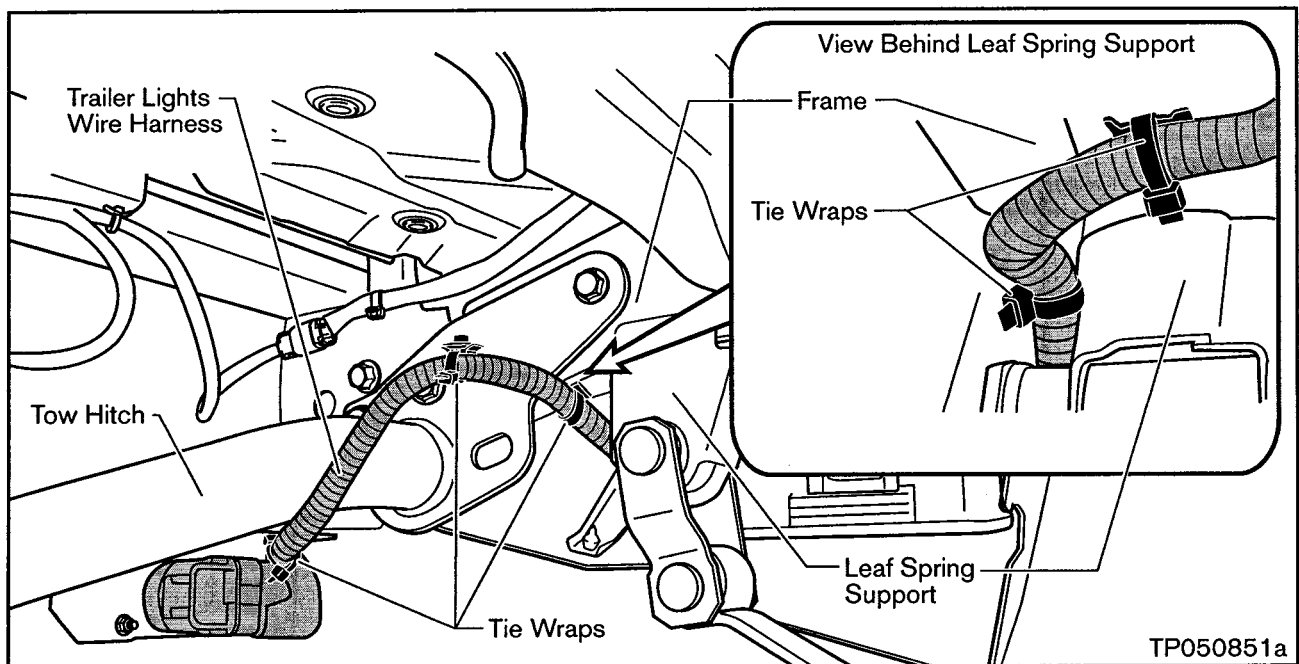
Figure 6

7. Remove the Trailer Lights Wire Harness (Tow Hitch side) from the vehicle as follows:
- Using a suitable pry tool, remove the Harness Tie Wraps from the Frame and Leaf Spring Support (see Figure 6). These Tie Wraps may get damaged during removal.
 - Using needle-nose pliers, release the Harness Tie Wraps from the Tow Hitch (these Tie Wraps will be used again later).
 - Allow the Harness to hang from the Tow Hitch.

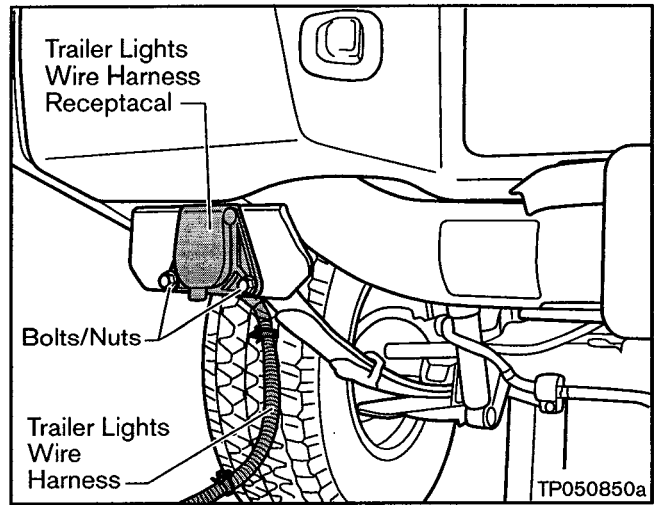
Figure 7

d. Remove two Bolts/Nuts and remove (slide DOWN) the Trailer Lights Wire Harness Receptacle from the Tow Hitch (see Figure 7).

- Once the receptacle is removed, re-install the Bolts/Nuts back into the Receptacle.
- The Bolts/Nuts will be used again later.

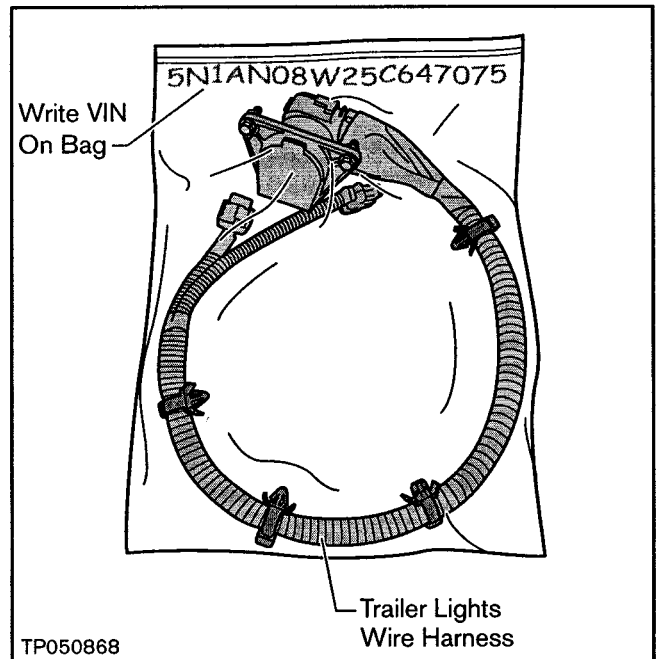
Figure 8

8. Place the removed Trailer Lights Wire Harness in a sealed plastic bag with the VIN written on the bag (see Figure 8).

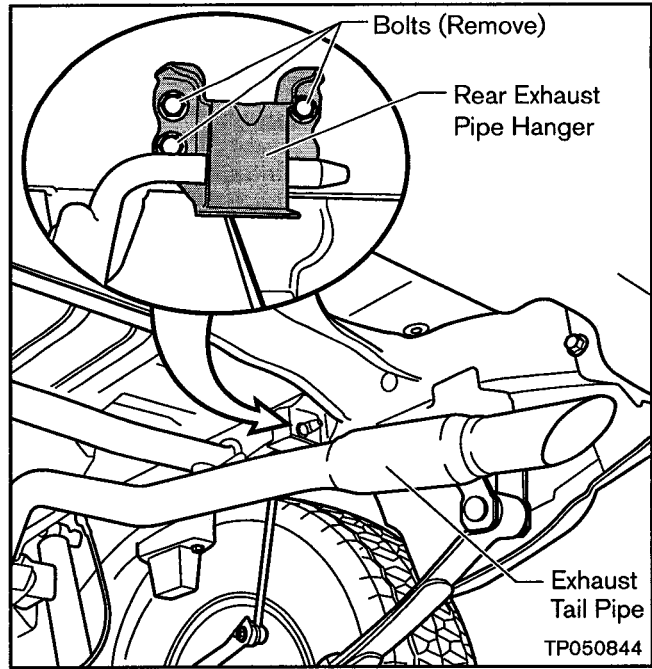
Figure 9

9. Remove three Bolts and disconnect the Rear Exhaust Pipe Hanger from the Frame (see Figure 9).

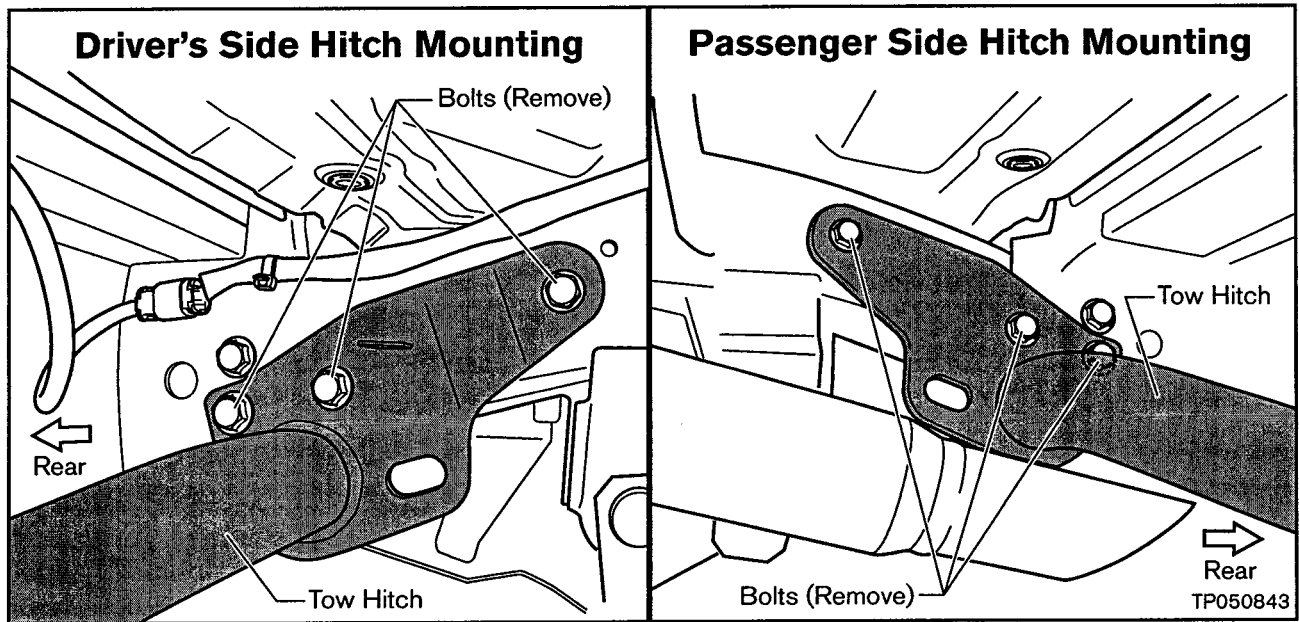
Figure 10

10. Remove the six Bolts that secure the Tow Hitch (see Figure 10).

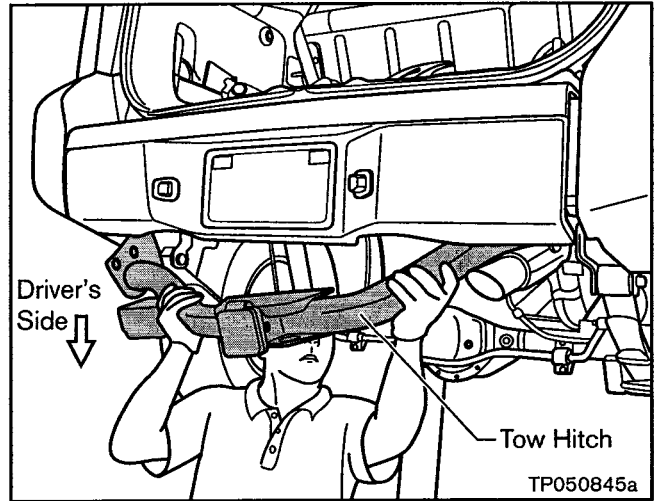
Figure 11

11. Remove the Tow Hitch from the vehicle (see Figure 11).

- When removing, lower the driver's side of the Tow Hitch first.

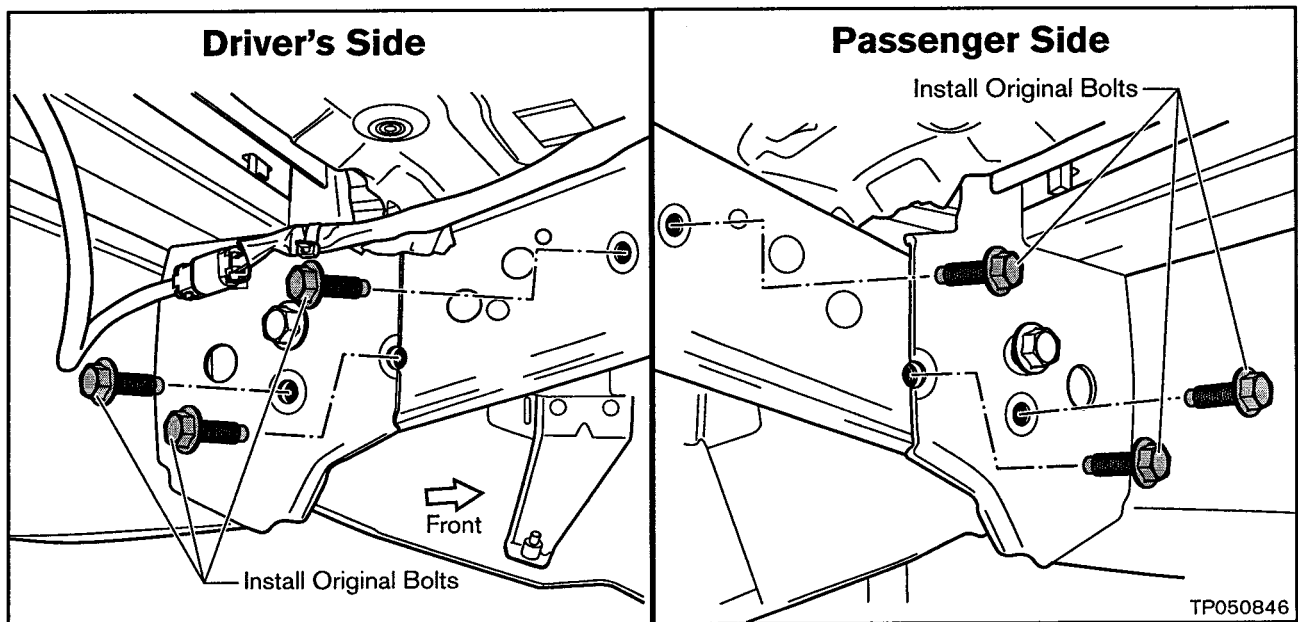
Figure 12

12. Re-install the original Tow Hitch Mounting Bolts into the vehicle frame and tighten the Bolts to **85 – 115 Nm (8.7 – 11.75 kg-m, 63 – 85 ft-lb)**.

CAUTION: You MUST re-install and tighten the original Tow Hitch Mounting Bolts into the vehicle frame. Four of the Bolts hold on the rear Bumper. Two of the Bolts plug up the unused threaded holes to protect from corrosion.

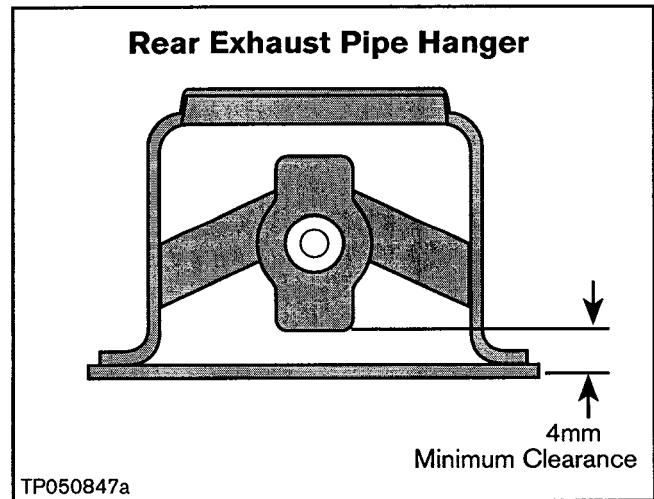
Figure 13

14. Make sure the clearance at the Rear Exhaust Pipe Hanger is at least 4mm (see Figure 13).

- If it's less than 4mm, adjust Exhaust Tail Pipe as necessary for proper clearance.

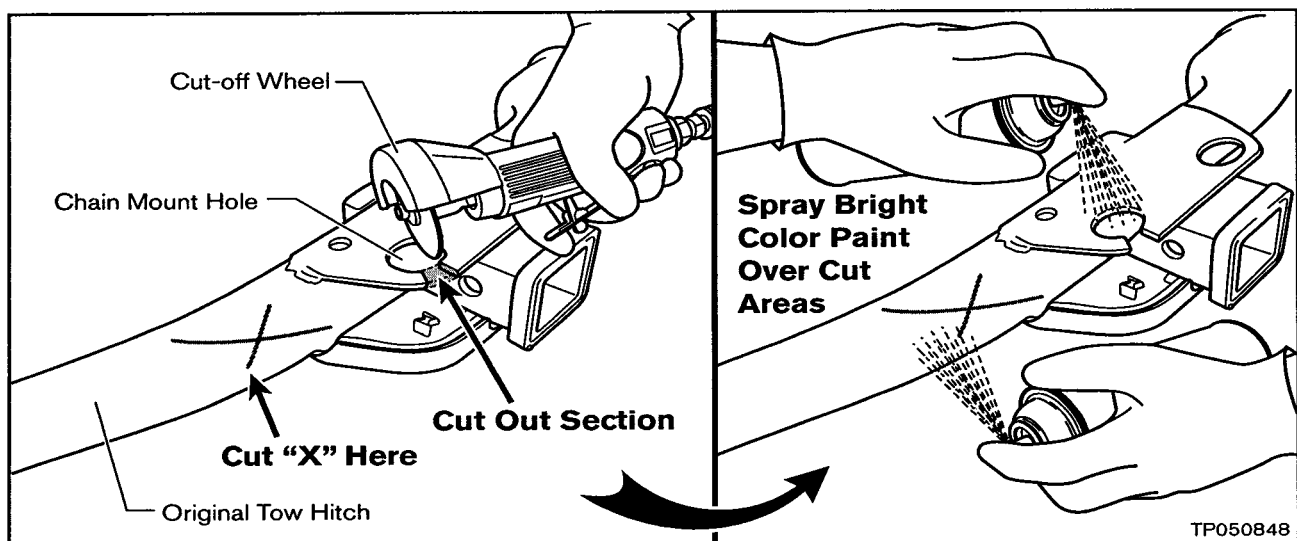
Figure 14

- Using a "cut off wheel" **and suitable hand and eye protection**, remove a section surrounding the Chain Mount Hole as shown in Figure 14. Then cut an "X" in the Tow Hitch surface (about 1/8" deep) as shown in Figure 14.
- Spray bright color paint (orange, red, or yellow) over the cut areas (see Figure 14).
- Discard the Tow Hitch.

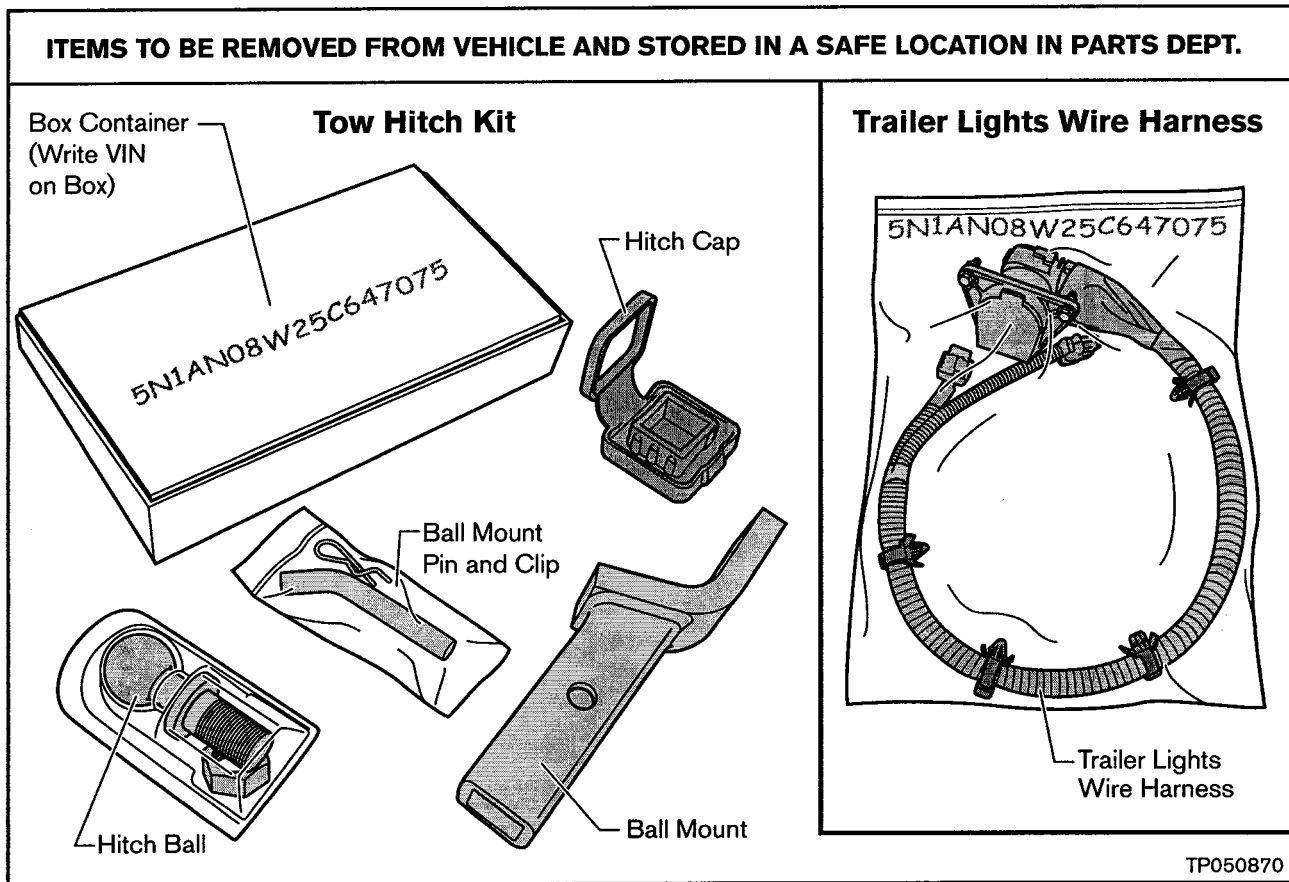
Figure 15

17. Store the Trailer Lights Wire Harness with the Tow Hitch Kit components for this vehicle (see Figure 15) in a safe location within the dealership (for example, Parts Department). These stored components will be re-installed when a replacement Tow Hitch is installed.
